Interim Reclamation and Stormwater Inspection

Date: 08/24/2022

Operator: WESTERN OPERATING COMPANY - 95620

Location ID: 312292

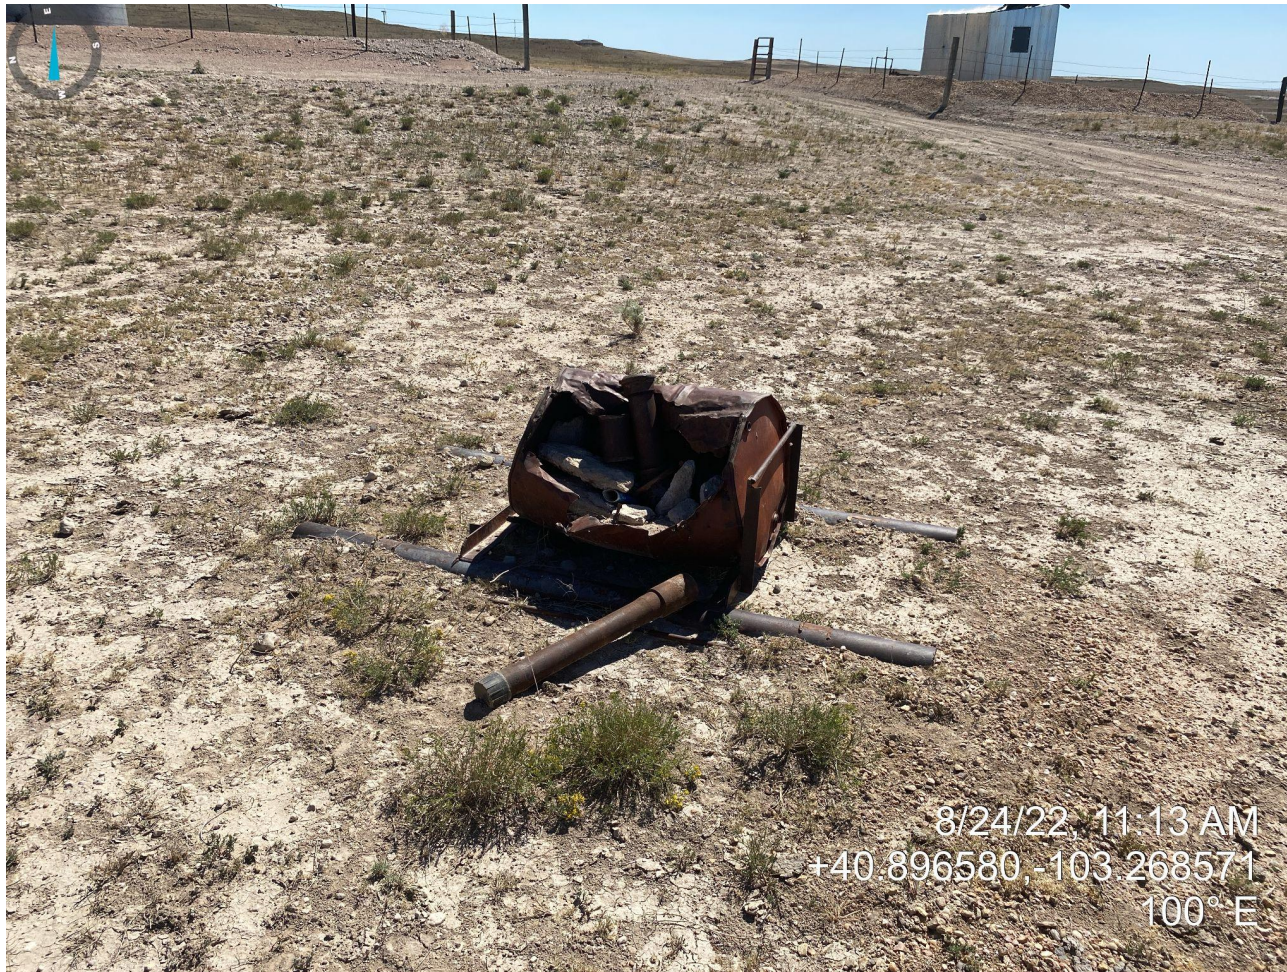
Photo 37. Location photo taken near center portion, facing east. Photo illustrates unused equipment and/or debris left on location.

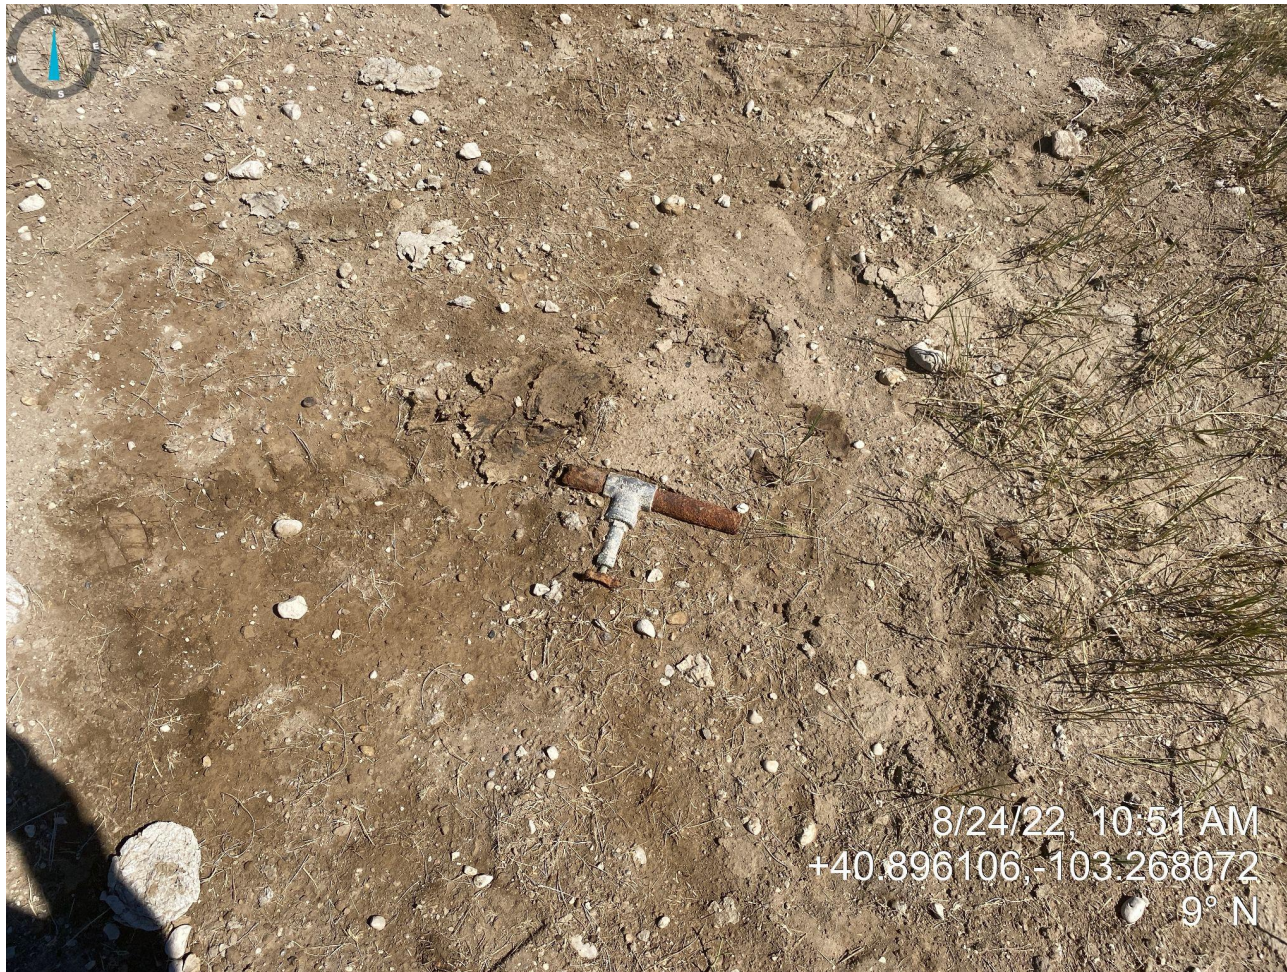
Photo 38. Photo illustrates debris left on location, near the eastern portion by the heater/separator.
