Inspection Photos

Location Name: Champlin 125 AMOCO B-2

Location ID: 322031

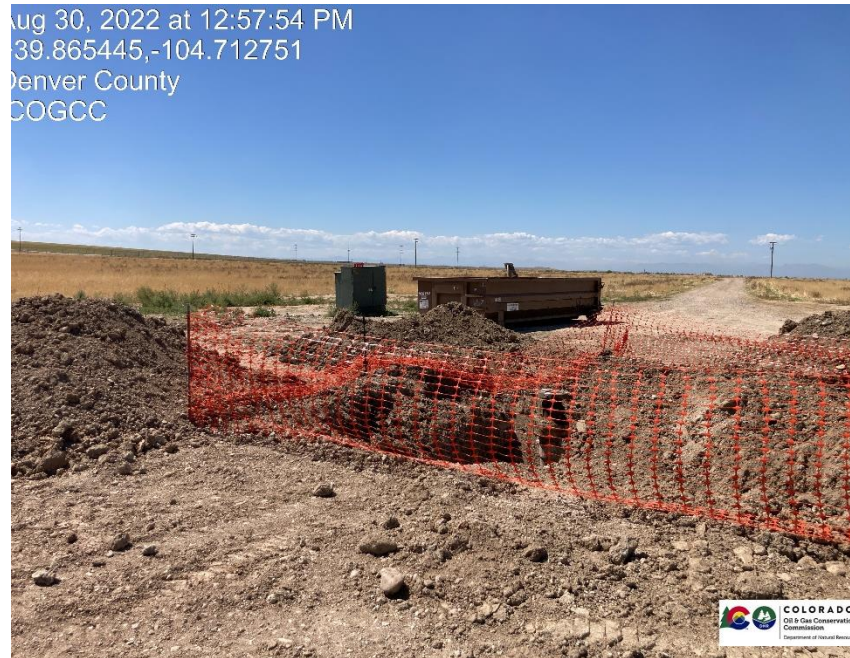
Pic 1 Wellhead needs to be cut.
