Inspection Photos
Location Name: Tiffany 1R
Location ID: 306777

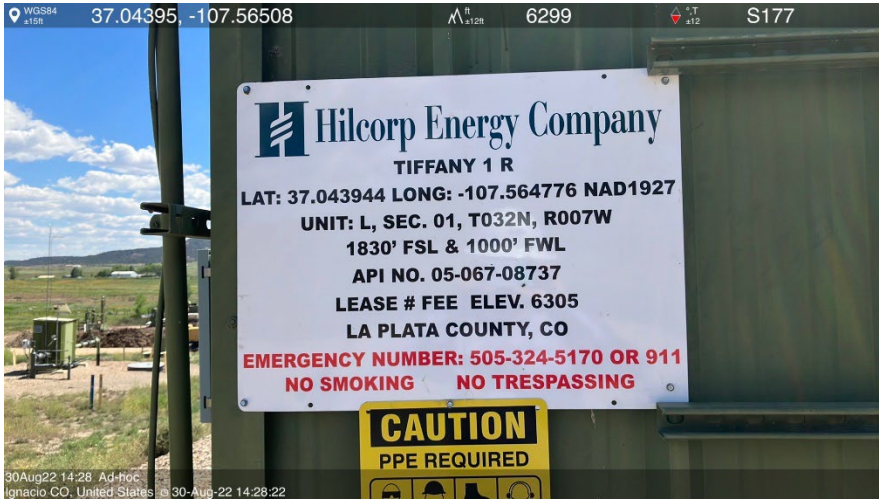
IMG 01
Well sign

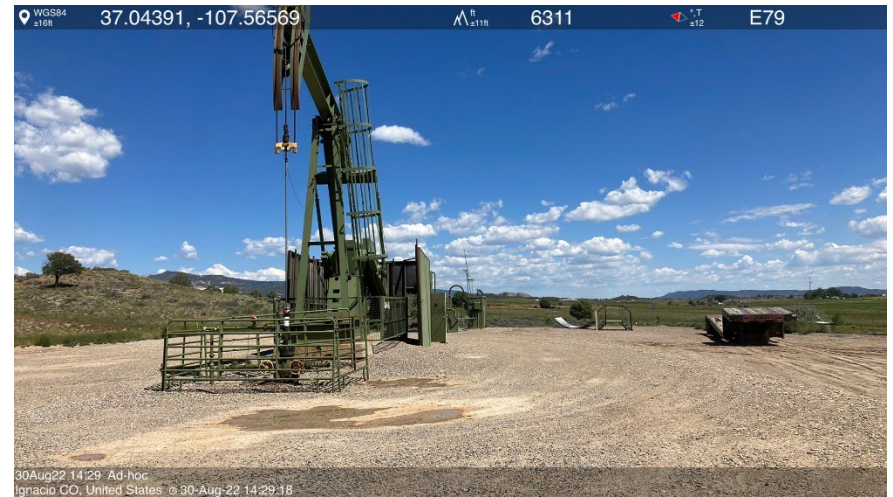
IMG 02
Location overview

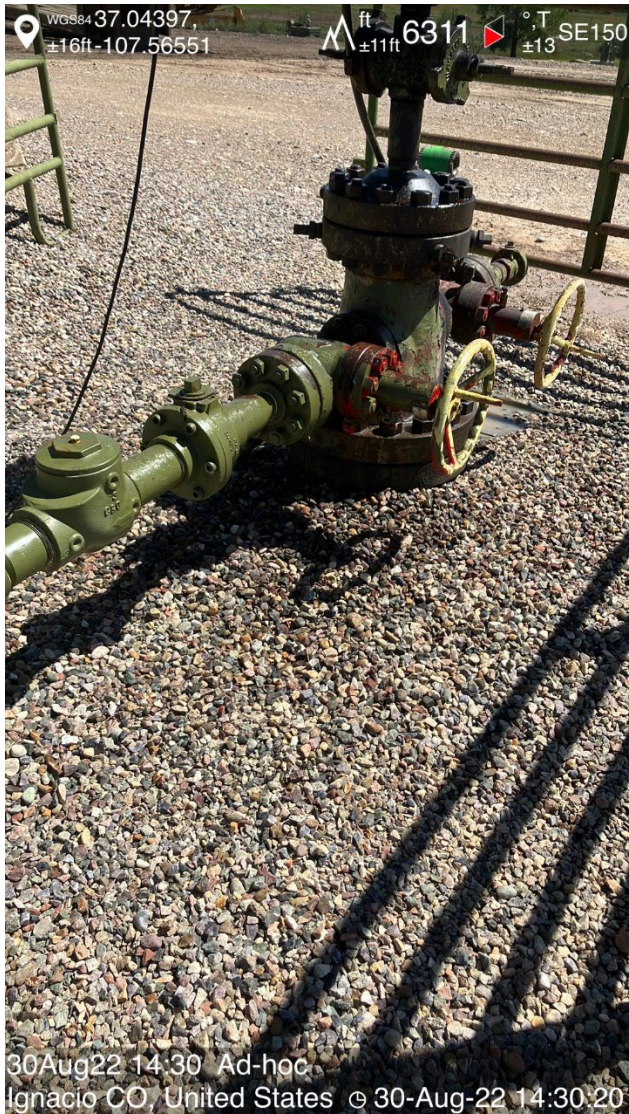
IMG 03

Lube oil has begun to impact surface material
