# Inspection Photos

Loc: 312083

Operator: SIMCOE LLC

Inspection Date: 8/30/2022

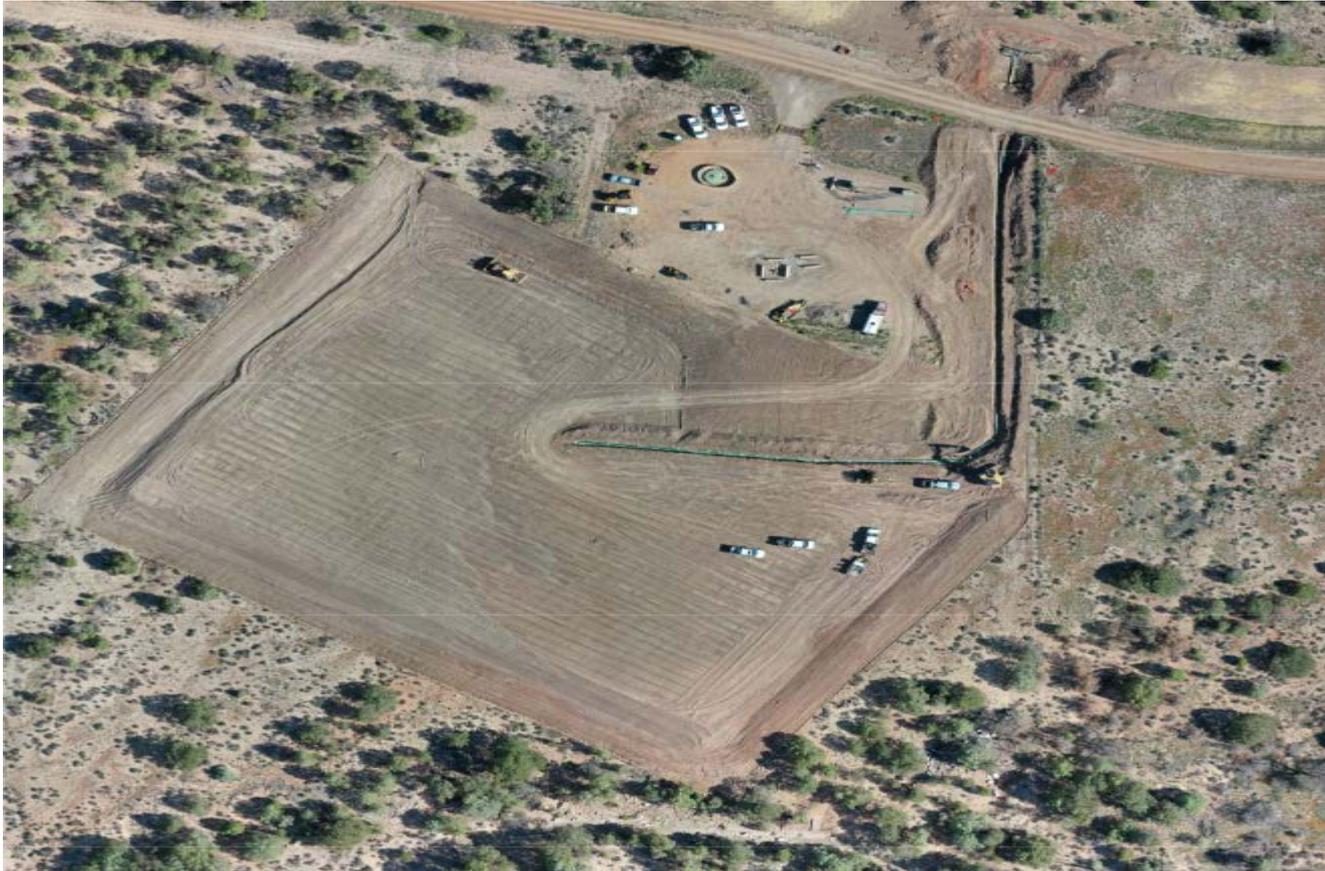
**Photo 1.** Drone aerial image facing down northward to the newly constructed location.

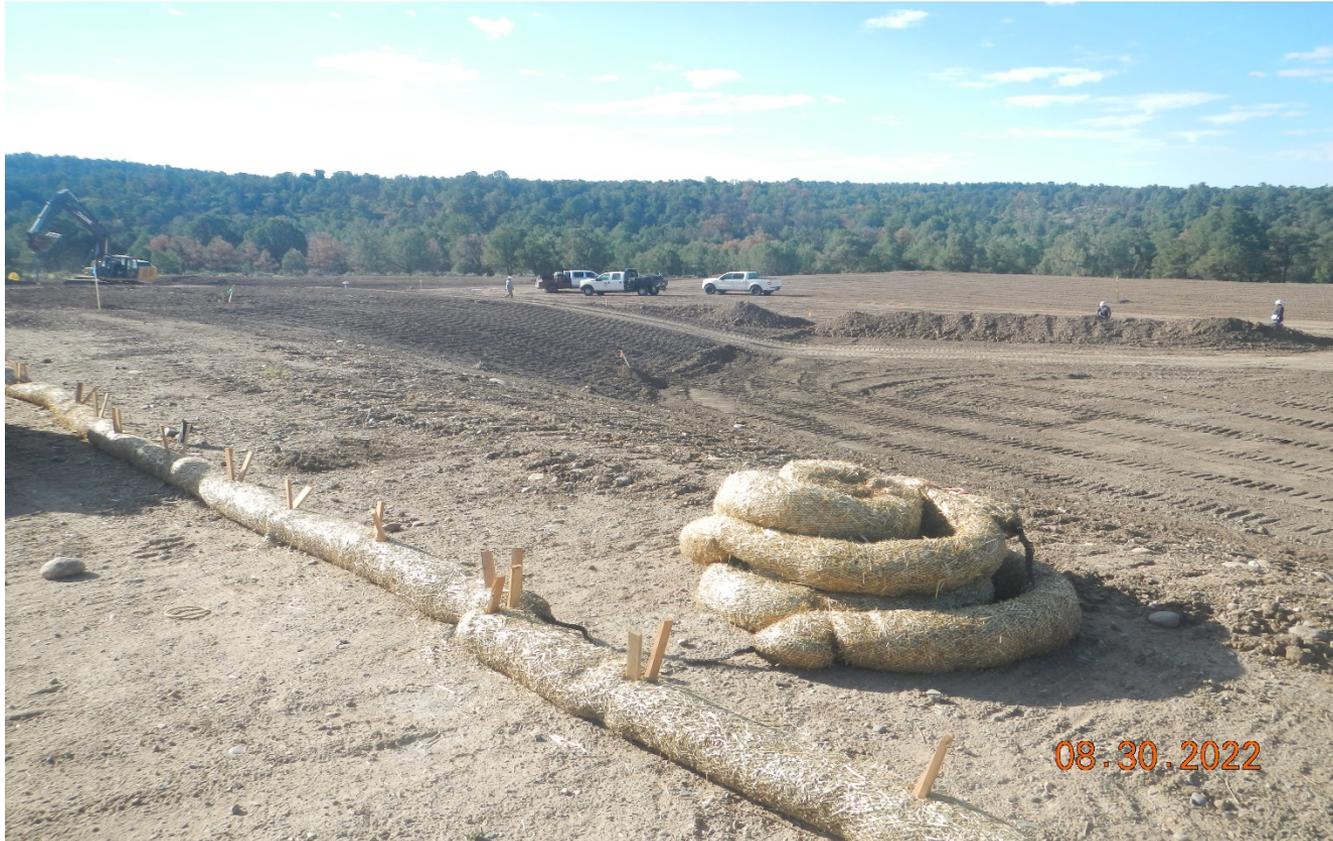
**Photo 2.** Facing southeast toward the location. The perimeter wattles shown in the photo were not trenched into the ground per good engineering practice.

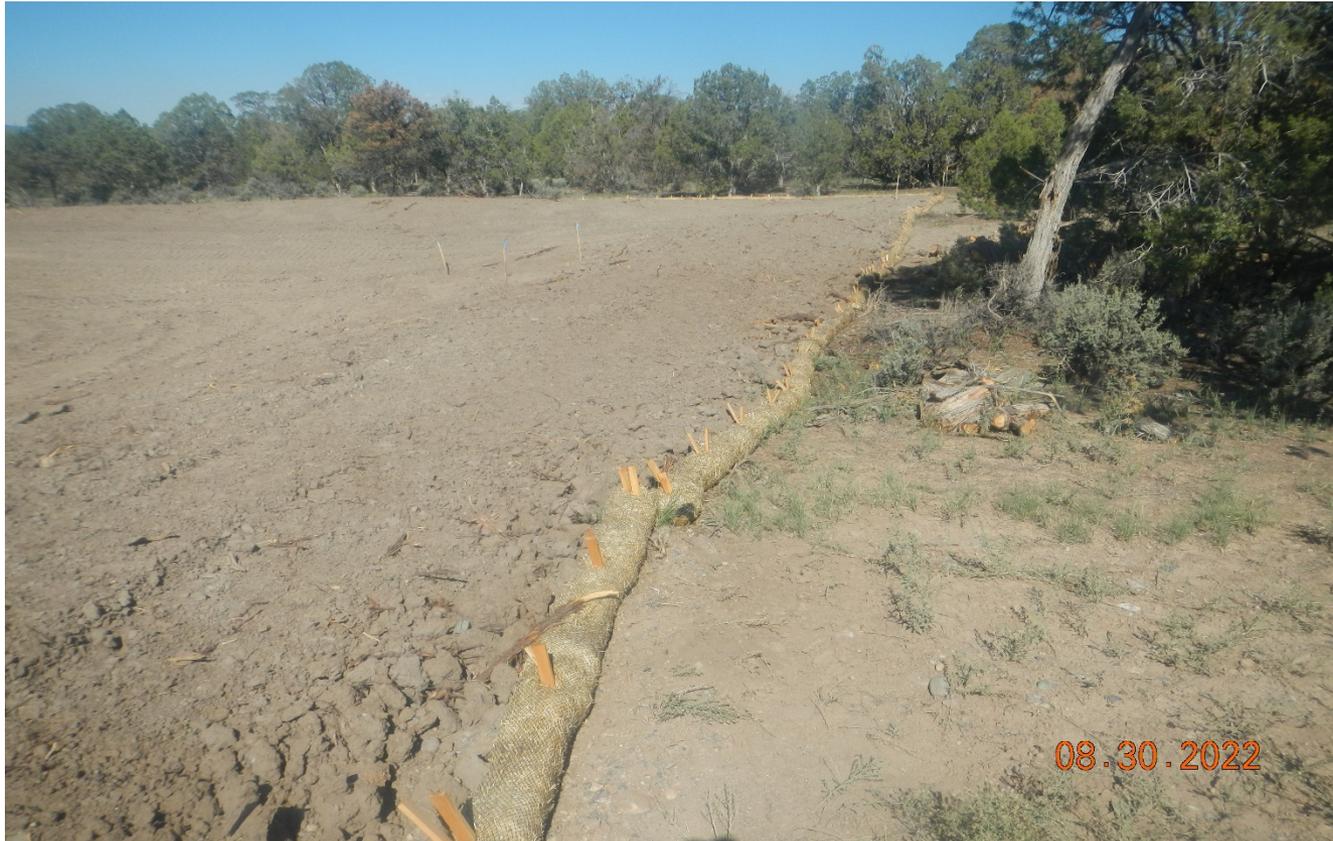
**Photo 3.** Facing toward the northwest side of the location. There is soil pile up and overtopping the stormwater wattles. It appears the 6" wattles are insufficient size.

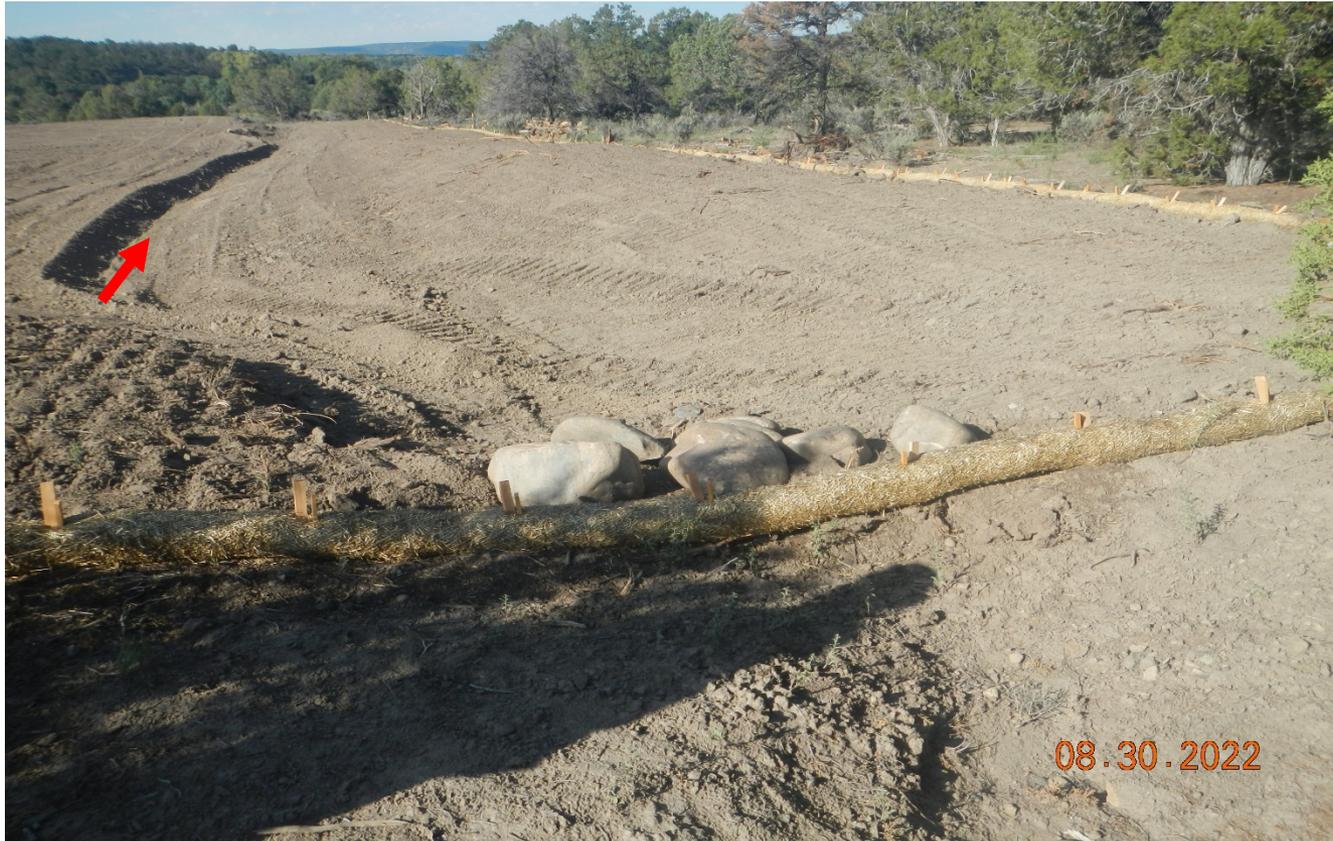
**Photo 4.** Facing southwest at the west side of the location. The rock inlet protection is insufficient in this area. Additional rock needs to be installed in this area and should include angular rock and geotextile. Additionally the stormwater drainage shown at red arrow consists of loose soil with no BMP's to prevent erosion.

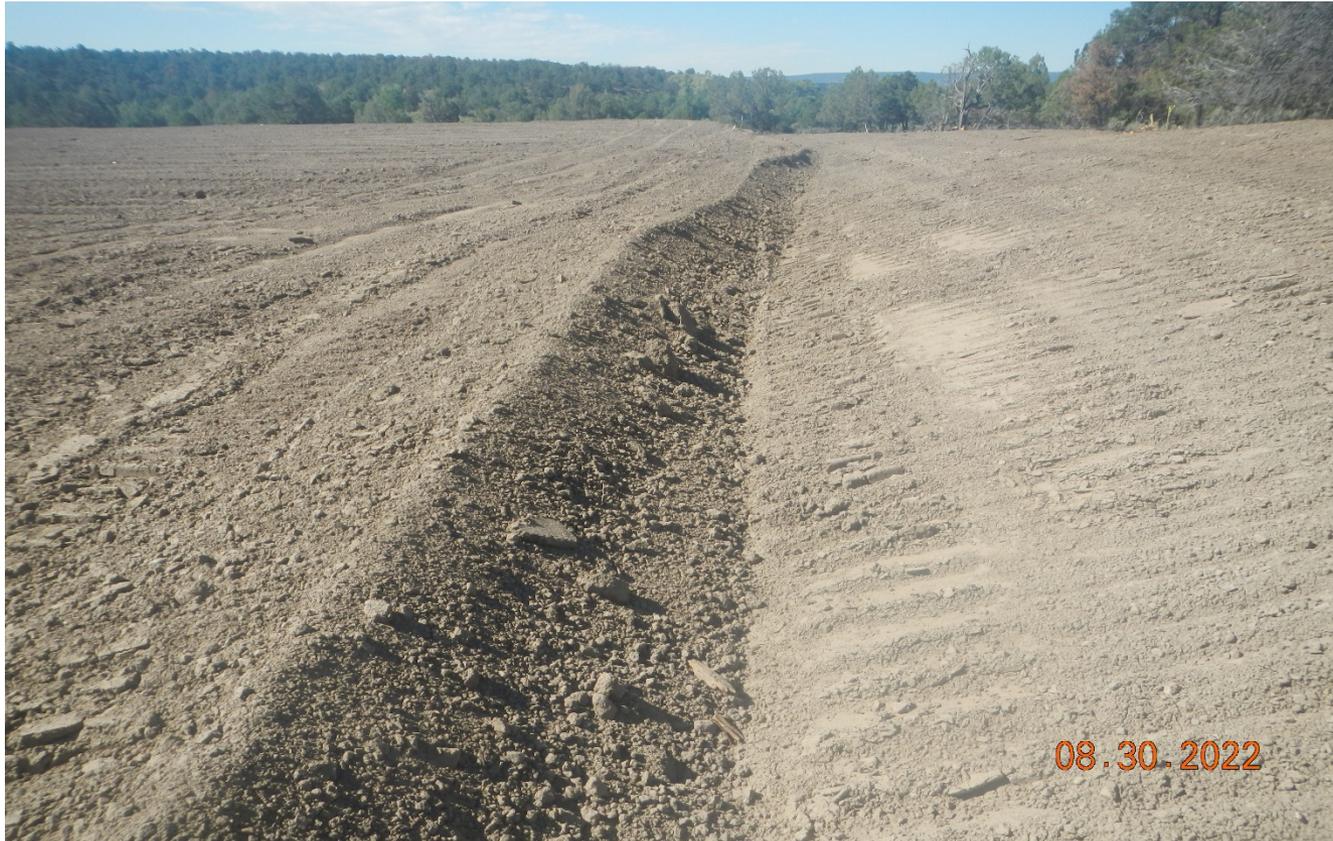
**Photo 5.** Facing southwest toward the stormwater diversion berm. The berm shown on the left is not compacted and loose soils are susceptible to erosion. The topsoil pile on the right side should be separated from the pad material.

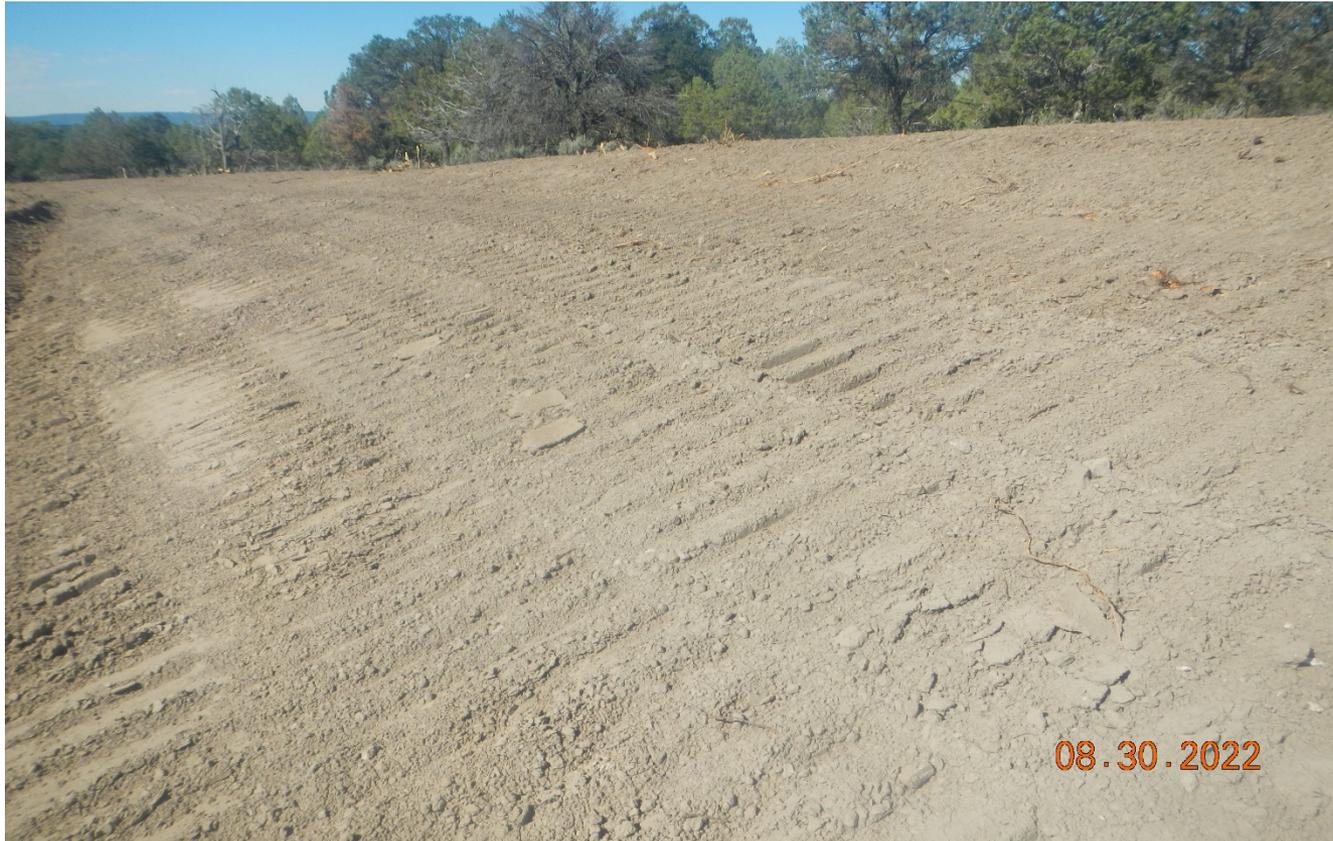
**Photo 6.** The topsoil pile is not properly tracked for temporary stabilization. Tracking must be performed perpendicular to the slope.

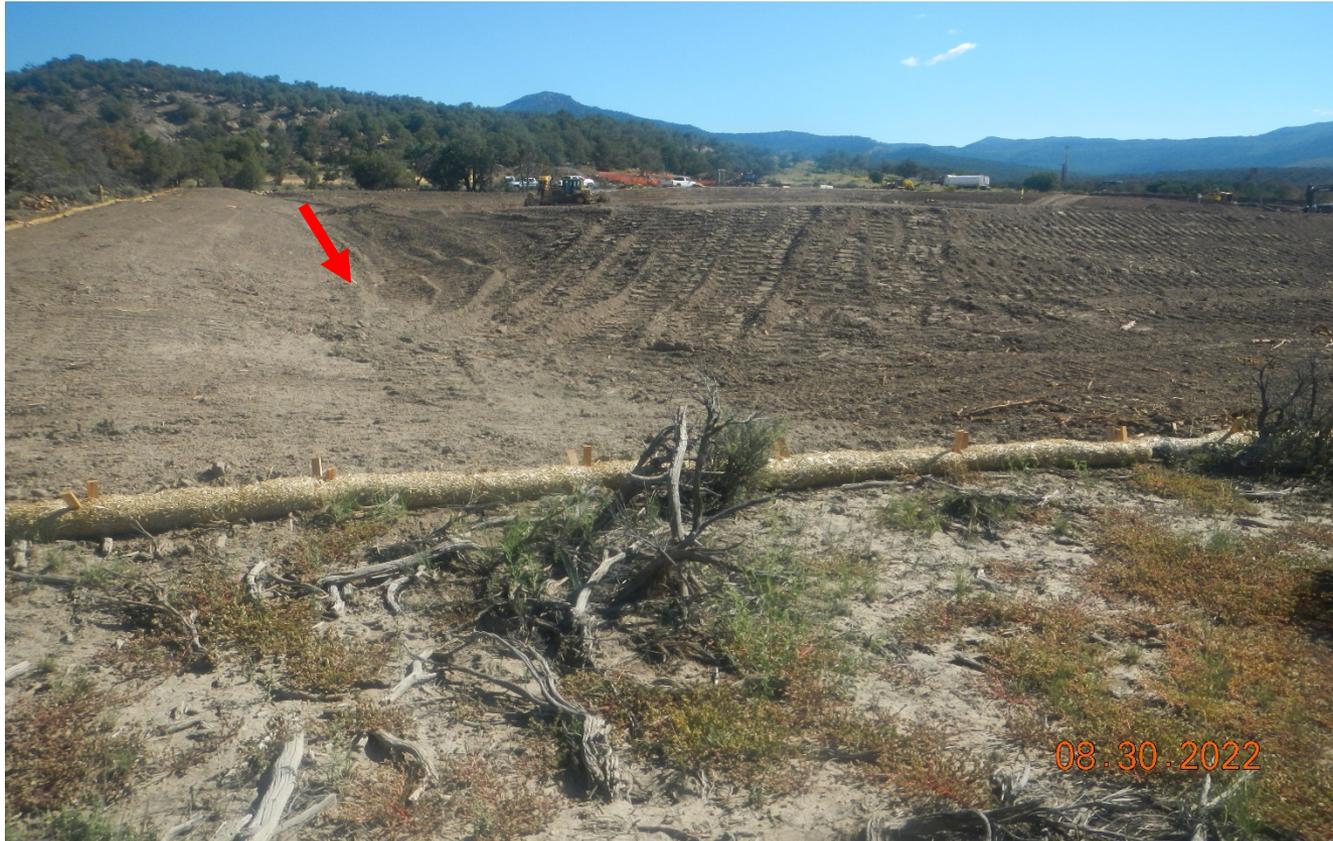
**Photo 7.** Southwest corner of the location facing northeast. There is insufficient BMP's installed in this area. The wattles installed will not prevent sediment migration offsite from the drainage shown at red arrow. Additional BMP's need to be installed which may include sediment trap, rip/rap ect. as determined and installed by good engineering practice.

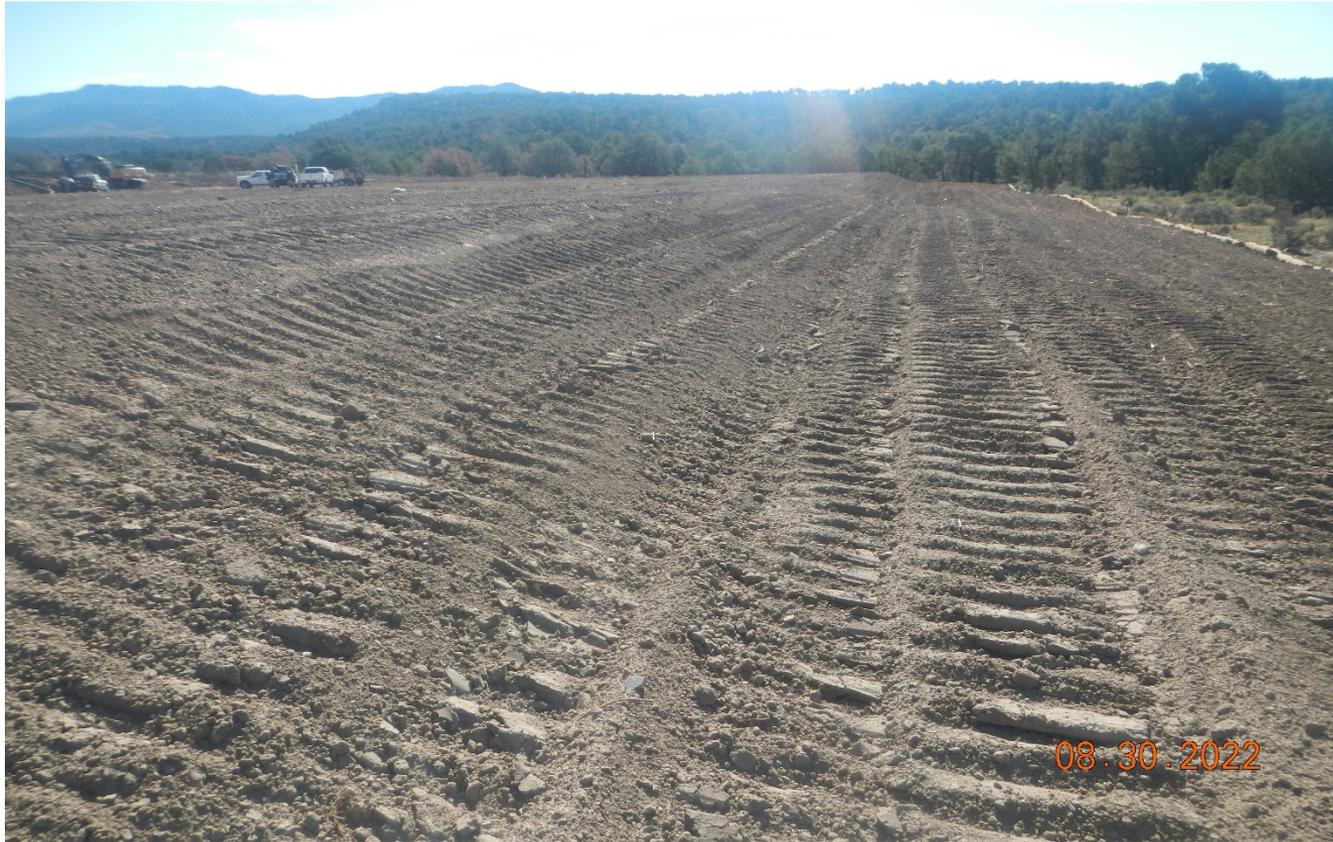
**Photo 8.** Facing southeast along the fill slope of the location. Tracking was not performed perpendicular to the slope.

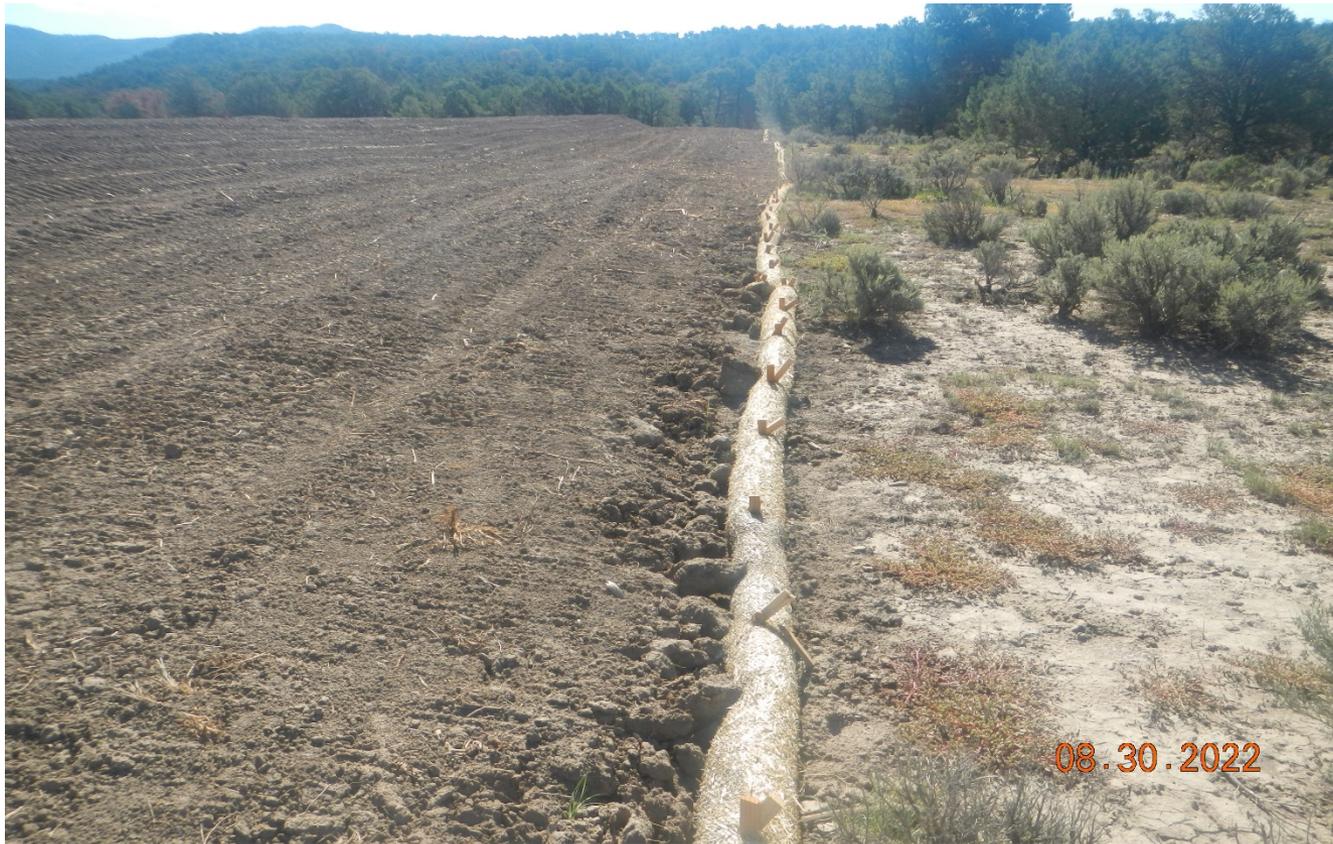
**Photo 9.** South side of the location facing southeast. There is soil piled up and overtopping the stormwater wattles. It appears the 6" wattles are insufficient size.

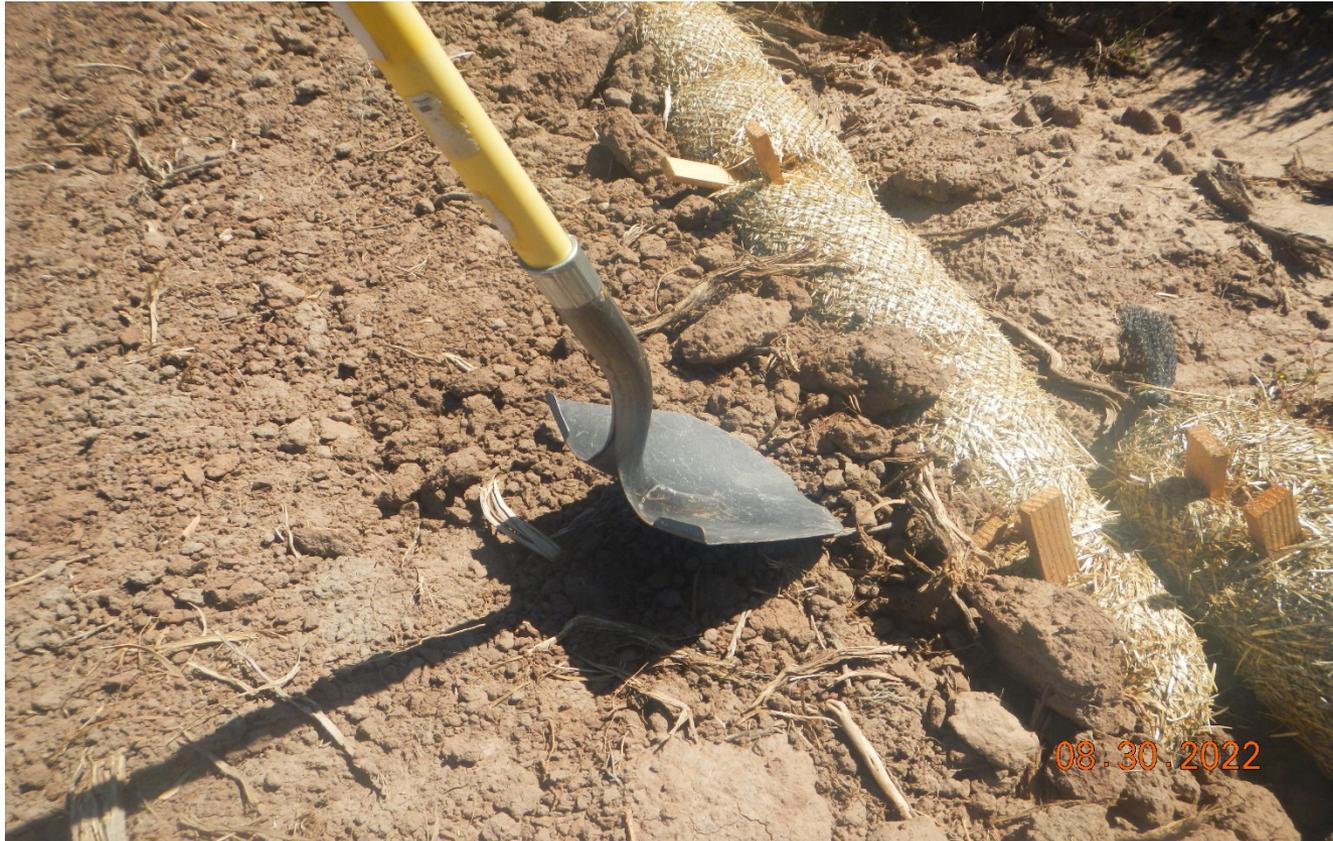
**Photo 10.** There is soil piled up and overtopping the stormwater wattles. It appears the 6" wattles are insufficient size.

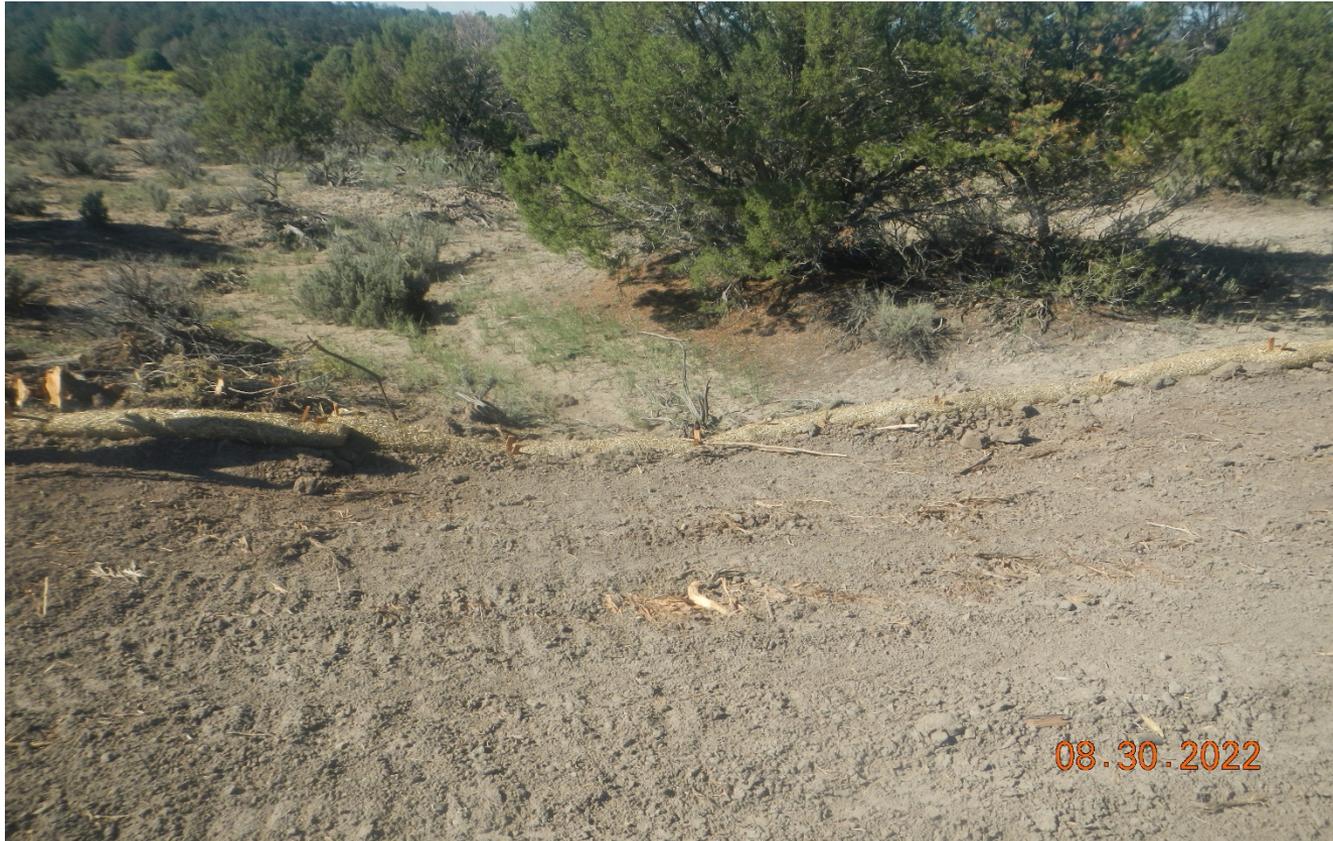
**Photo 11.** Stormwater drainage and sediment directed to this area will overtop the wattles shown at red arrow. Additional BMP's need to be installed and tracking needs to be done perpendicular to the slope.

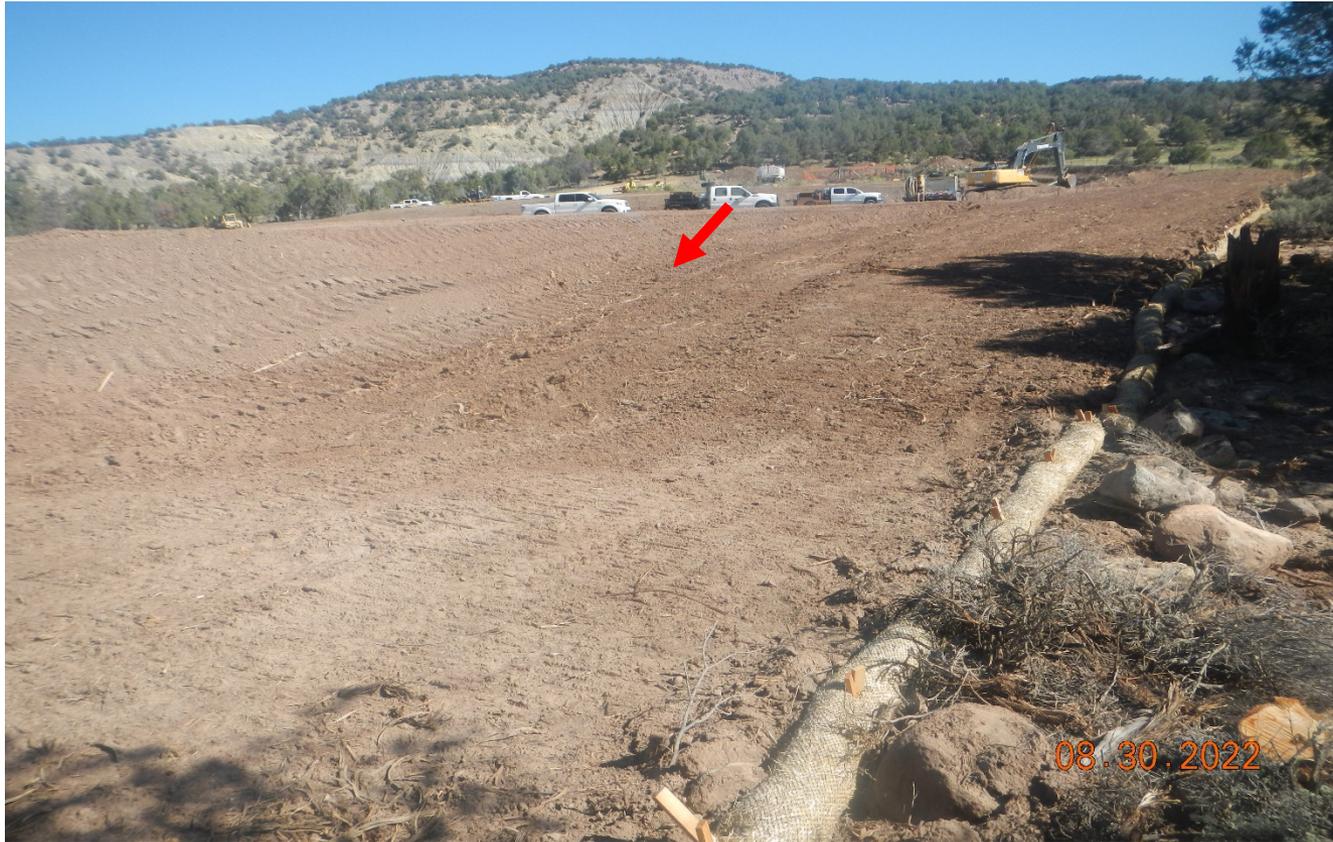
**Photo 12.** Southeast corner of the location facing north. There is insufficient BMP's installed in this area. The wattles installed will not prevent sediment migration offsite from the drainage shown at red arrow. Additional BMP's need to be installed which may include sediment trap, rip/rap ect. as determined and installed by good engineering practice.

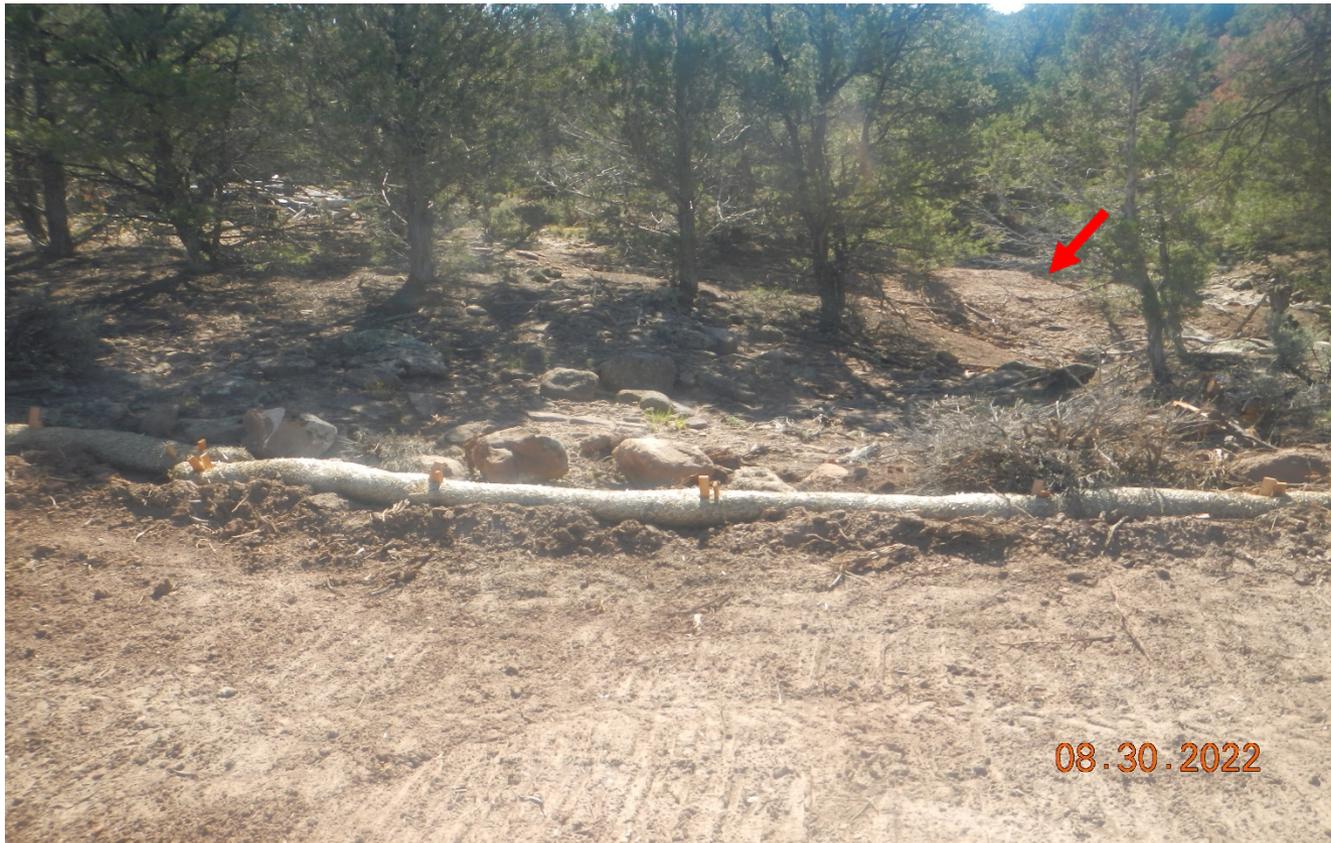
**Photo 13.** There is an ephemeral drainage show at red area approximately 60' from the wattles. The wattles installed will not prevent sediment migration offsite from the drainage shown at red arrow. Additional BMP's need to be installed which may include sediment trap, rip/rap ect. as determined and installed by good engineering practice.

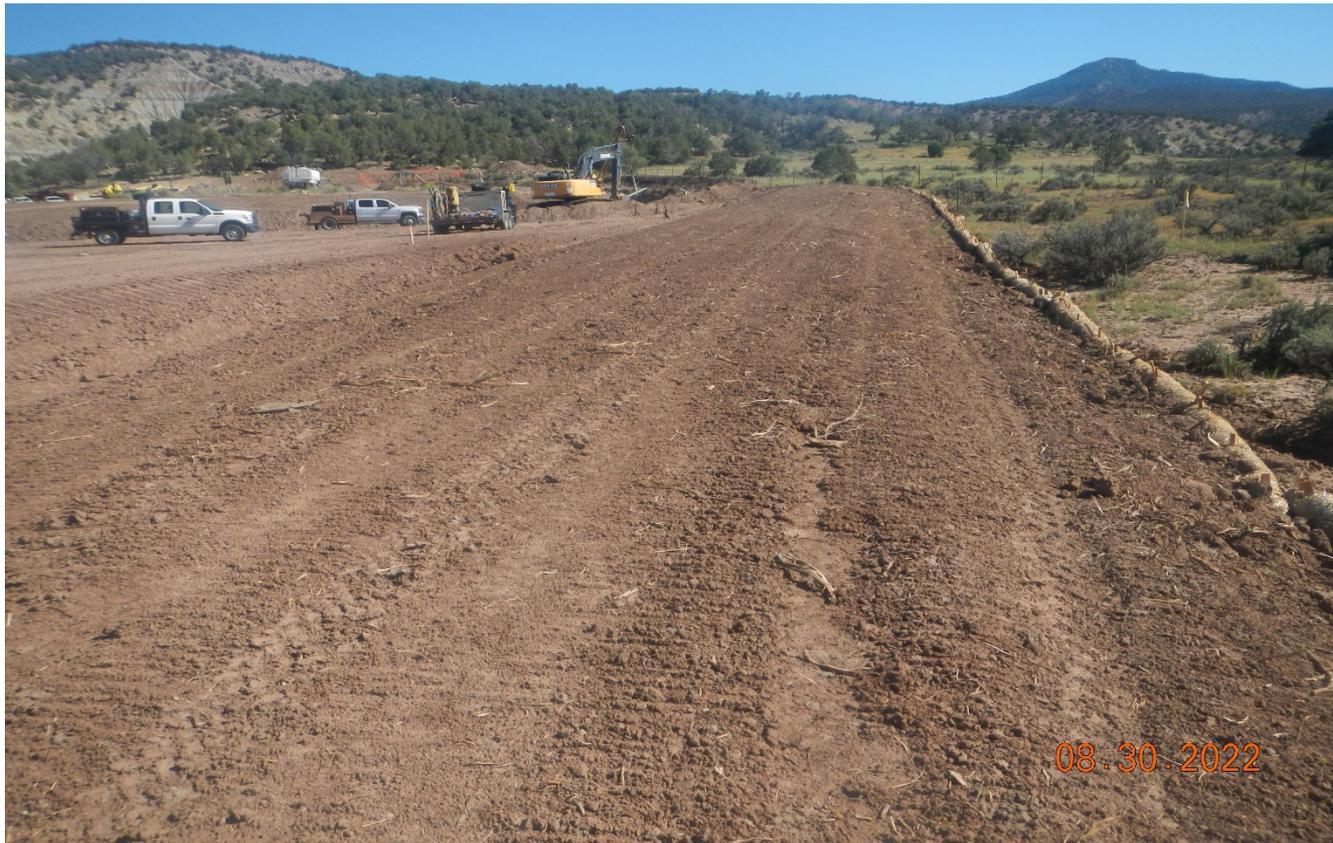
**Photo 14.** Facing northeast toward the topsoil pile at the east side of the location.

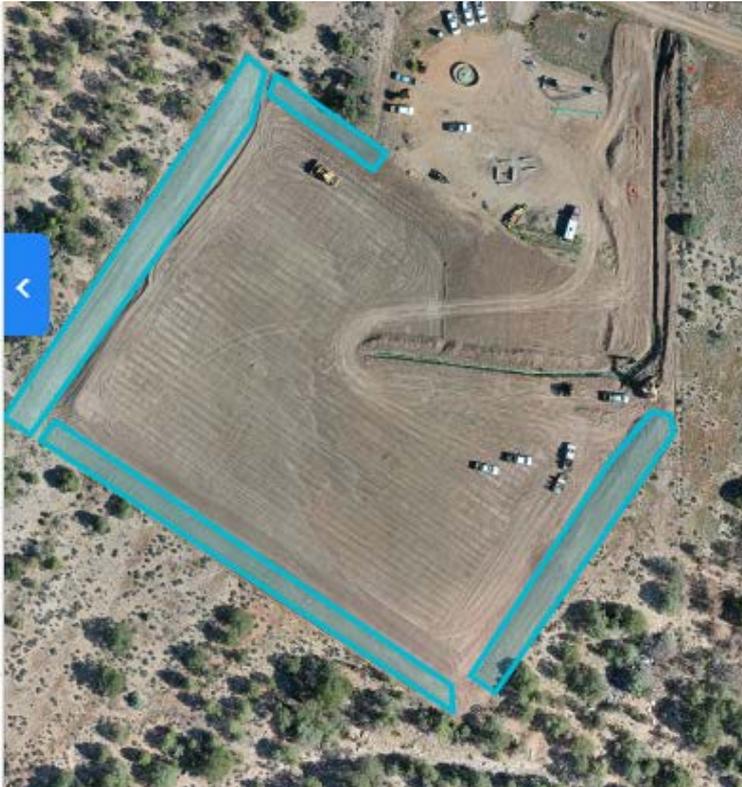
**Photo 15.** Drone aerial calculations of topsoil piles indicates approximately 1089 cubic feet of topsoil was salvaged and stored at the location.
