Inspection Photos
Morgan A1
Spill ID 481051 (CL) & 482224 (AC)

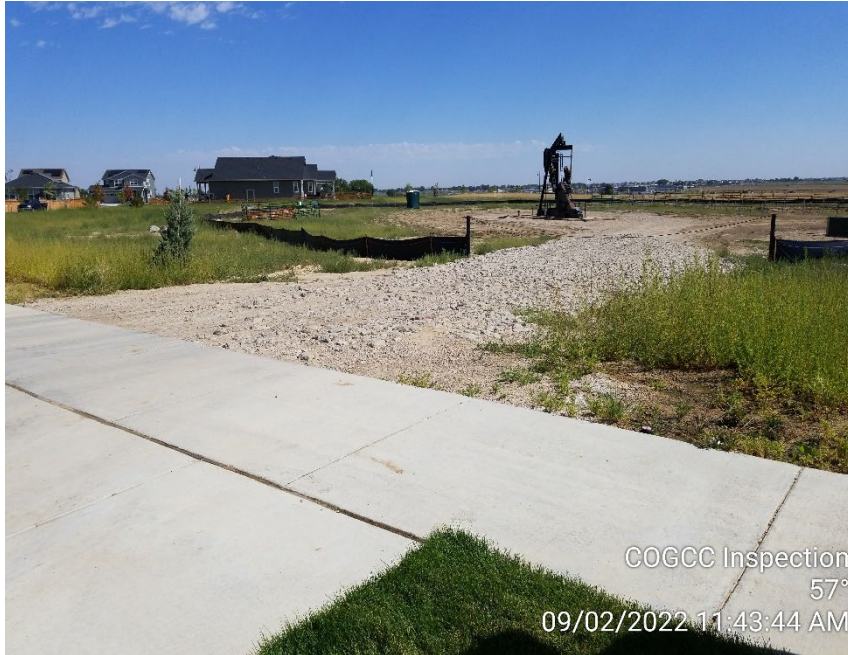
Photo 1 – Location photo.

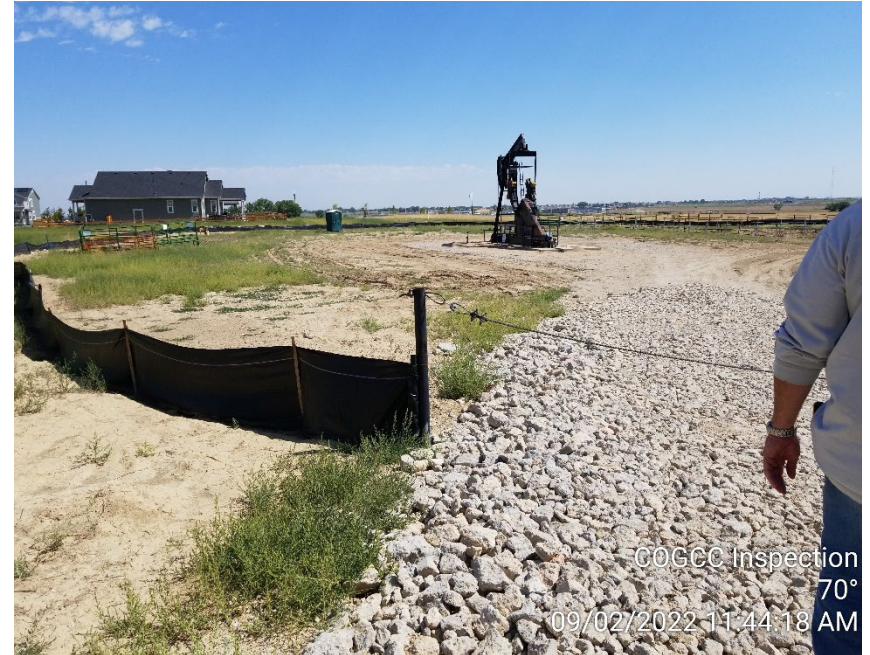
Photo 2 – Access to location secured upon COGCC arrival.

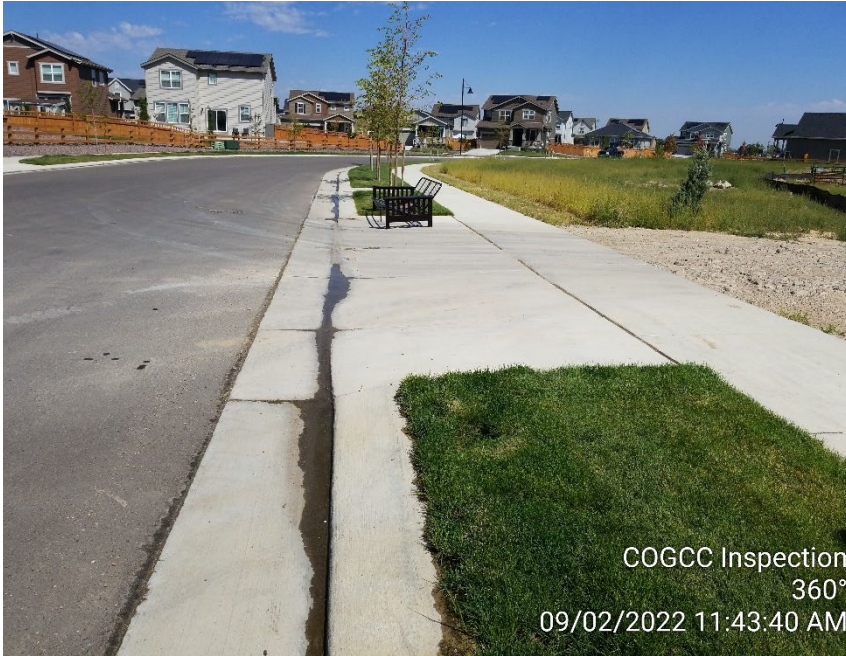
Photo 3 – Dirt being tracked off location observed in previous inspection has been cleaned. No maintenance appears to have been performed on vehicle tracking pad.

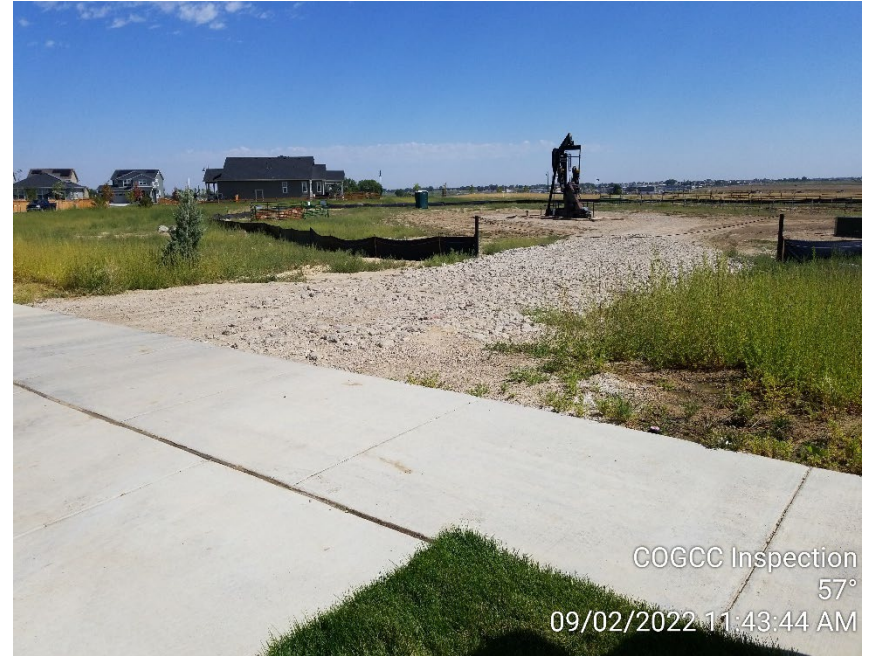
Photo 4 – Dirt being tracked off location observed in previous inspection has been cleaned. No maintenance appears to have been performed on vehicle tracking pad.

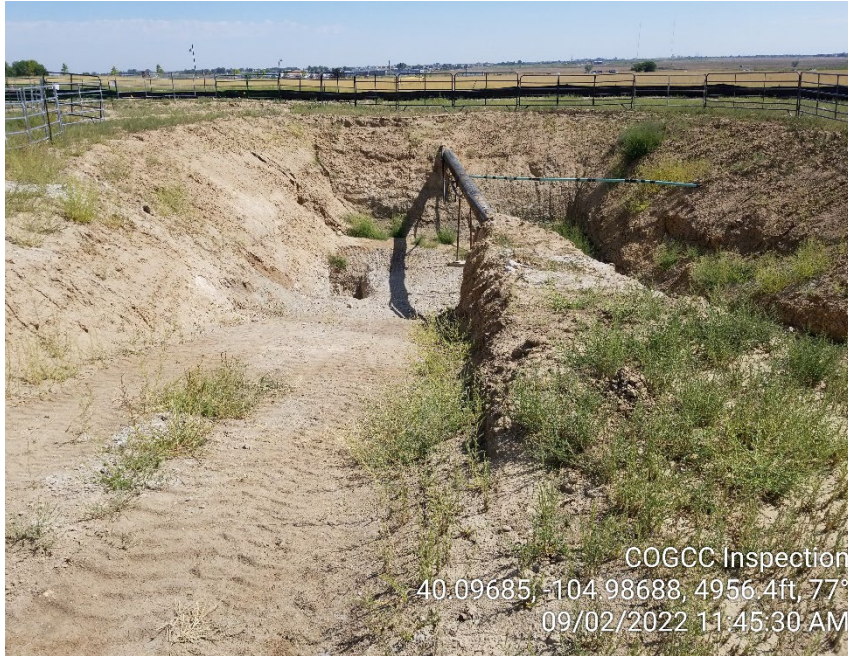
Photo 5 – Open excavation, Spill ID 481051

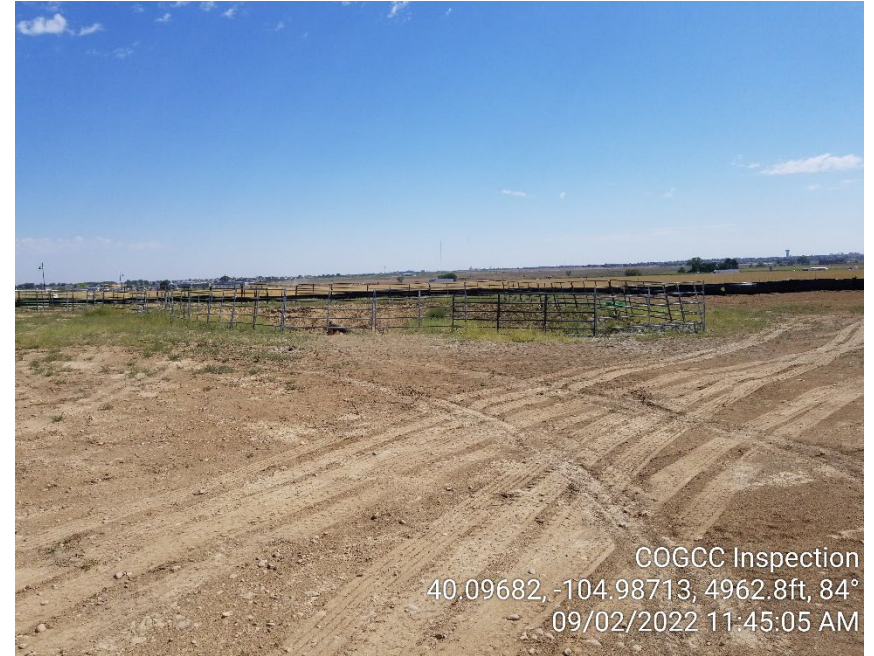
Photo 6 – Open excavation, Spill ID 481051

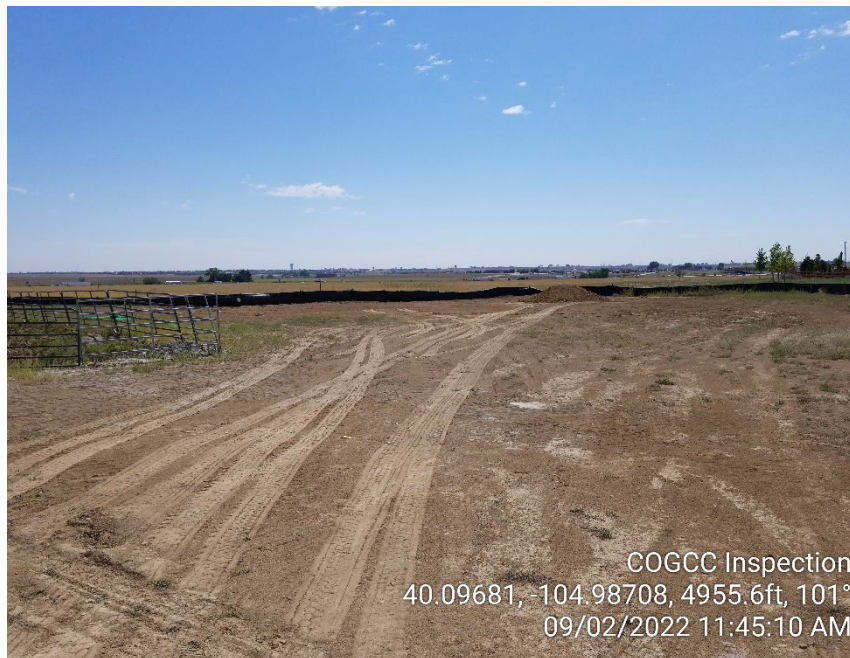
Photo 7 – Previously stored contaminated soil has been removed from location. One pile of soil for backfill has been stored on site.

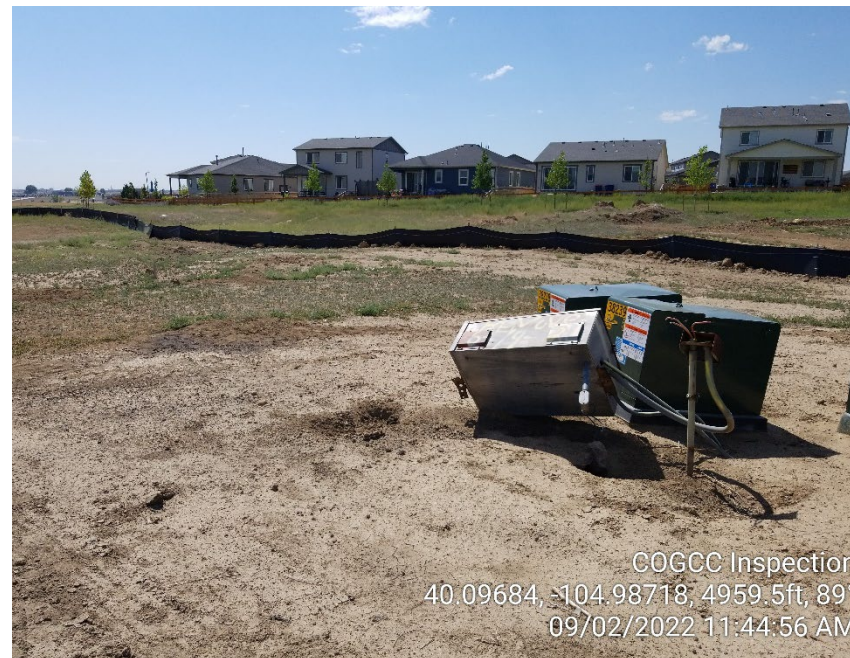
Photo 8 – Previously observed trash has been removed from location.

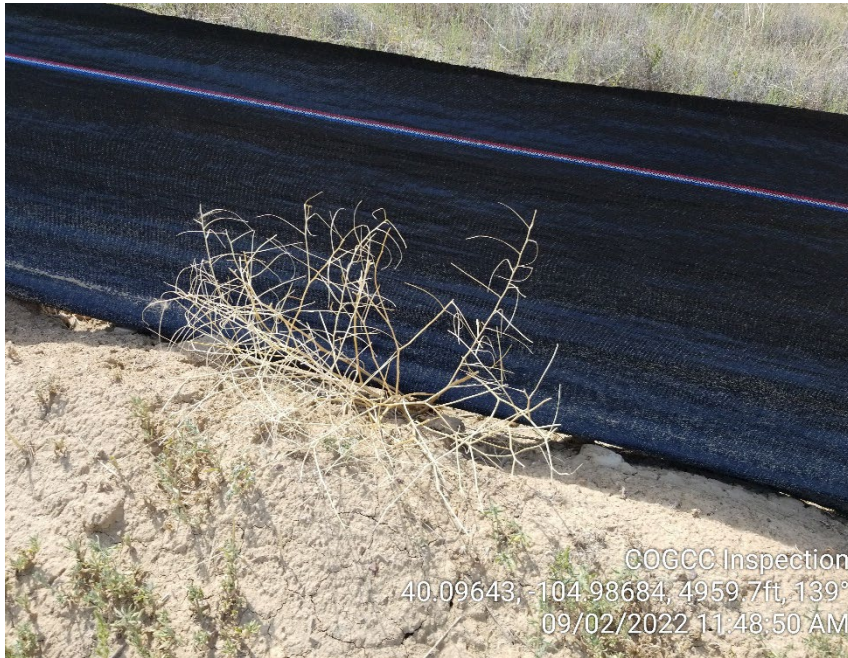
Photo 9 – Silt fence is inadequately installed

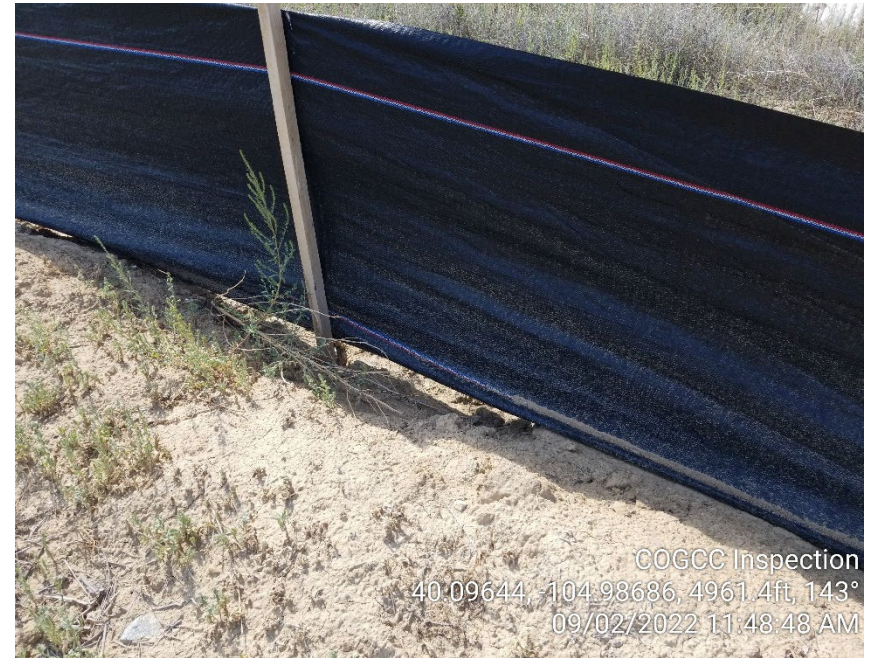
Photo 10 – Silt fence is inadequately installed

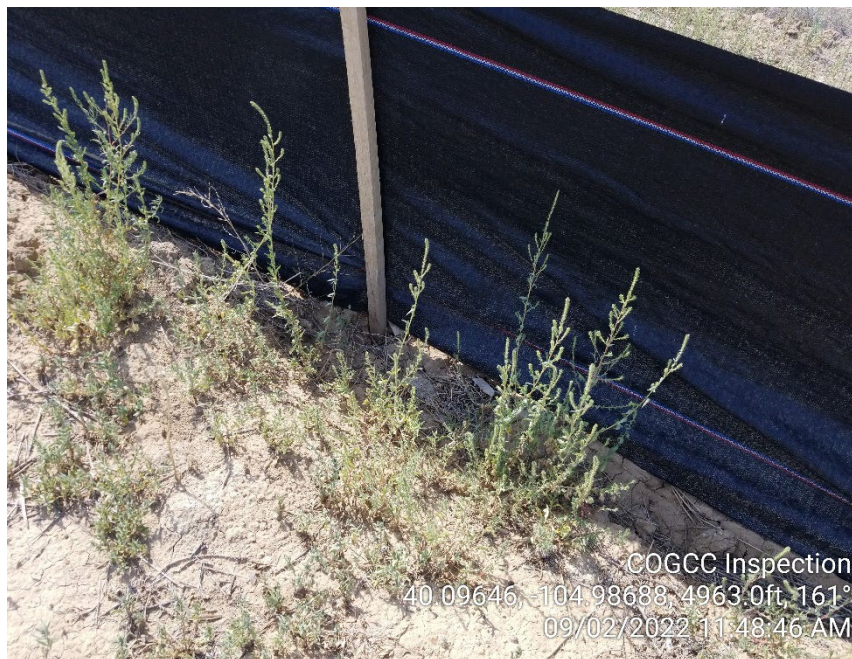
Photo 11 – Silt fence is inadequately installed

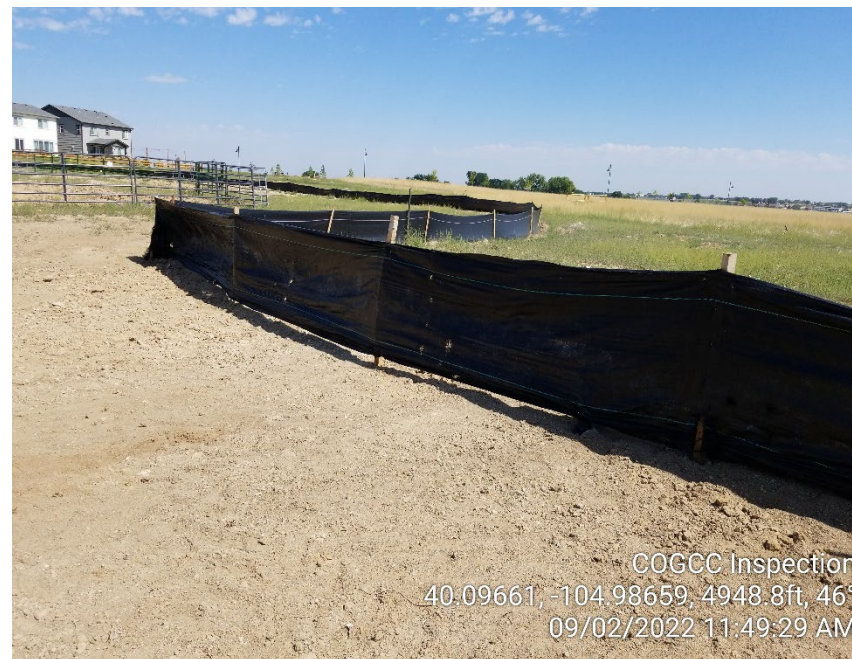
Photo 12 – Silt fence is inadequately installed

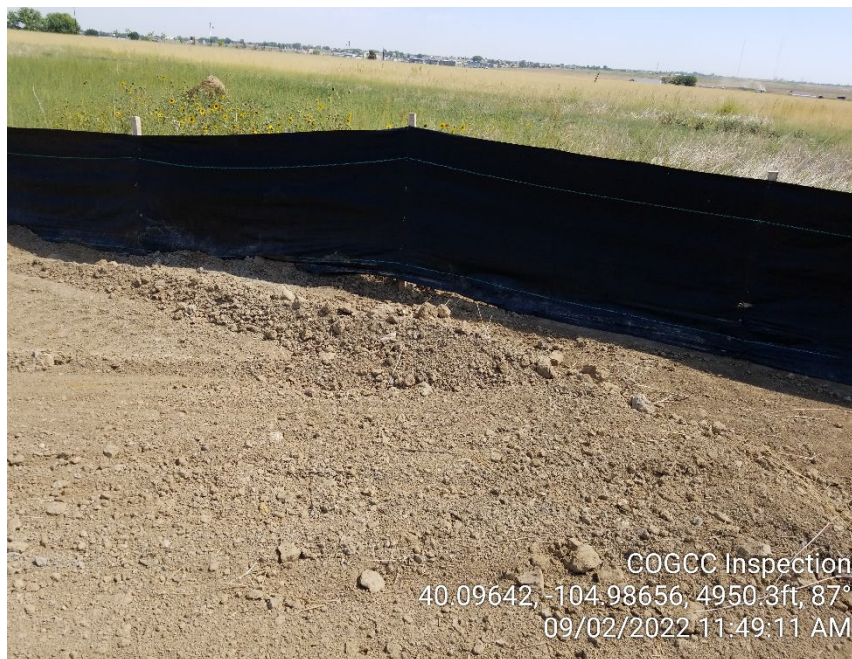
Photo 13 – Silt fence is inadequately installed

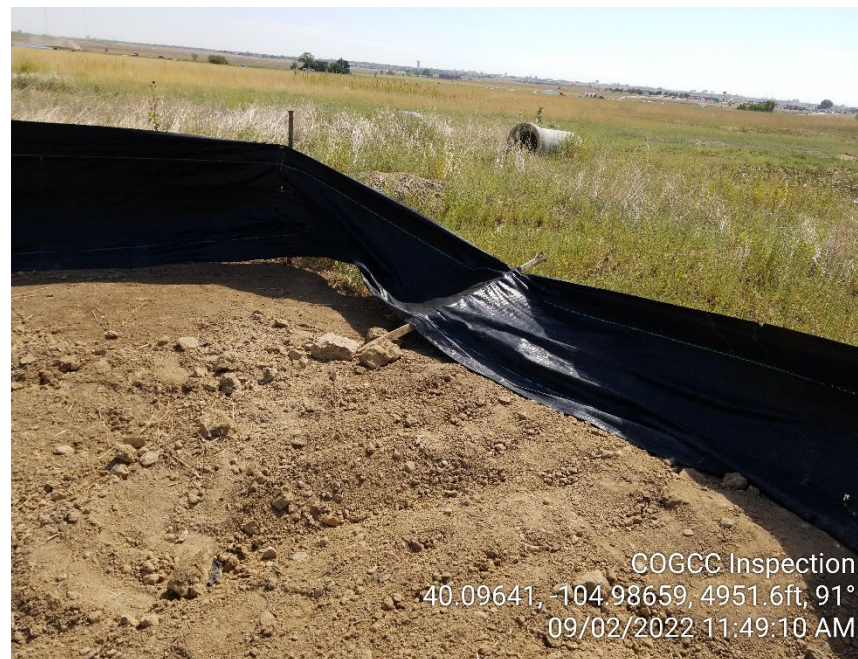
Photo 14 – Silt fence beginning to fall
