Inspection Photos
Location Name: Josephine B Miles #5
Location ID:318991

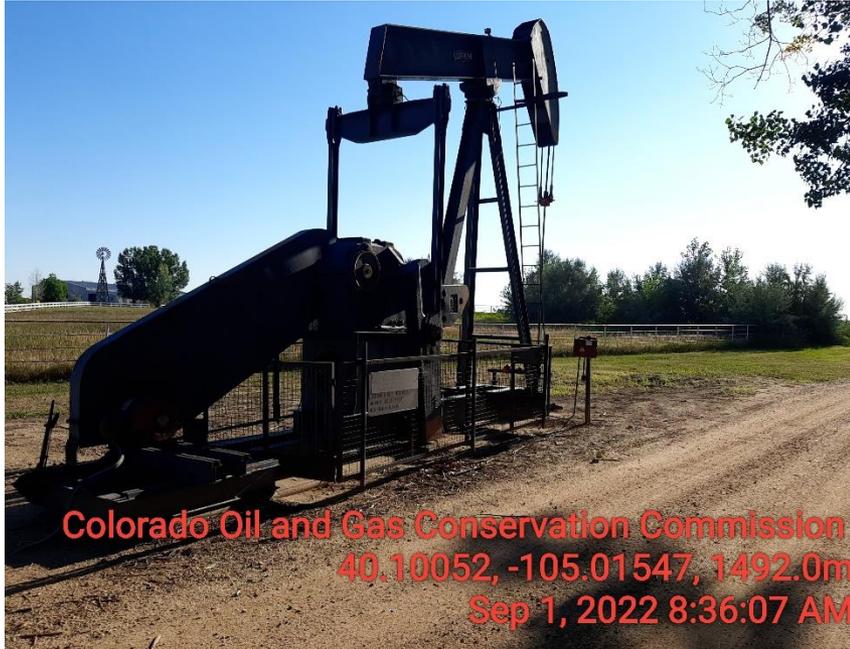
Photo 1 Sept 1 inspection to confirm well is shut in

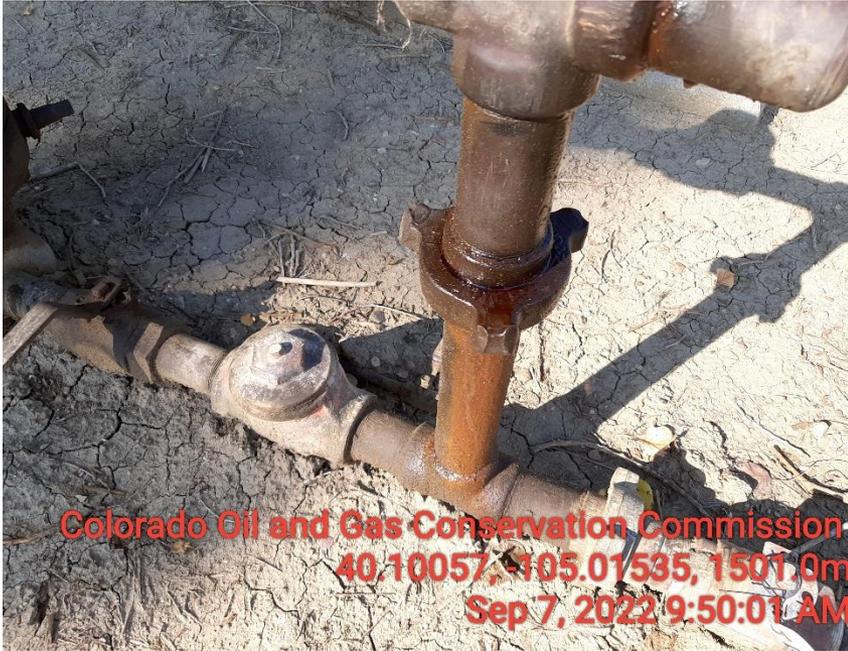
Photo 3 mechanical issue 2" flow line leaking around hammer union

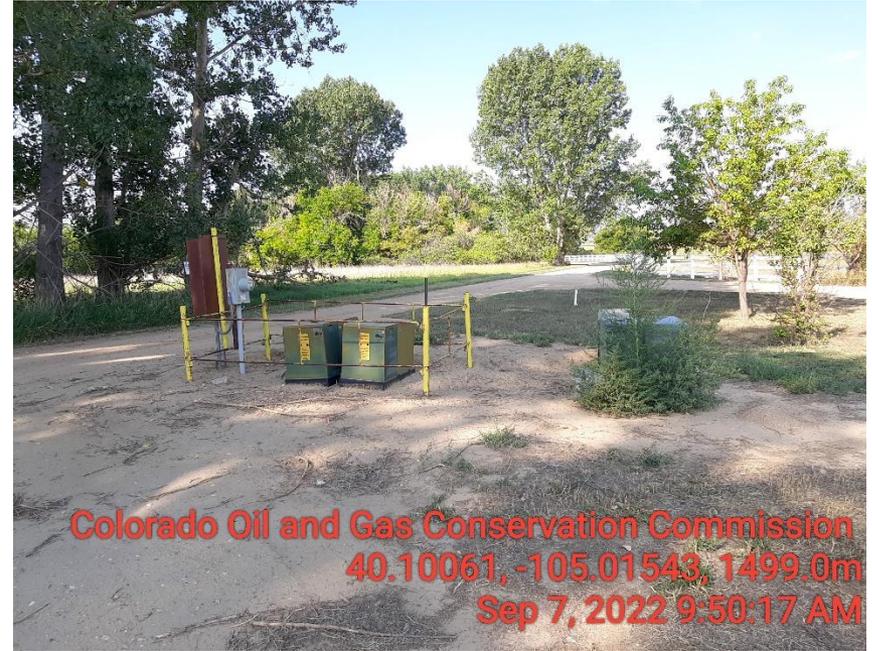
Photo 4 Weeds around electric equipment.

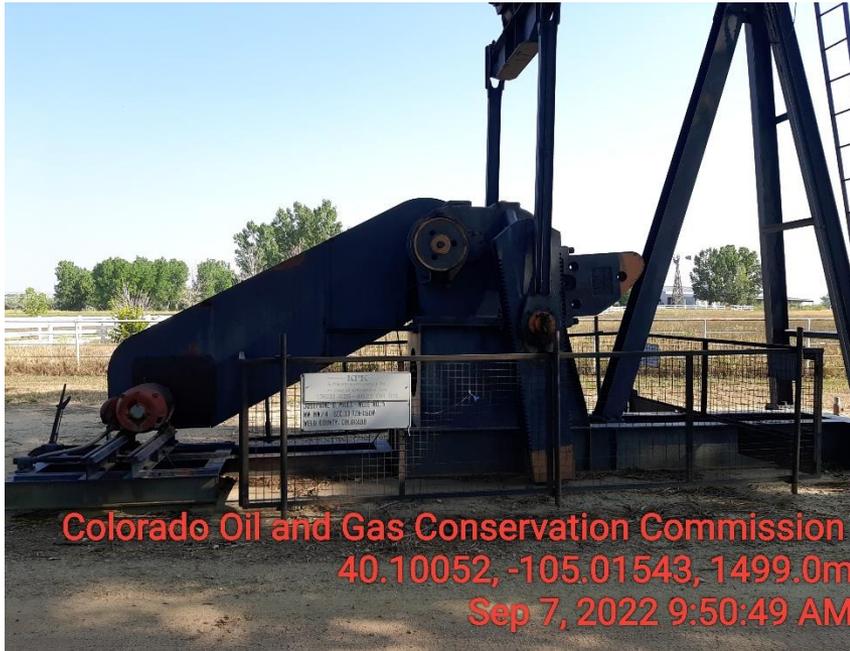
Photo 5 well sign faded not legible
