Inspection Photos
Location Name: Champlin 86 Amoco B #2
Location ID: 318253

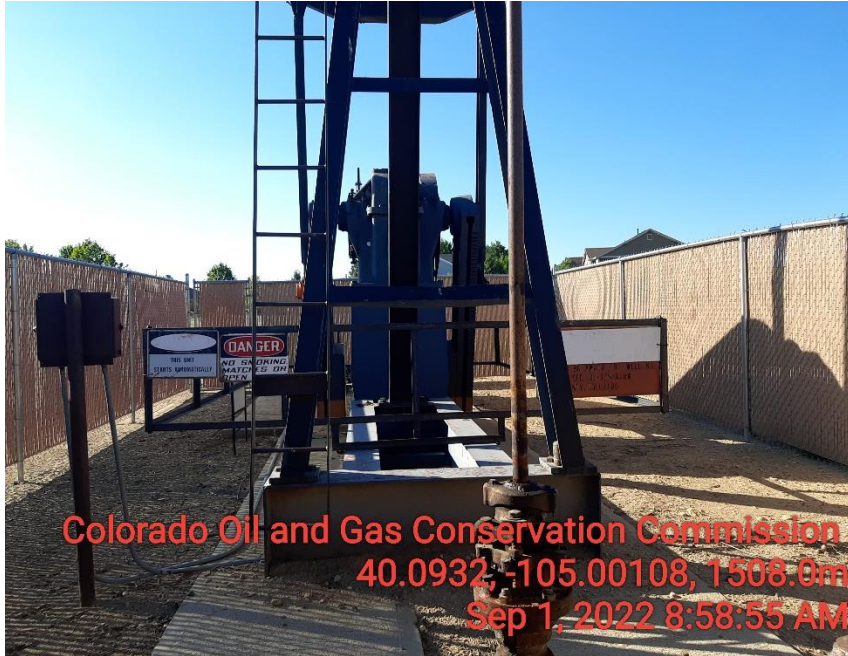
Photo 1 Sept 1 inspection to confirm well is shut in

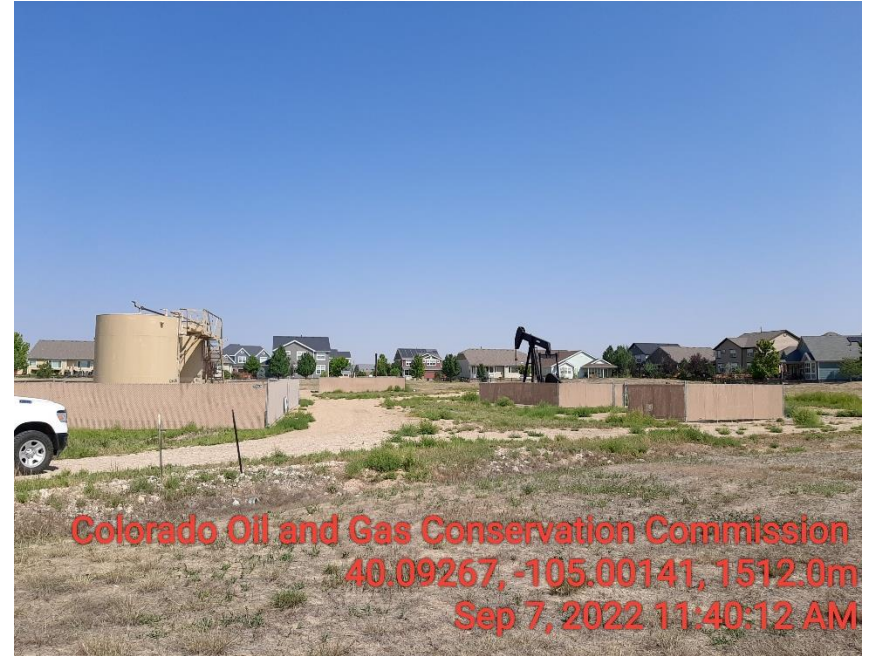
Photo 2 loc pic, weeds on site

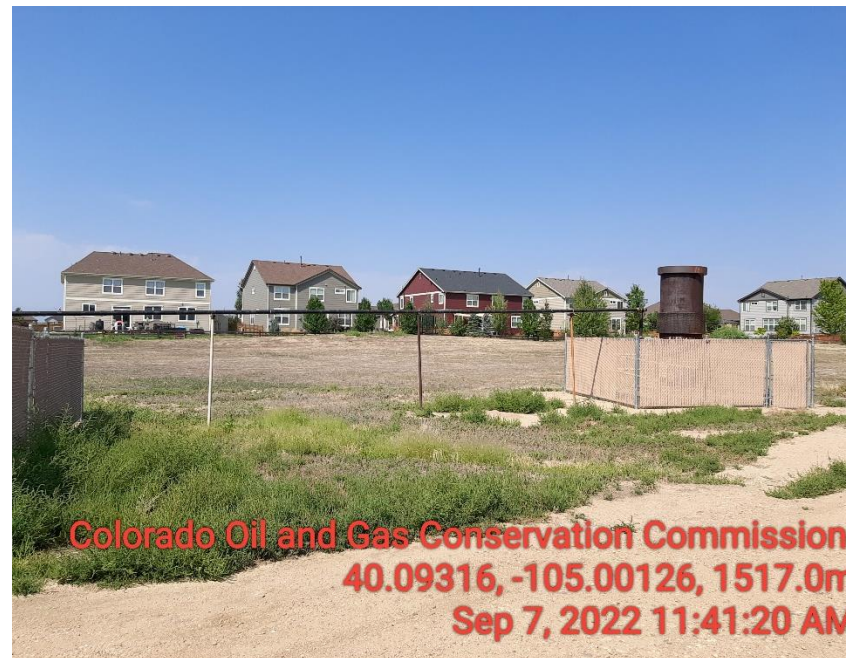
Photo 4 ECD Weeds on location

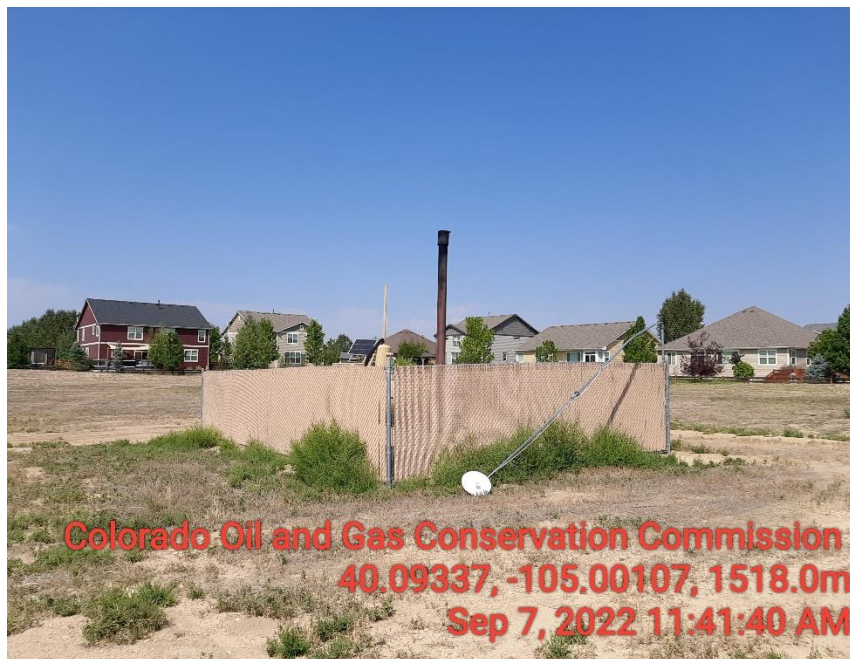
Photo 5 unused equipment broken pipe. Weeds around separator.

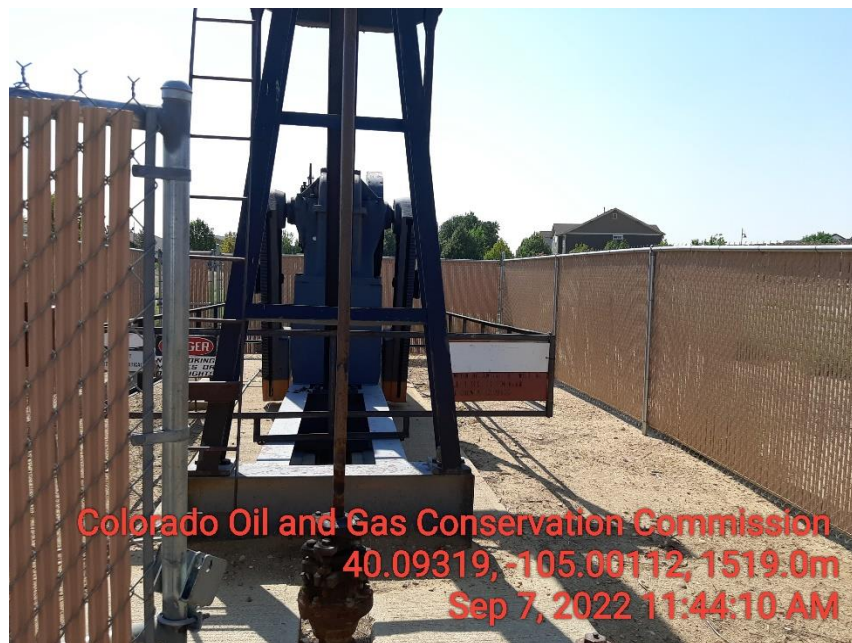
Photo 7 Well head sign faded not legible

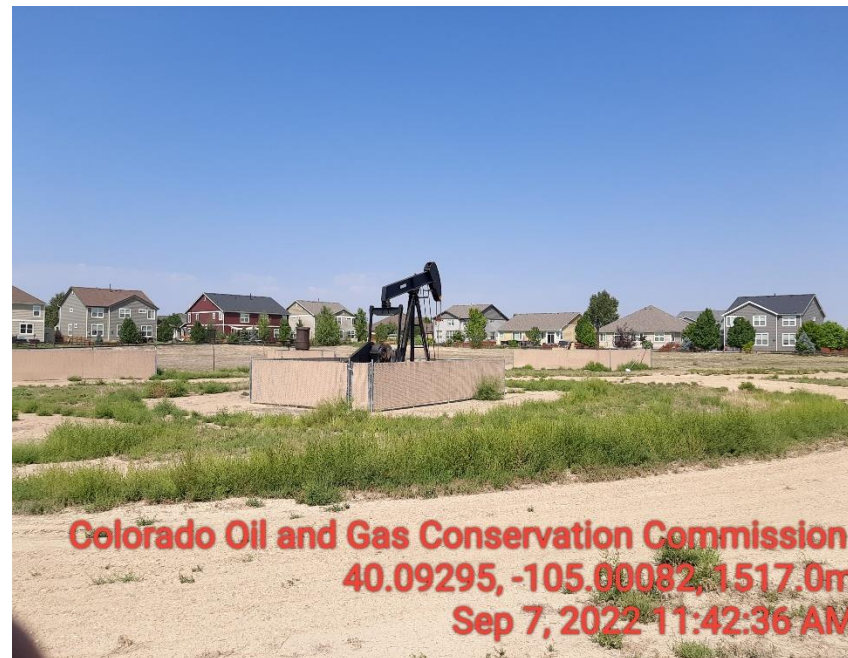
Photo 8 loc pic weeds on location.
