Inspection Photos

API: 071-08419

Operator: OGRIS OPERATING LLC

Inspection Date: 9/8/2022

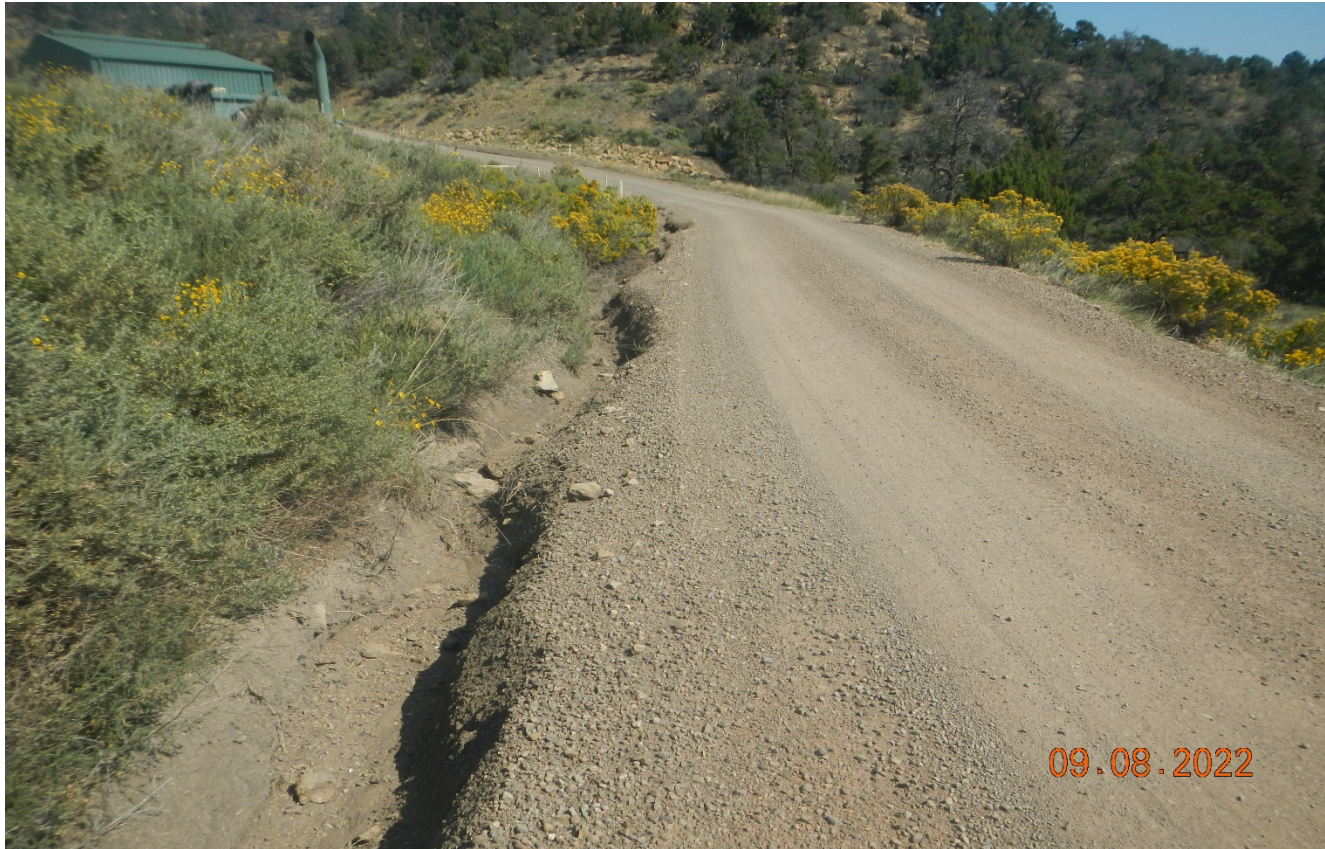
Photo 1. Facing north along the road. The road side is eroding in this area due to concentrated stormwater flow. BMP's need to be installed in this area (e.g. check dams, rip/rap).

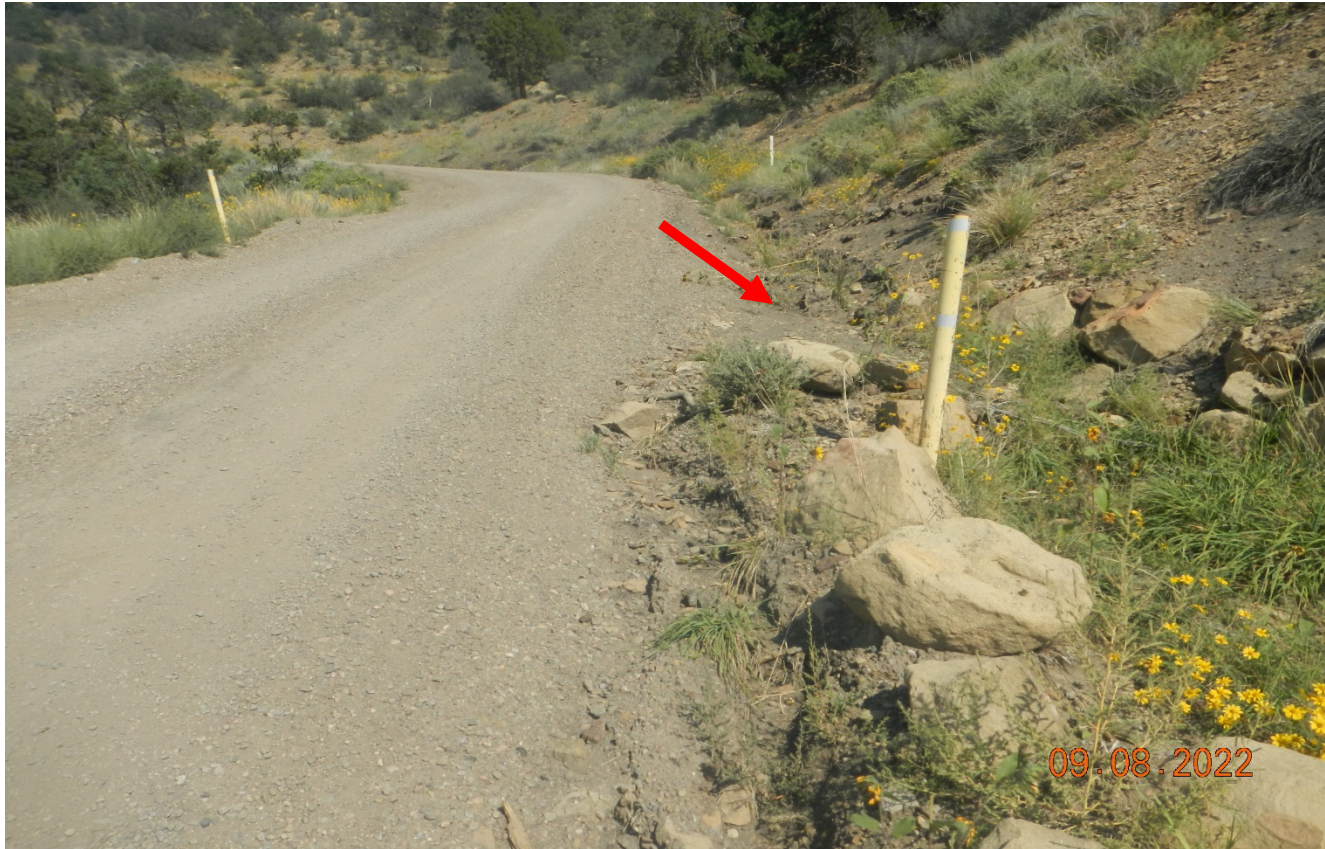
Photo 2. Just past the compressor facility, stormwater is not properly diverted off the road in this area and is flowing past the diversion shown at red arrow.

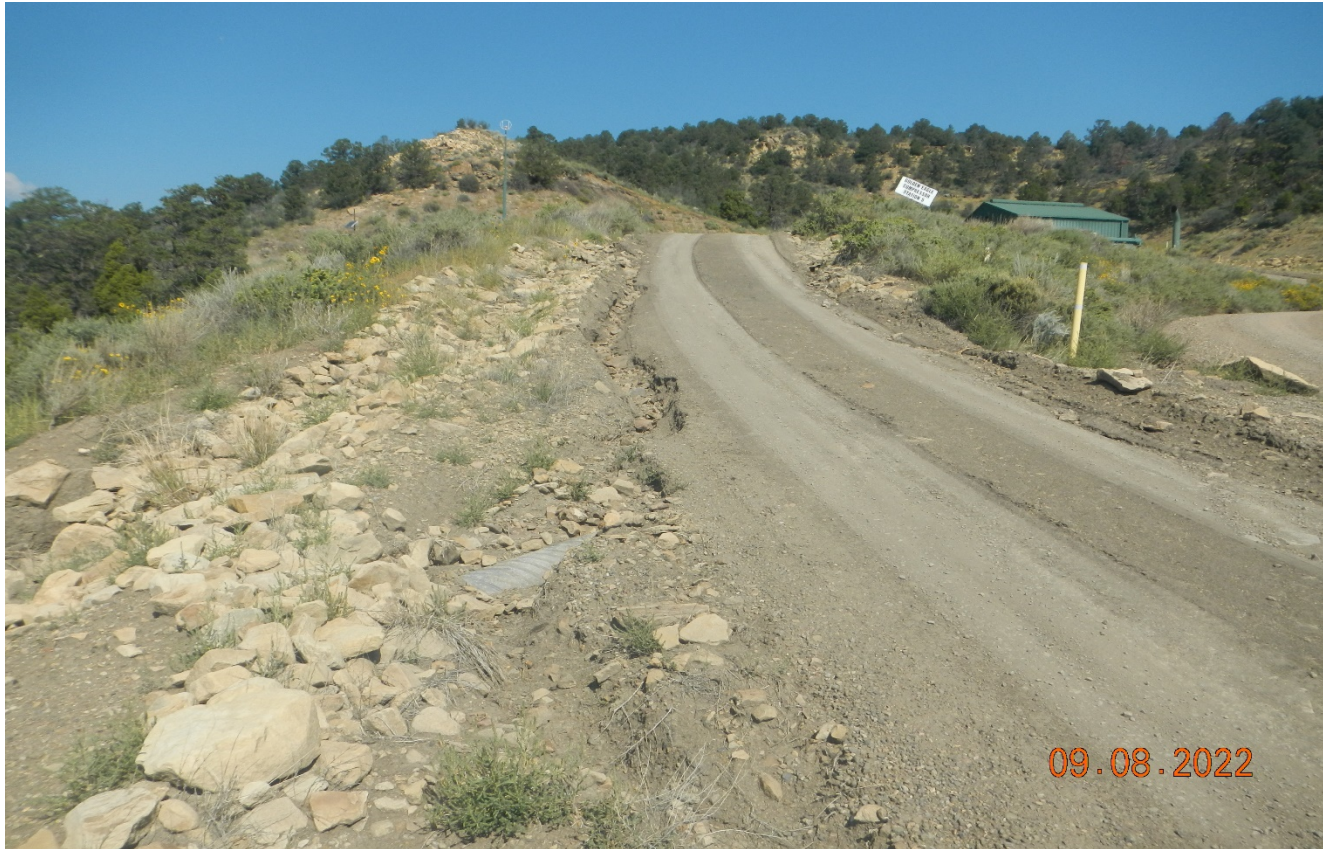
Photo 3. There is erosion occurring at the access road. Which is not being diverted toward the rock rip/rap outlet.

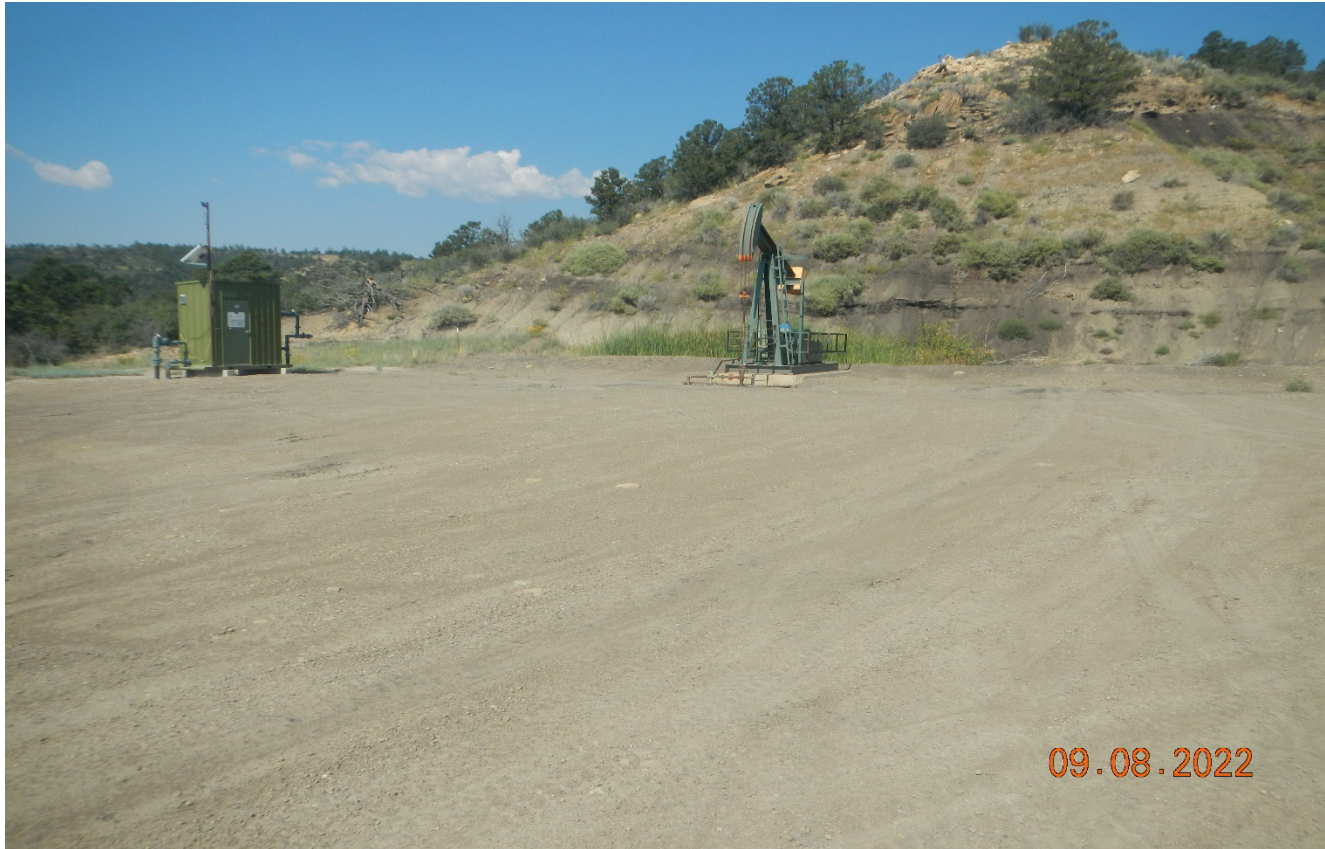
Photo 4. Facing toward the wellsite.
