Inspection Photos

Operator: EOG Resources Inc - #27742

Location Name: Kaline Unit-612N94W /23SENW

Inspection Document #: 702800687

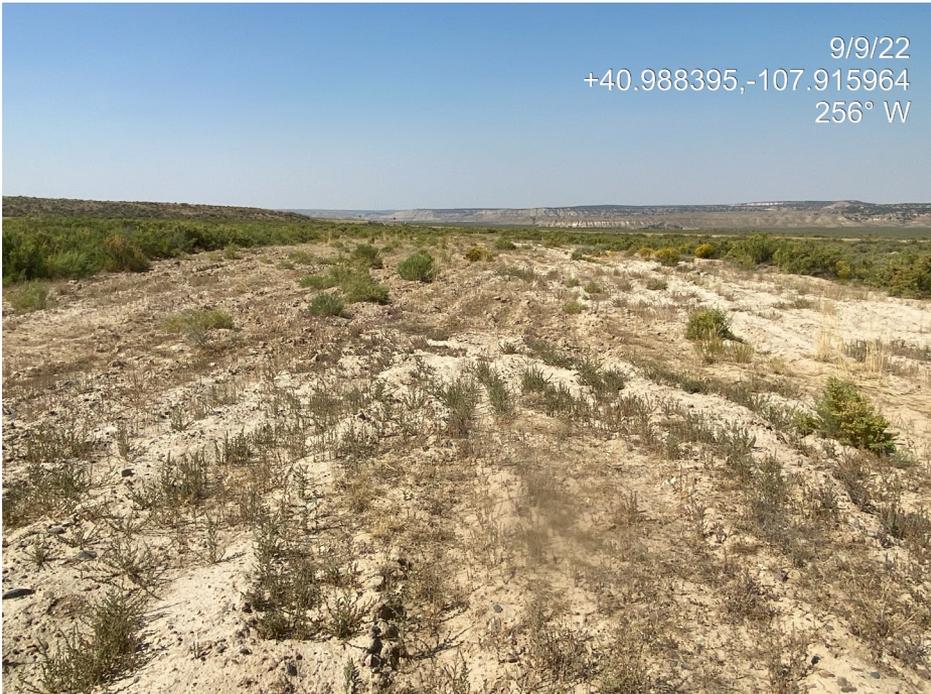
Photo 1. Photo taken to the northeast of the Location shows the access road is dominated by bare ground and kochia, an annual undesirable plant species/weed.

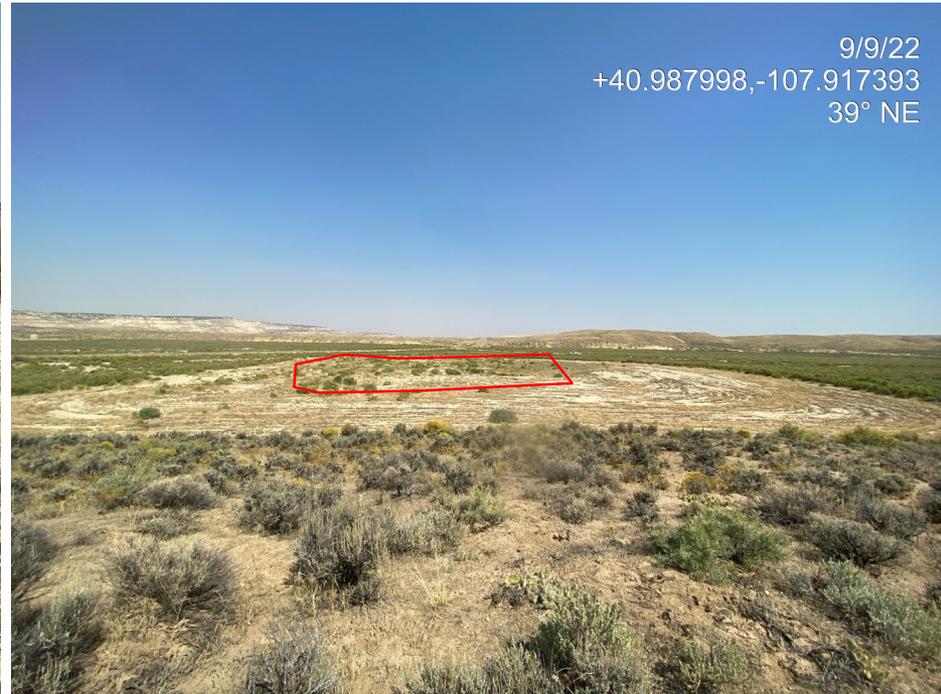
Photo 2. Photo taken to the west shows an overview of the Location. Note the red polygon shows where transects were conducted. This area has higher perennial cover than the rest of the Location, which can be seen from this photo. Perennial cover overall is lower than that calculated from transect data.

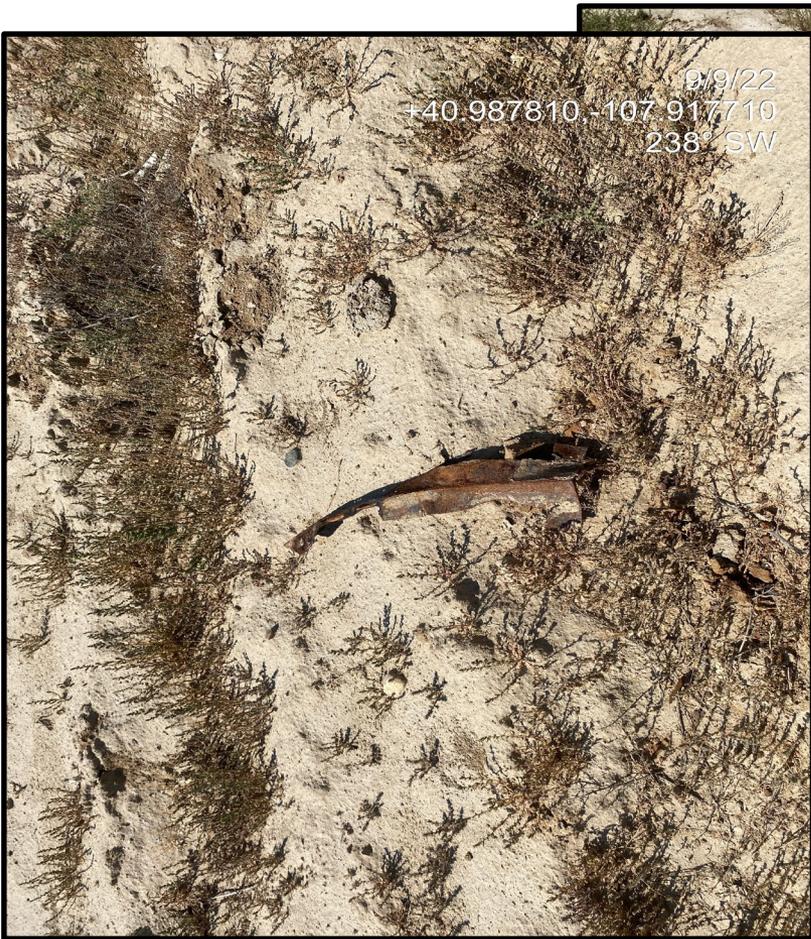
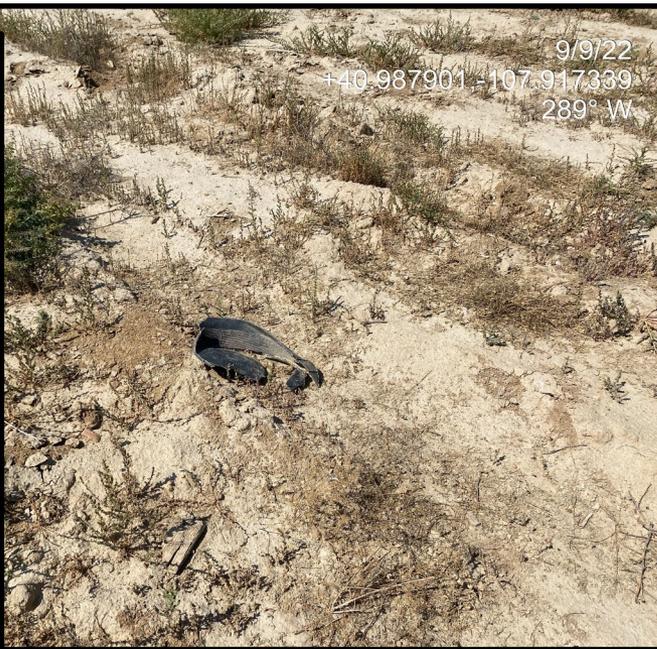
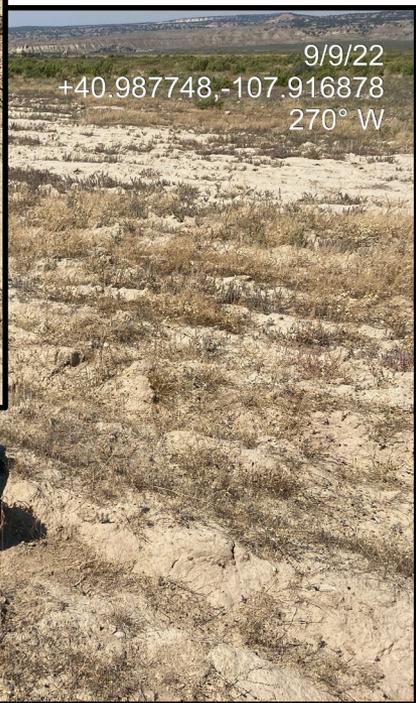
Photo 3. Photos show examples of trash/debris on Location.

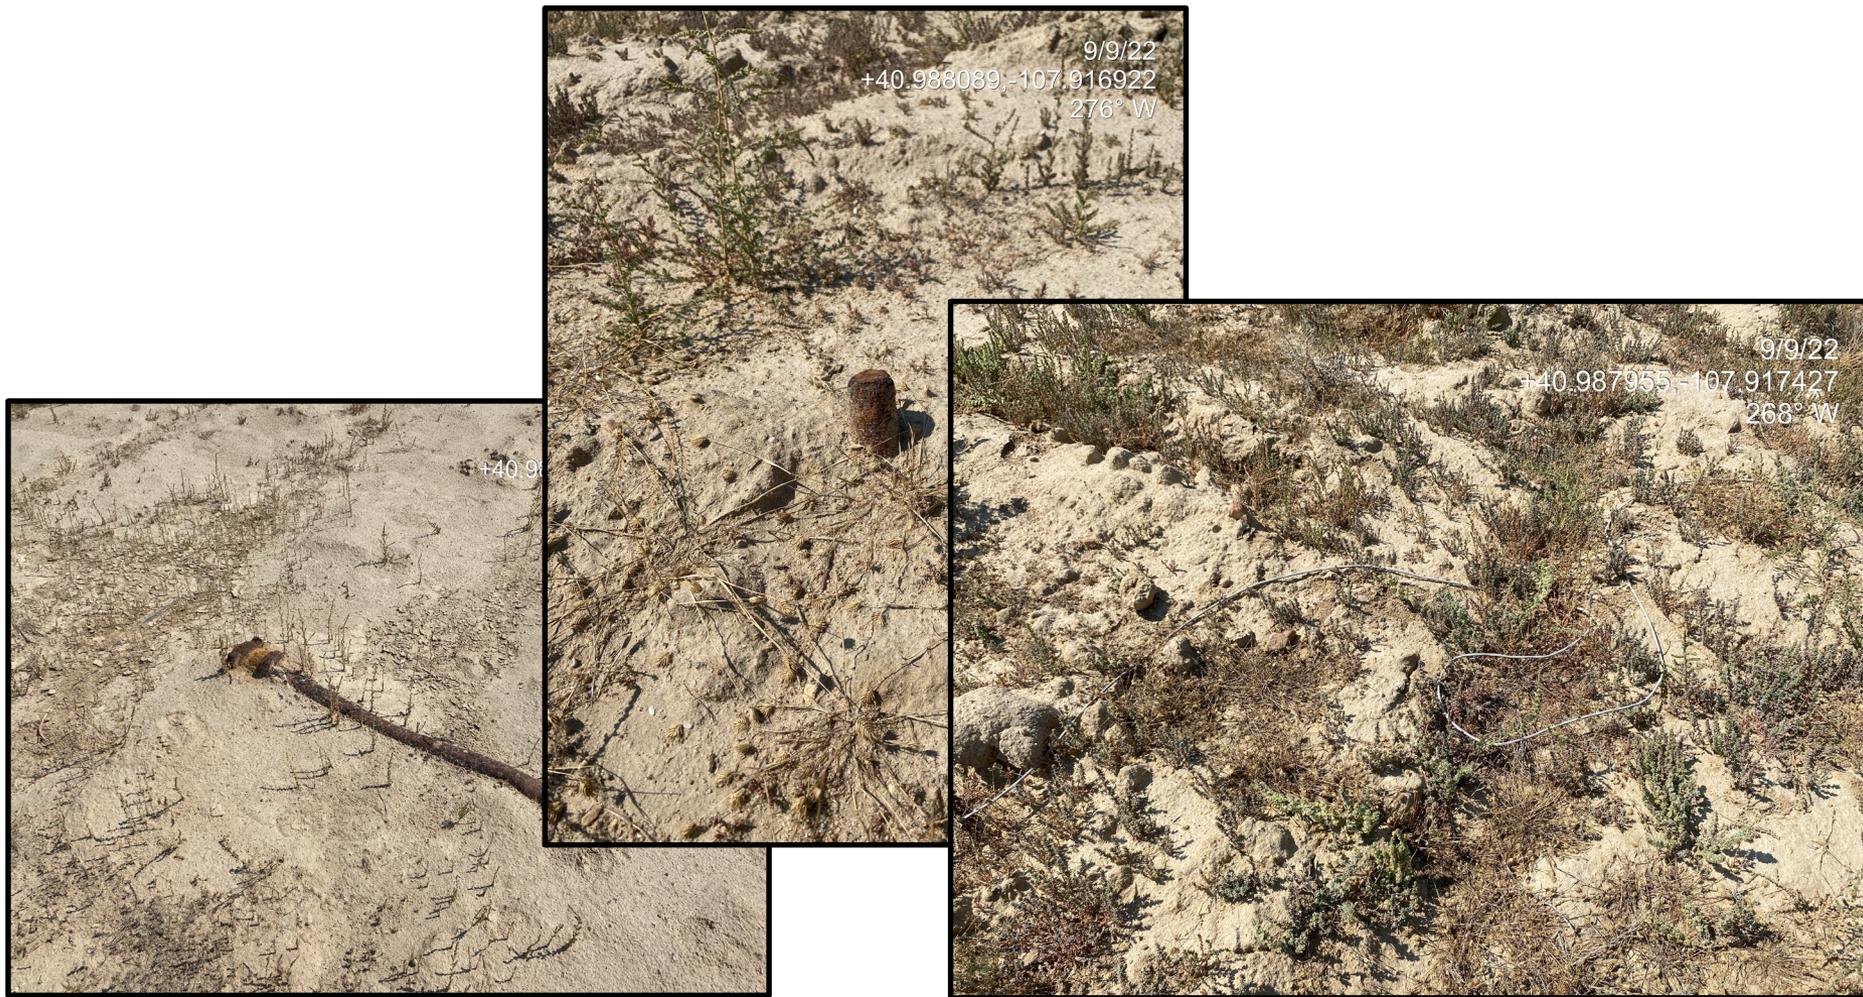
Photo 4. Photos show examples of trash/debris on Location.

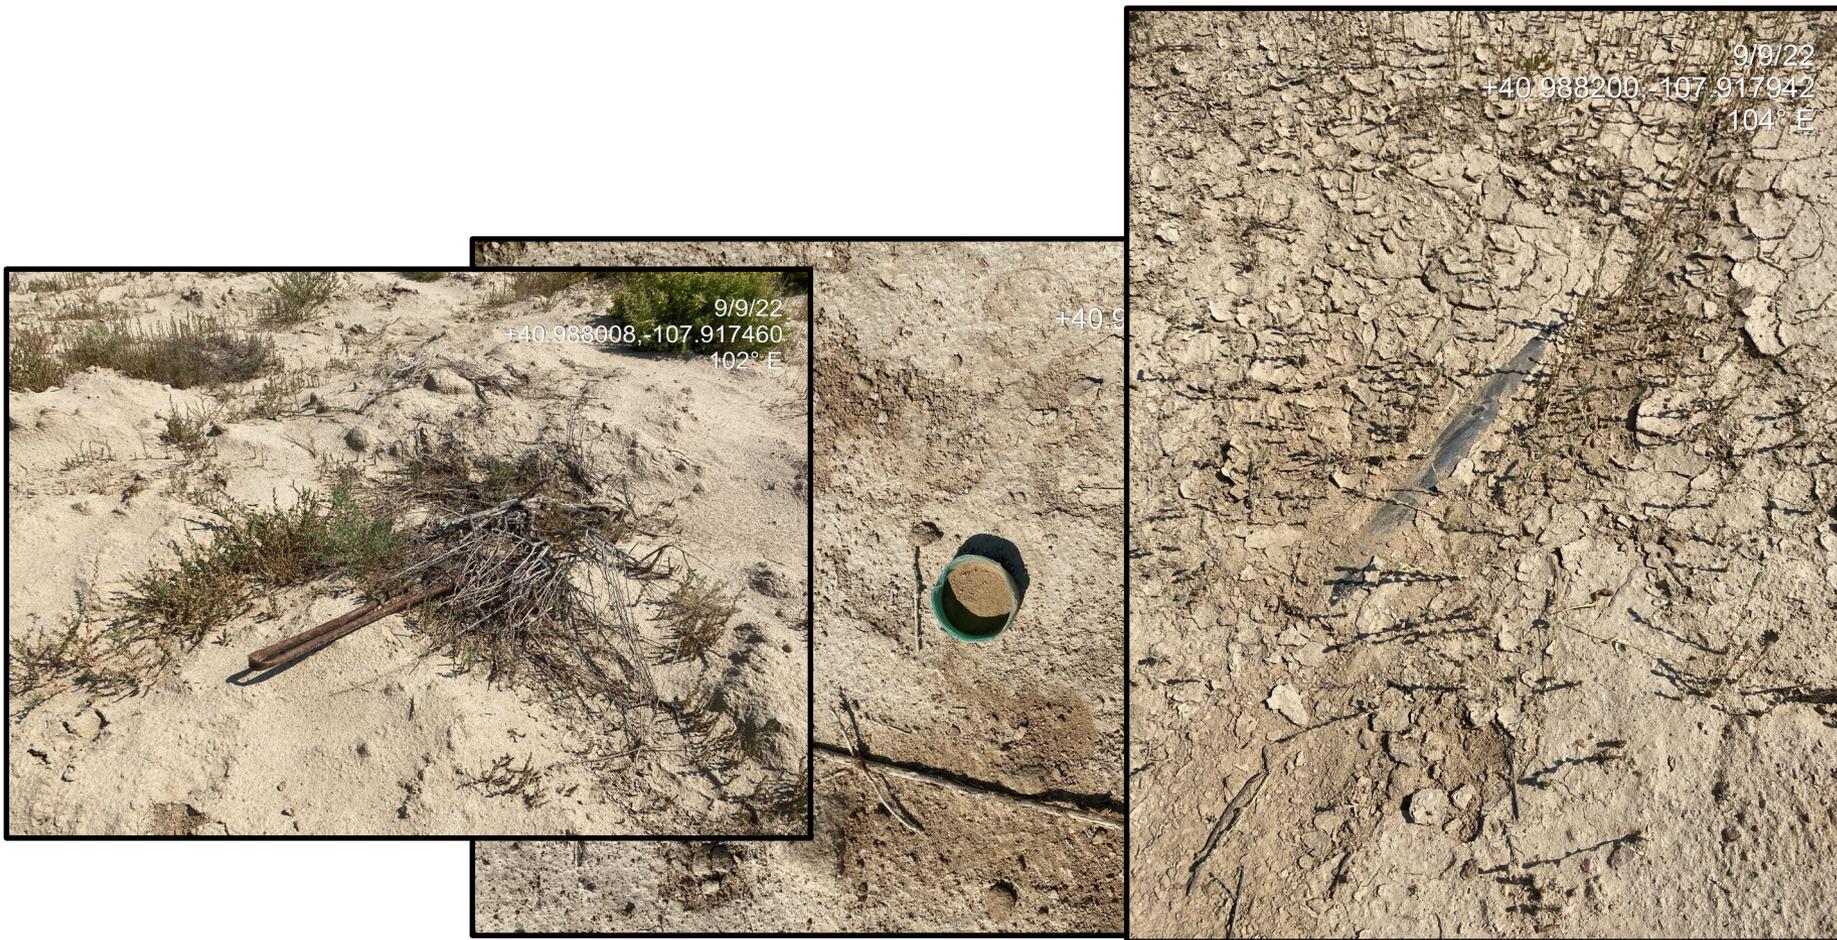
Photo 5. Photos show examples of trash/debris on Location.

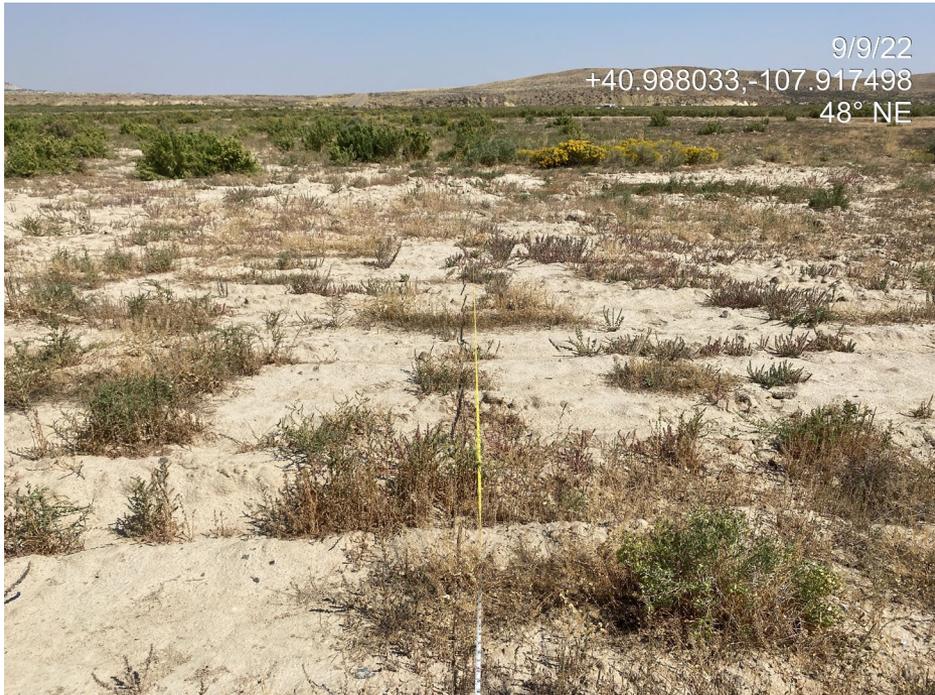
Photo 6. Photo taken from the center of the Location shows the start of the disturbed area vegetation monitoring transect.

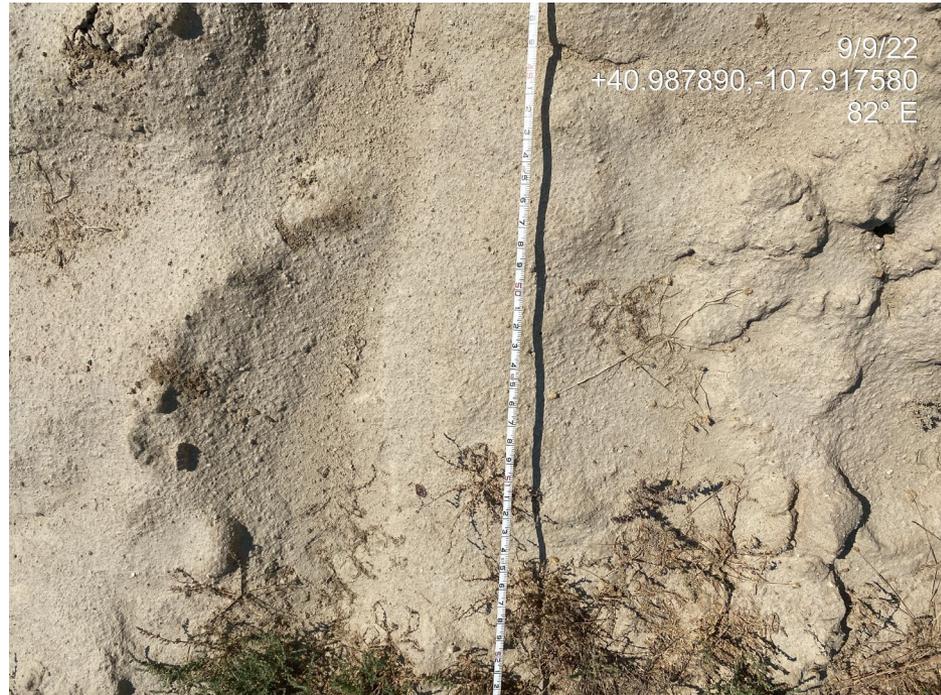
Photo 7. Photo taken from the center of the Location shows the ground surface at the midpoint of the disturbed area vegetation monitoring transect.

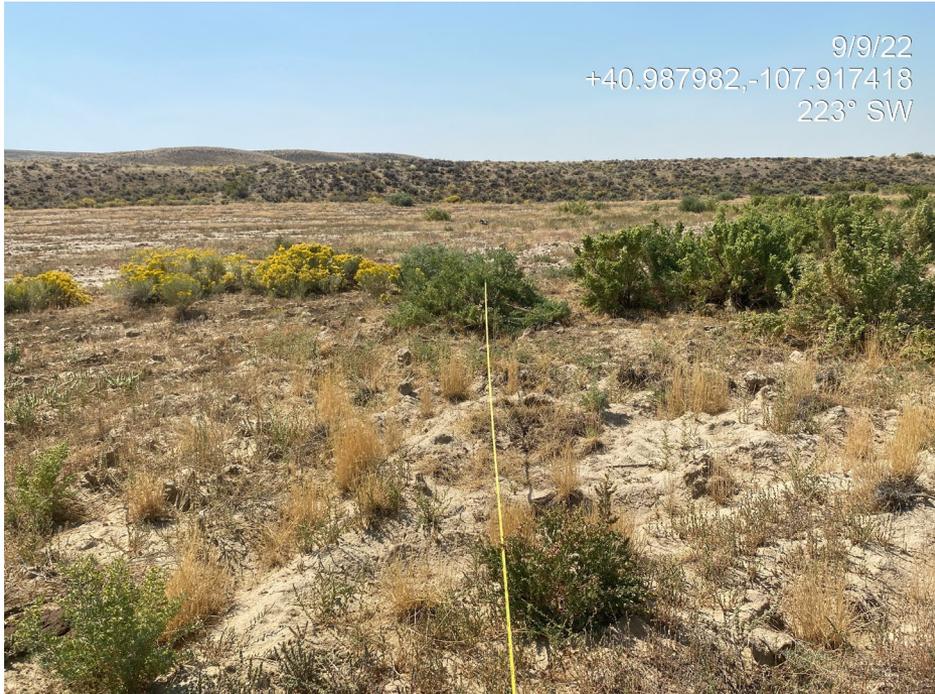
Photo 8. Photo taken from the center of the Location shows the end of the disturbed area vegetation monitoring transect.

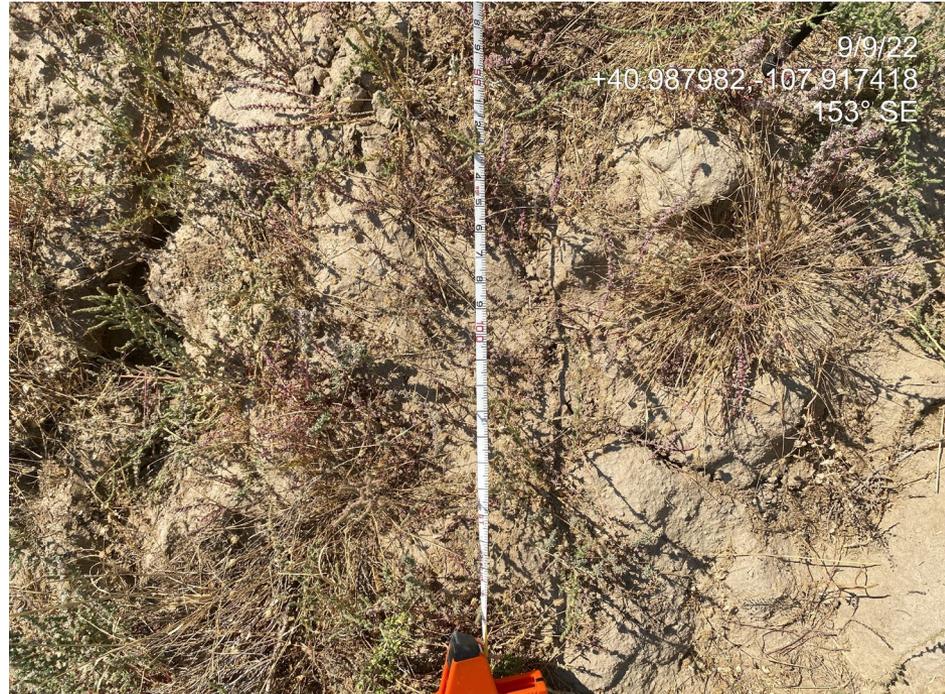
Photo 9. Photo taken from the center of the Location shows the ground surface at the end of the disturbed area vegetation monitoring transect.

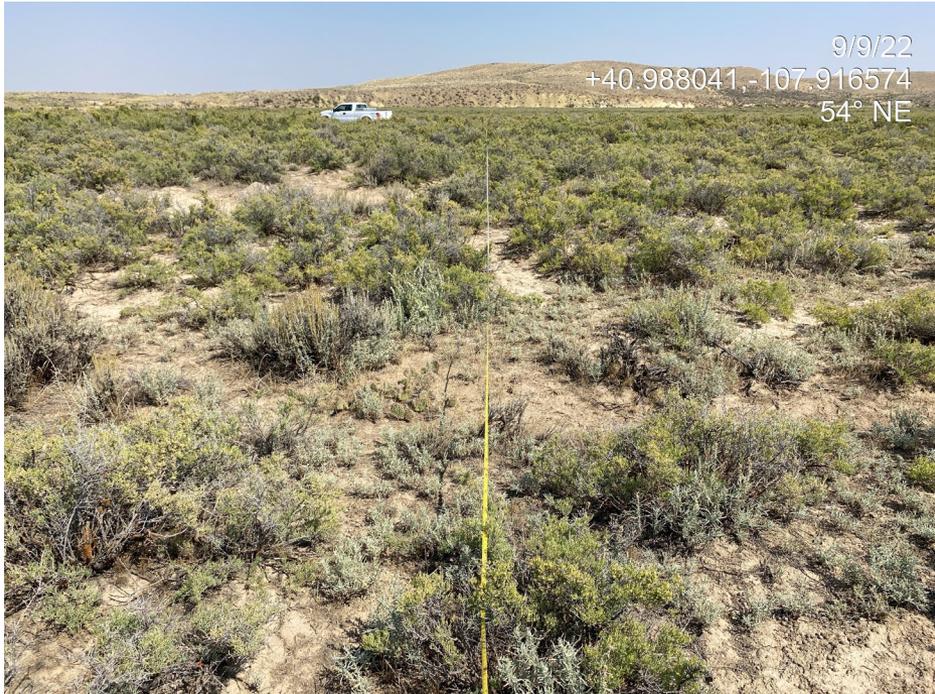
Photo 10. Photo taken to the east of the Location shows the start of the reference area vegetation monitoring transect.

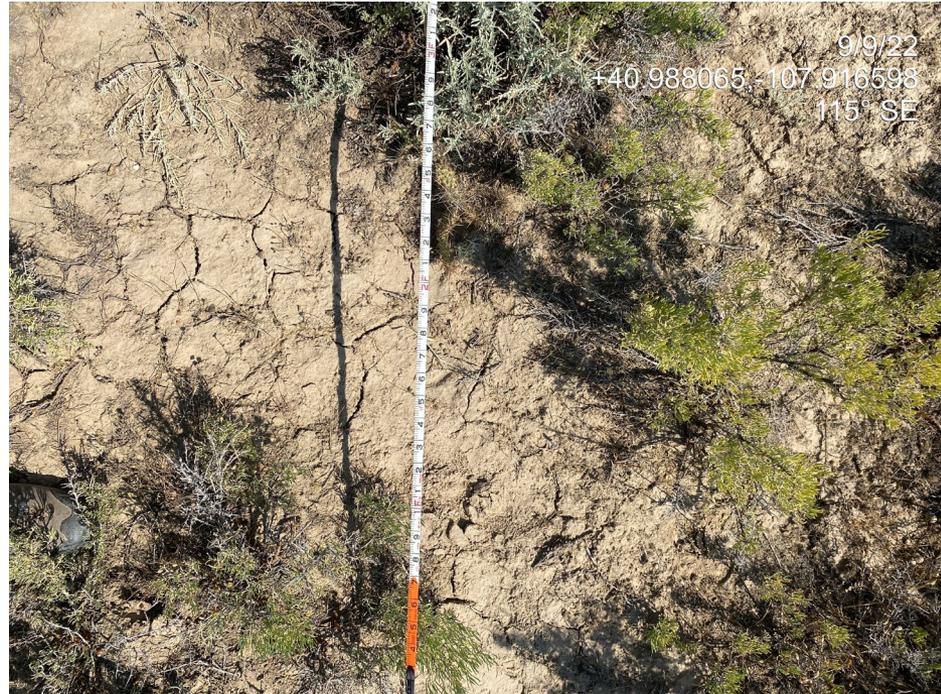
Photo 11. Photo taken to the east of the Location shows the ground surface at the start of the reference area vegetation monitoring transect.

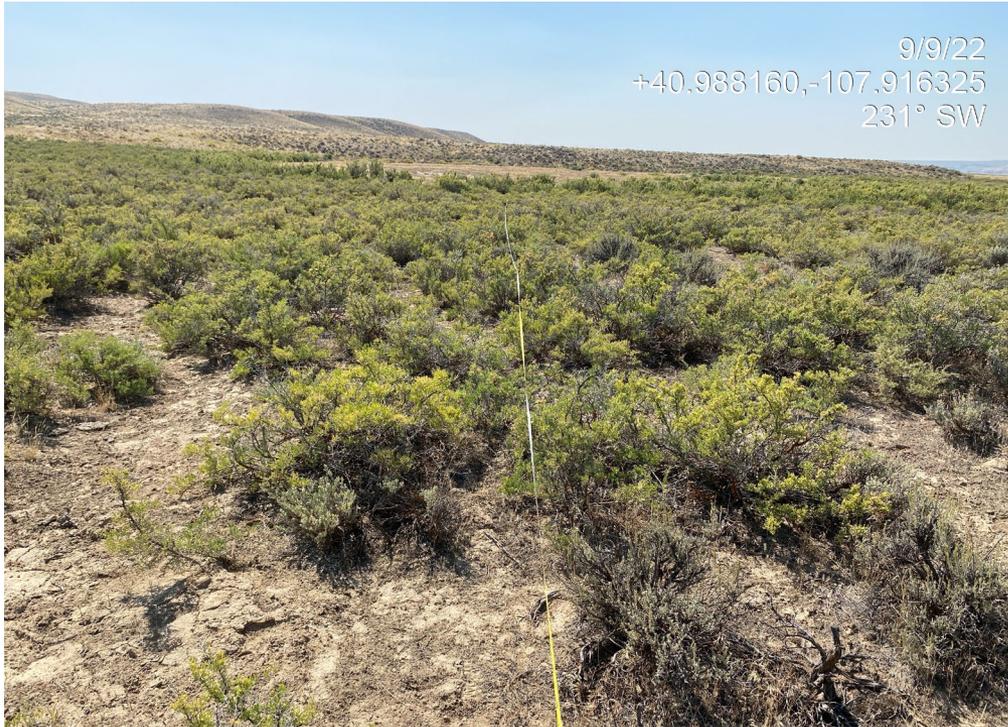
Photo 12. Photo taken to the east of the Location shows the end of the reference area vegetation monitoring transect.

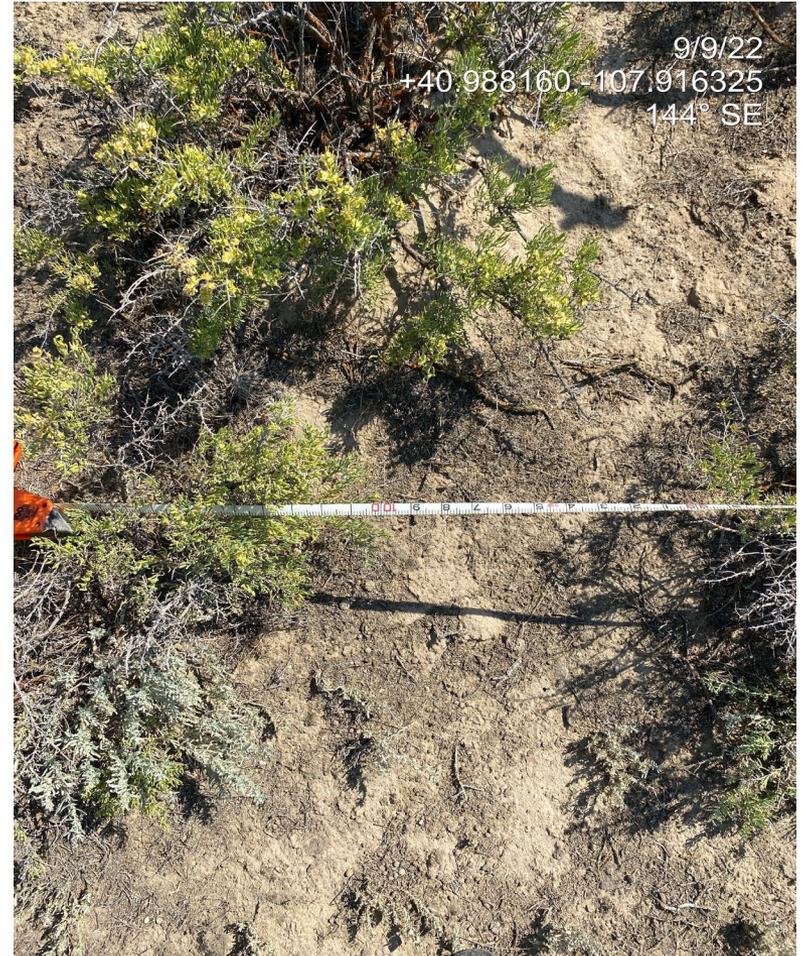
Photo 13. Photo taken to the east of the Location shows the ground surface at the end of the reference area vegetation monitoring transect.

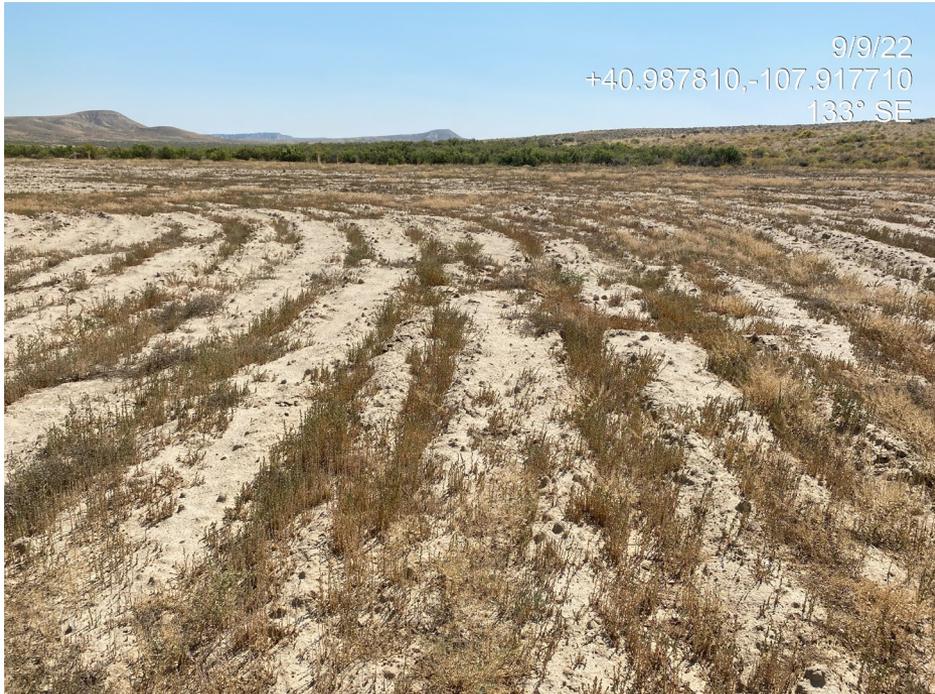
Photo 14. Photo shows areas of the Location with less perennial establishment than at the interior, where transects were conducted. Transects were placed in areas with the greatest amount of perennial cover. Vegetation in this photo consists of kochia, halogeton and annual wheatgrass (annual undesirable plant species and noxious weeds.)

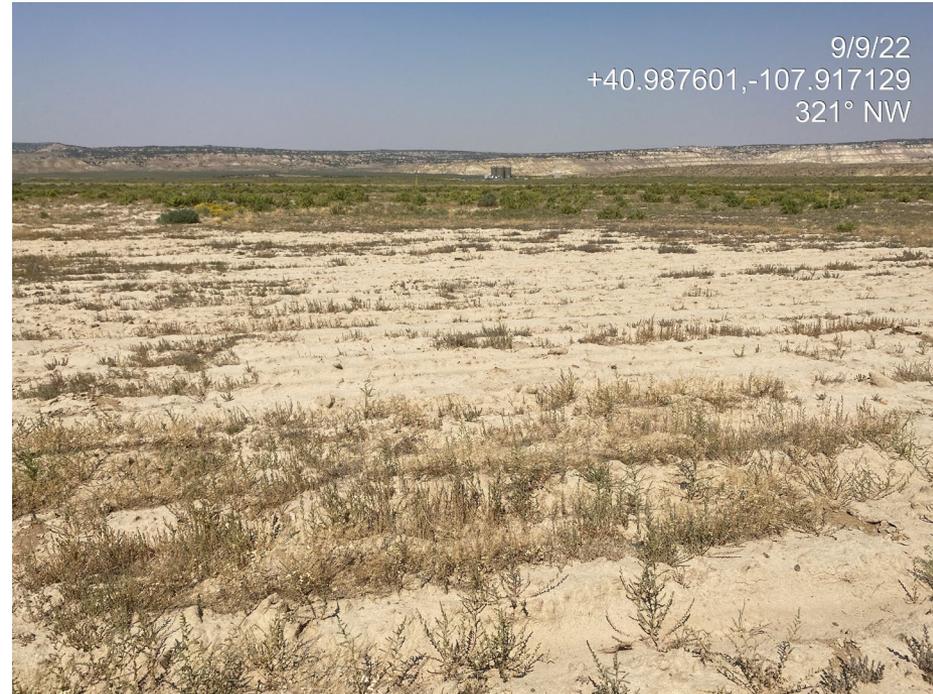
Photo 15. Refer to Photo 14 comment.
