# Site Inspection Report

**Site: RODGERS #1 FLOWLINE**  
09/09/2022

# SITE INSPECTION REPORT

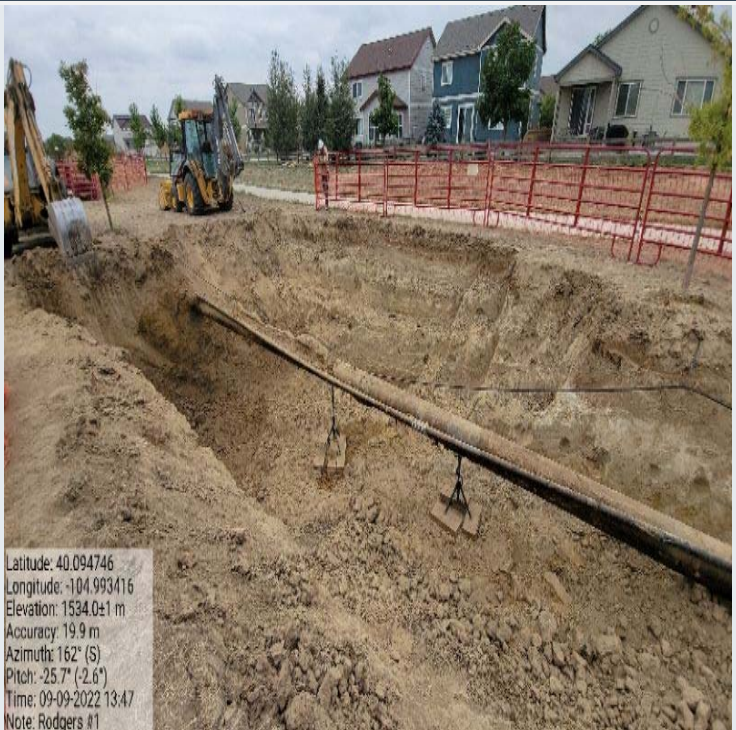
Remediation Activity Checklist	
	Photo
<p><b>Question:</b> Open excavation(s)? Note: Approximate size(s) (Length x Width x Depth, ft)</p> <p><b>Response:</b> Yes</p> <p><b>Notes:</b> Two excavations at the ends of the flowline and one spill excavation</p>

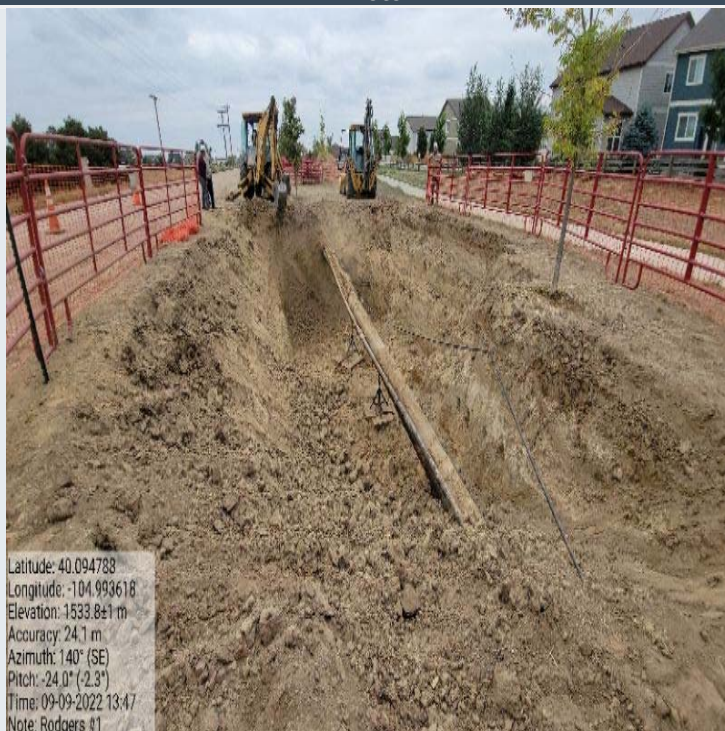
**Question:** Open excavation(s)? Note: Approximate size(s) (Length x Width x Depth, ft)

**Response:** Yes

**Notes:** Two at the ends of the flowline and one spill excavation

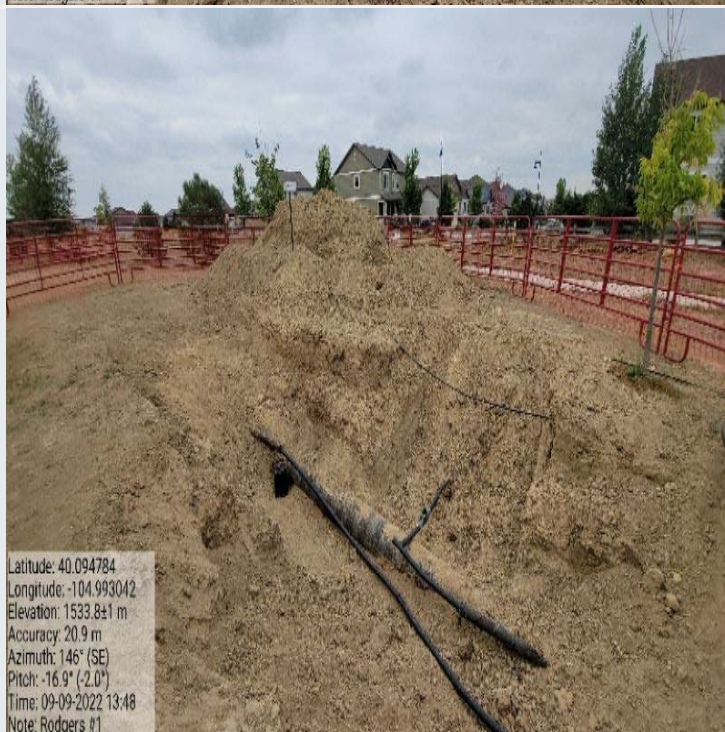
**Question:** Open excavation(s)? Note: Approximate size(s) (Length x Width x Depth, ft)

**Response:** Yes

**Notes:** Two at the ends of the flowline and one spill excavation

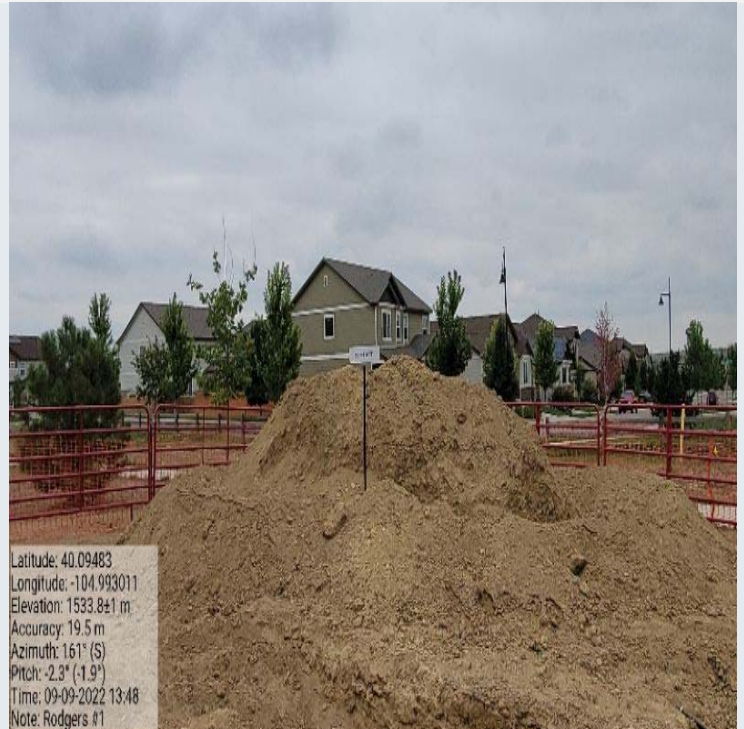
Photo
<b>Question:</b> E&P waste signage present, legible, accurate and up to date (labelled per KPK CWMP)? <b>Response:</b> Yes <b>Notes:</b> Clean waste. All contaminated waste continued to be loaded into soil truck immediately

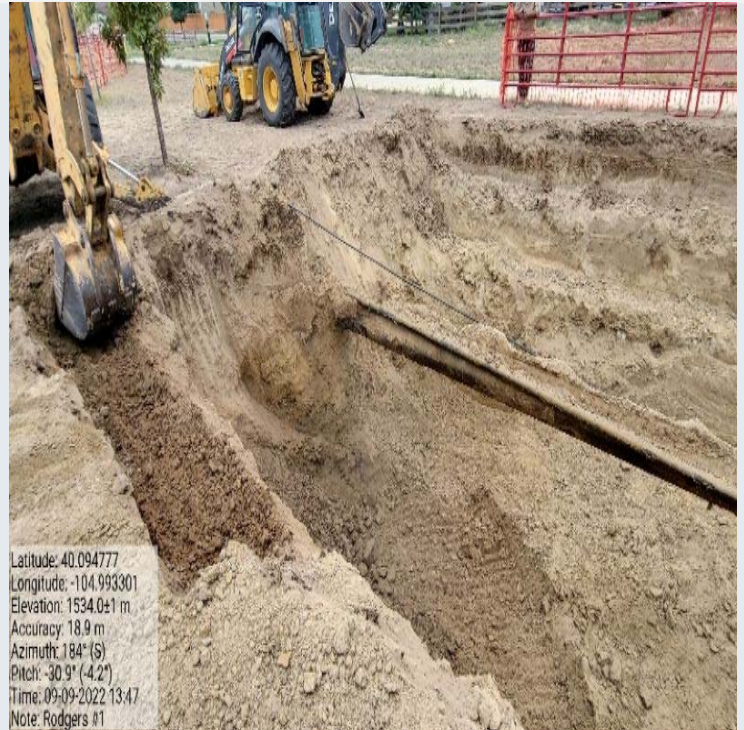
**Question:** Ground surface appears clean (no evidence of new equipment leaks, oil leaks, spills, or releases)?

**Response:** No

**Notes:** Staining visible within spill excavation

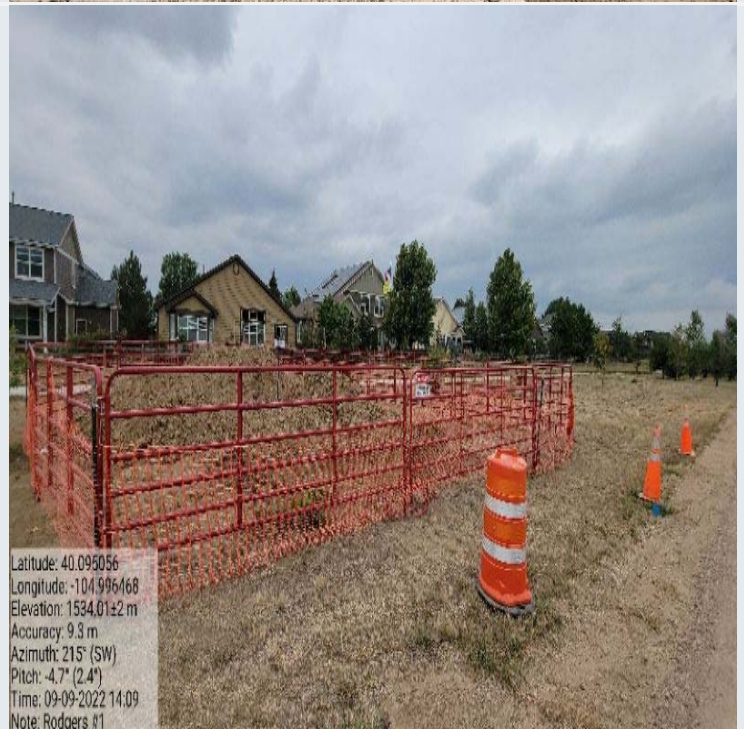
**Question:** Open excavation properly fenced/covered (in accordance with Rule 913.b.(5)B.i.)?

**Response:** Yes

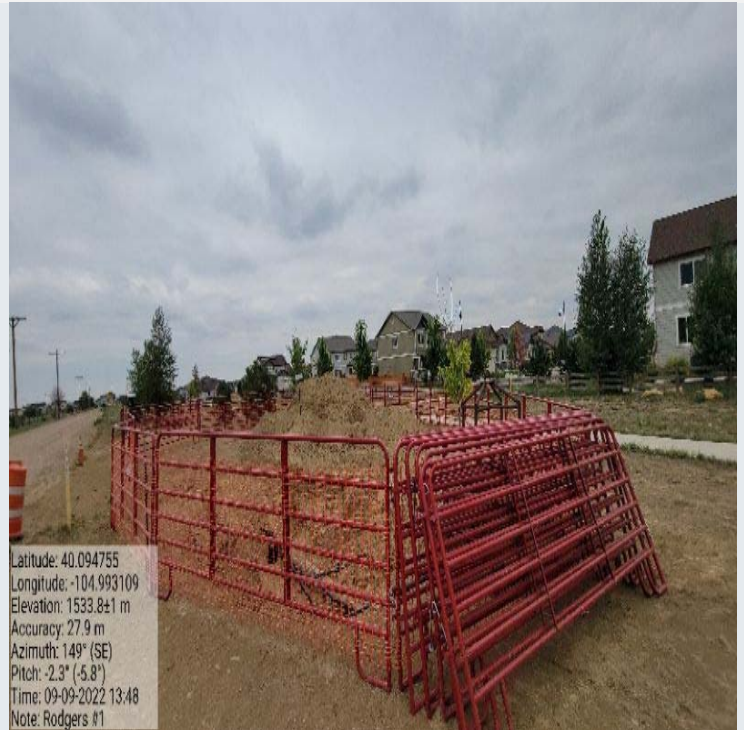
**Question:** Open excavation properly fenced/covered (in accordance with Rule 913.b.(5)B.i.)?

**Response:** Yes

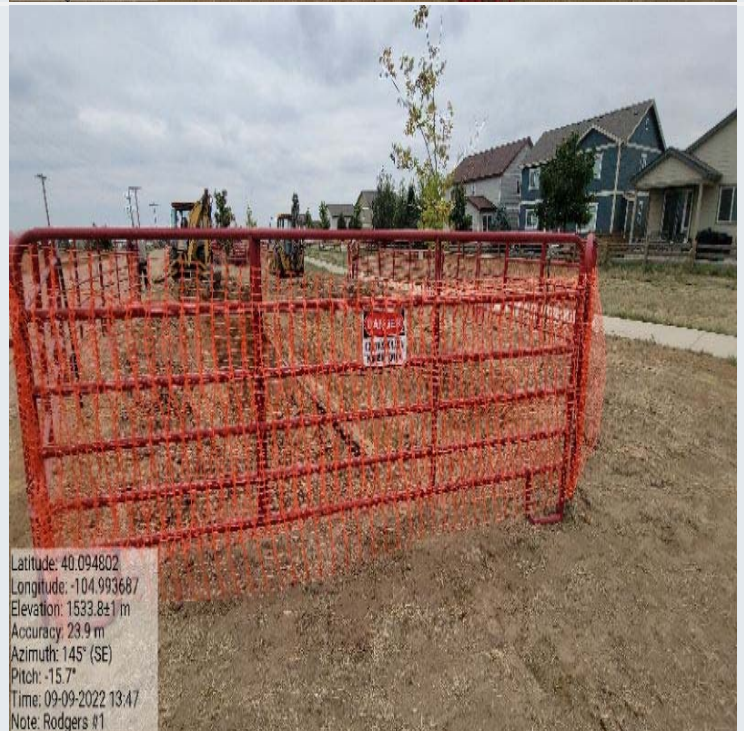
**Question:** Open excavation properly fenced/covered (in accordance with Rule 913.b.(5)B.i.)?

**Response:** Yes

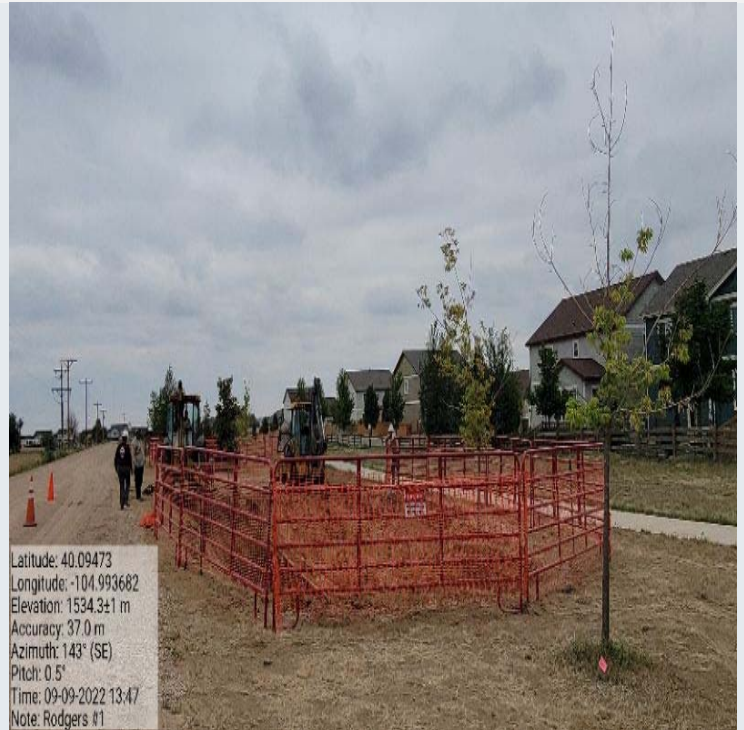
**Question:** Open excavation properly fenced/covered (in accordance with Rule 913.b.(5)B.i.)?

**Response:** Yes

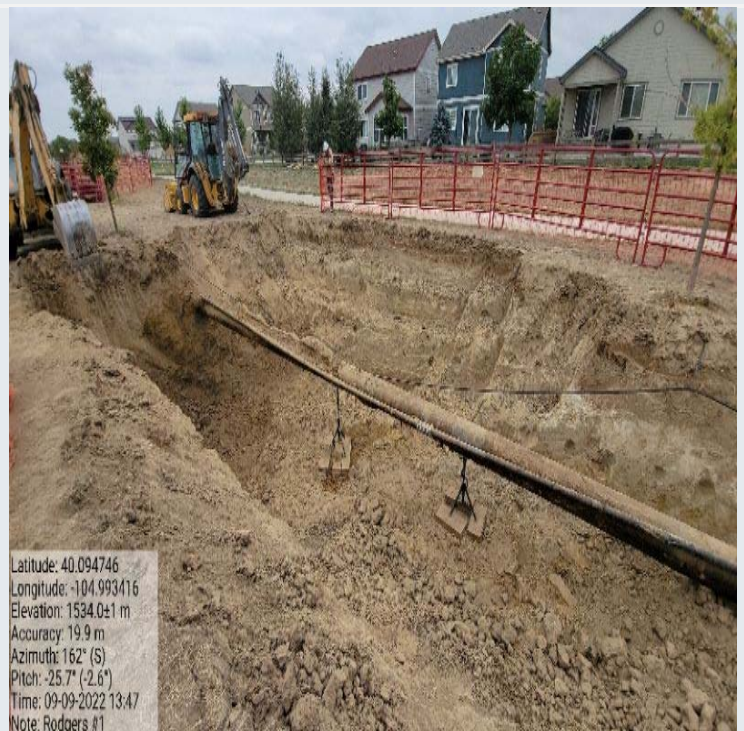
**Question:** Exposed buried/underground flowlines within excavation?

**Response:** Yes

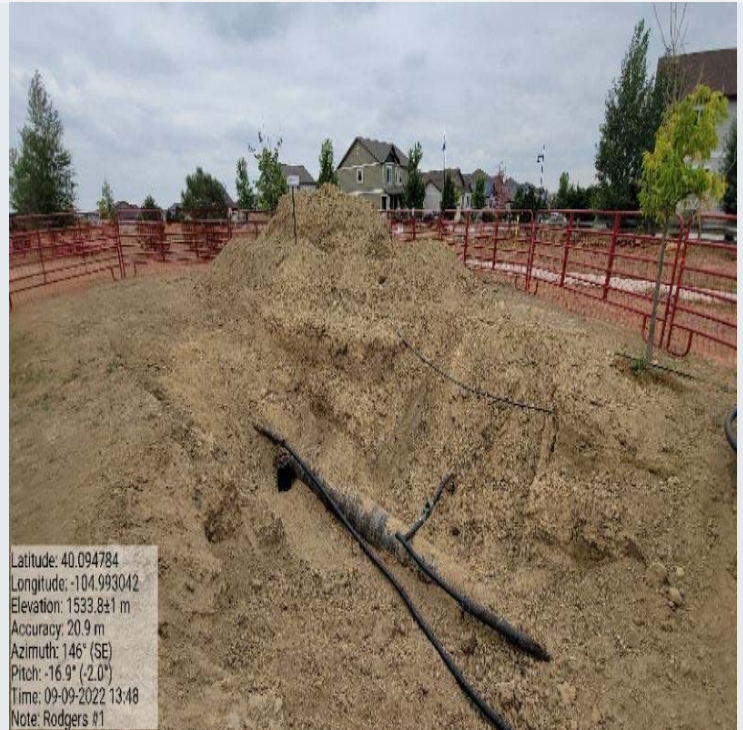
**Question:** Exposed buried/underground flowlines within excavation?

**Response:** Yes

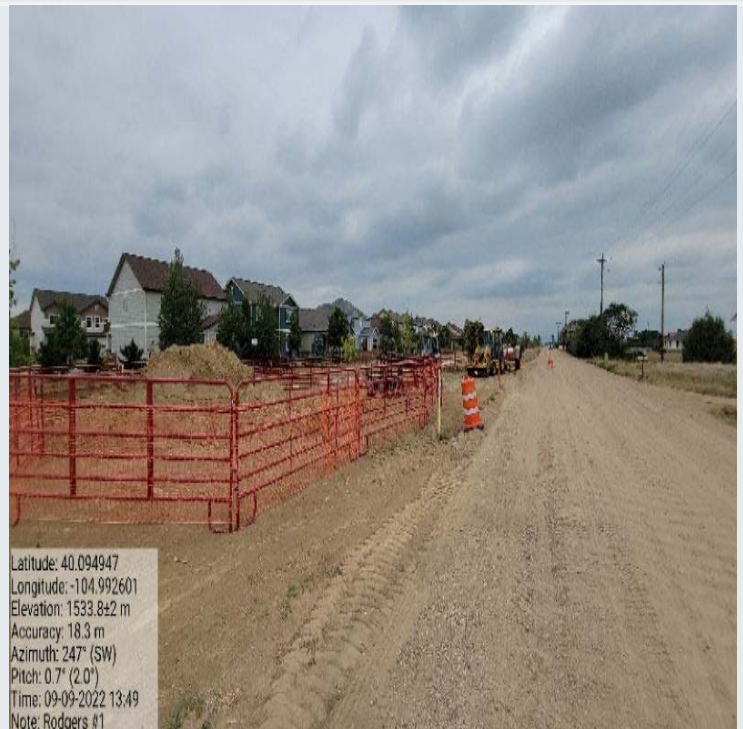
**Question:** Site is protected from vehicular traffic (properly fenced, gated or barricaded)?

**Response:** Yes

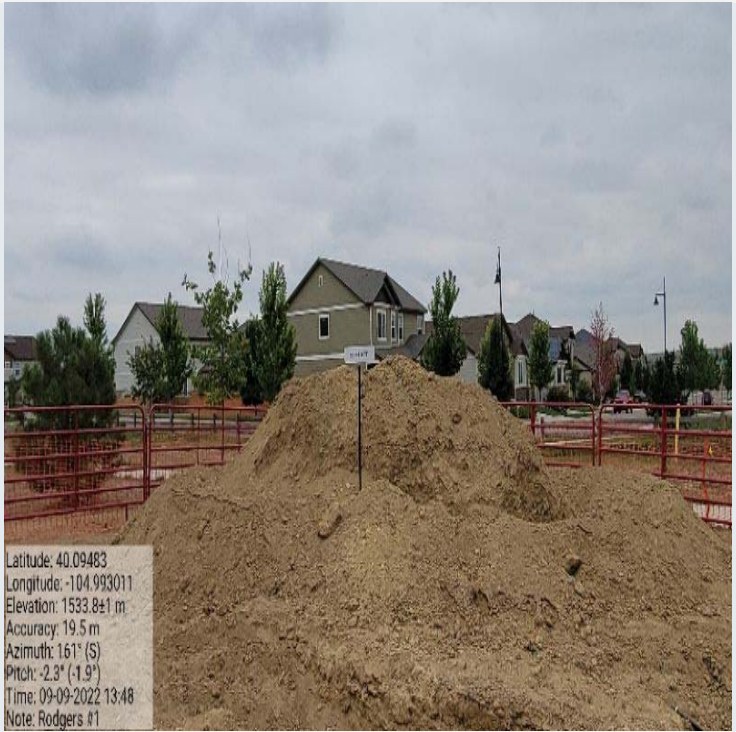
Site Condition Checklist	
	Photo
<b>Question:</b> Is earthen berm secondary containment present and in good condition (compacted, complete, no evidence of erosion, animal burrowing, etc.)? <b>Response:</b> Yes <b>Notes:</b> Around clean stockpile
