Diagram of the Getty Pan Am #19A Location

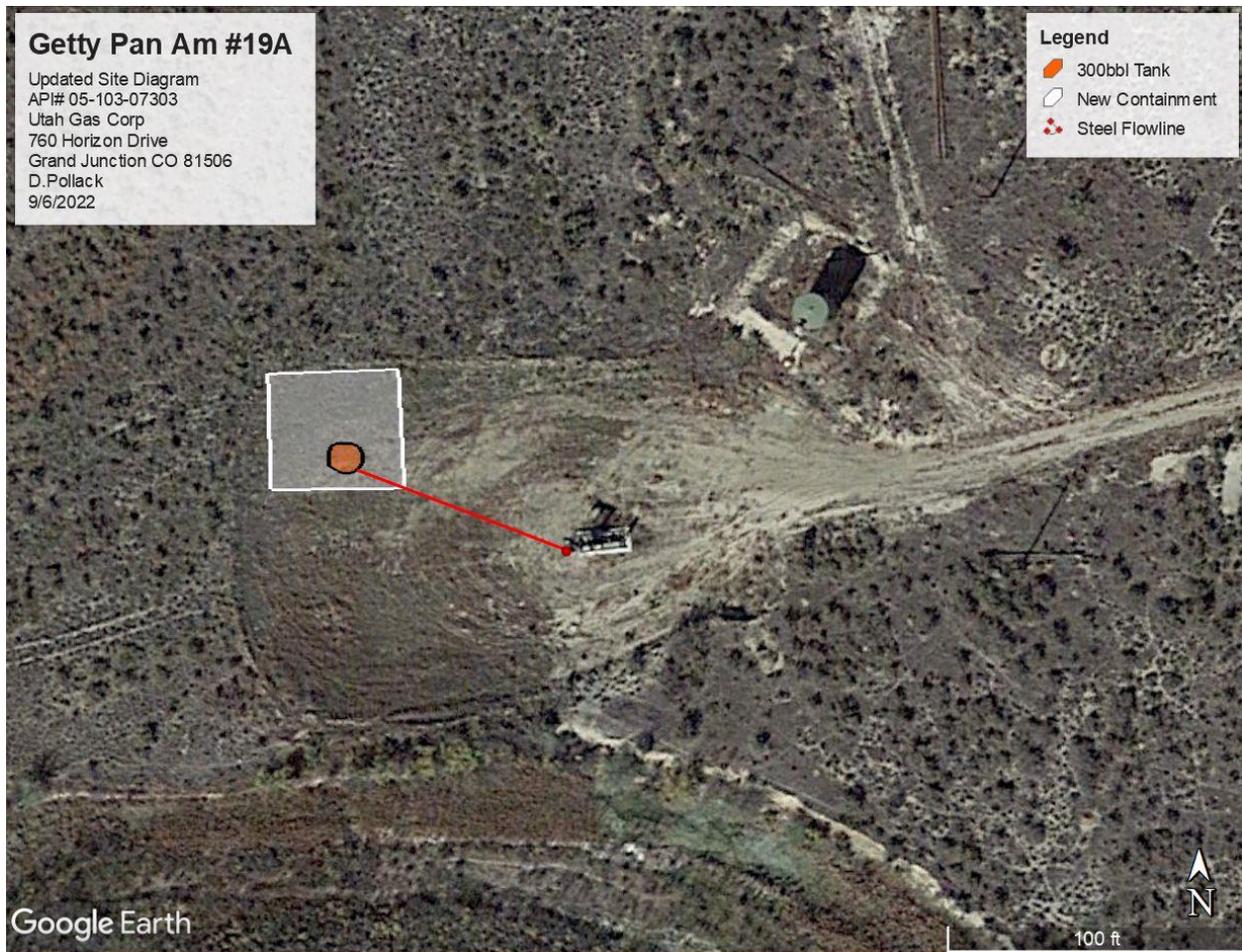
The original tank sat in the northeast corner of the pad. UGC is re-configuring the well pad because impacts were found in the soil during a flowline repair performed in spring 2022. The tank and flowline needed to be moved to the northwest corner of the pad because UGC will be sampling the soil where the original flowline was laid on a quarterly basis. The new pad layout is depicted by the white and orange polygons, and the red line.
