Inspection Photos

Loc: 325172

Operator: LOGOS OPERATING LLC

Inspection Date: 8/30/2022

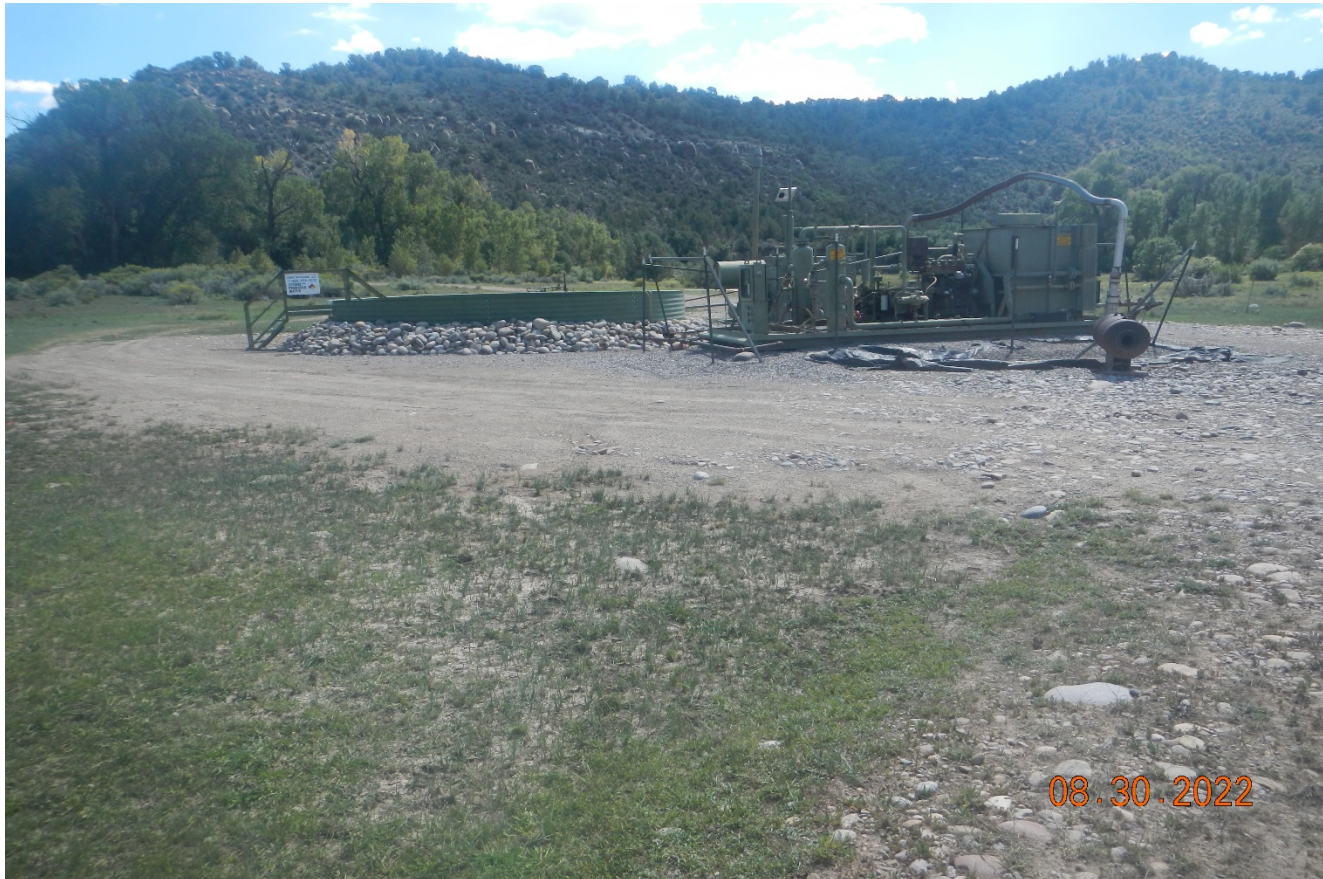
Photo 1. Facing southeast toward the location and production equipment. The wellsite is located within an oxbow of the Florida River that is prone to flooding.

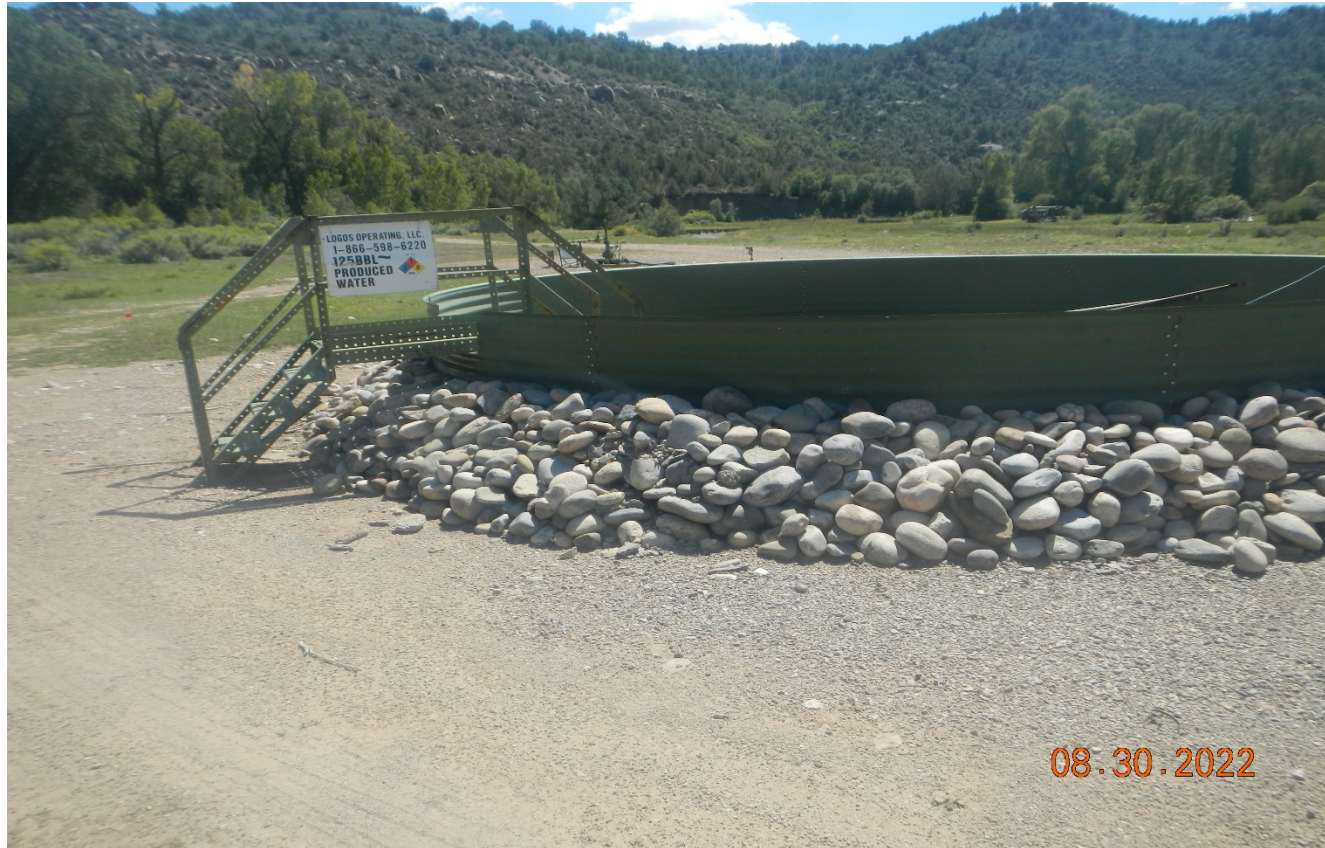
Photo 2. Facing toward the open top tank. There has been round rock placed around the containment. The round rock is pervious and will not prevent flood water from entering underneath the steel containment. Round rock will also be easily displaced as they do not lock in place as well as angular rock. Another solution needs to be implemented.

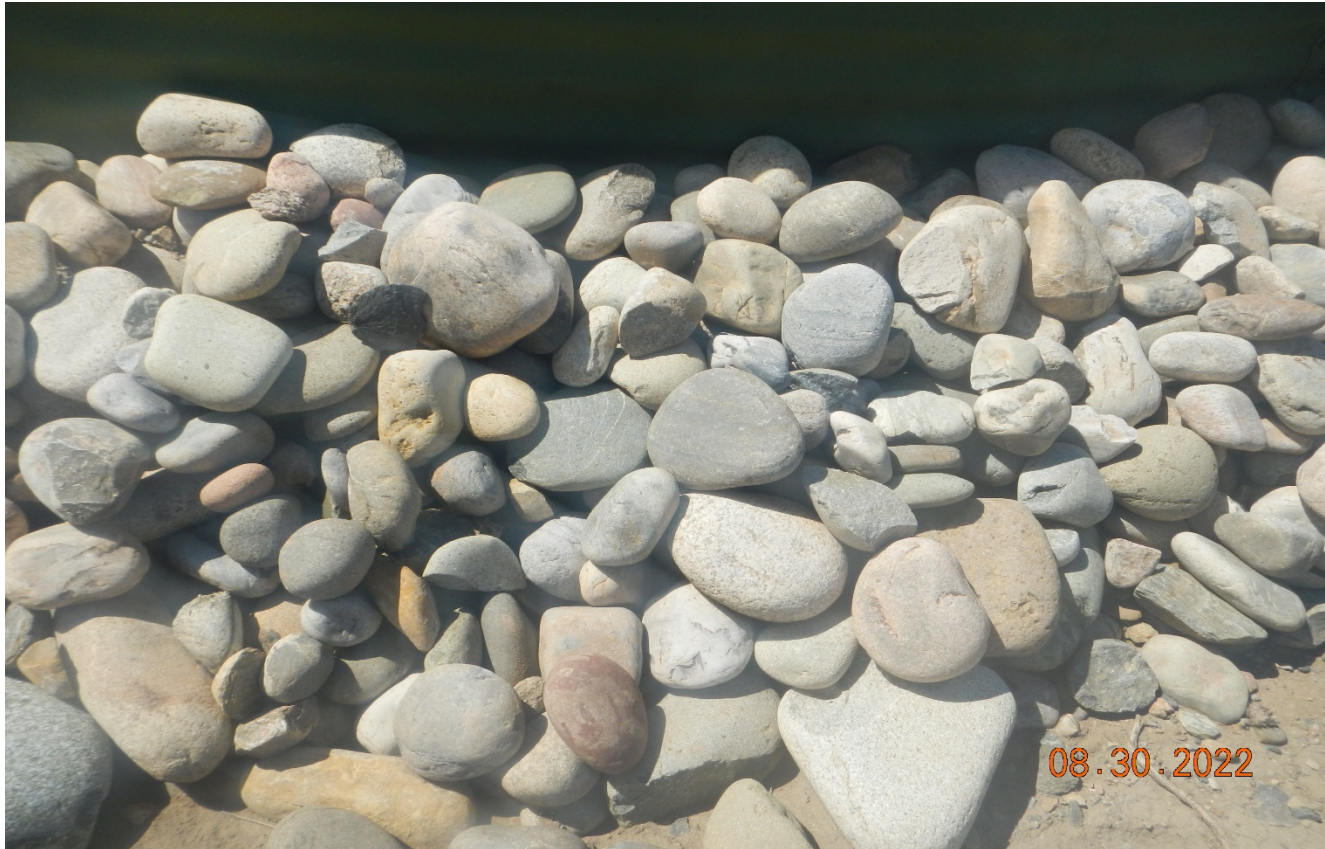
Photo 3. The round rock is pervious and will not prevent flood water from entering underneath the steel containment. Round rock will also be easily displaced as they do not lock in place as well as angular rock. Another solution needs to be implemented.

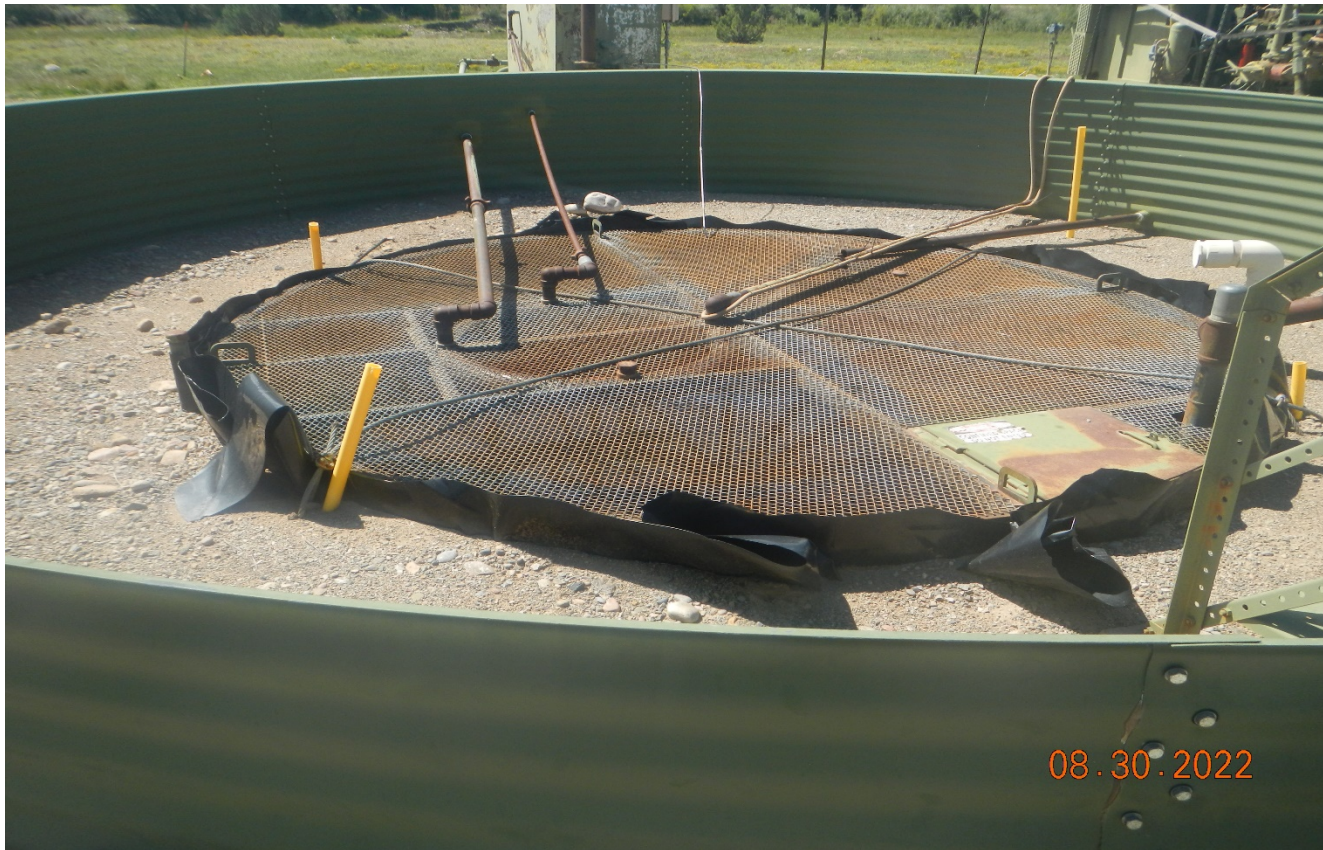
Photo 4. The open top tank has a steel grate which will not prevent spillage from occurring.

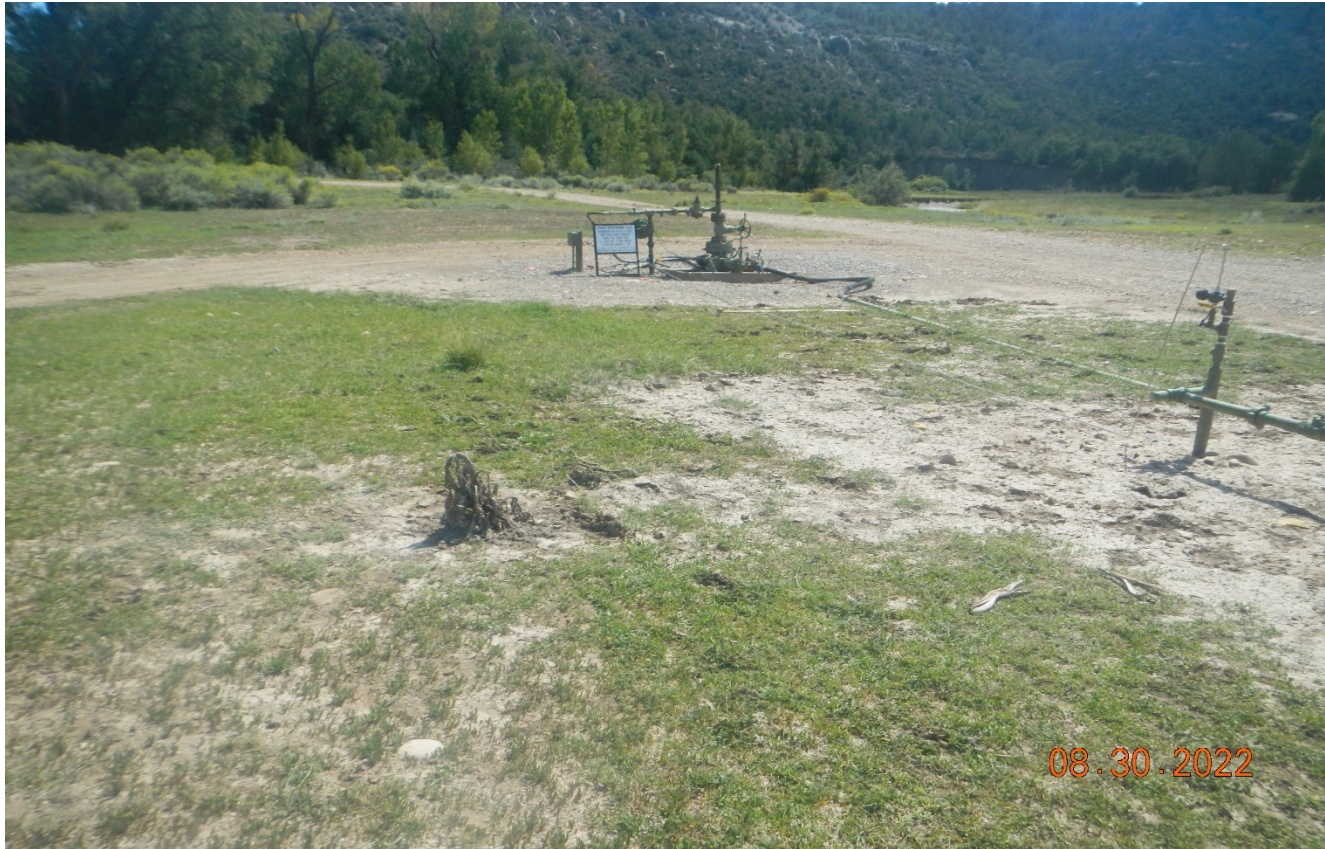
Photo 5. Facing south toward the well.

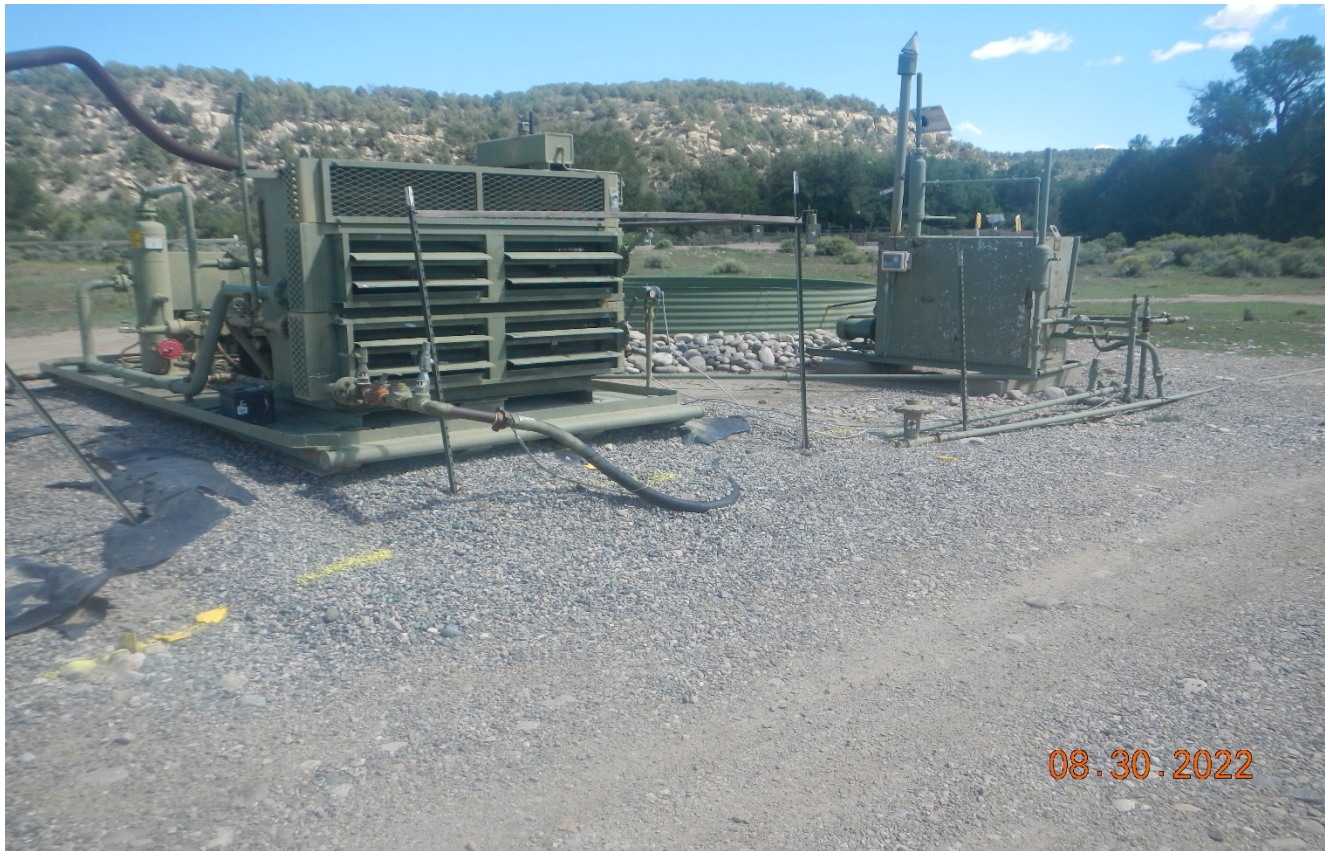
Photo 6. Facing back northeast toward the production equipment.

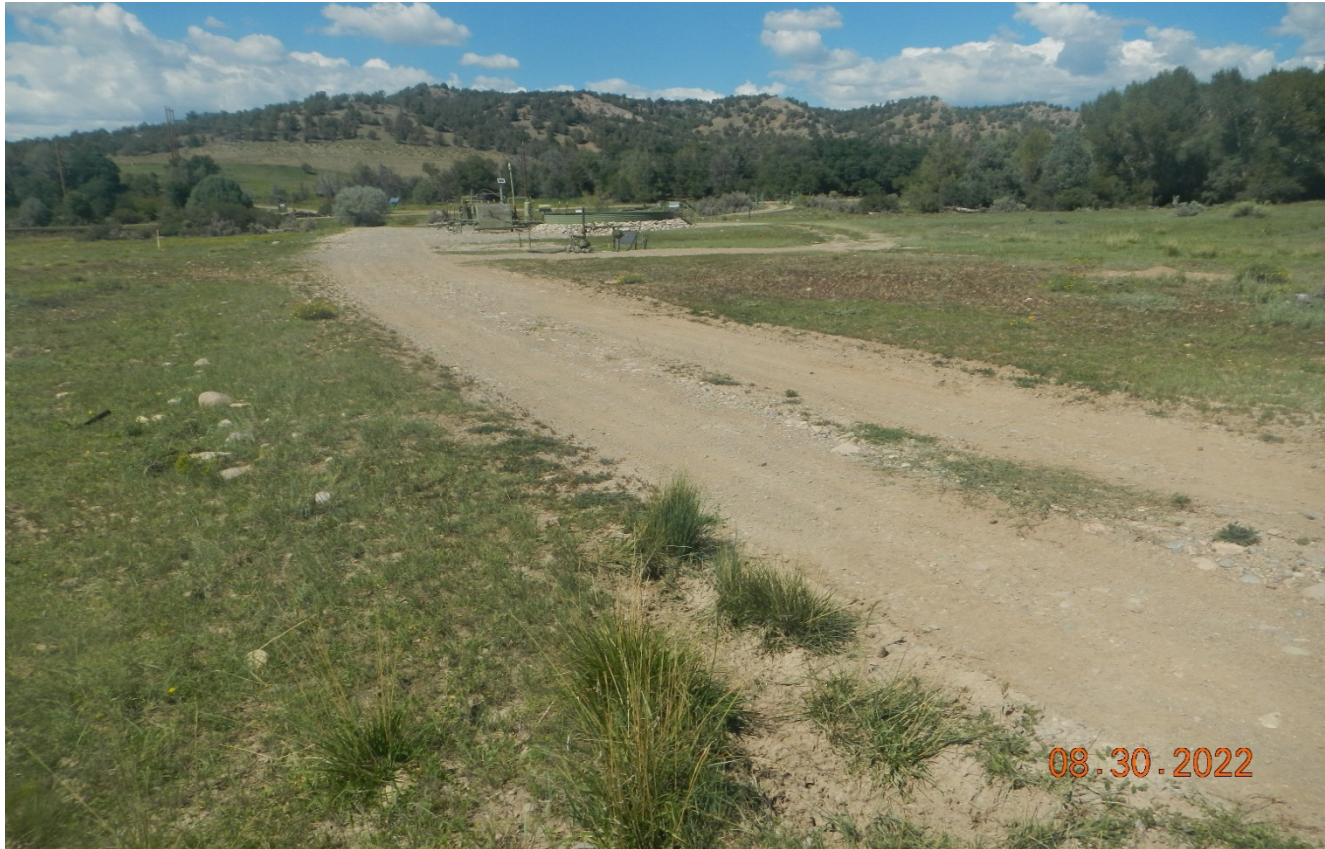
Photo 7. Facing north toward the well site location that is located within an oxbow of the Florida River that is prone to flooding.
