# Inspection Photos

Loc: 312051

Operator: SIMCOE/ LOGOS

Inspection Date: 8/30/2022

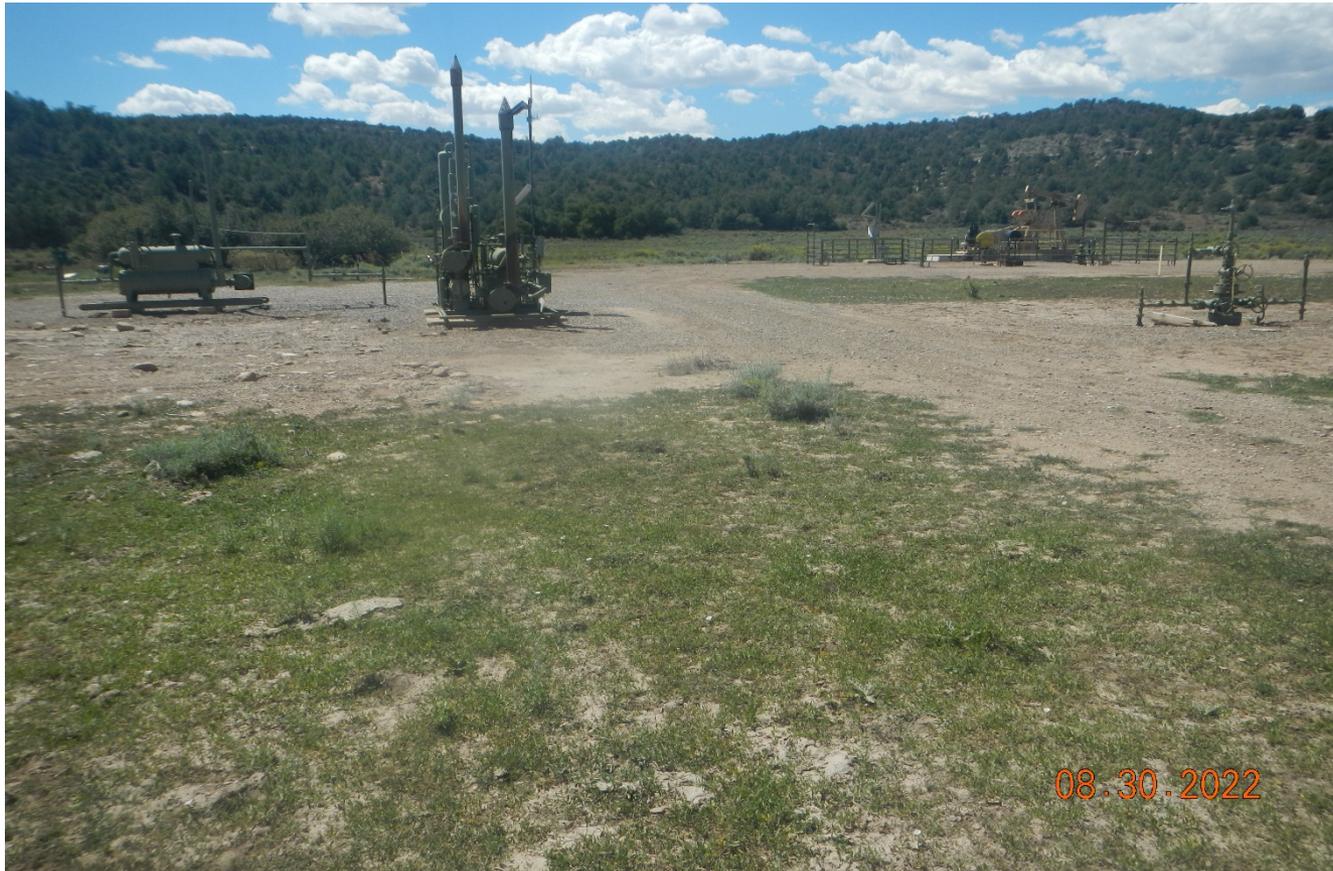
**Photo 1.** Facing southeast toward the location and production equipment.

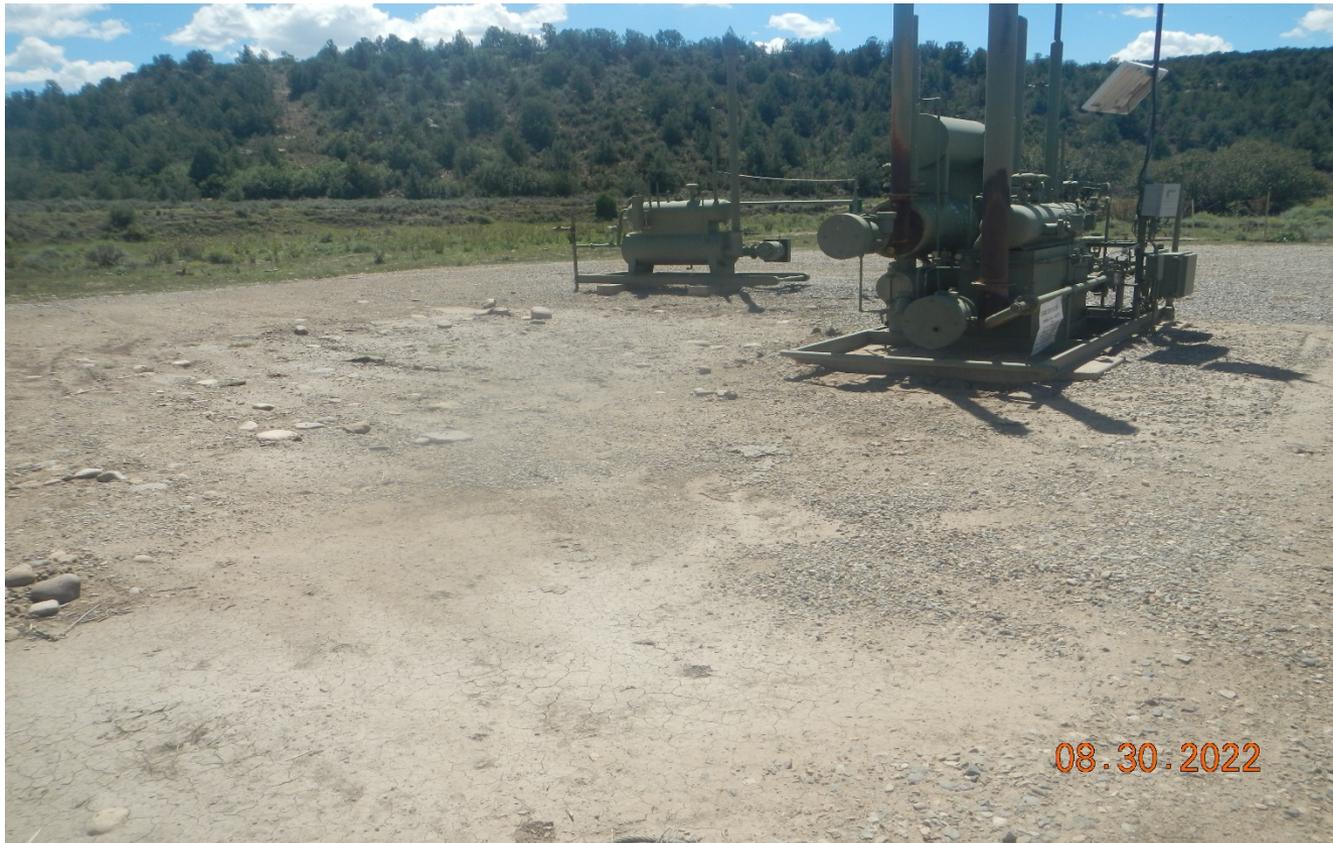
**Photo 2.** Facing southeast toward Bondad 33-9 equipment. The open top tank has been removed from this site. The remaining equipment needs to have improved secondary containment installed.

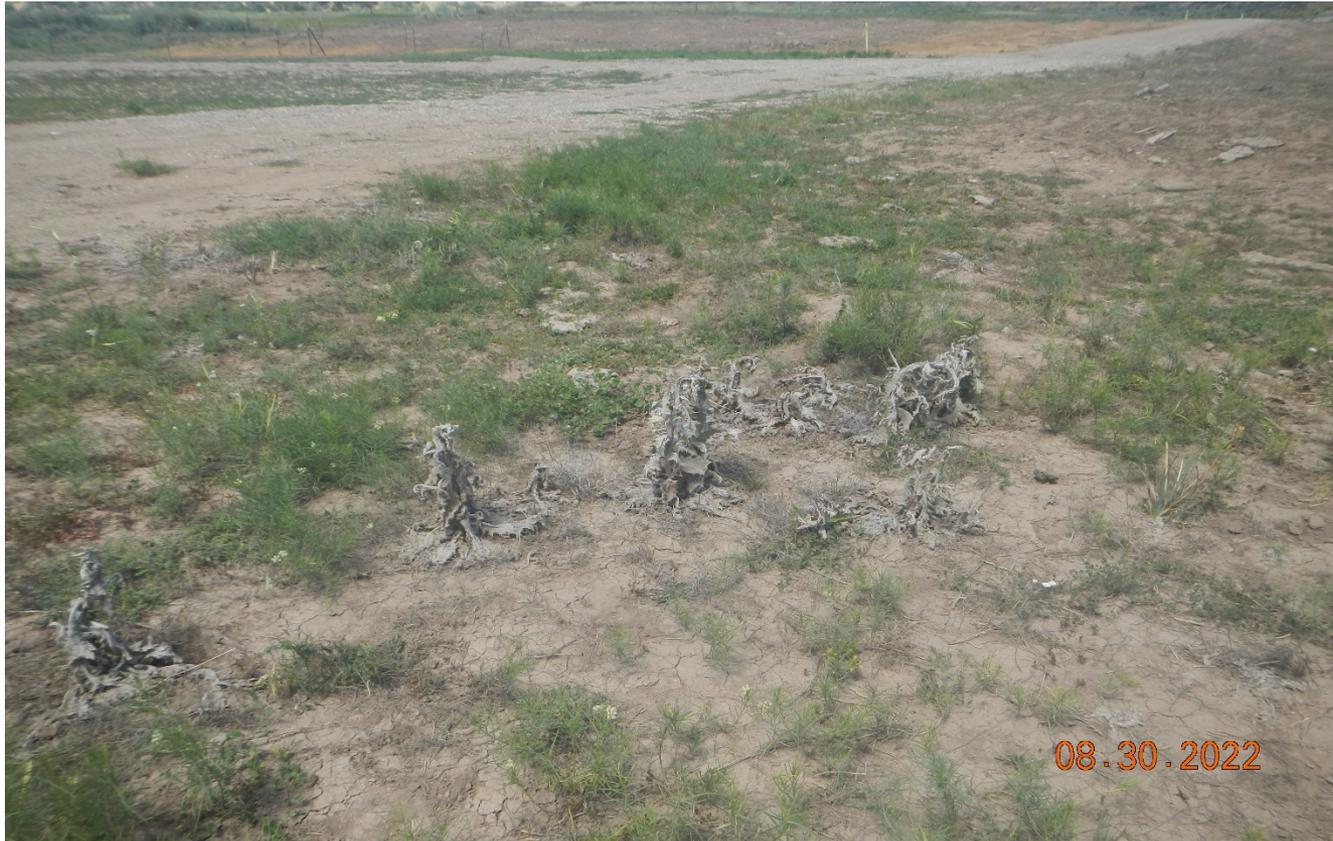
**Photo 3.** East side of the location facing northwest. The east/ northeastern portion of the location has not been revegetated with perennial vegetation. There has been no recent seeding and stabilization.

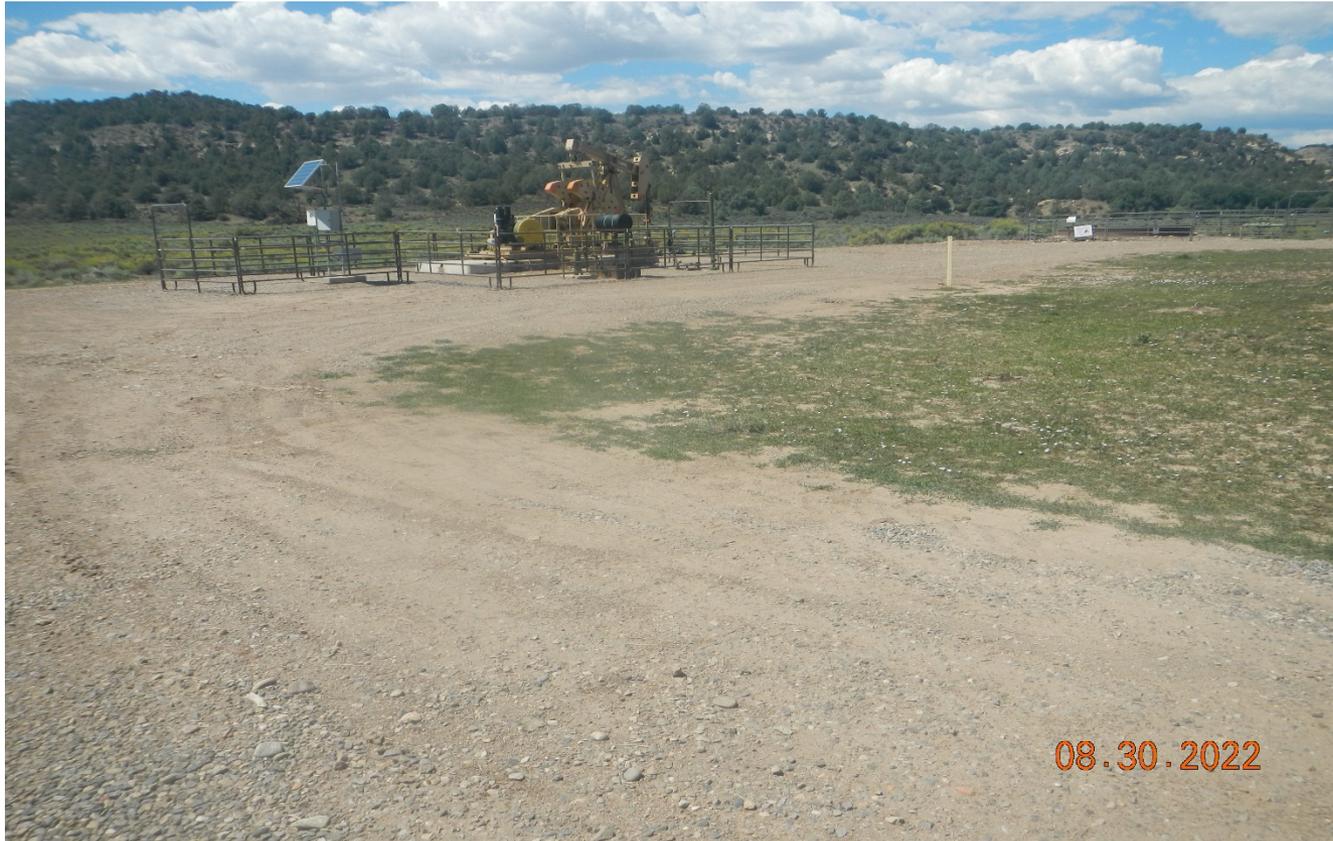
**Photo 4.** Facing southwest toward the Barnes A-2 well site.

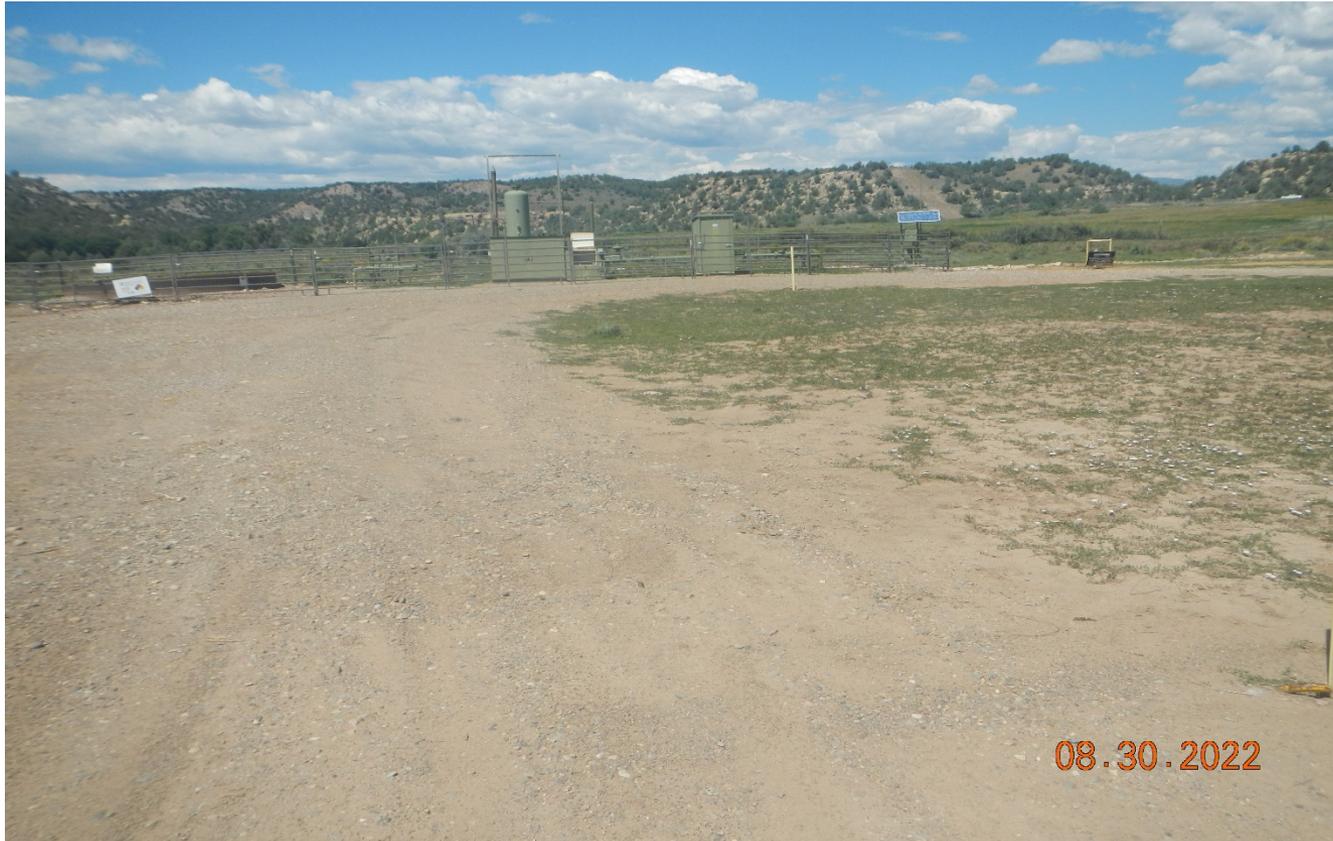
**Photo 5.** Facing west toward the Barnes A-2 production equipment.

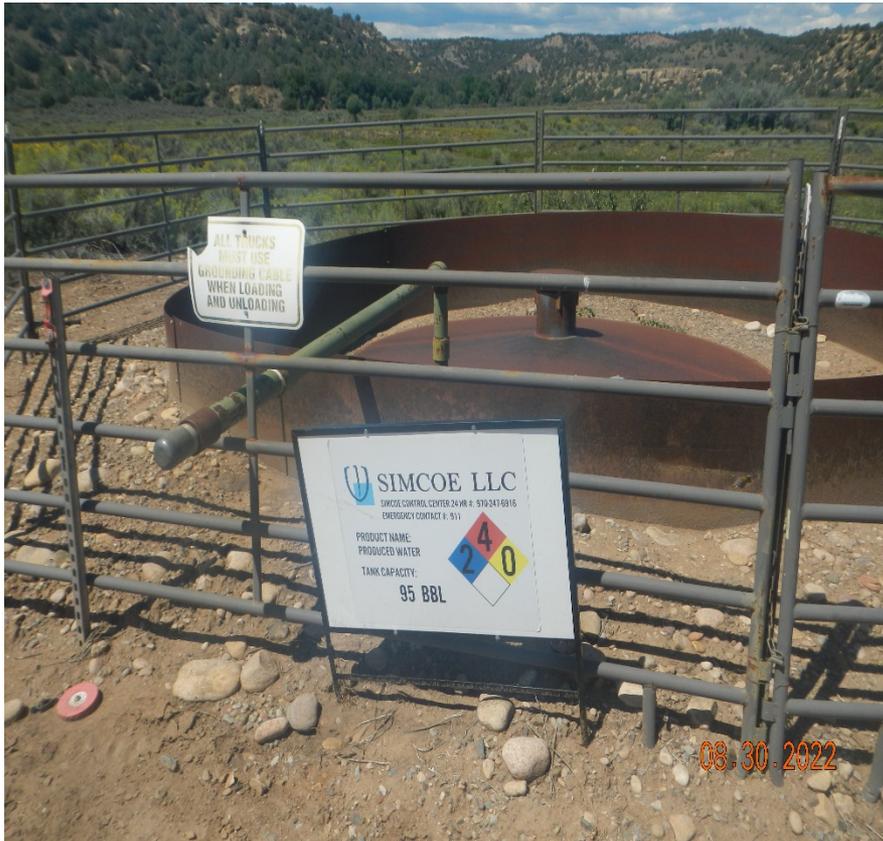
**Photo 6.** Facing toward the below ground tank at the west side of the location. Barnes A-2 production equipment.

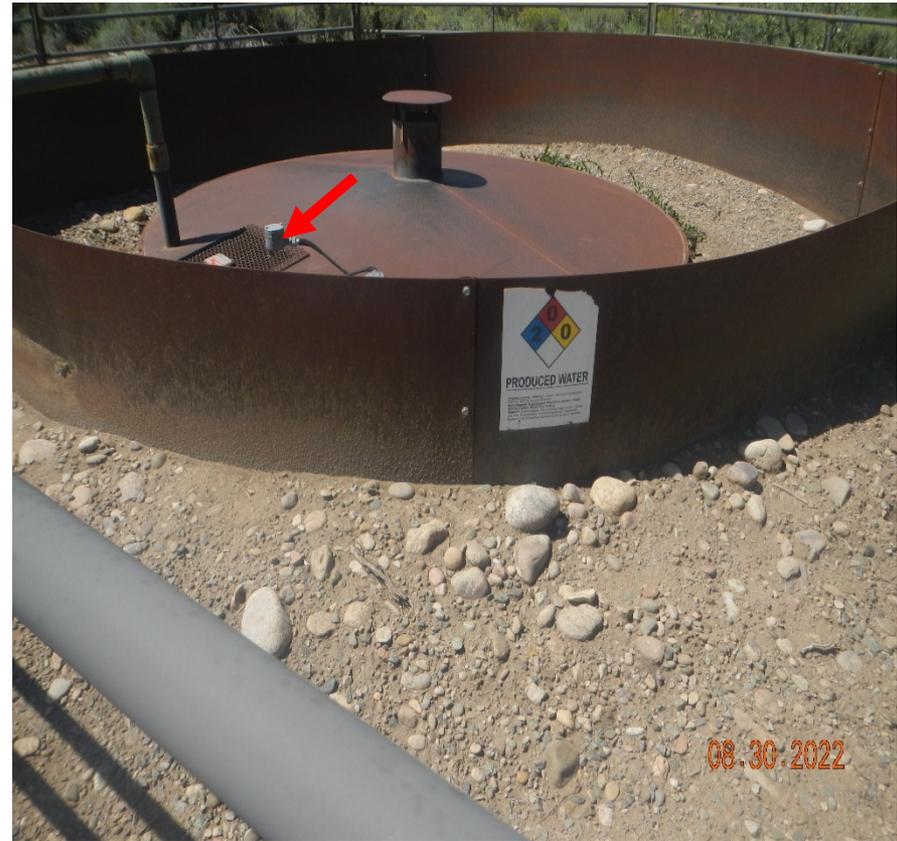
**Photo 7.** The tank has a steel pervious grate shown at red arrow. This needs to be covered to prevent overflow spillage.

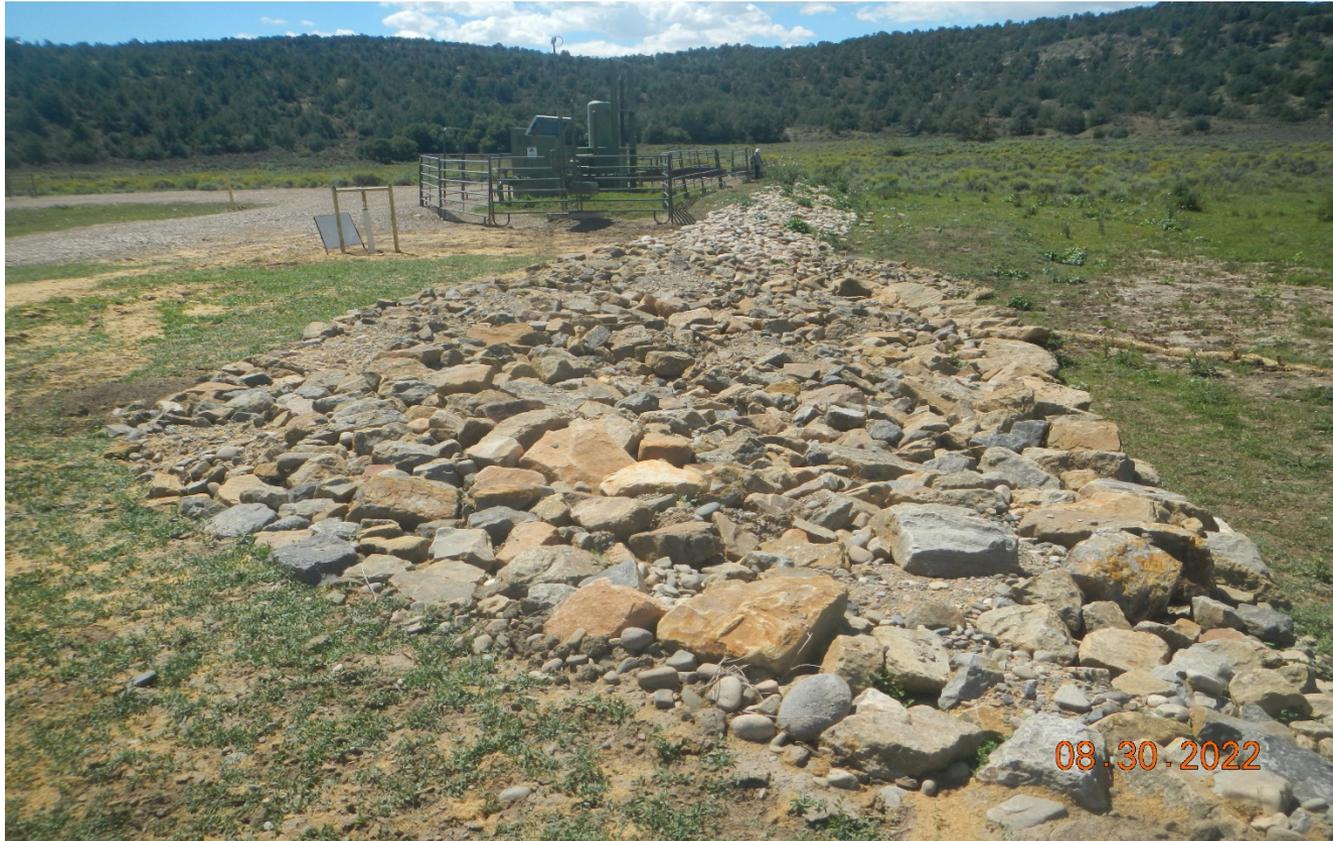
**Photo 8.** Facing southwest at the west side of the location. This area of previous erosion was repaired and angular rock rip/rap has been installed.

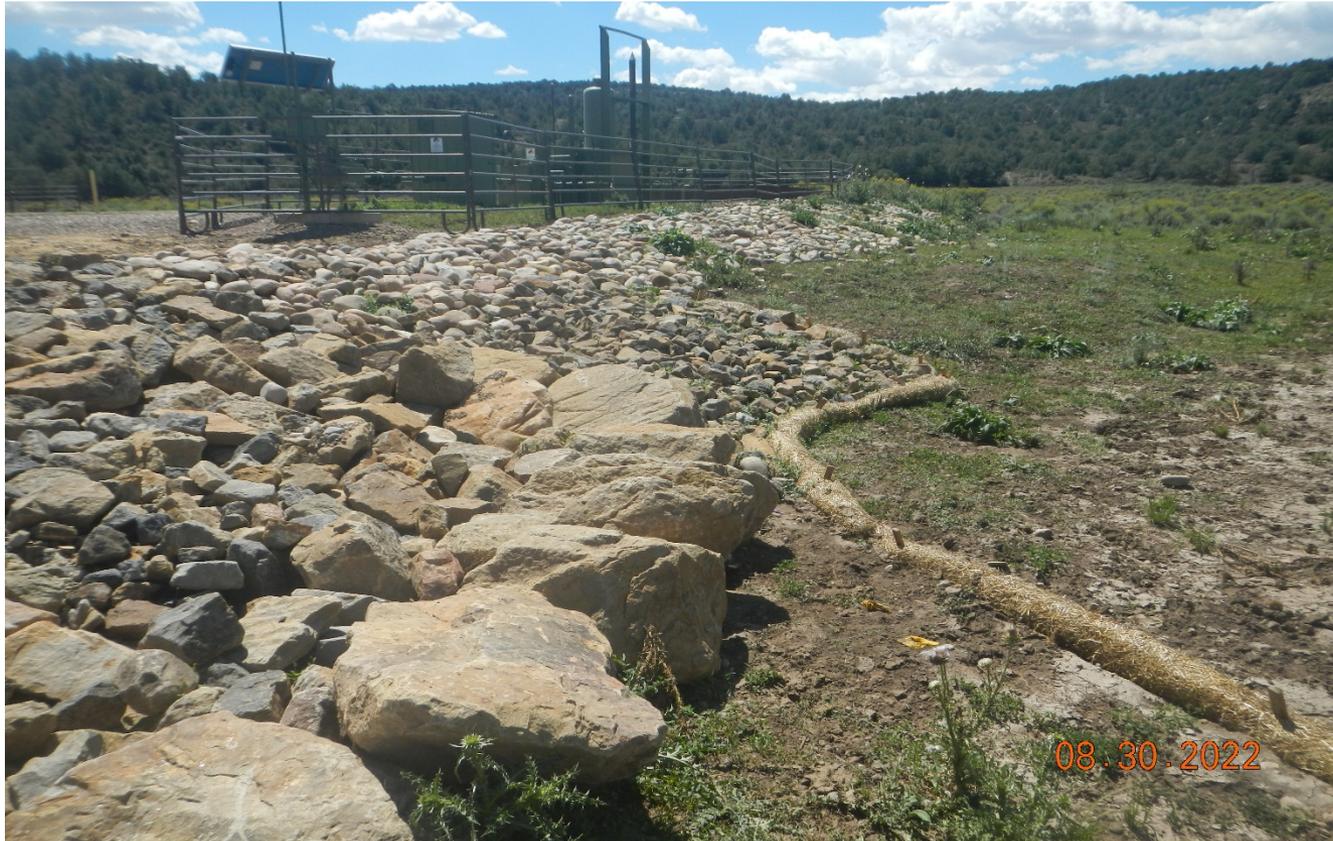
**Photo 9.** Facing southwest at the west side of the location. Further along the bank the rock rip/rap changes to round rock which does not hold in place very well for proper stabilization. There are numerous noxious weeds in this area that need to be controlled. (Musk thistle, Hounds tongue, Canada thistle).

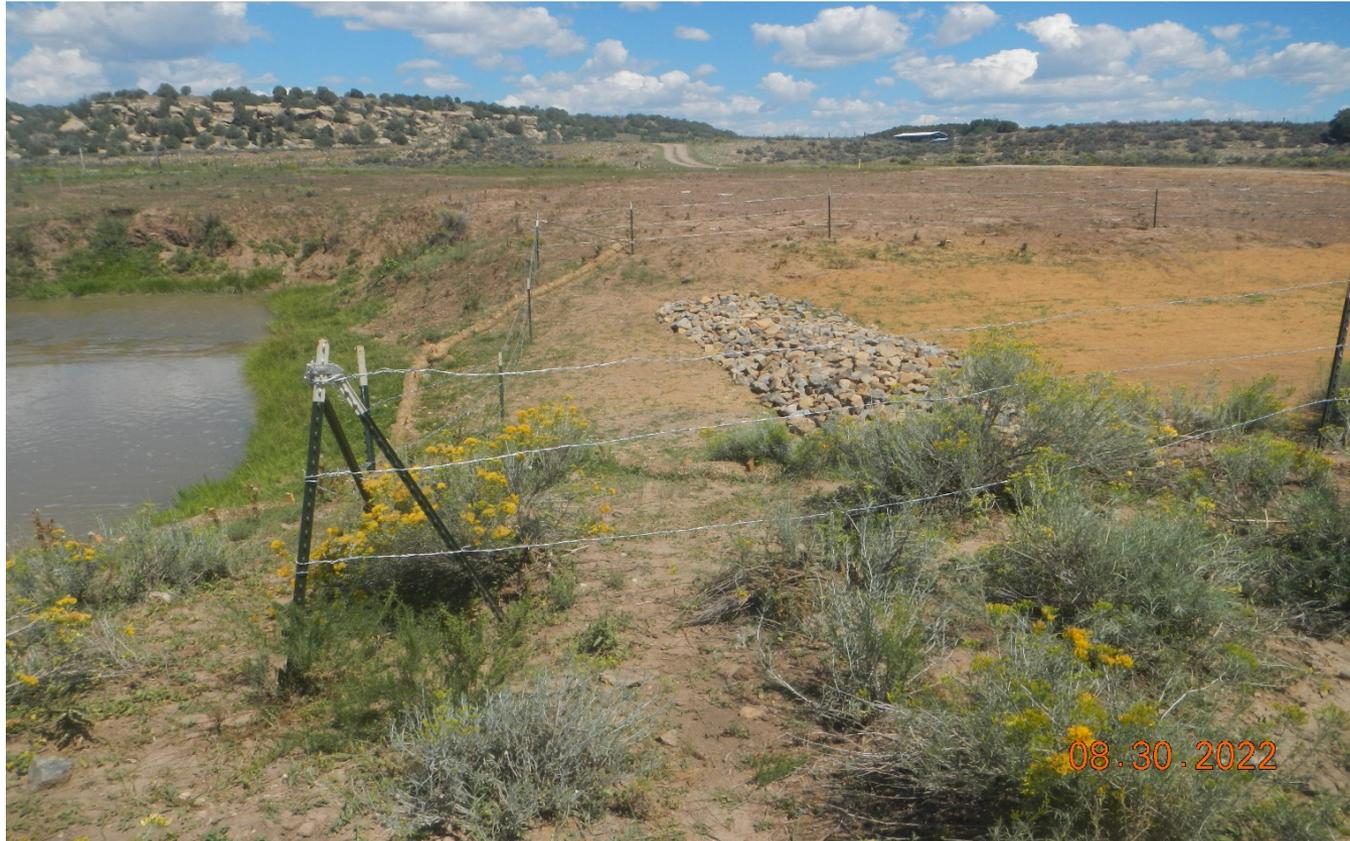
**Photo 10.** Facing northeast toward the swaled area along the stream bank. There has been rock rip/rap, wattles, and erosion blanket installed in this area where erosion had occurred.

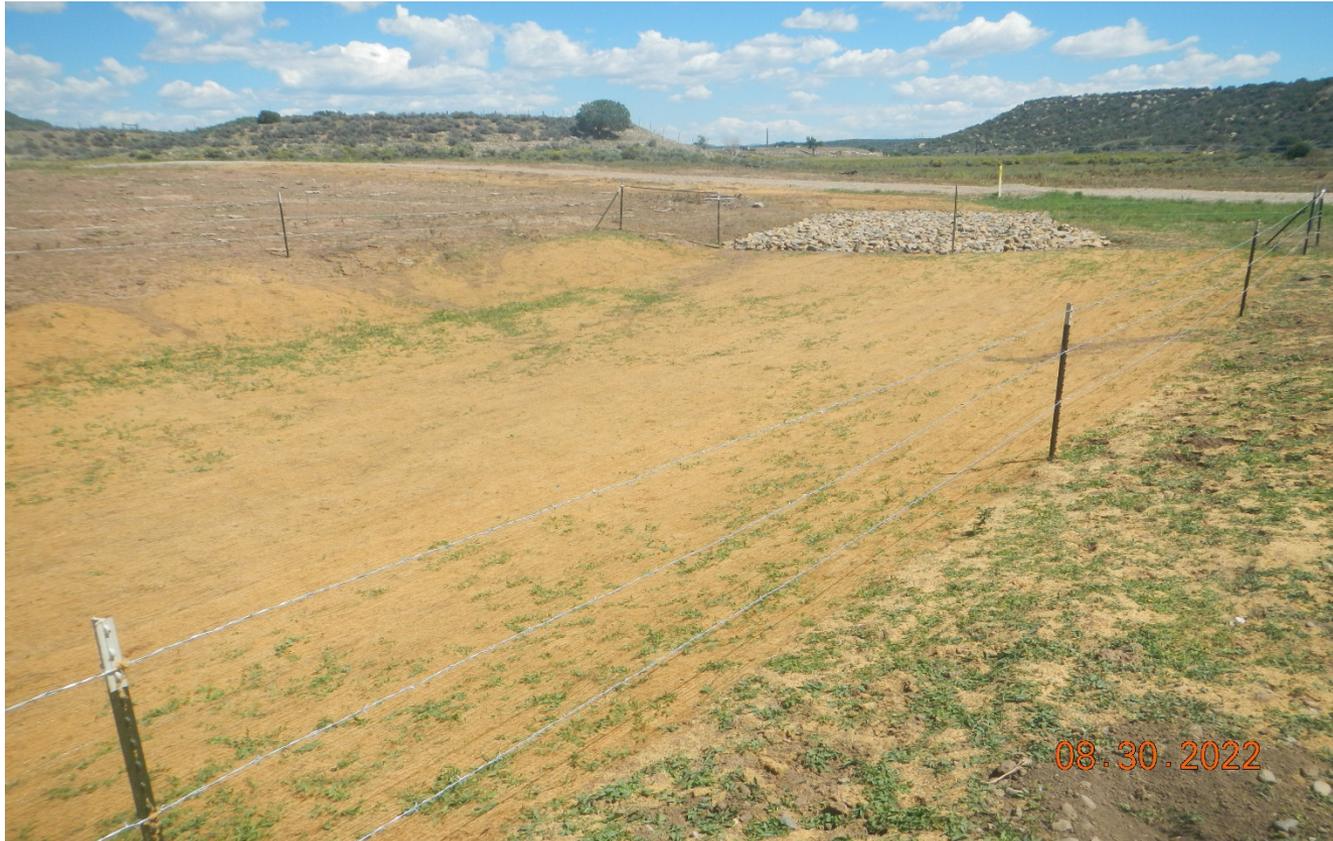
**Photo 11.** Facing east toward the swaled area at the north side of the location. There has been rock rip/rap, wattles, and erosion blanket installed in this area where erosion had occurred.

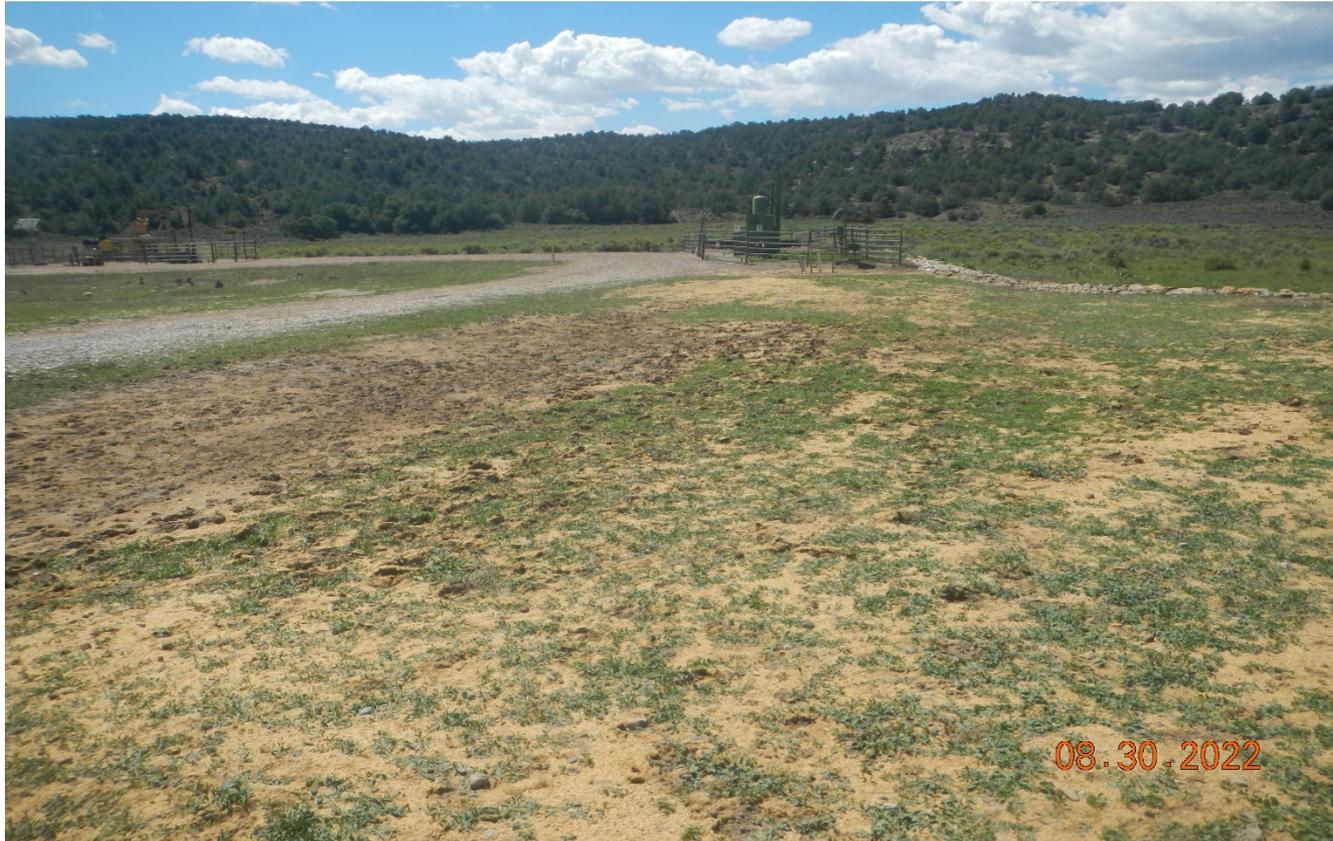
**Photo 12.** Facing southwest at the location.

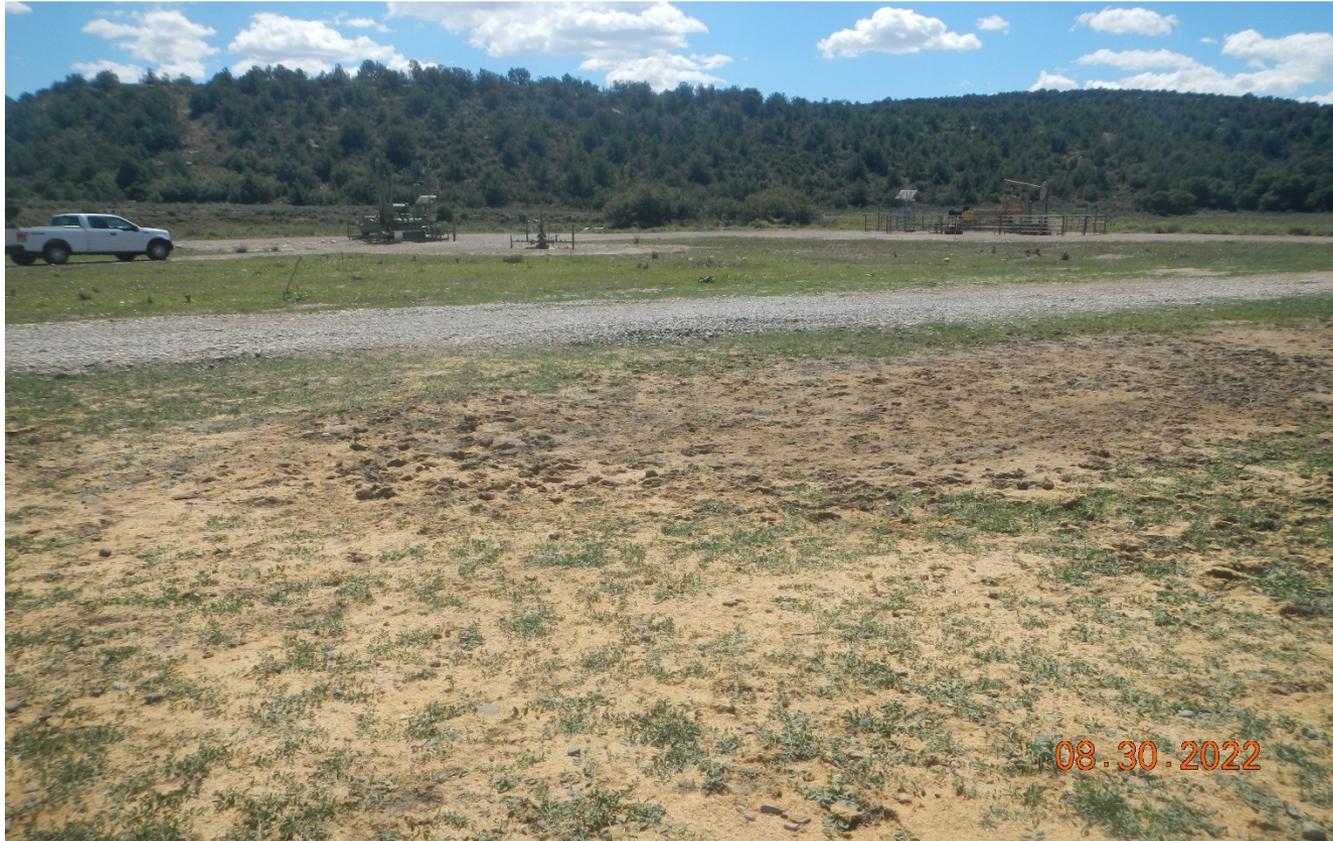
**Photo 13.** Facing southeast at the location.
