Inspection Photos

API: 009-06236

Operator: DOVER ATWOOD CORPORATION

Inspection Date: 9/13/2022

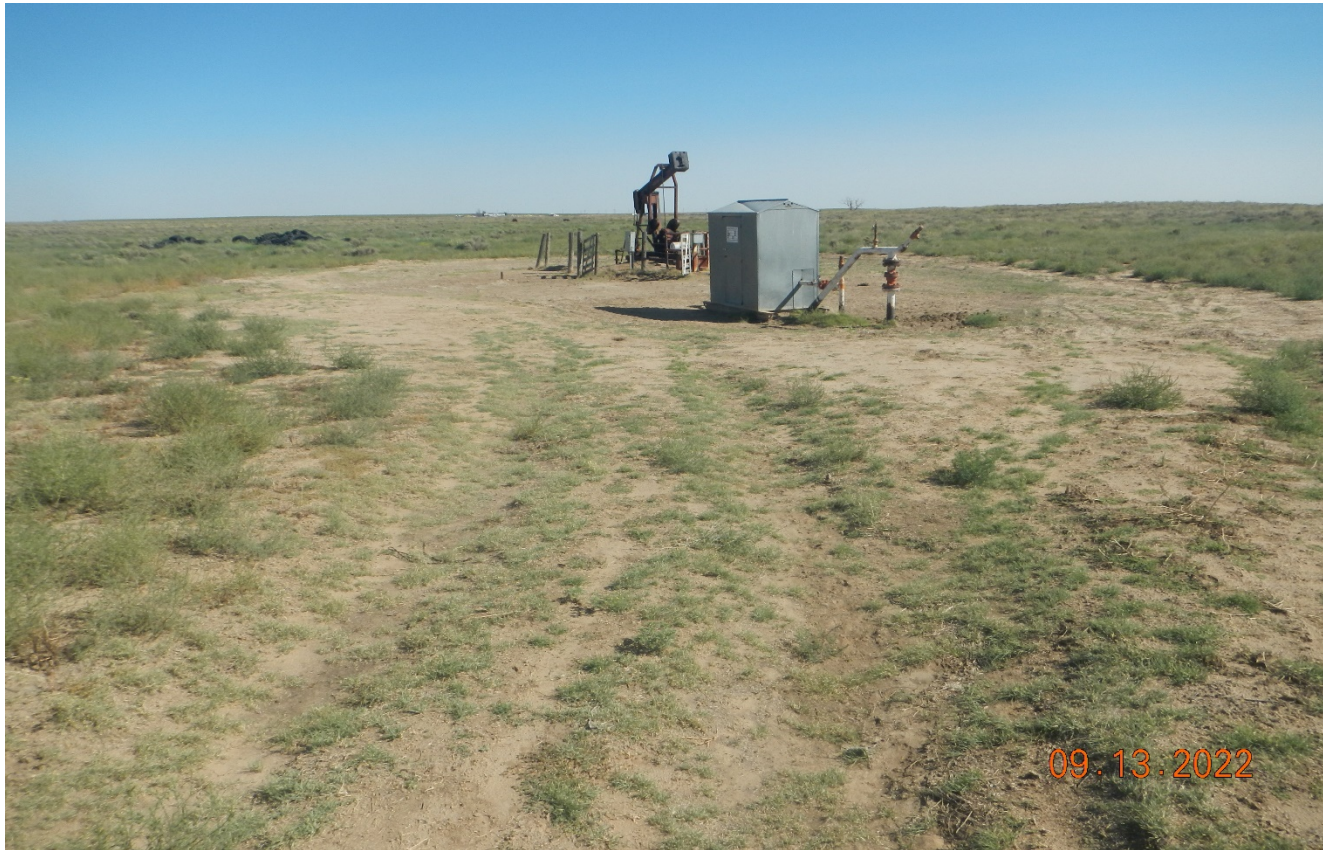
Photo 1. Facing northeast toward wellsite.

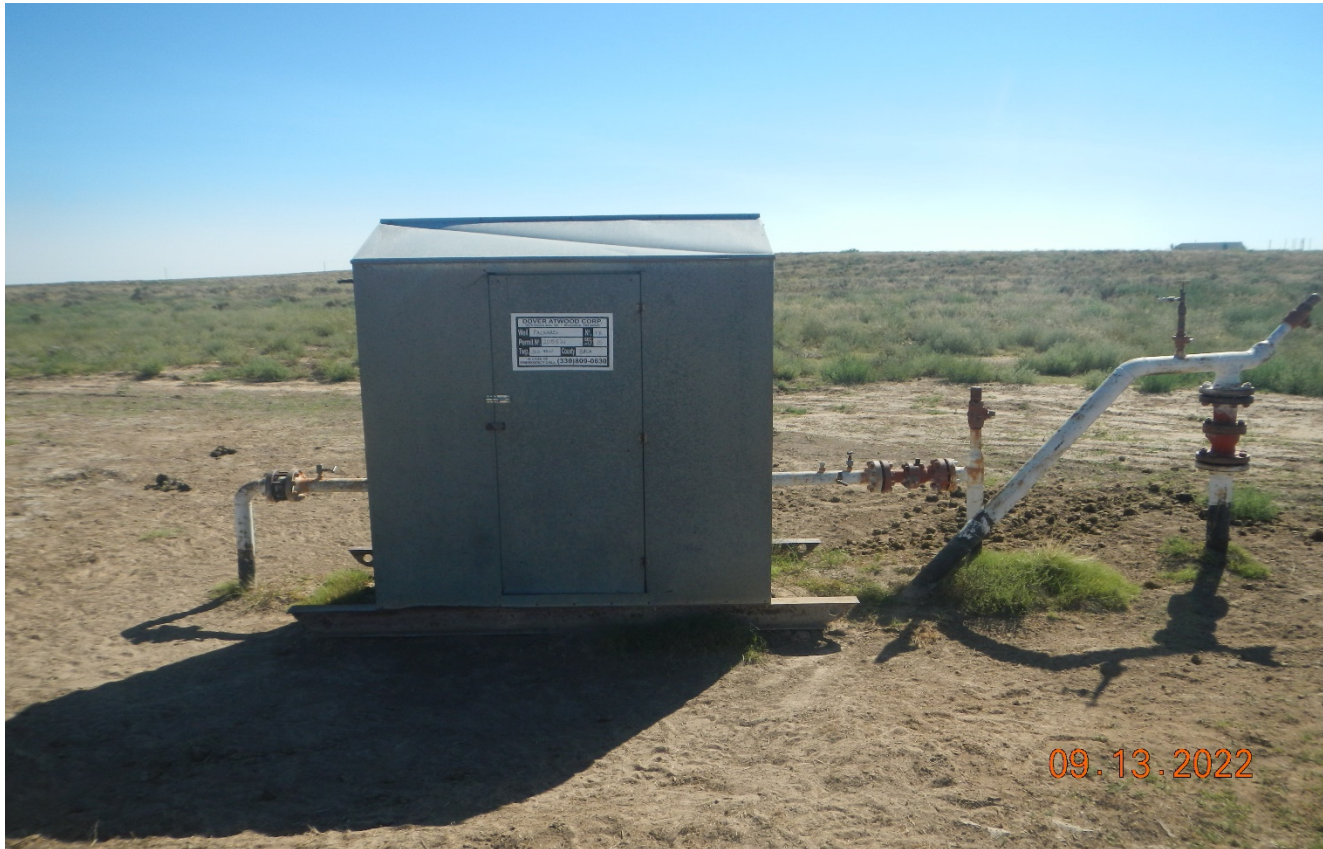
Photo 2. A new sign has been posted on the meter shed however, the sign does not meet the requirements of Rule 605.d.

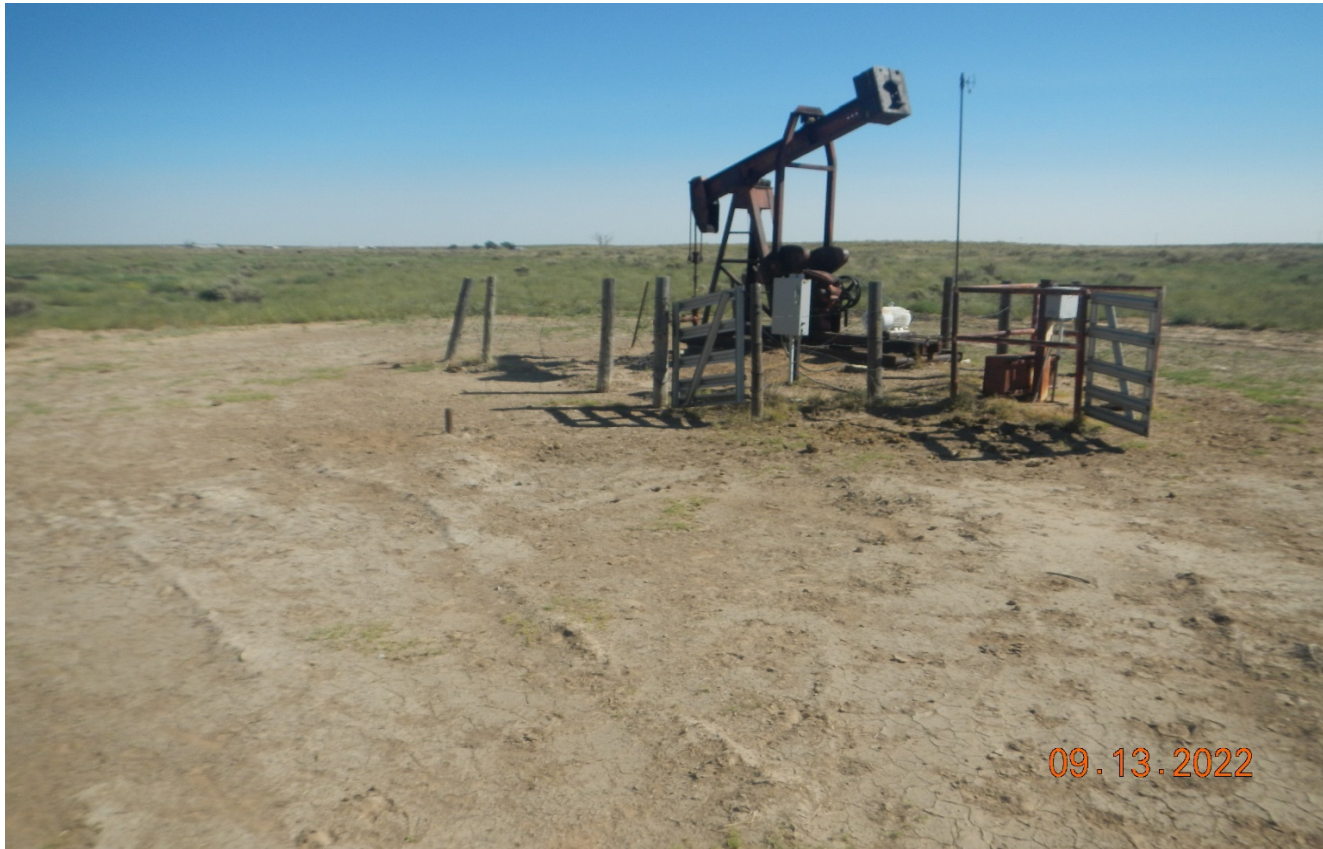
Photo 3. Facing toward the wellsite. The broken tank has been removed.

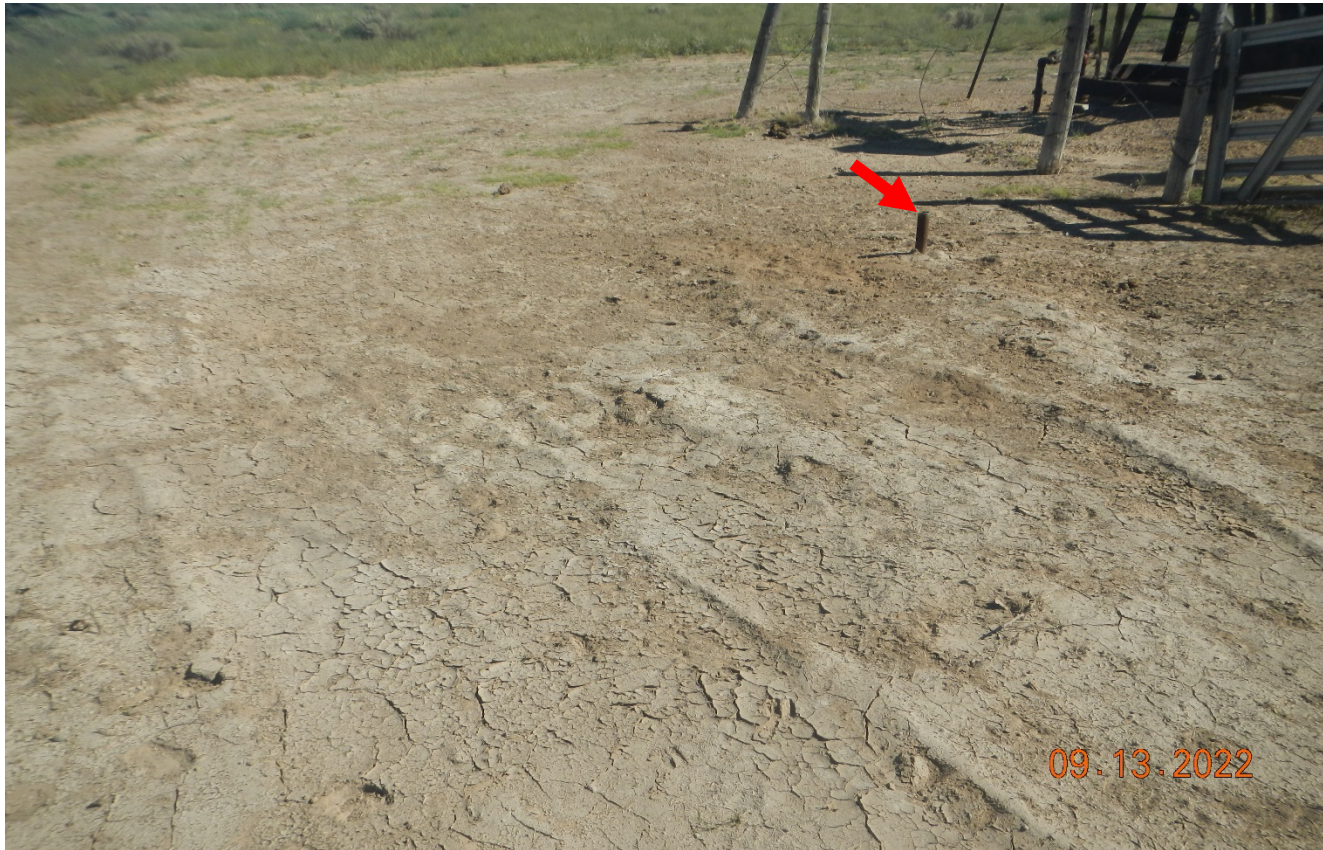
Photo 4. This is the area the broken tank was at. There is an uncapped pipe riser at the red arrow that likely fed into the tank which need to be removed.

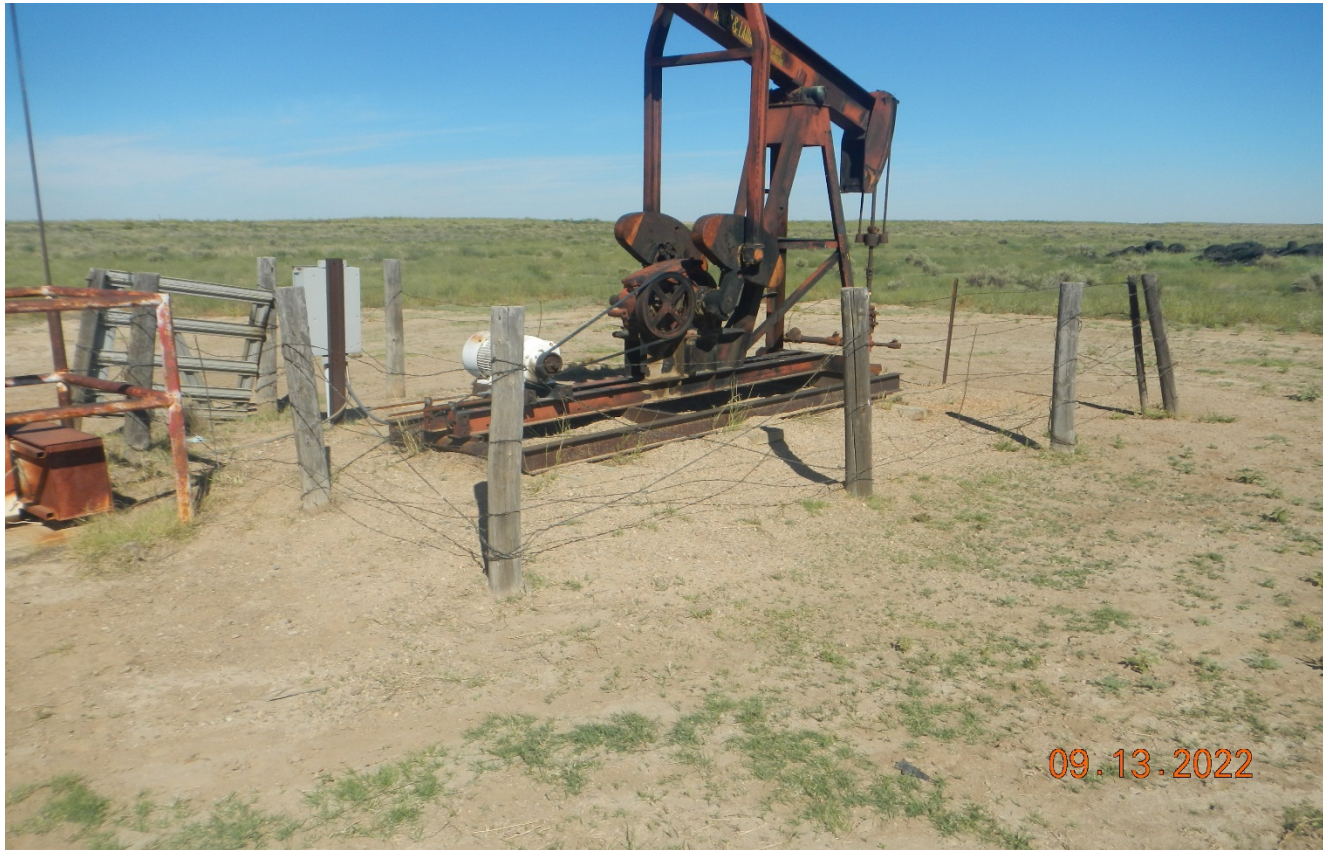
Photo 5. Facing toward the punmpjack. The debris around the pumpjack has been removed.
