Inspection Photos

ID:438617

Operator: DOVER ATWOOD CORPORATION

Inspection Date: 9/13/2022

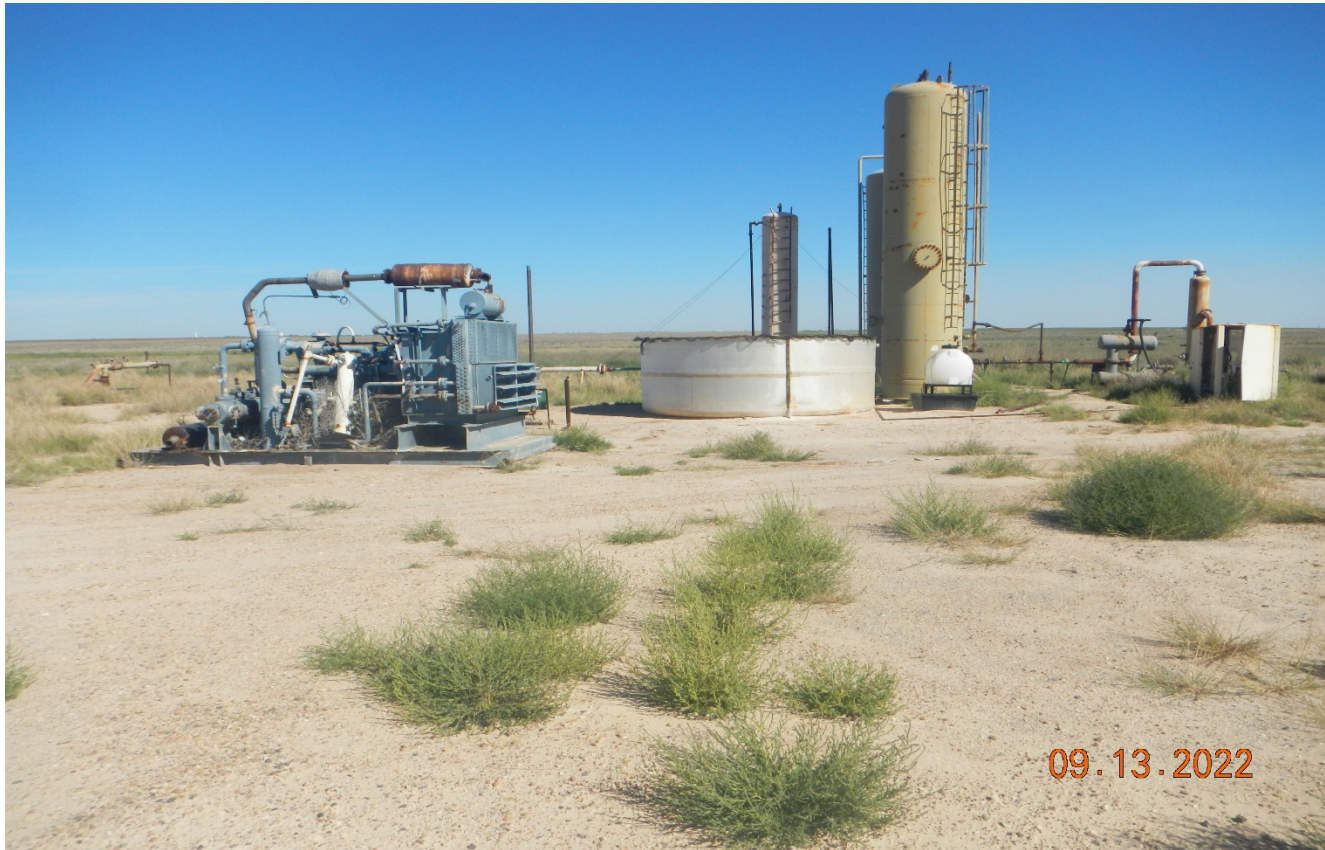
Photo 1. Facing northeast toward the gas treatment facility.

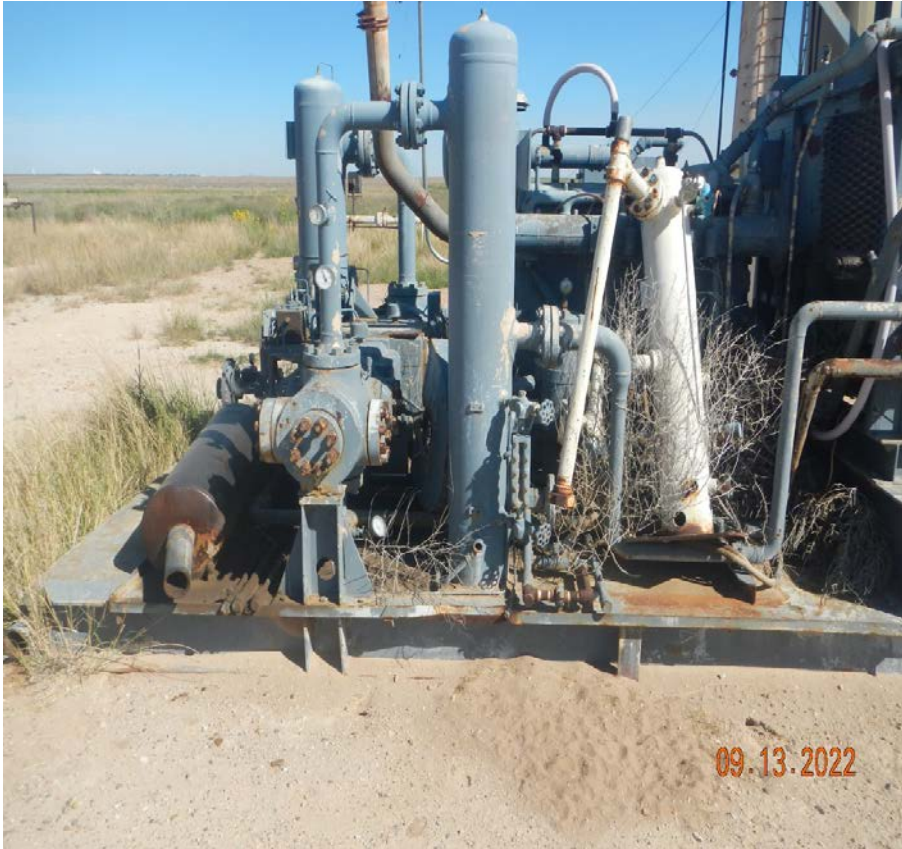
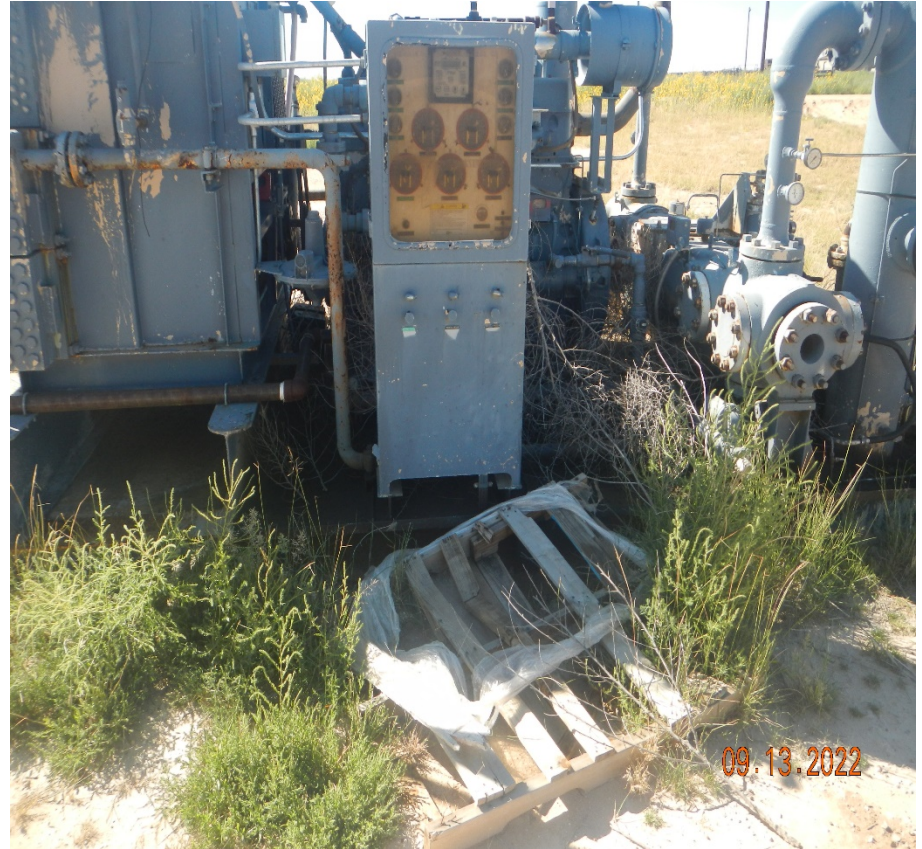
Photo 2. There is an unused compressor stored on location that need to be removed. The compressor engine has various unconnected parts and does not appear to be functional. Previous corrective action is not completed.

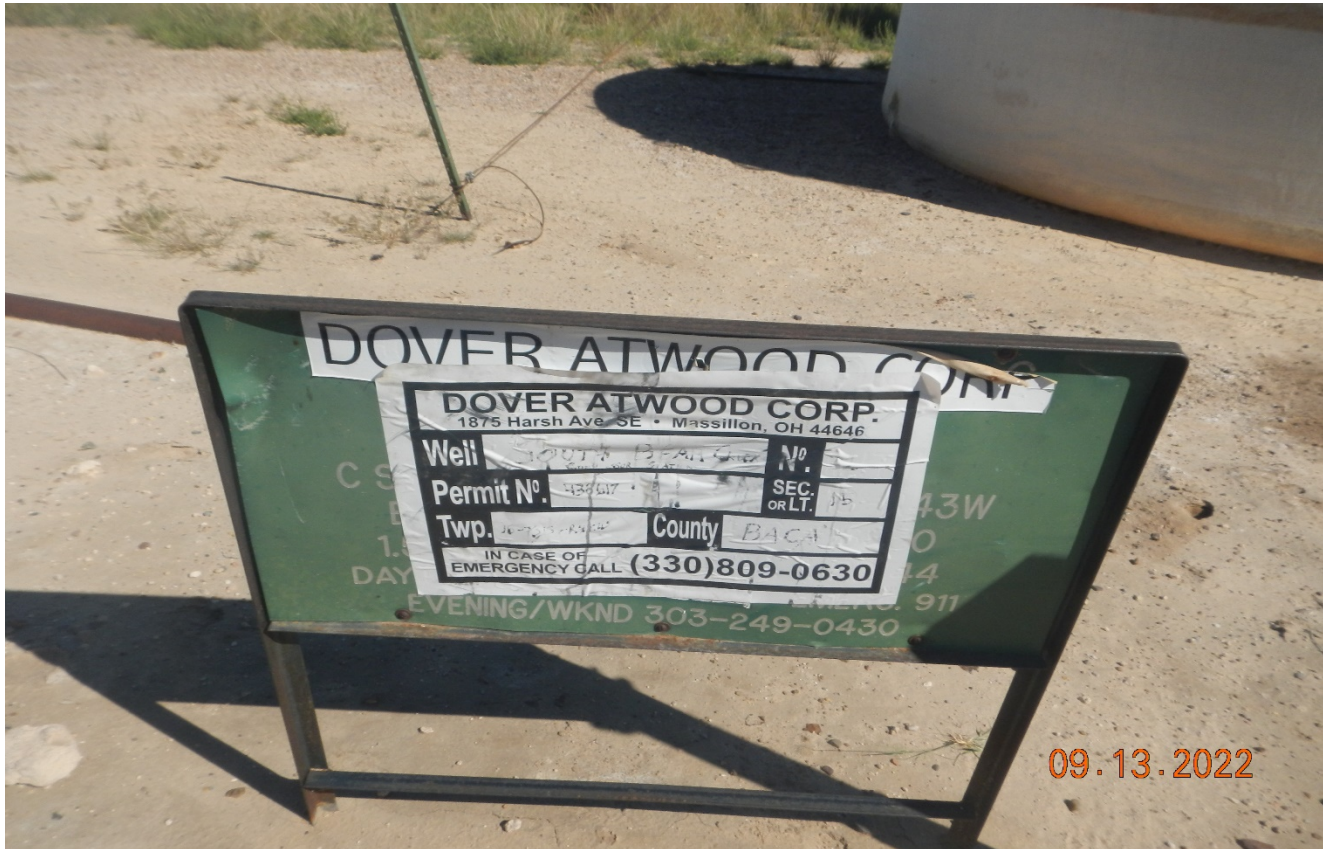
Photo 3. The facility sign is obscured behind the compressor. The sign does not meet the requirements and is not legible. Previous corrective action is not completed.

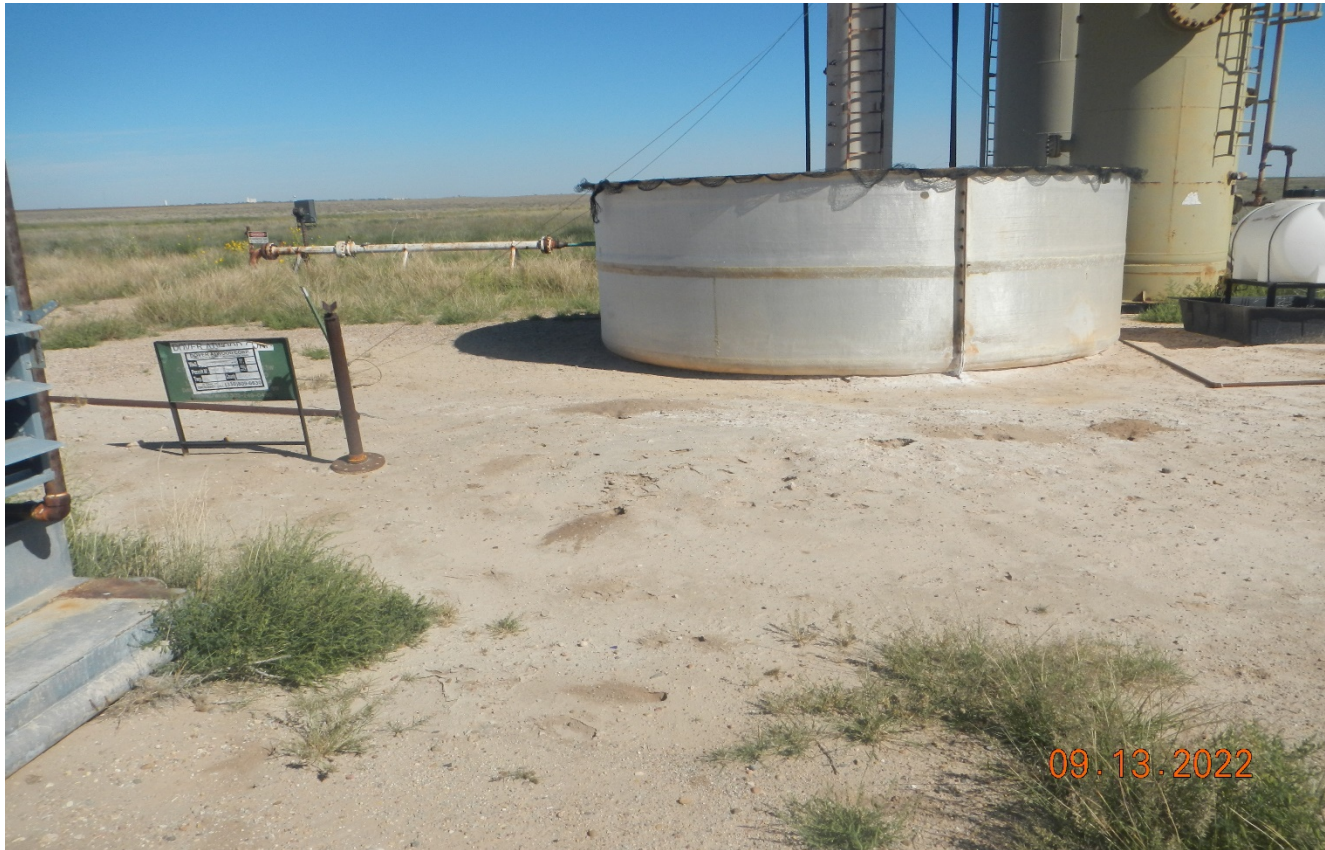
Photo 4. Facing toward the open top tank. It appears the tank has previously leaked due to white stained soil. There is no secondary containment around the tank. There is no signage on the tank. Previous corrective action is not completed.

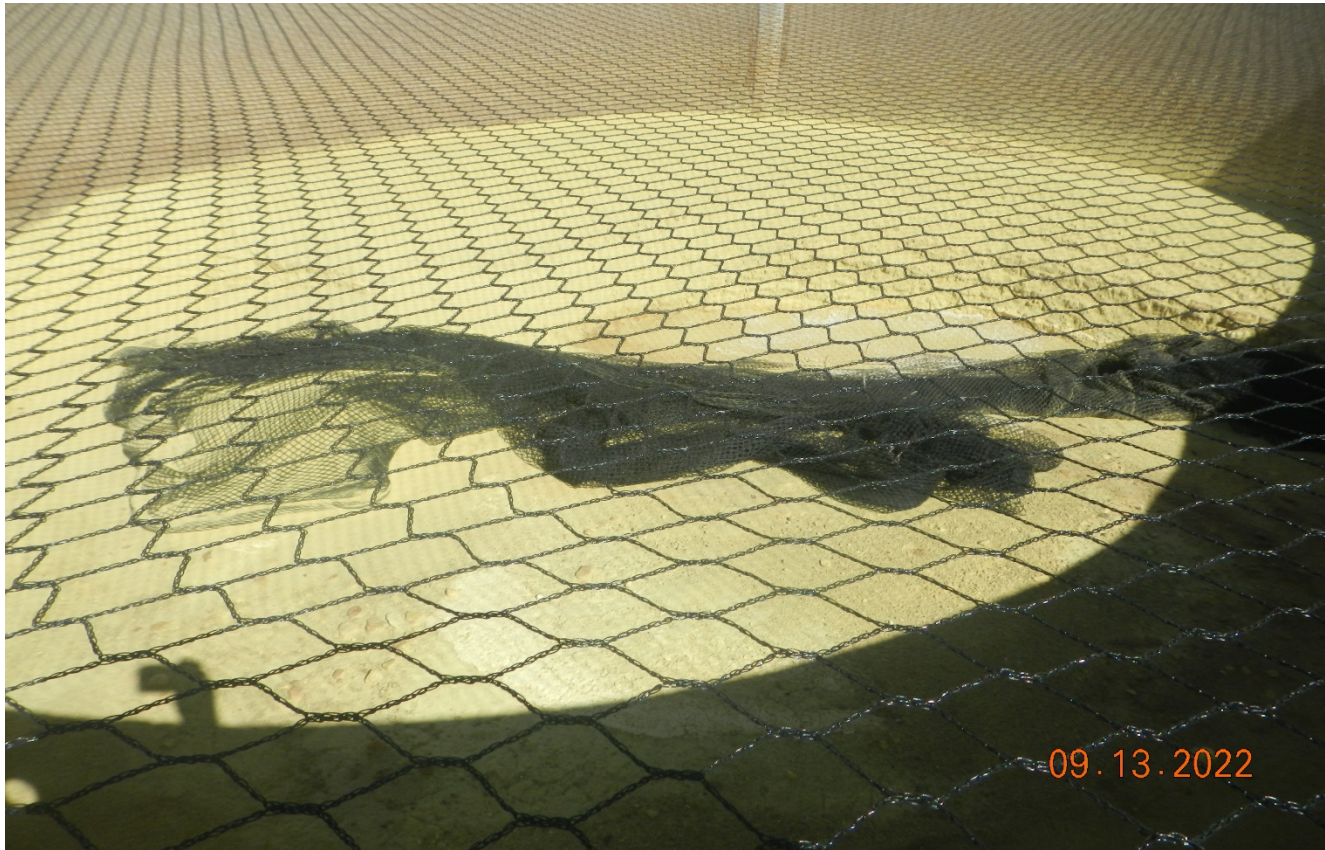
Photo 5. The netting over the tank has been reinstalled.

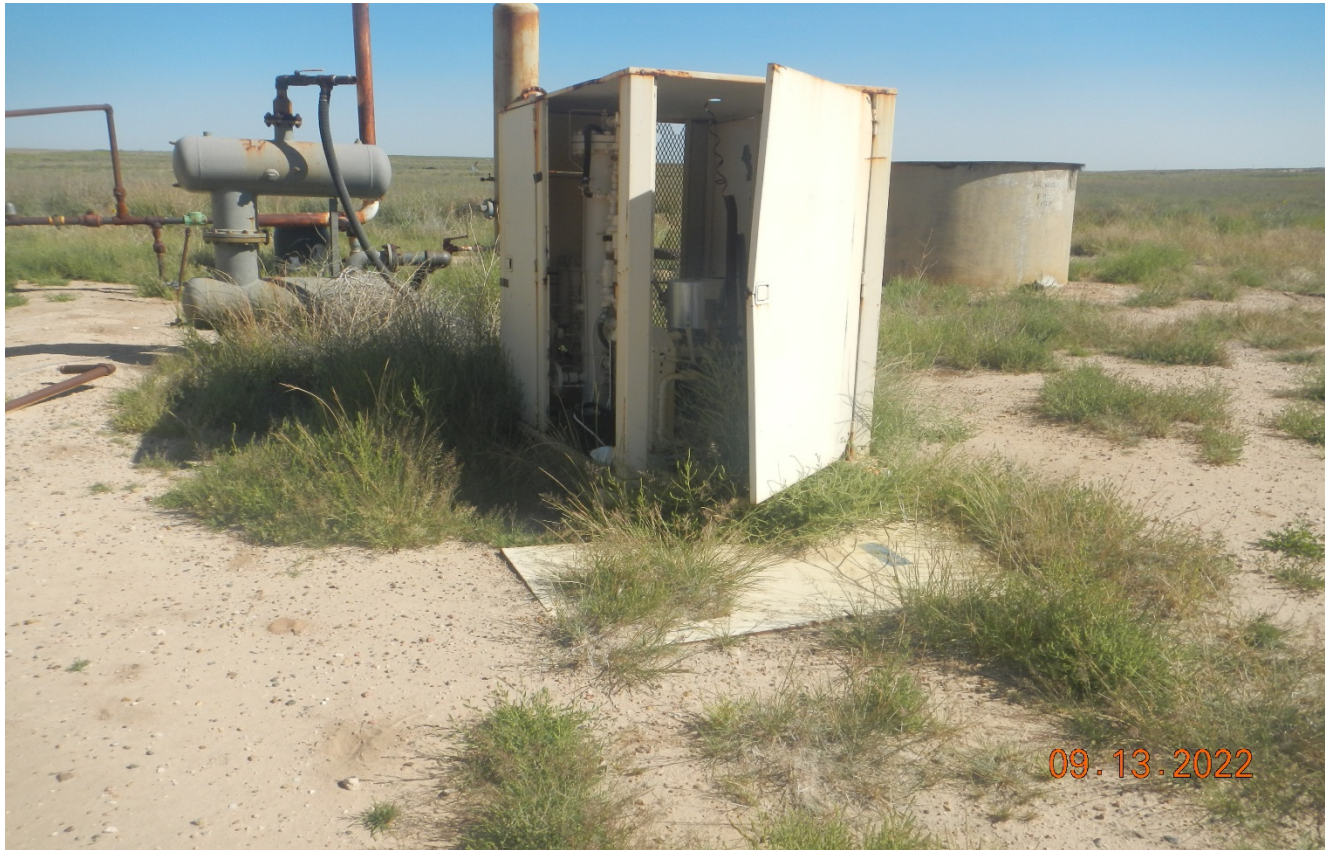
Photo 6. There is equipment not maintained on location. Door has fallen off this shed. Previous corrective action is not completed.

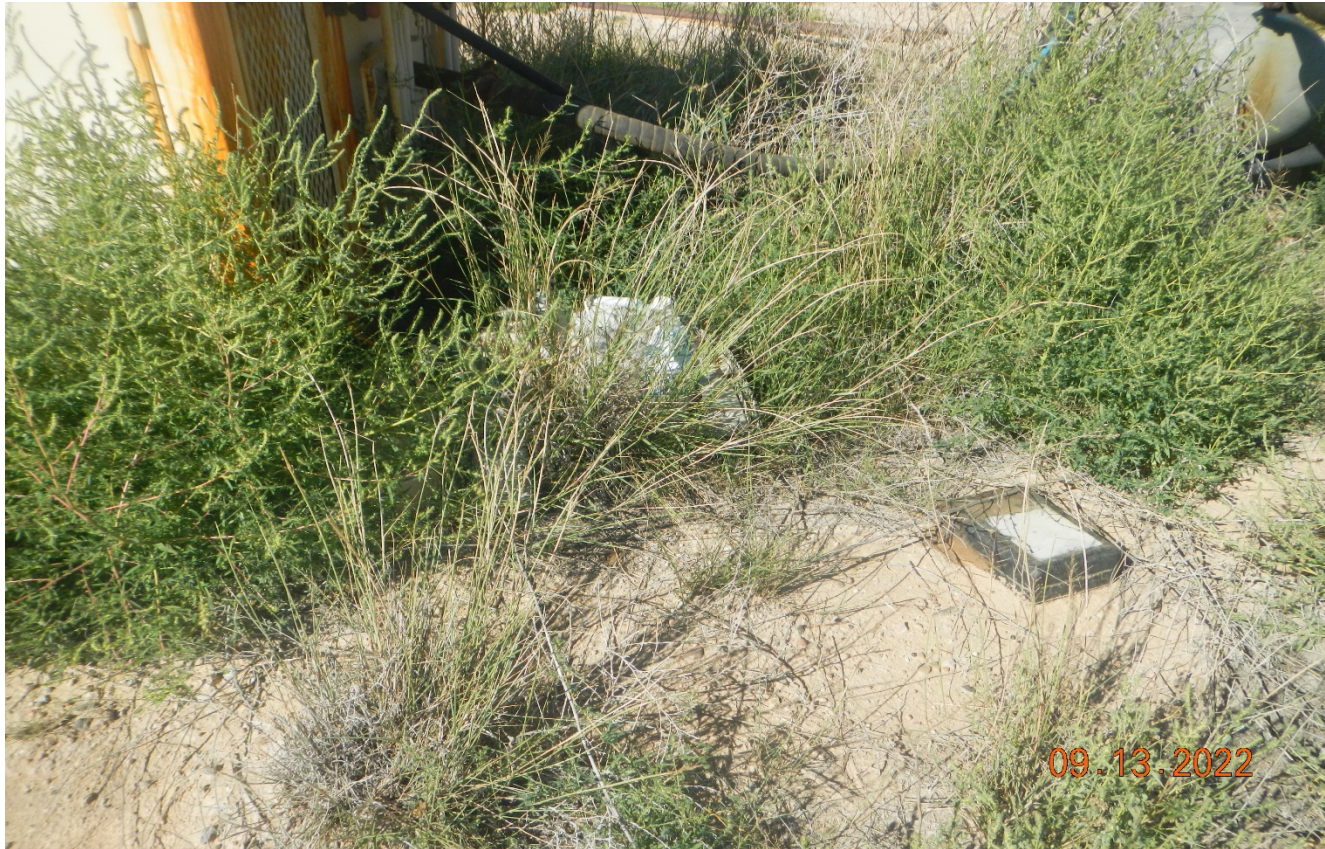
Photo 7. There is oil/chemical containers and trash not properly or disposed of. Previous corrective action is not completed.

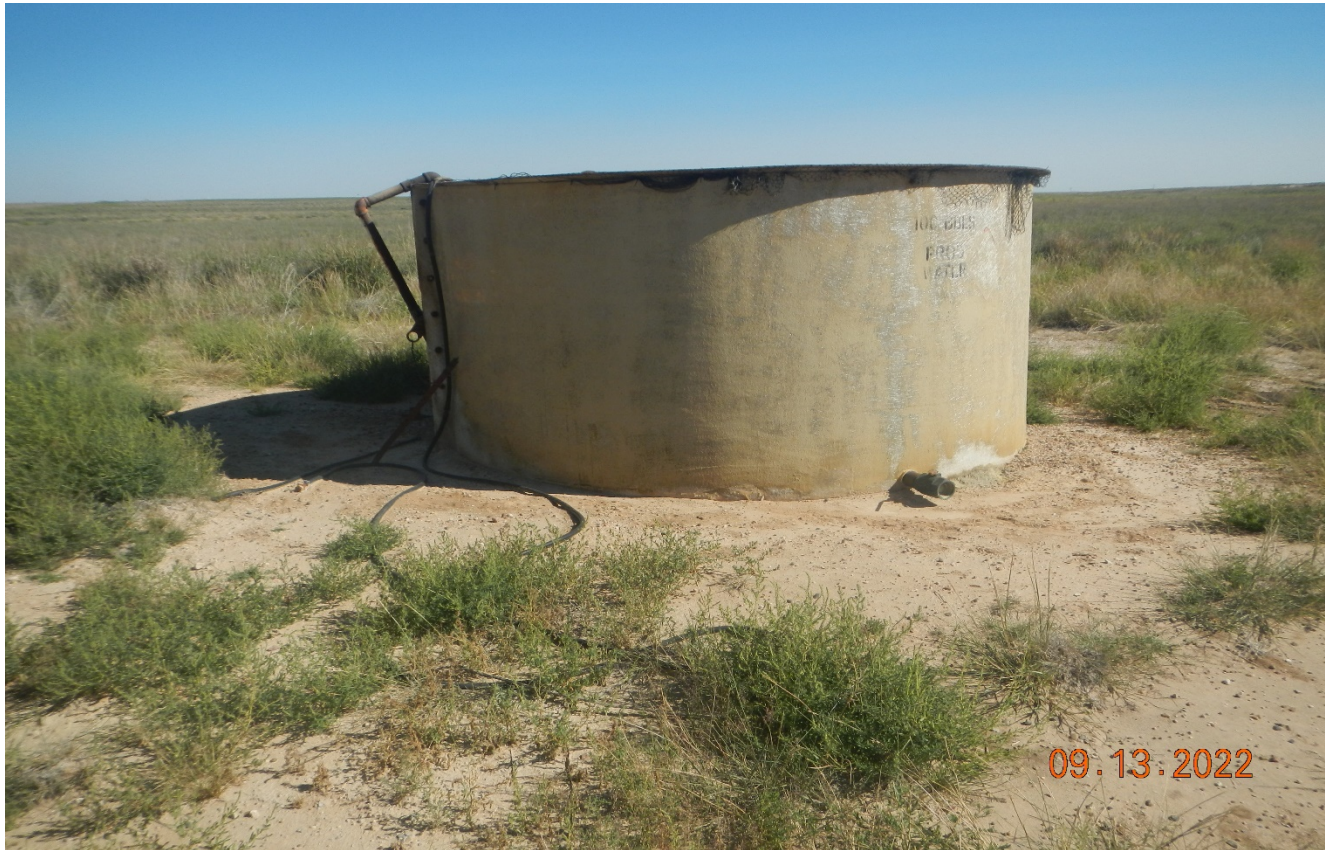
Photo 8. There is an open top tank at the east side of the location. It appears the tank has previously leaked due to white stained soil. There is no secondary containment around the tank. The signage has faded. Previous corrective action is not completed.

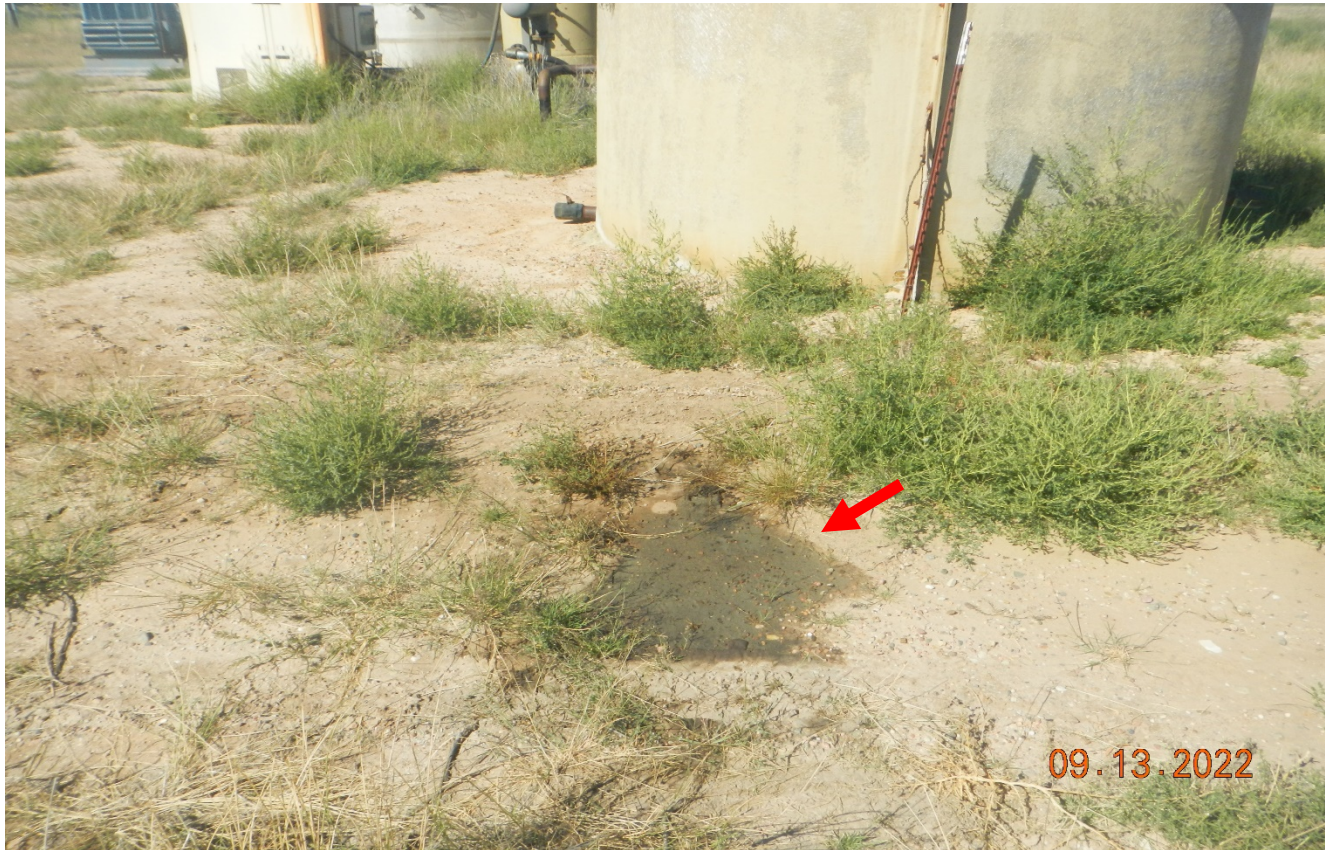
Photo 9. There is oily stained soil at red arrow which appears to be fluids which were drained from the tank. Stained soil need to be cleaned up and properly disposed.

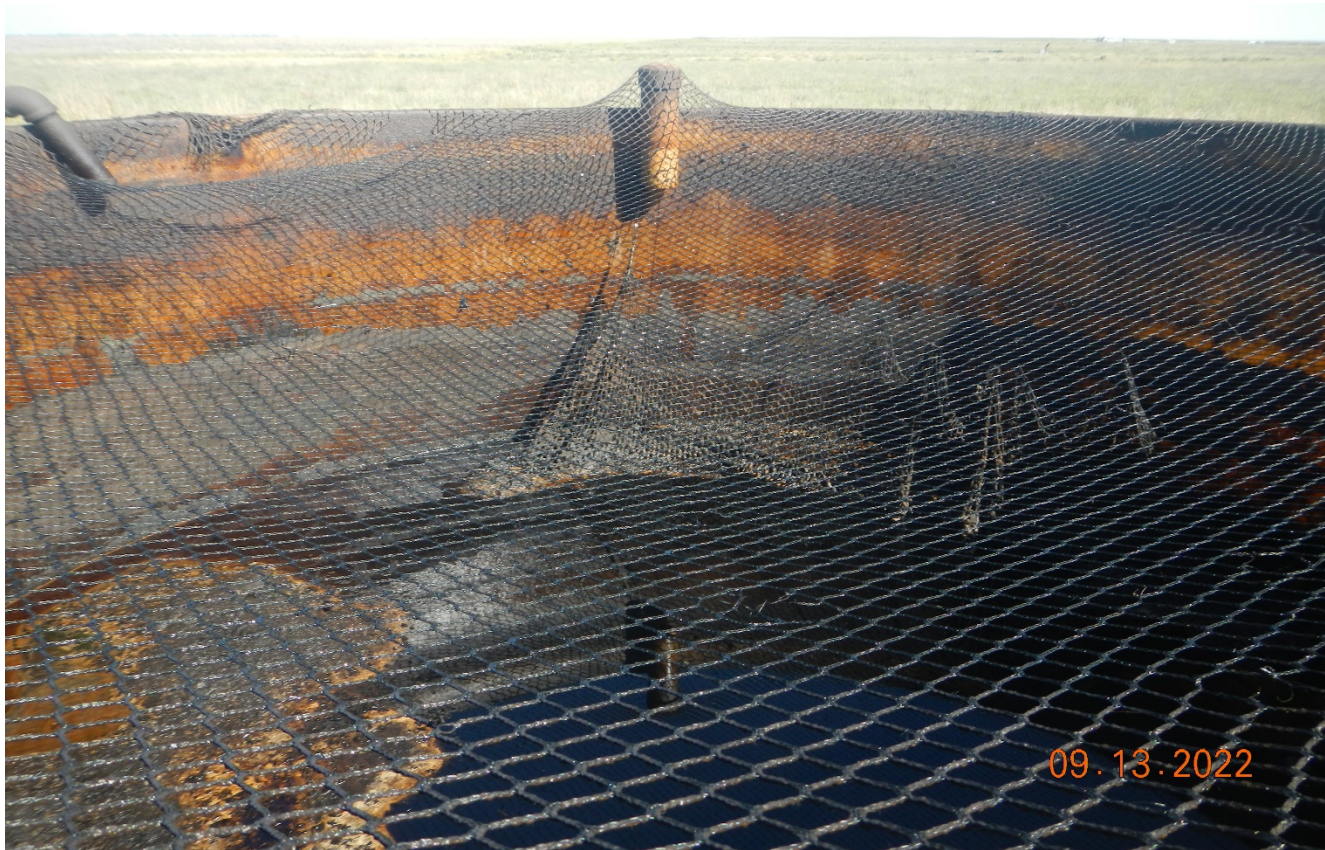
Photo 10. The liquid in the tank has been lowered.

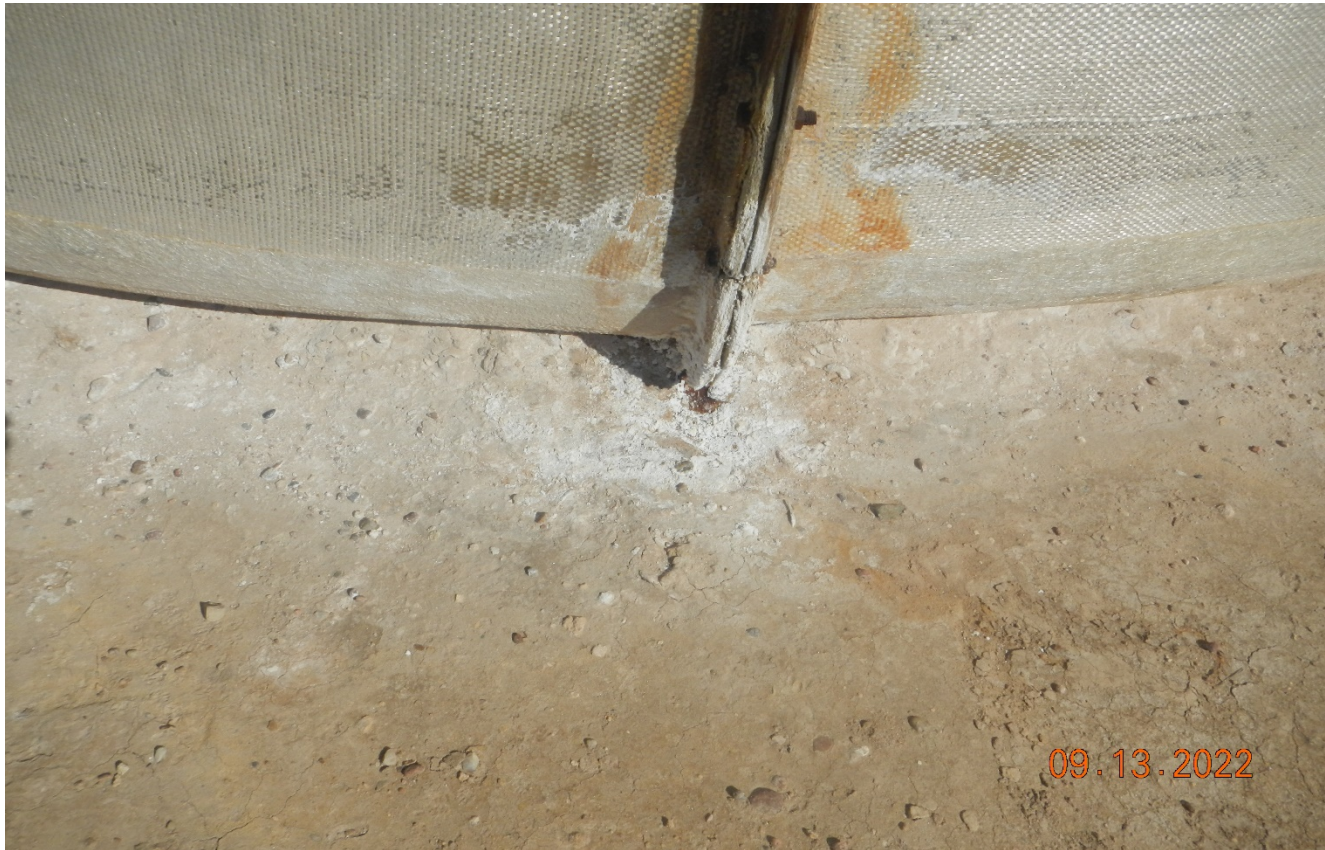
Photo 11. There are signs of a previous leak at the tanks due to white stained soils at the base of the tanks.

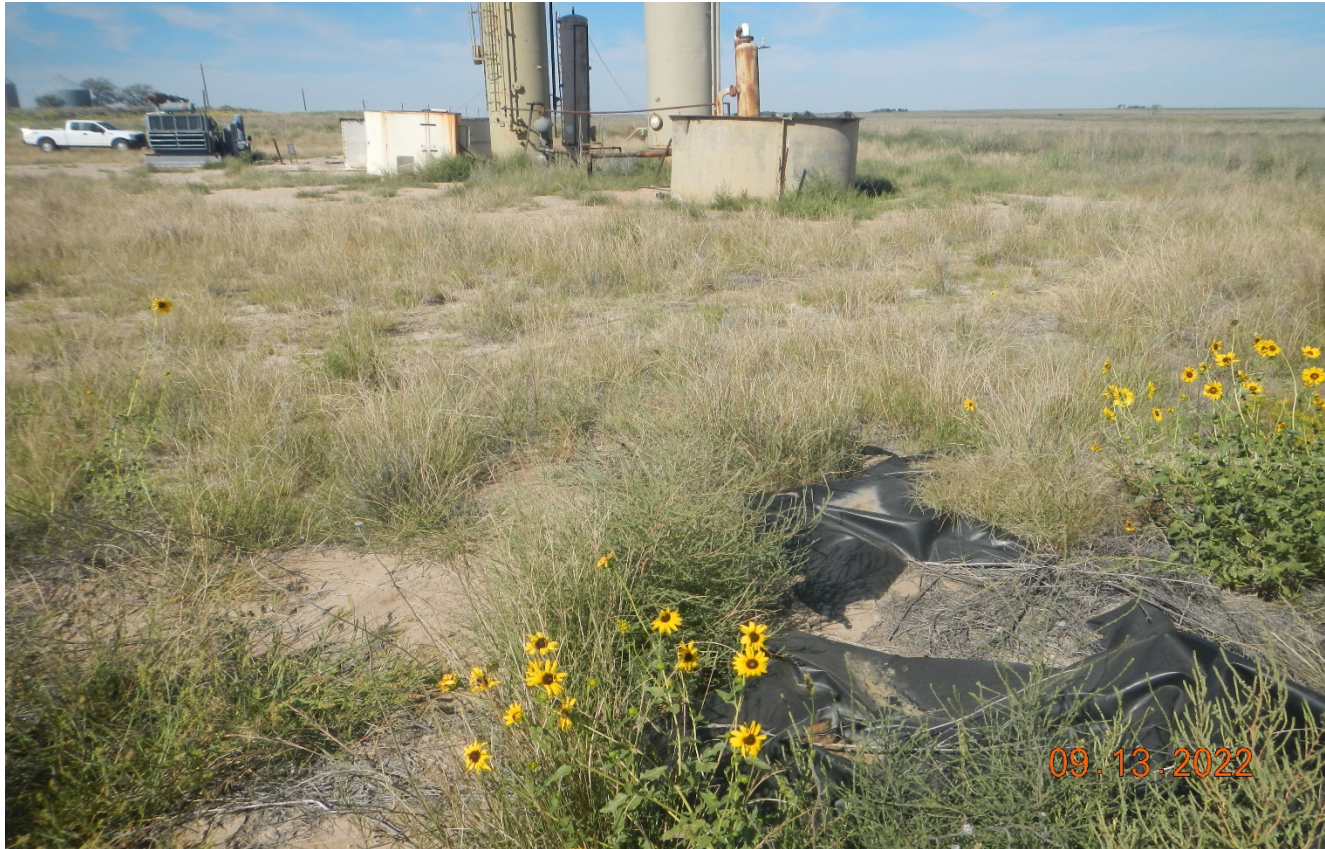
Photo 12. Facing west toward the location. There is a plastic liner debris at east side of the location that needs to be removed.

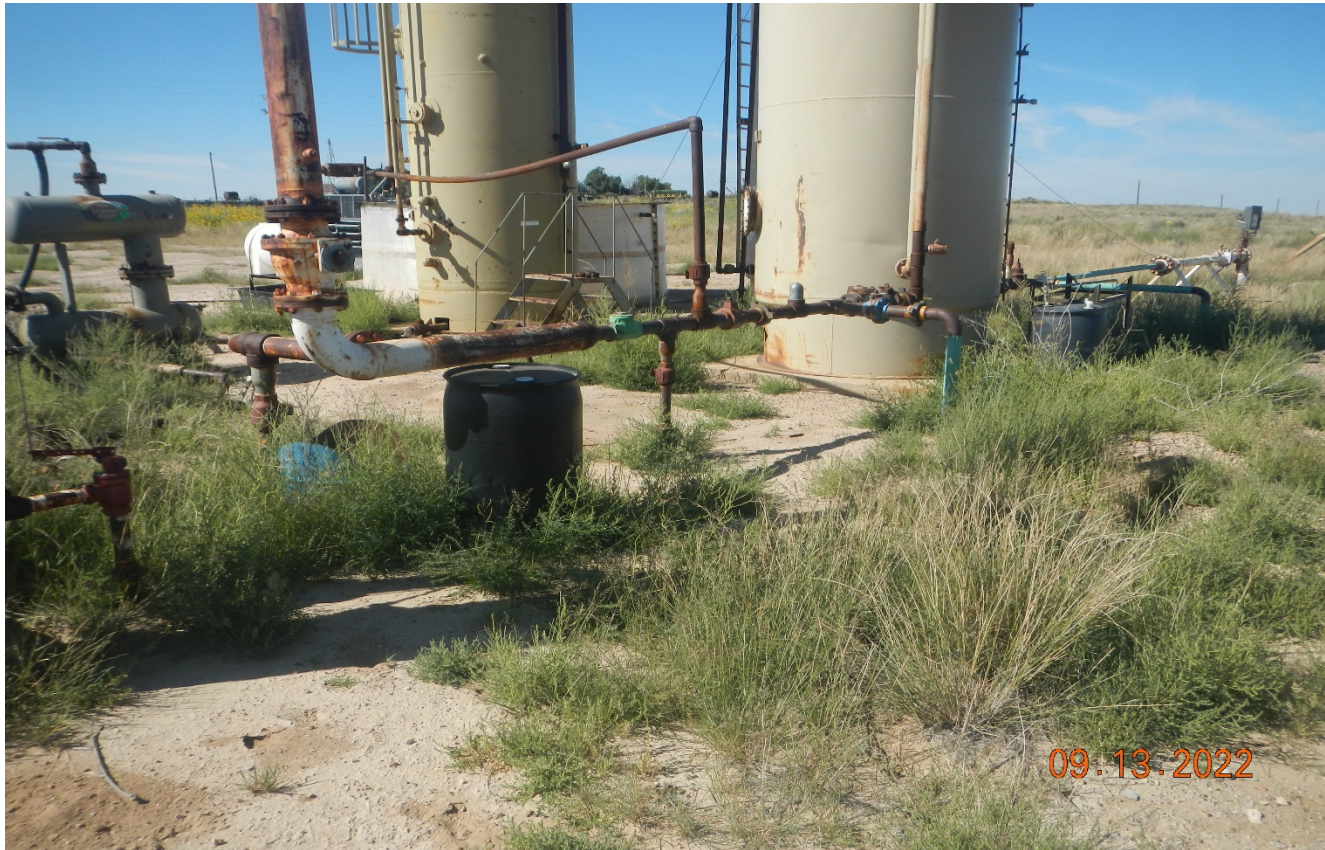
Photo 13. There is unused supplies and a black barrels with no labeling. There are weeds and vegetation around the equipment which is a fire hazard. Previous corrective action is not completed.

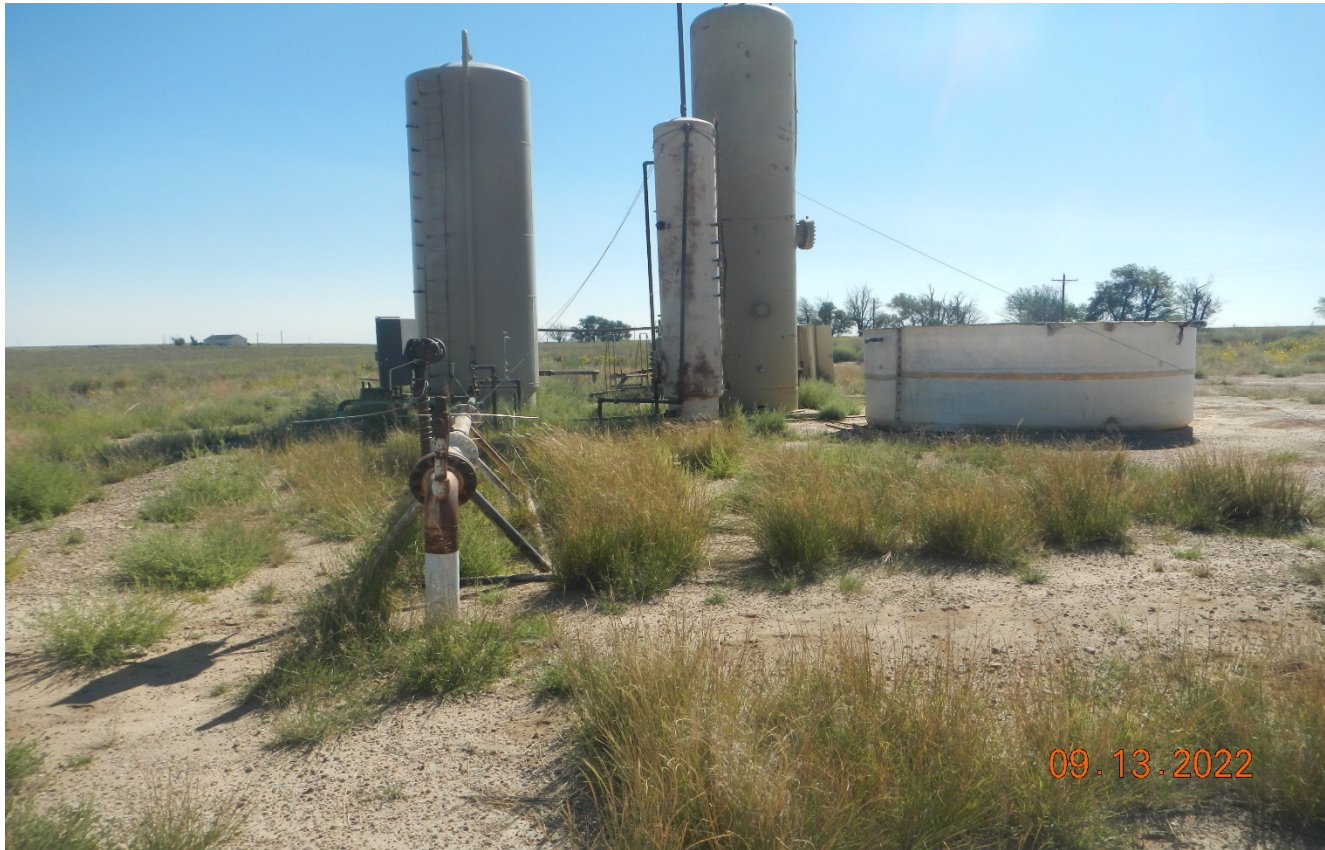
Photo 14. Facing east toward the facility. There are weeds and vegetation around the equipment which is a fire hazard.

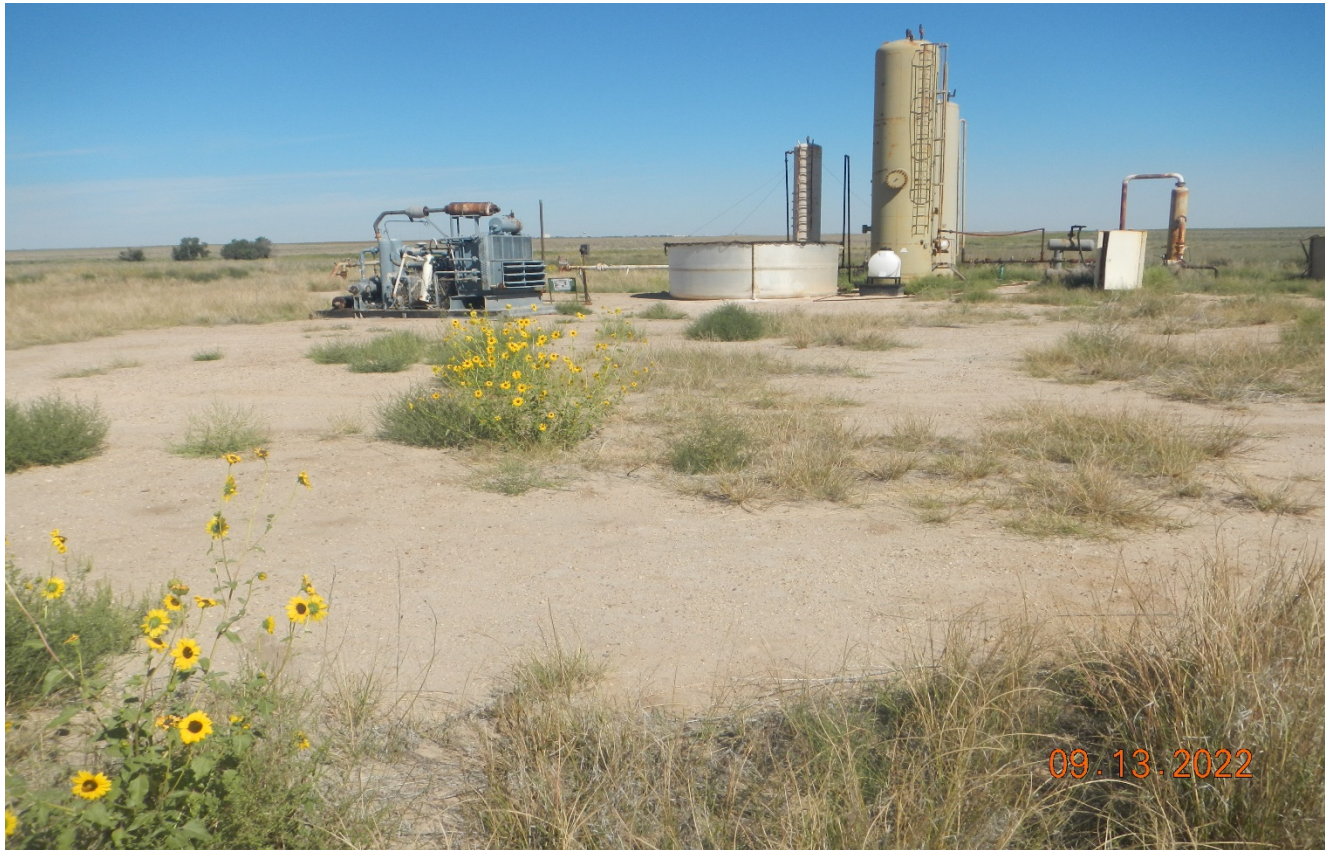
Photo 15. Facing north toward the facility. The surrounding disturbance area has areas that are bare of vegetation that need to be reclaimed per Rule 1003.

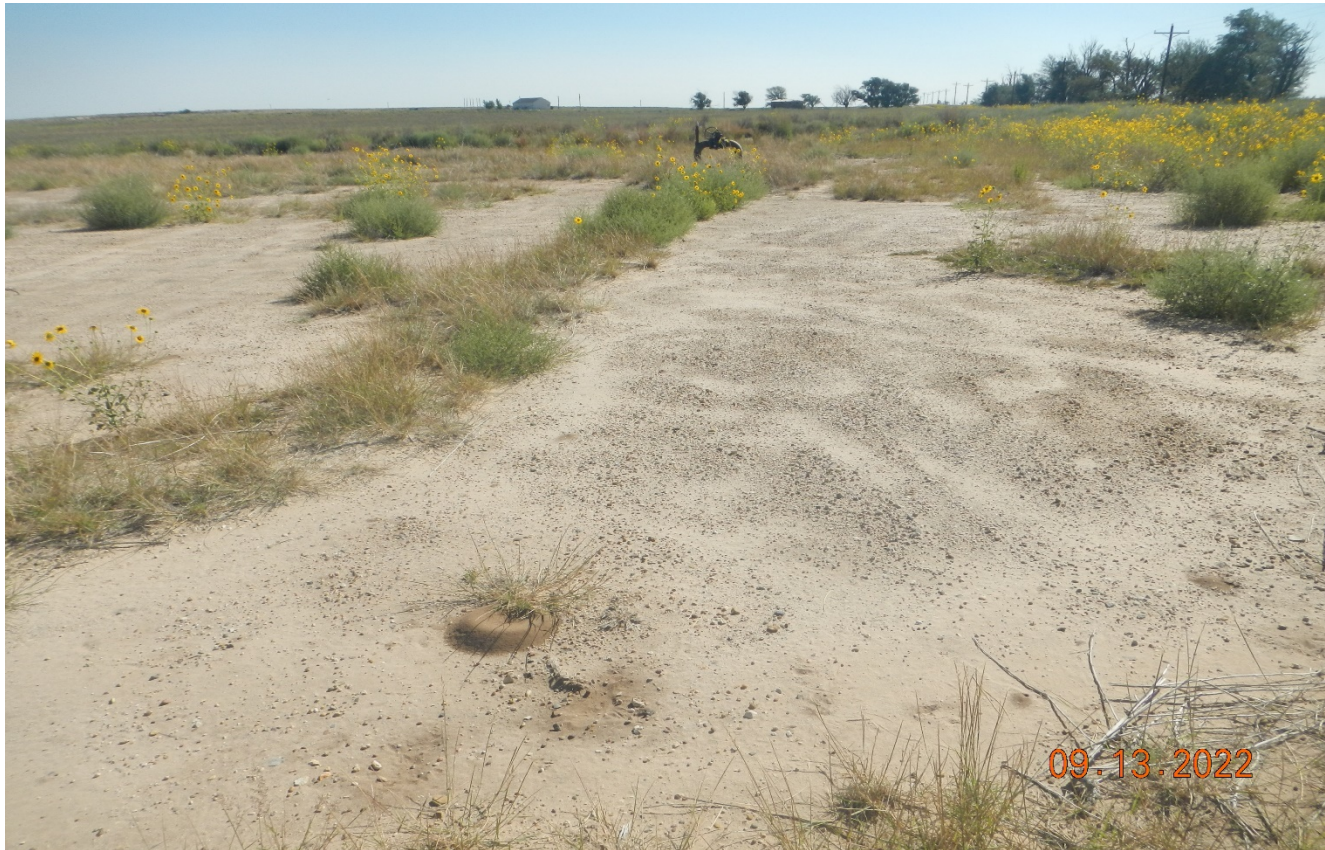
Photo 16. Facing east at the south side of the location. The surrounding disturbance area has areas that are bare of vegetation that need to be reclaimed per Rule 1003.
