Inspection Photos

ID# 441082

Operator: DOVER ATWOOD CORPORATION

Inspection Date: 9/13/2022

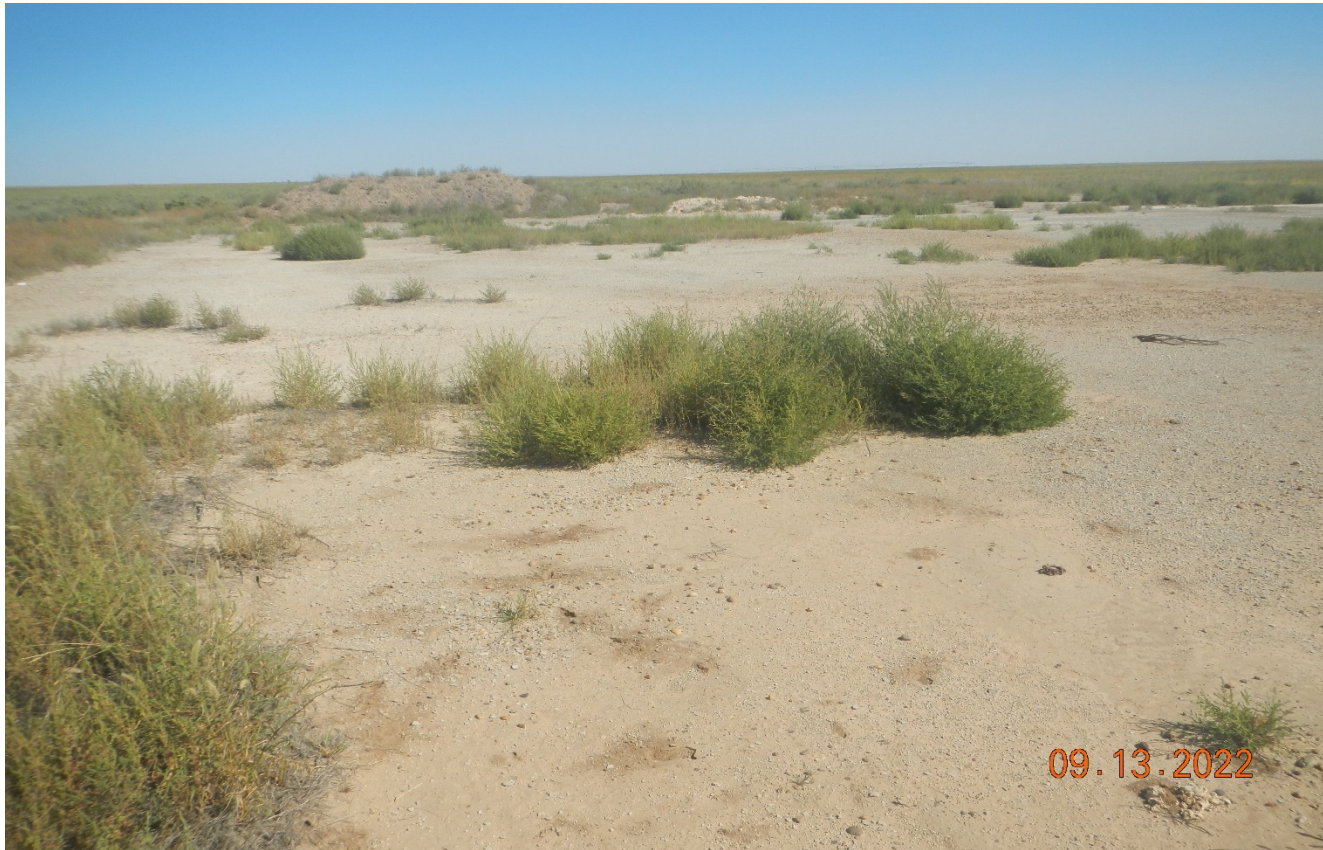
Photo 1. Facing northeast toward the location. The disturbed location has not been reclaimed. Previous corrective actions were not performed.

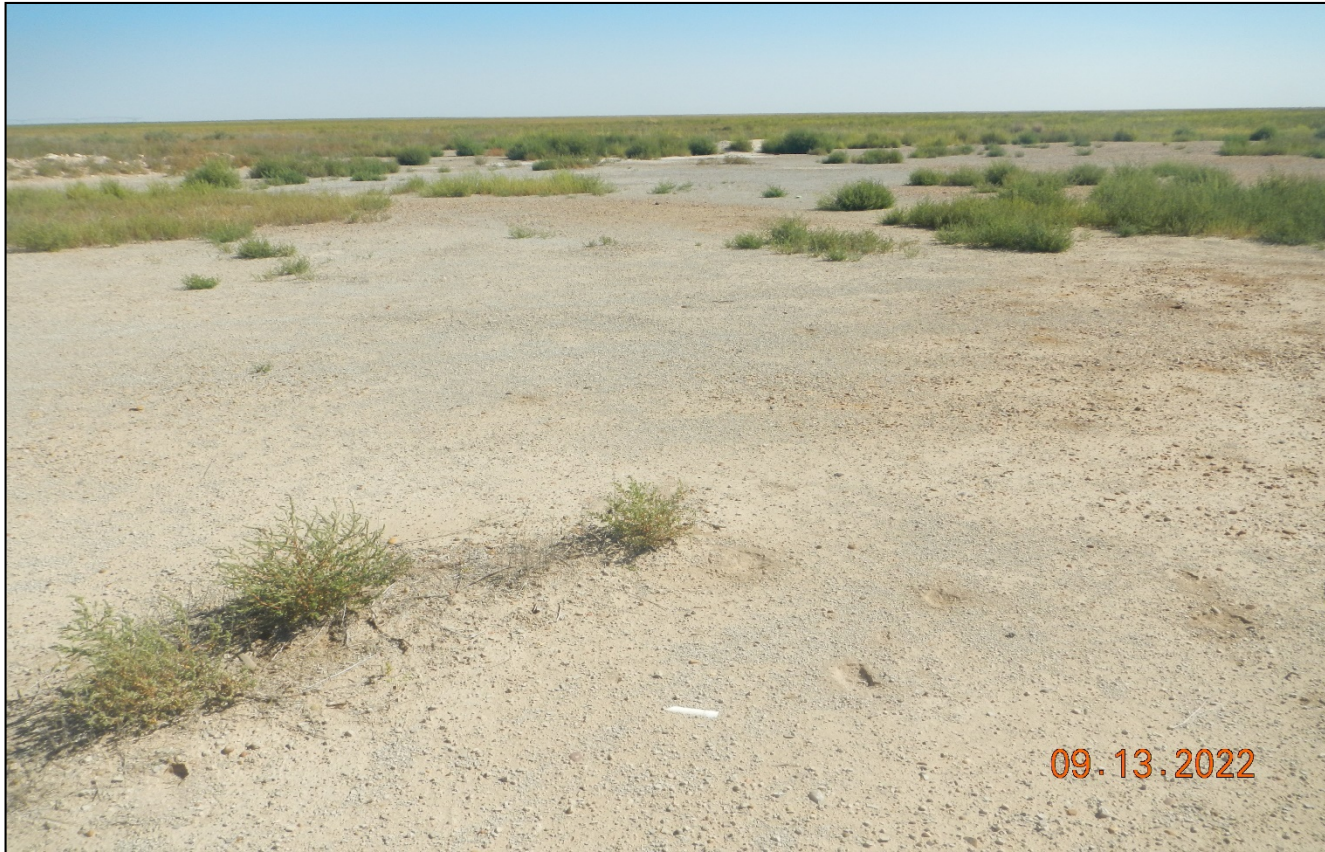
Photo 2. Facing northeast at the location. Soils are compacted and the location has not been reclaimed. Previous corrective actions were not performed. Soils must be decompacted by cross ripping to a depth of 18 inches.

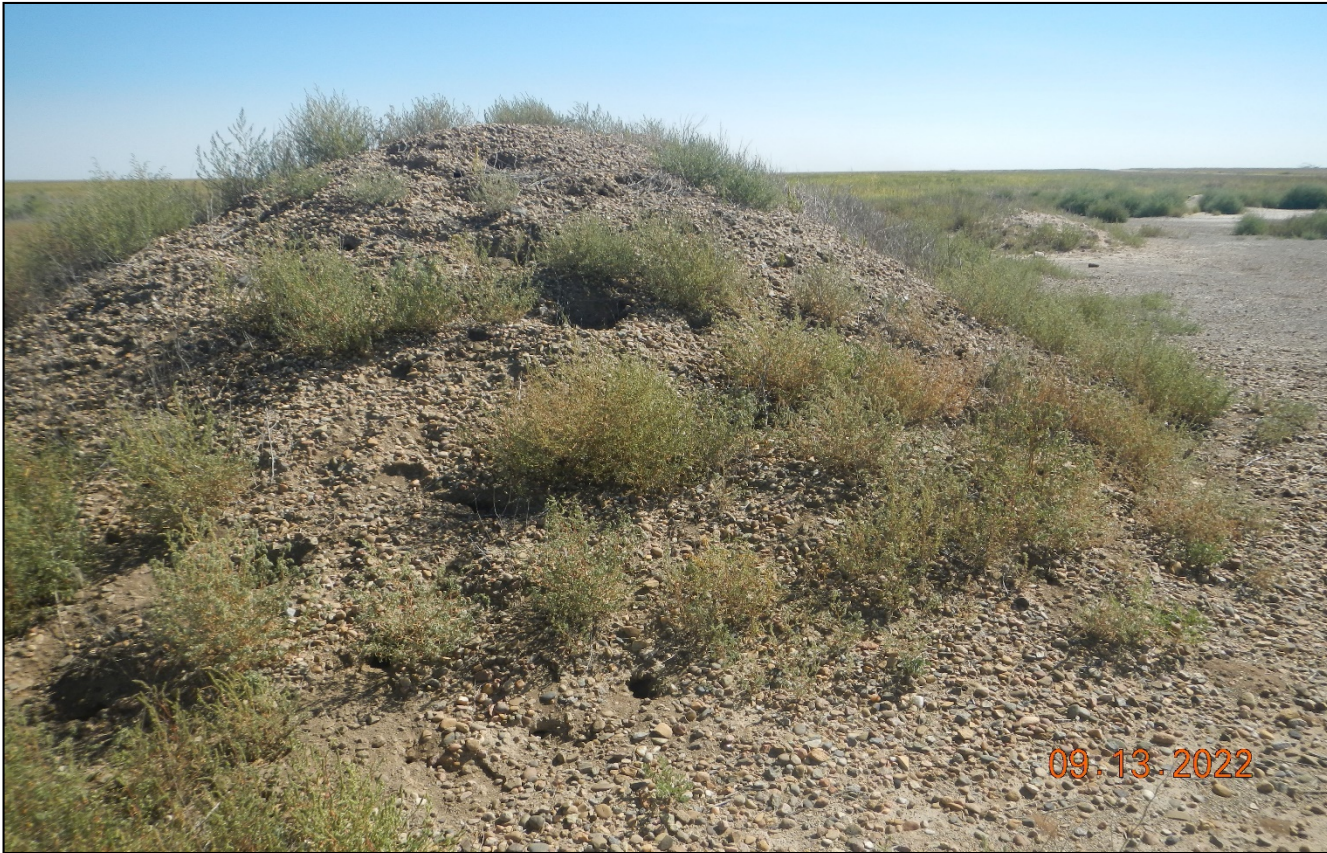
Photo 3. There are gravel and soil piles that remain at the north side of the location. The piles need to be removed. There are undesirable weeds on the piles.

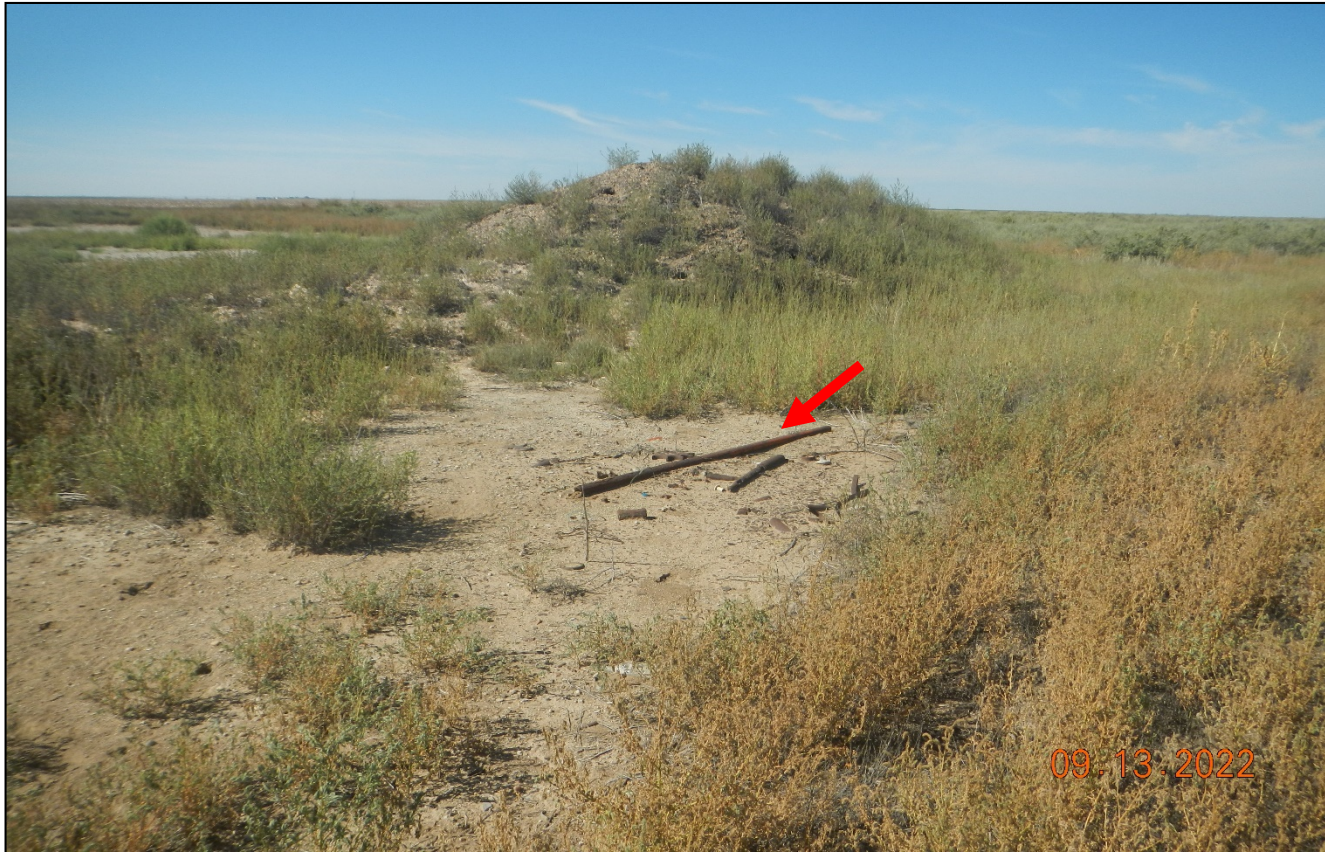
Photo 4. Facing southwest at the north side of the location. There is undesirable throughout the location which must be controlled. There is metal debris shown at red arrow.

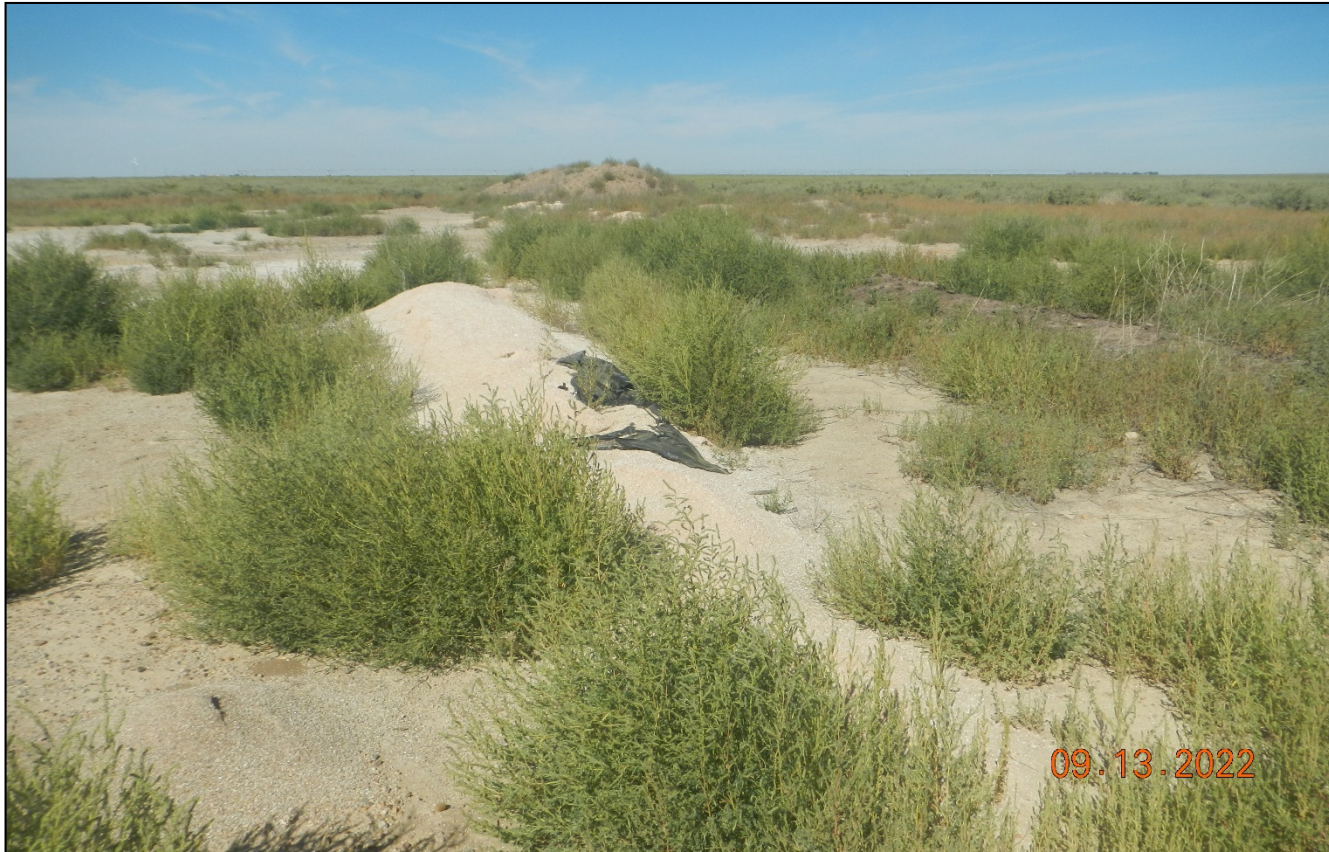
Photo 5. Facing east at the location. There are piles of manure and material left on the location. There are undesirable weeds throughout the location.

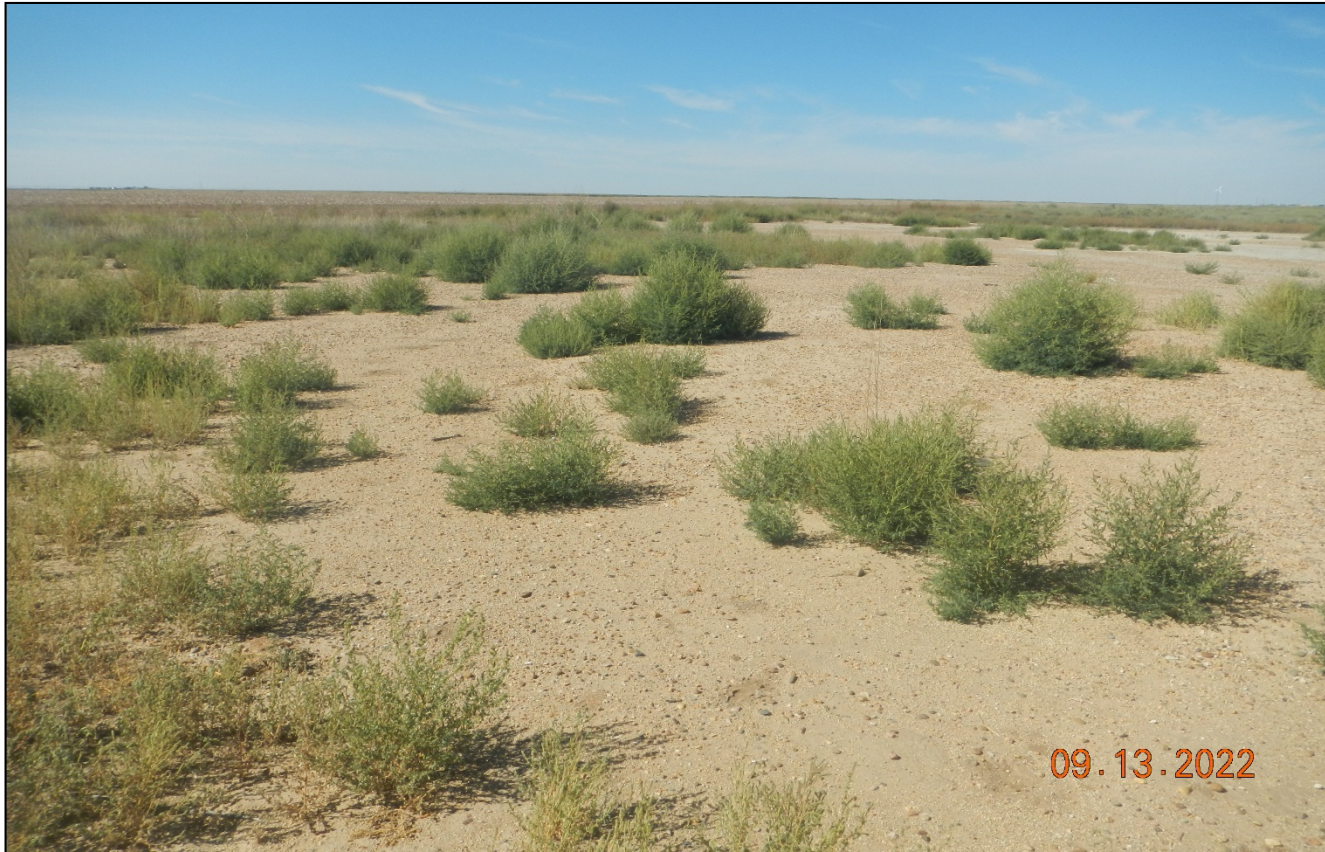
Photo 6. Facing west at the location. Soils are compacted and the location has not been reclaimed. Previous corrective actions were not performed.

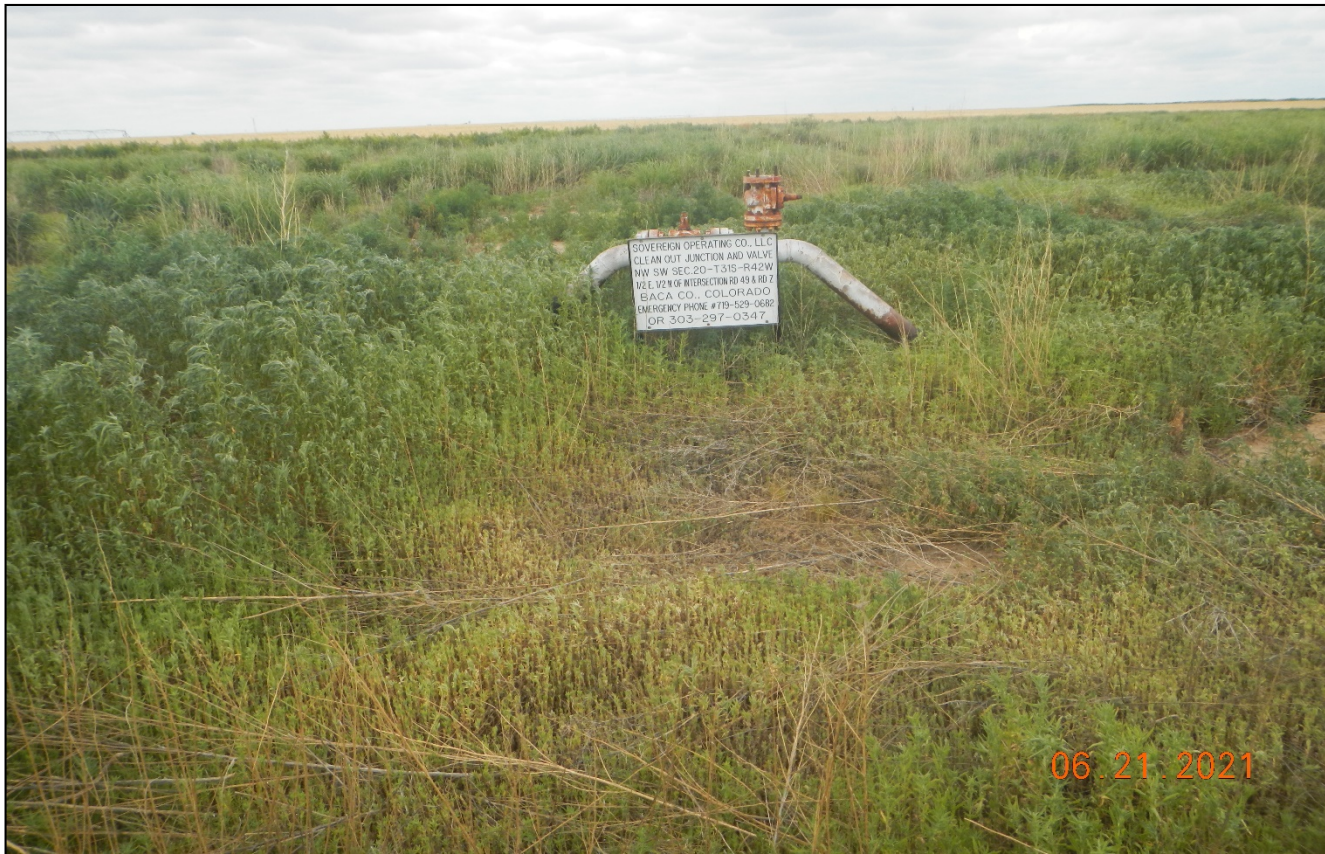
Photo 7. There is a cleanout junction 1850 ft. north of the pipeline which is associated with the former gas compressor station and must be removed.
