Taproot – Big Mountain Viper Pad – Produced Water Release

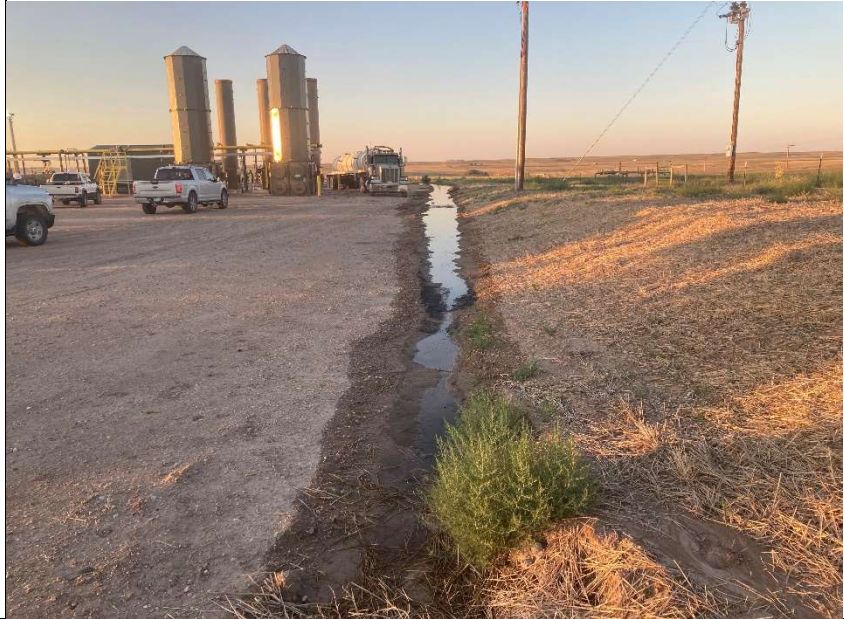
Photo: 3

Initial site conditions looking south.

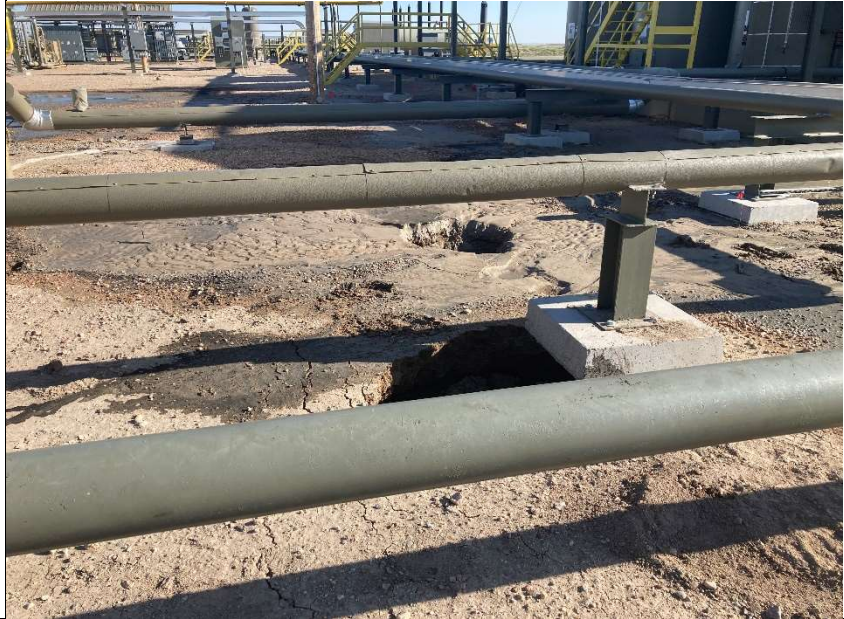
Photo: 4

Release location.

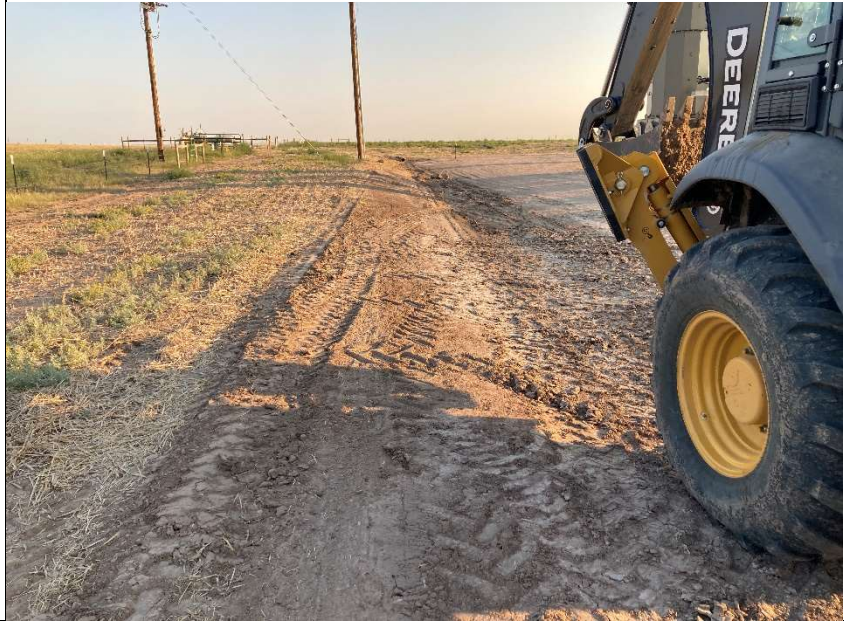
Photo: 11

Surface scrapping of impacted area to remove visible wet soil.

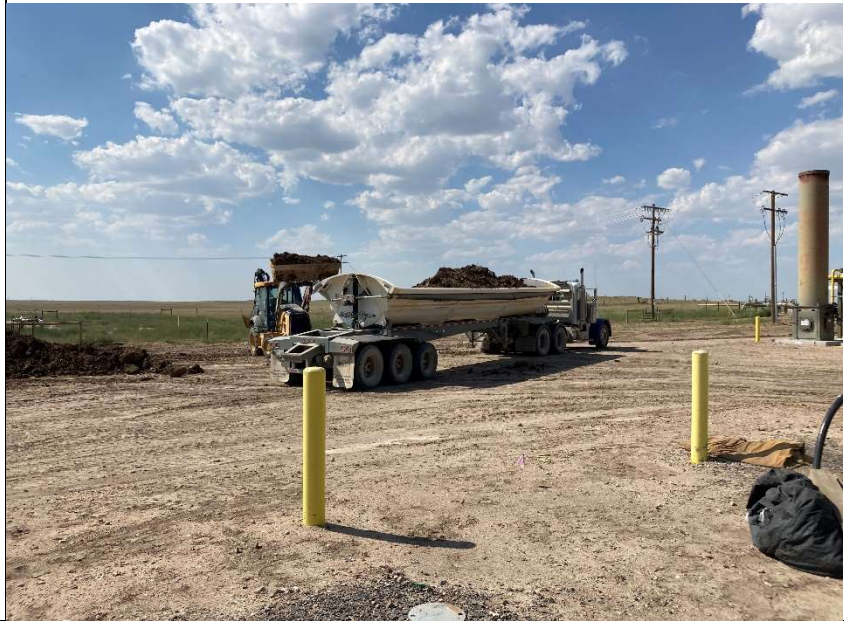
Photo: 12

Loading impacted soil for disposal.

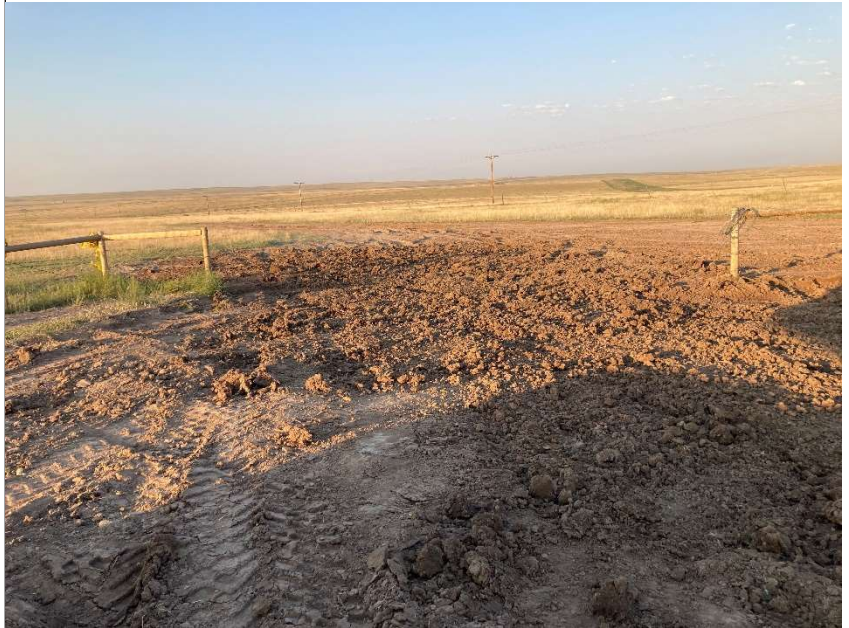
Photo: 17

Adjacent property after surface scrape.
