Inspection Photos

Location Name: TEP ROCKY MOUNTAIN LLC FEDERAL-67S96W /4SWSW

Location ID: 324072

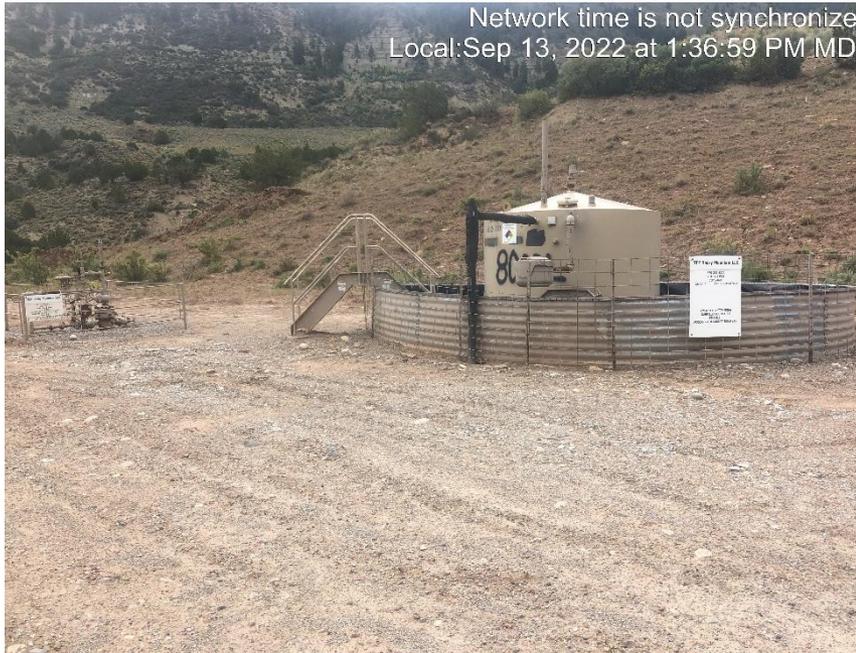
Photo #7674 From entrance to location.

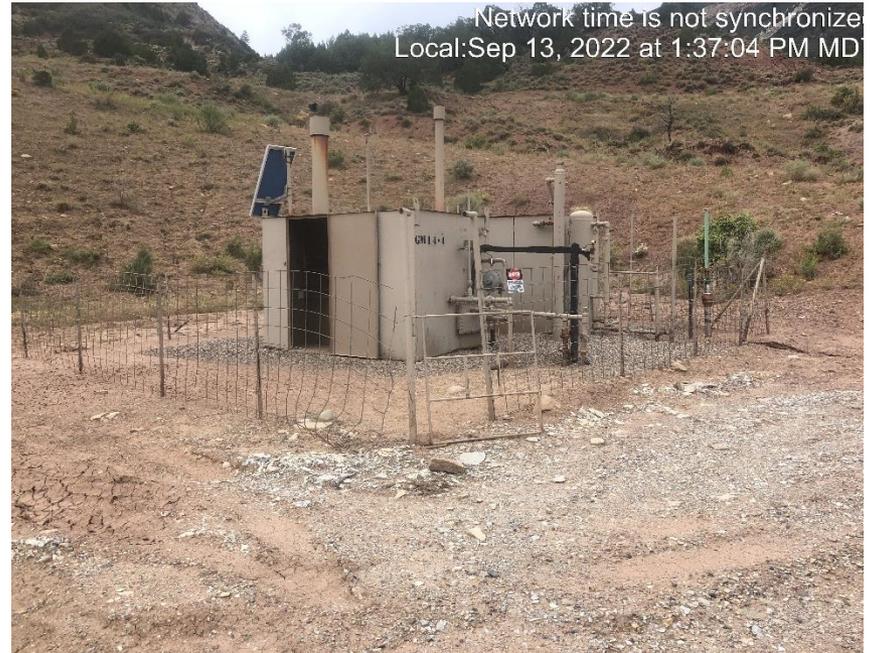
Photo #7675 From entrance to location.

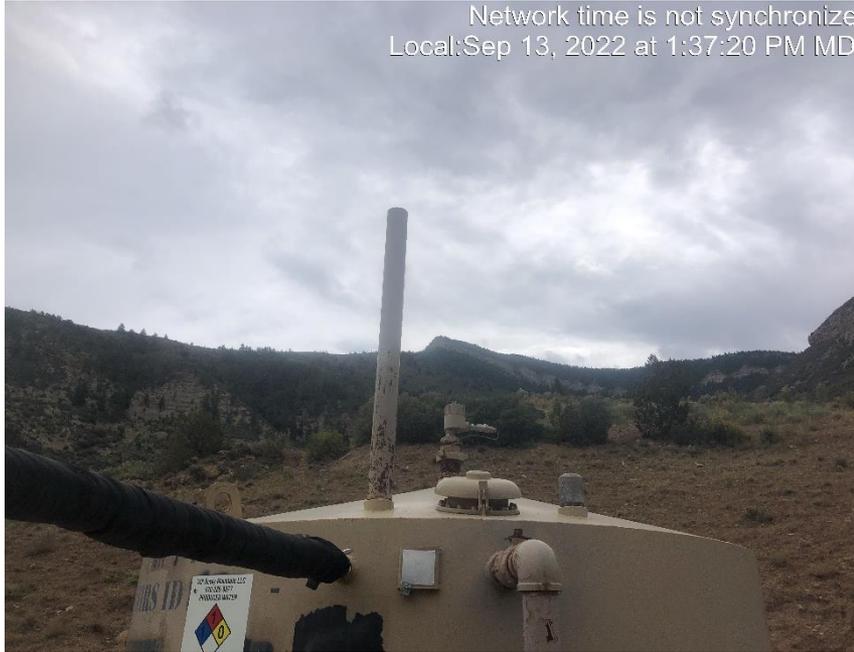
Photo #7677 Vent pipe on tank open ended.

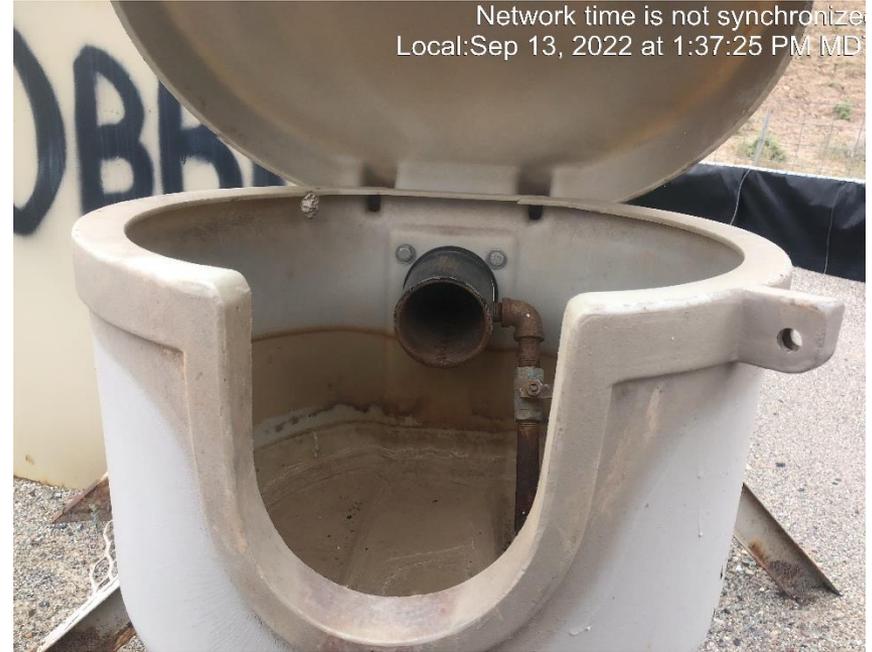
Photo #7678 Loadline open ended.

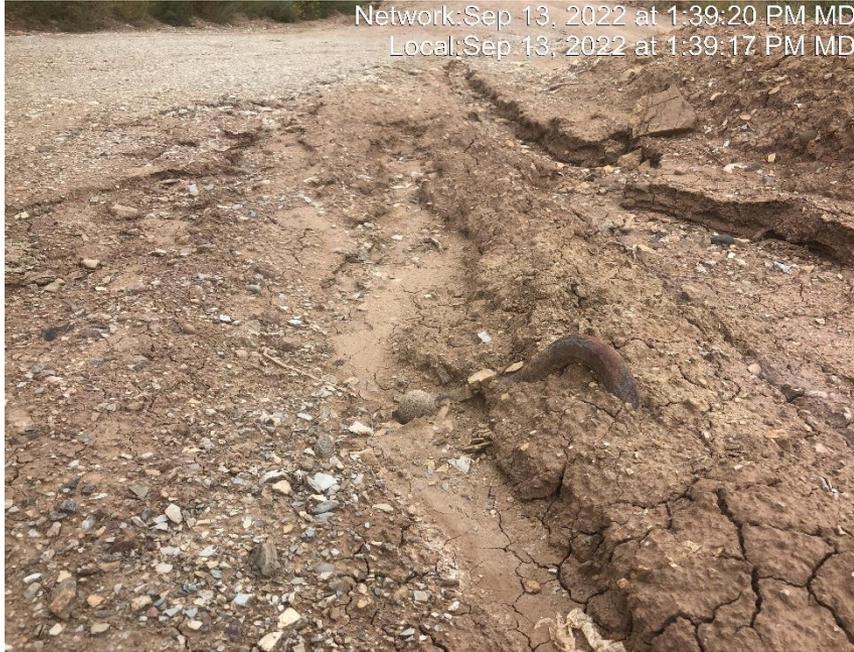
Photo #7684 Unmarked deadman.

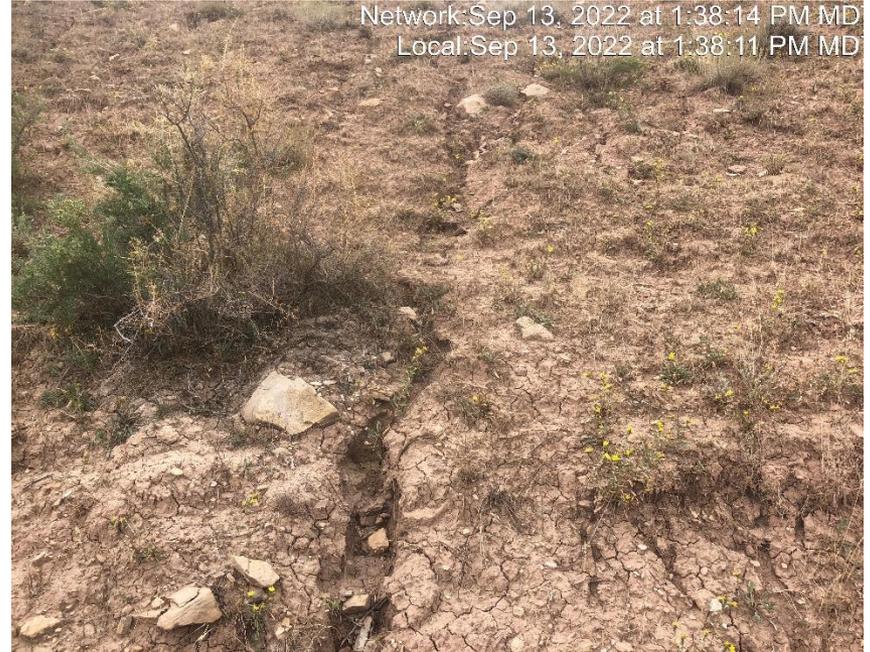
Photo #7680 Rill erosion occurring on cut slope.

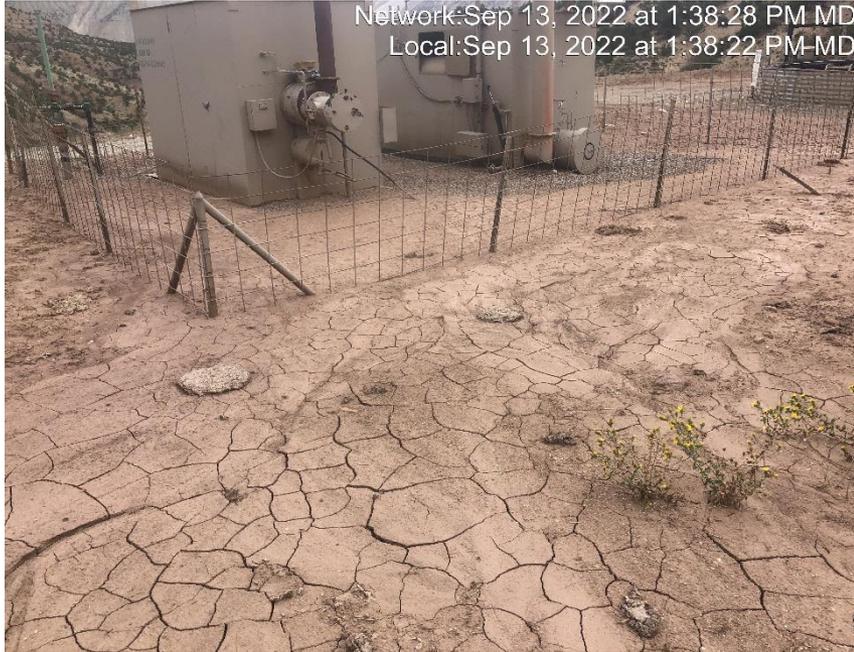
Photo #7681 Sediment encroaching on equipment.

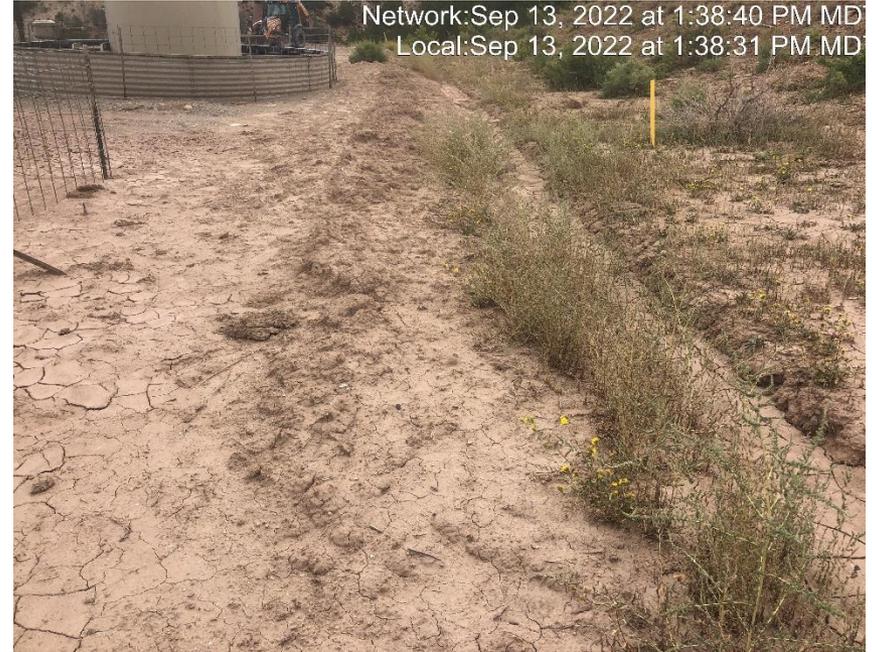
Photo #7682 Run on to location is not being controlled.

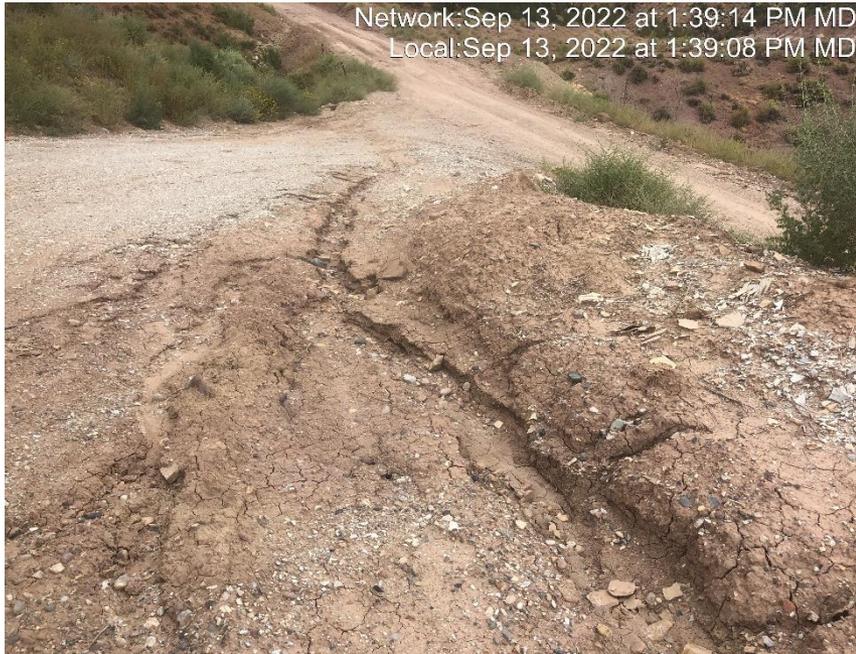
Photo #7683 Rill erosion occurring on access road.
