Inspection Photos

API: 009-06596

Operator: WEST TEXAS OPERATING CO

Inspection Date: 9/13/2022

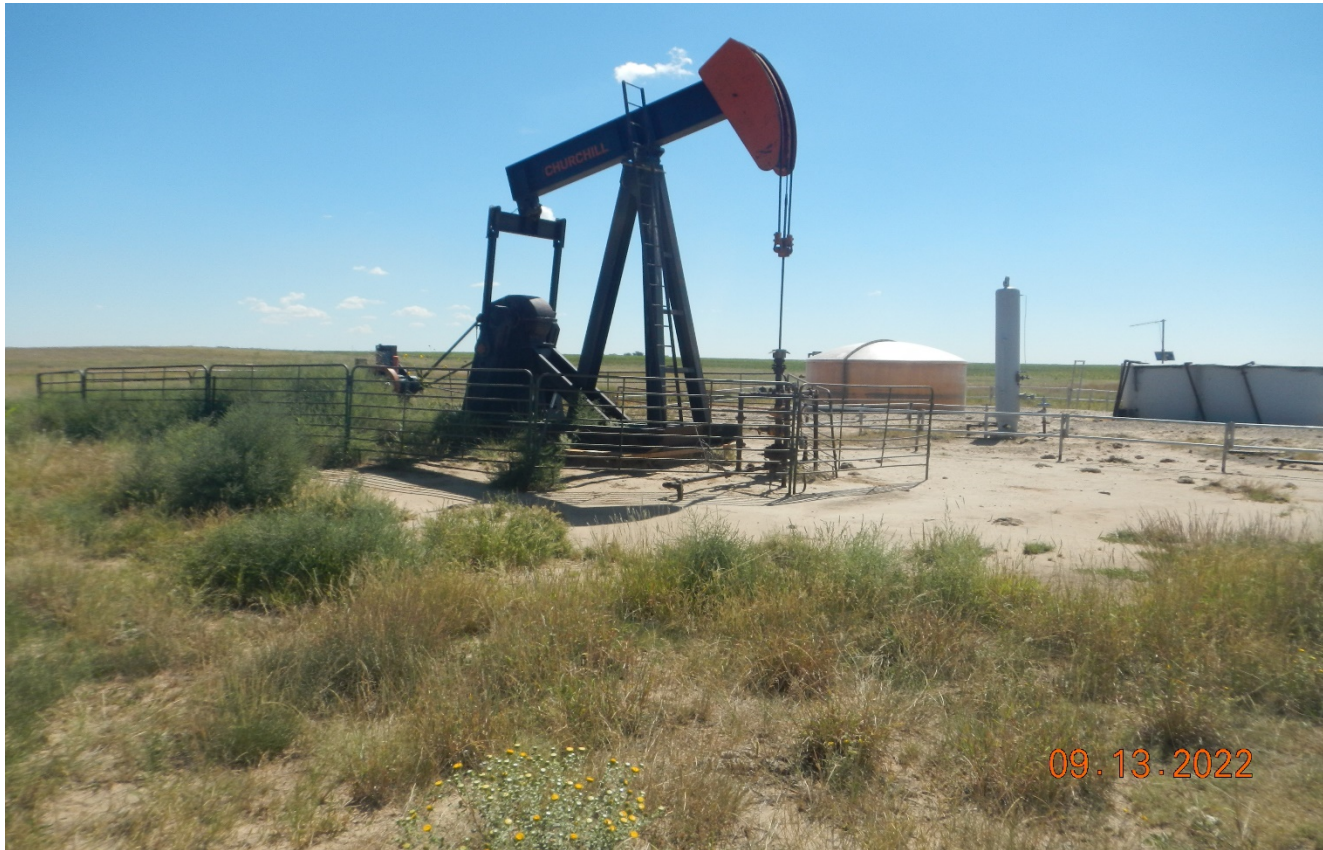
Photo 1. Facing southeast toward the wellsite. There are weeds around the pumpjack that need to be removed.

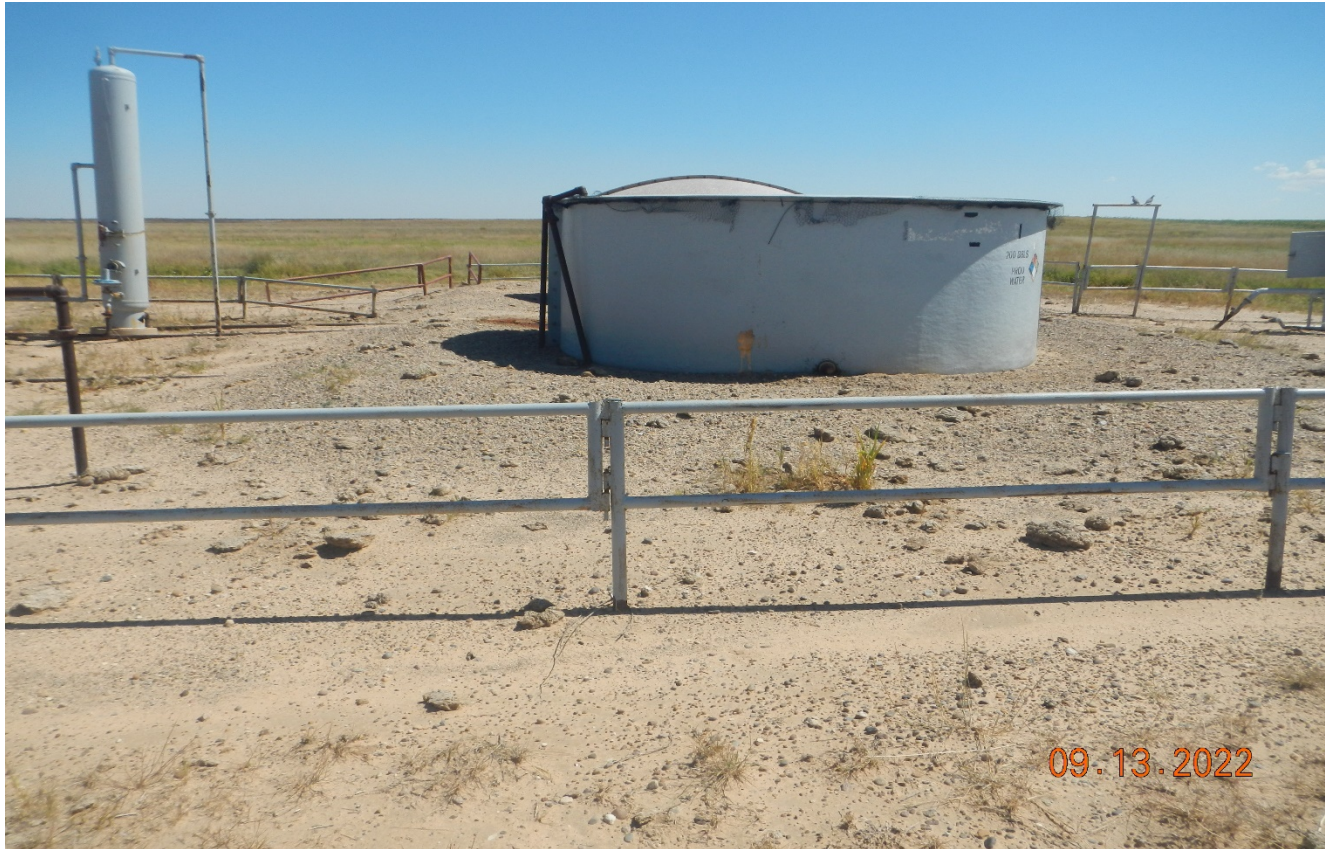
Photo 2. Facing toward the open top tank. There is inadequate secondary containment around the tanks.

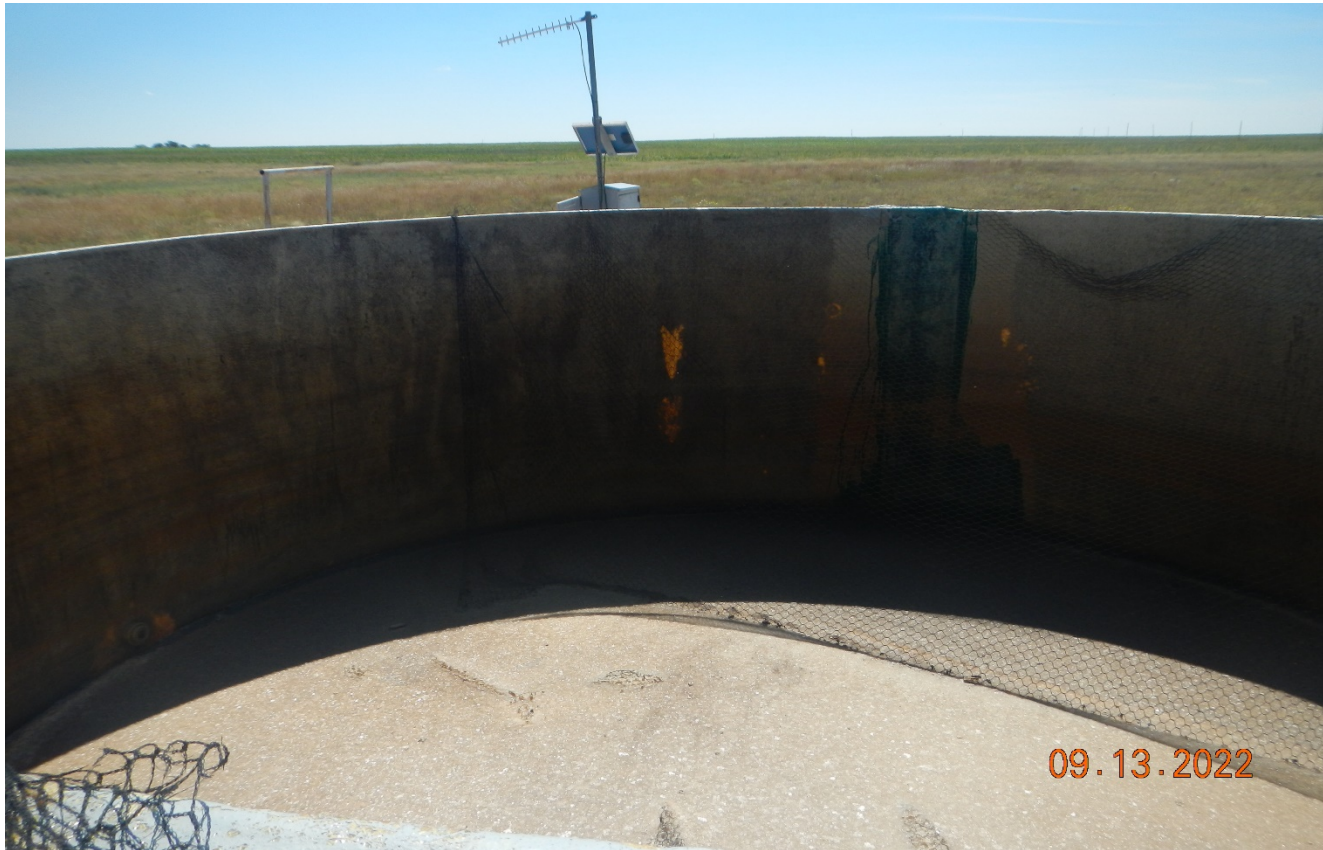
Photo 3. The netting on the tank is in disrepair. Netting needs to be installed to prevent wildlife entry.

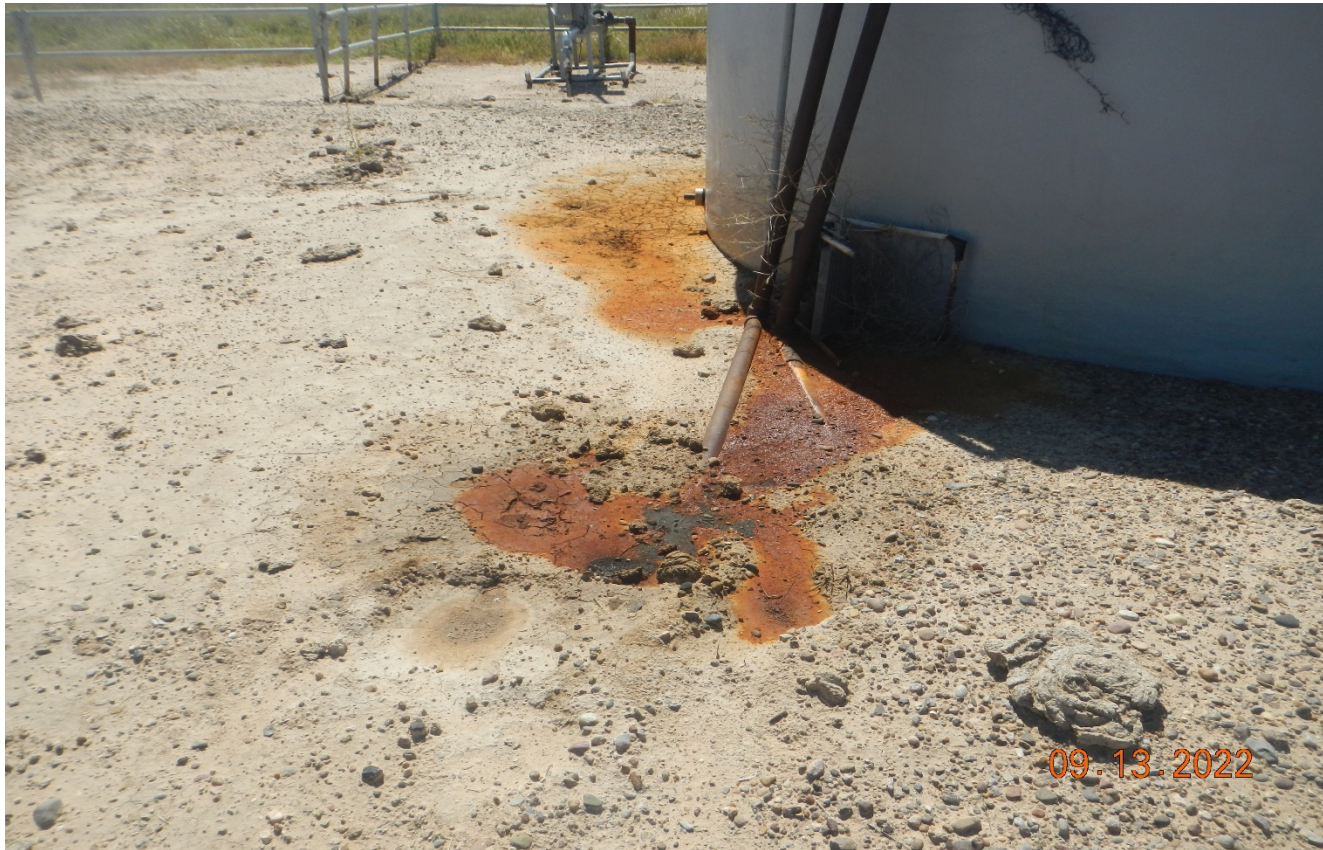
Photo 4. There are signs of a leak that had occurred, perhaps from the piping. Stained soil needs to be cleaned up and the tank and piping need to be inspection for integrity.

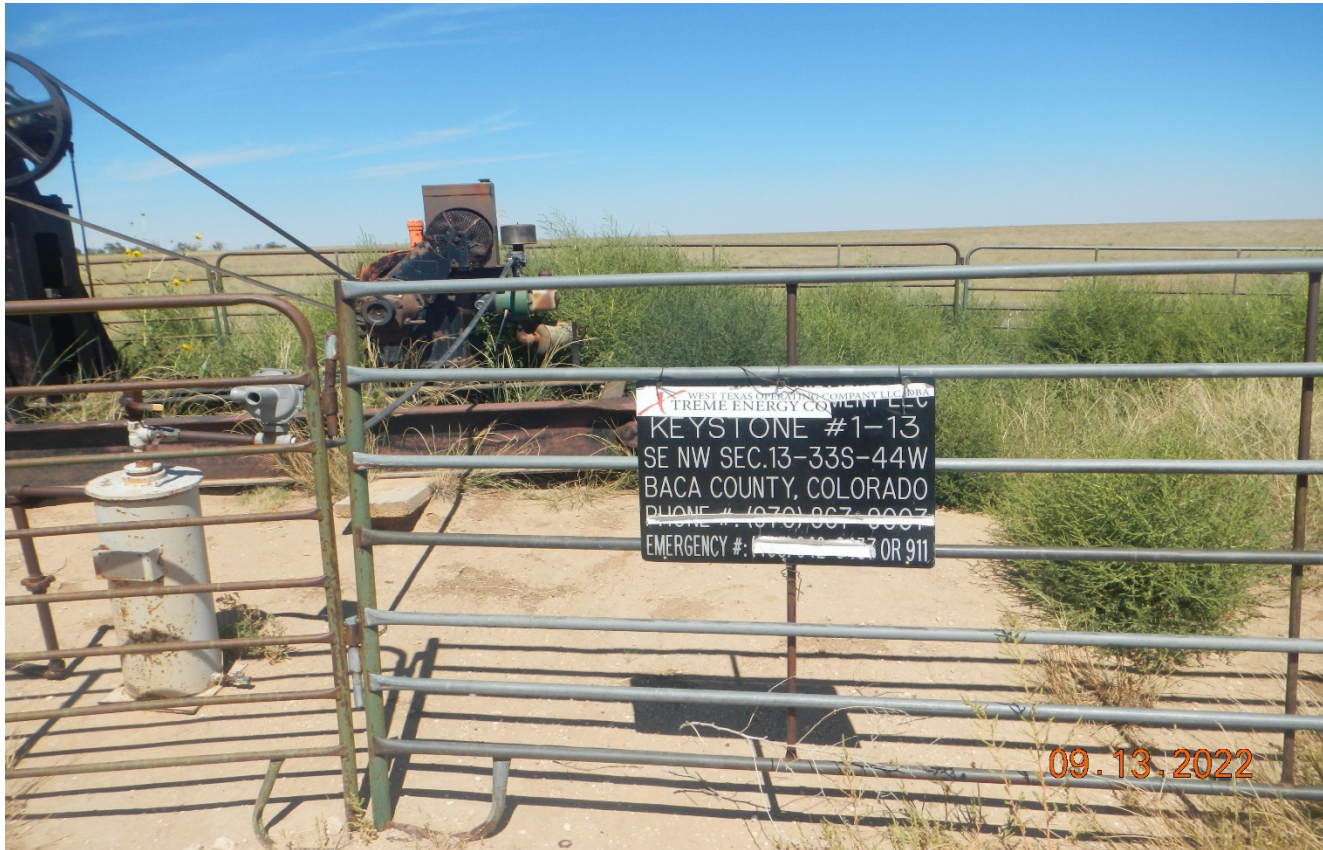
Photo 5. Well sign is posted by the pumpjack. The taped sign is peeled and faded and there is no emergency contact number.

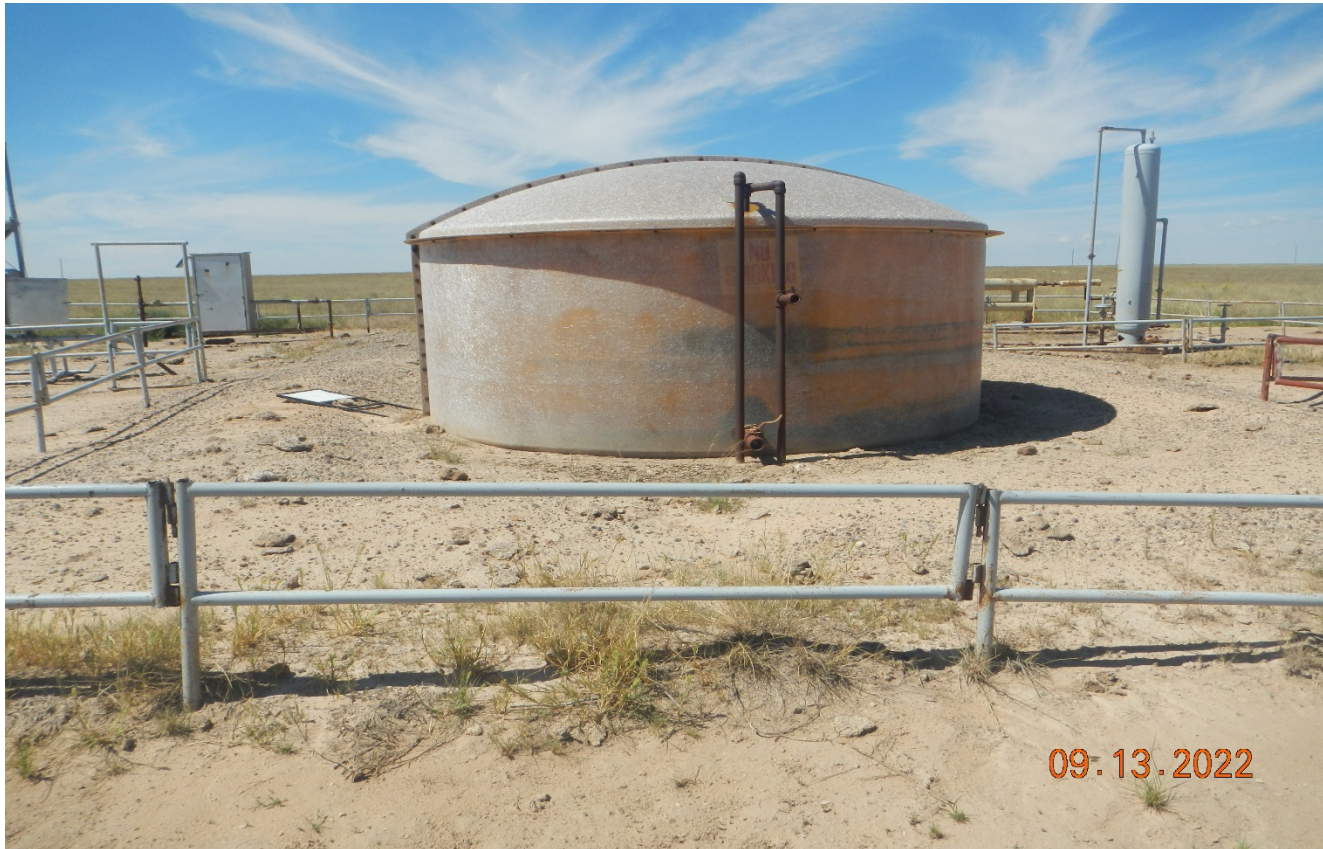
Photo 6. There is no labeling on the fiberglass tank and no secondary containment.

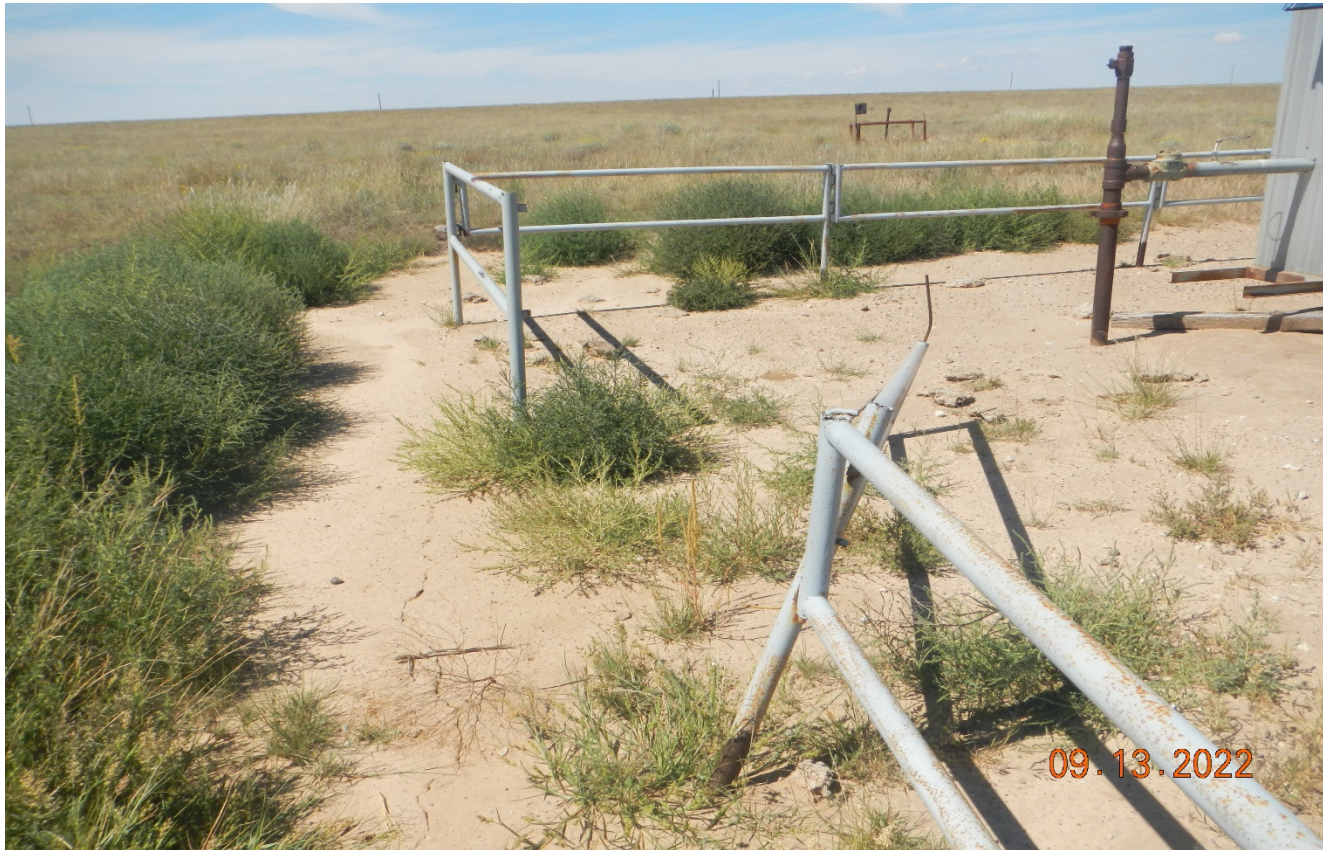
Photo 7. The pipe fence around the equipment is in need of maintenance.
