# Inspection Photos

API: 009-06624

Operator: ENERGY ALLIANCE COMPANY INC

Inspection Date: 9/13/2022

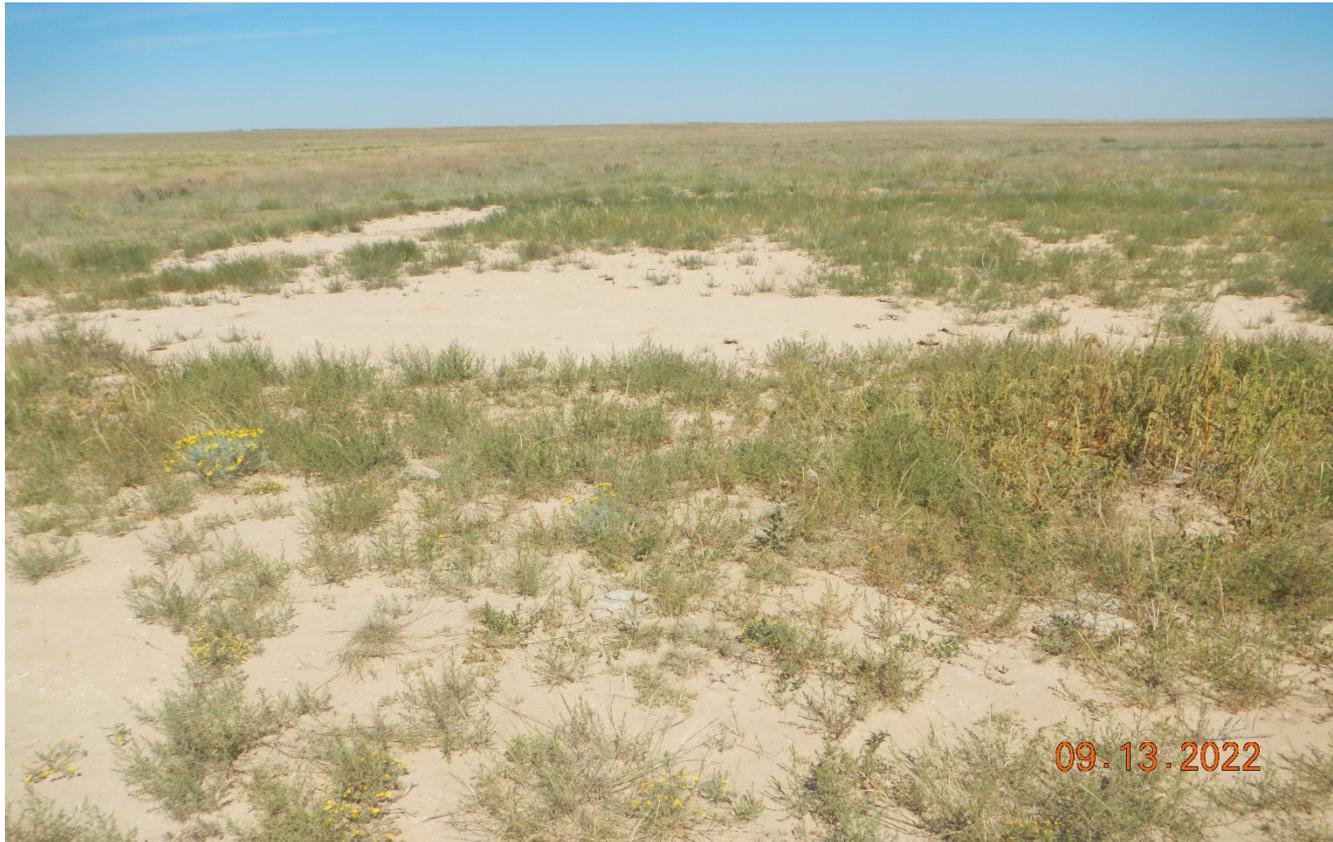
**Photo 1.** Facing north toward the location. There are areas that have not established desirable perennial vegetation.

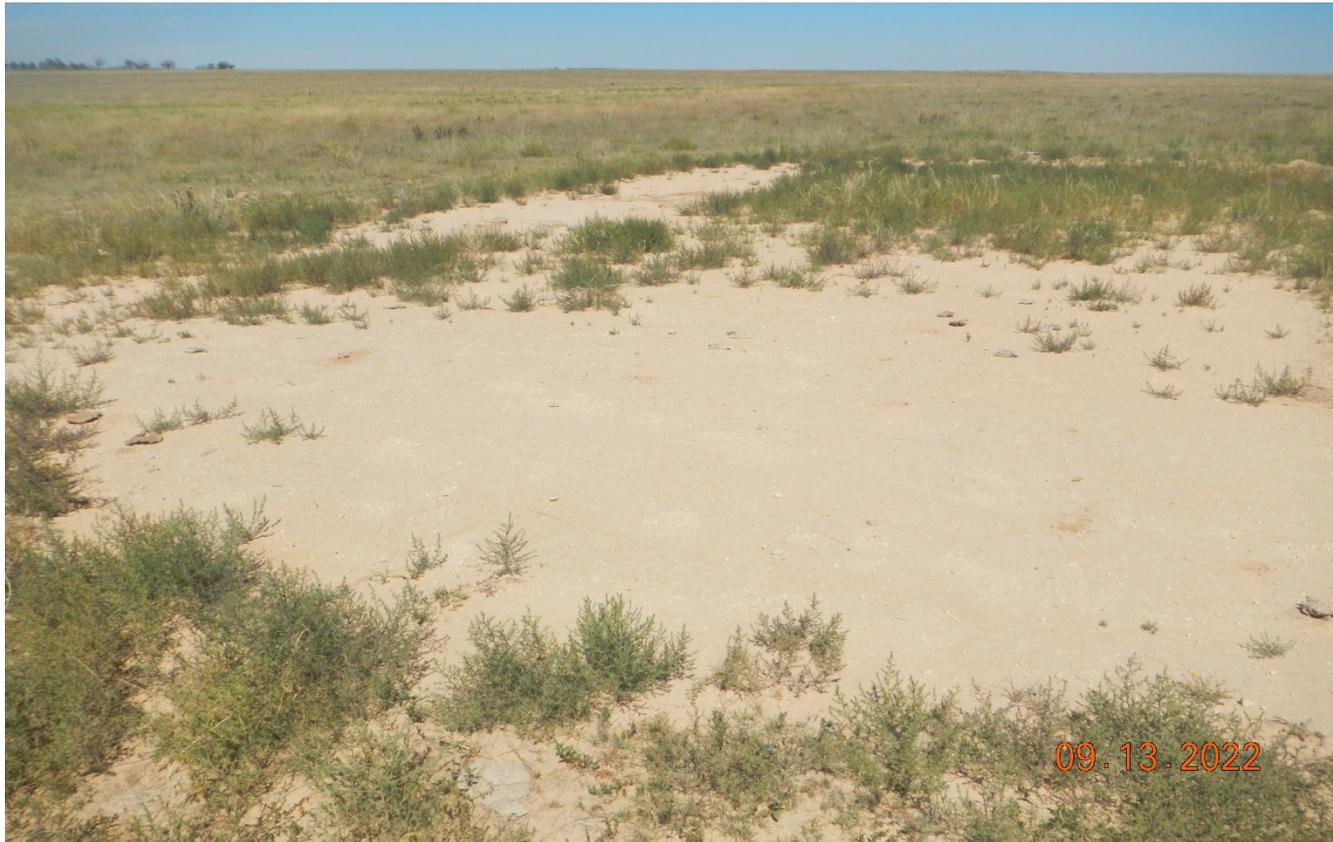
**Photo 2.** This area of the location has no vegetation growth which indicates soil issues.

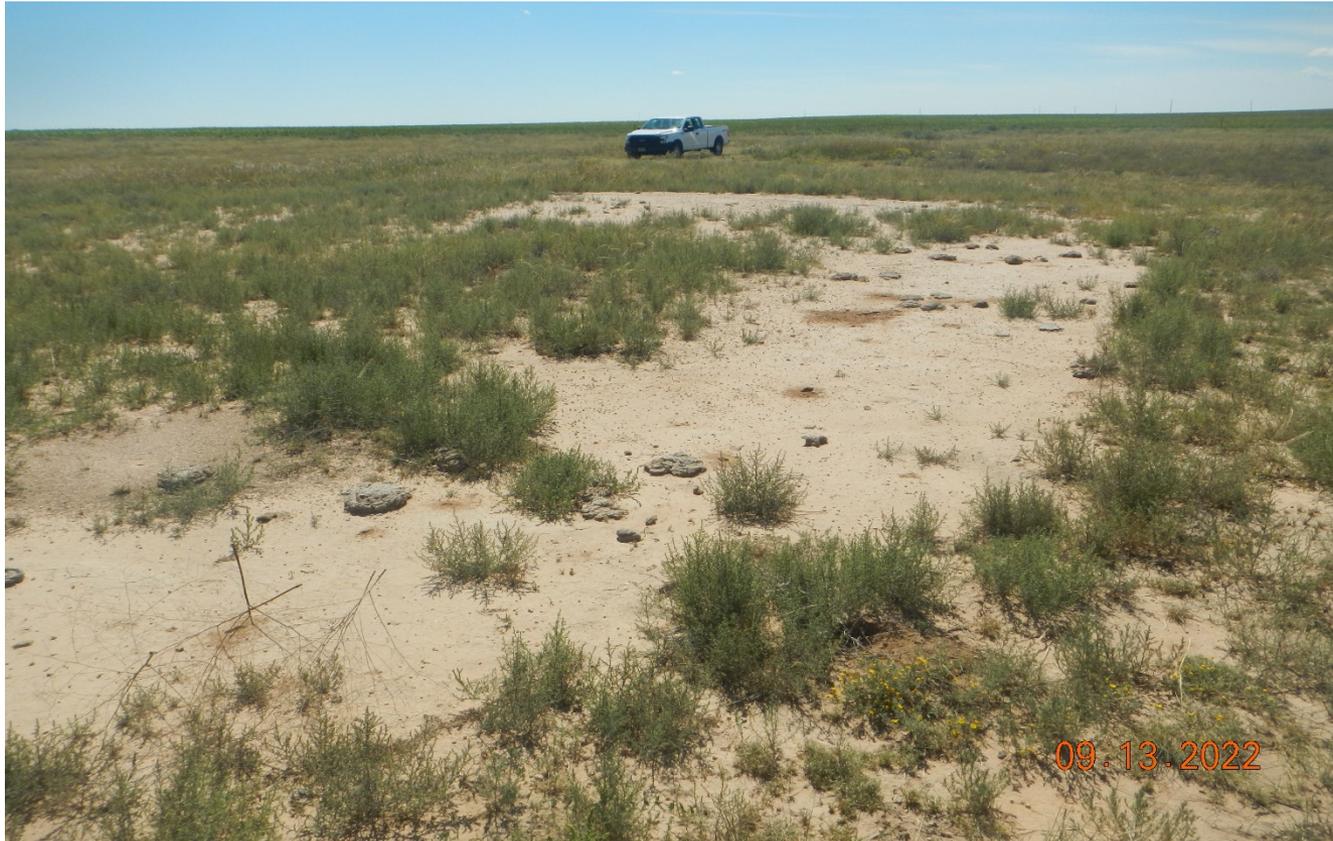
**Photo 3.** Facing back to the south at the location. This area of the location has no vegetation growth which indicates soil issues.

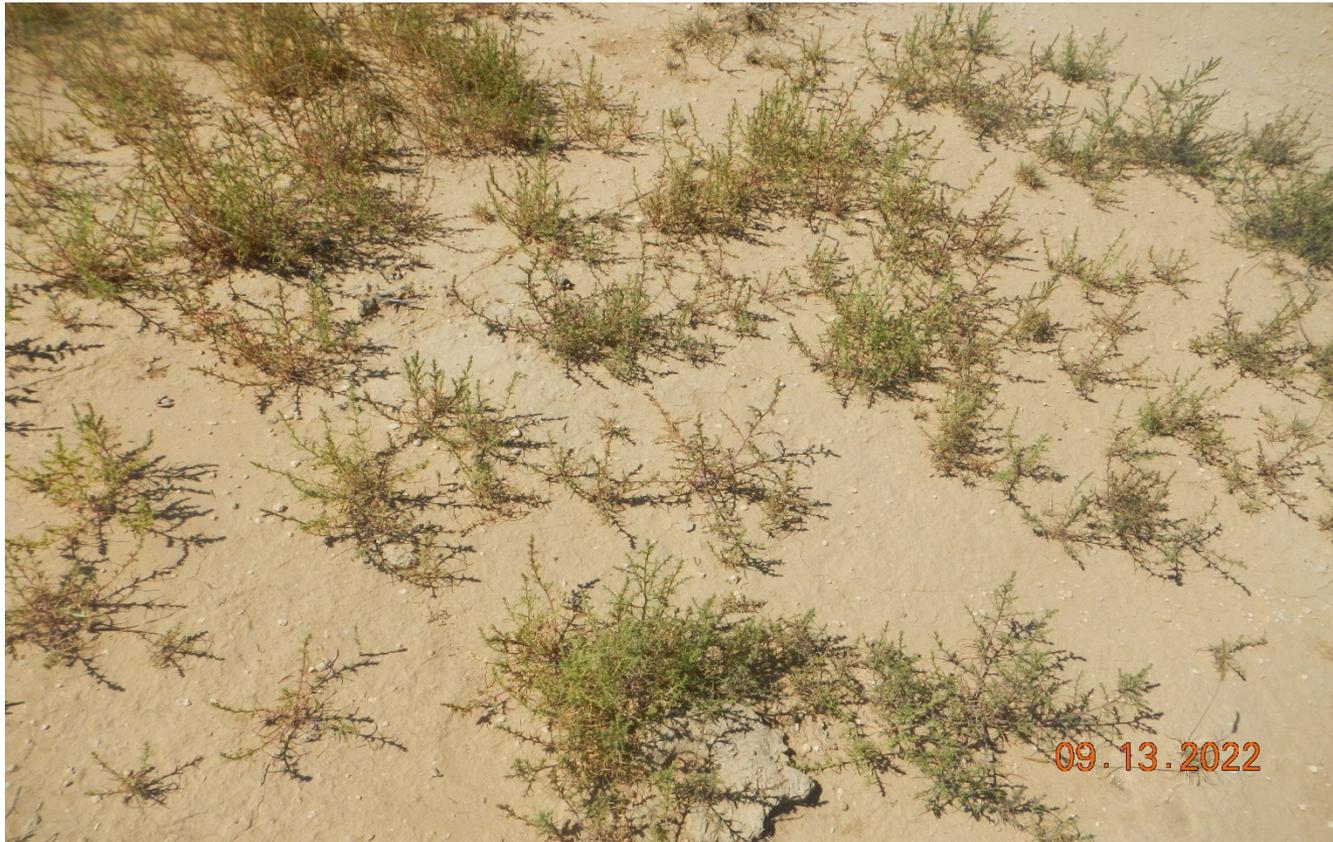
**Photo 4.** View of groundcover shows only undesirable weeds and bare soil.

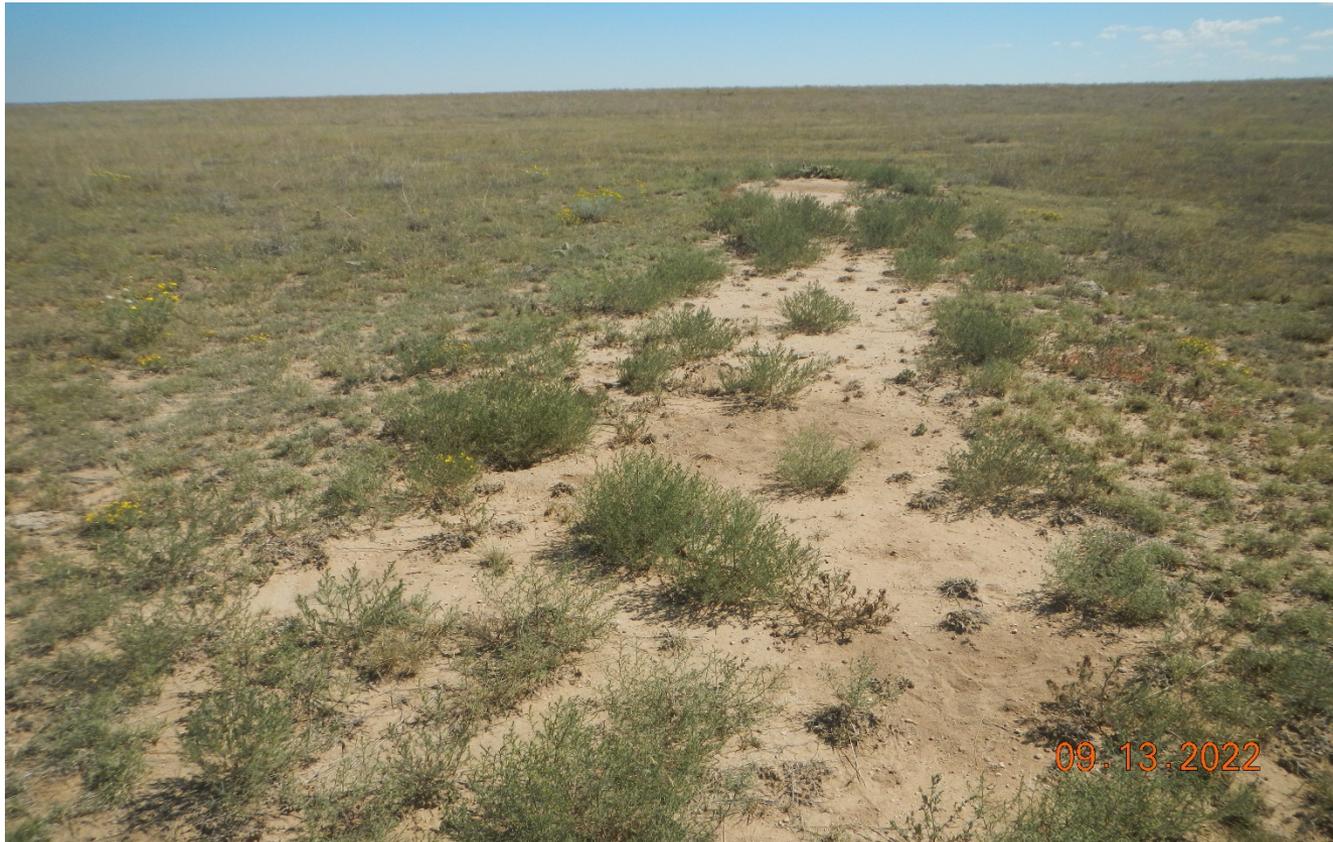
**Photo 5.** Northeast of the location is a long area with inadequate vegetation growth.

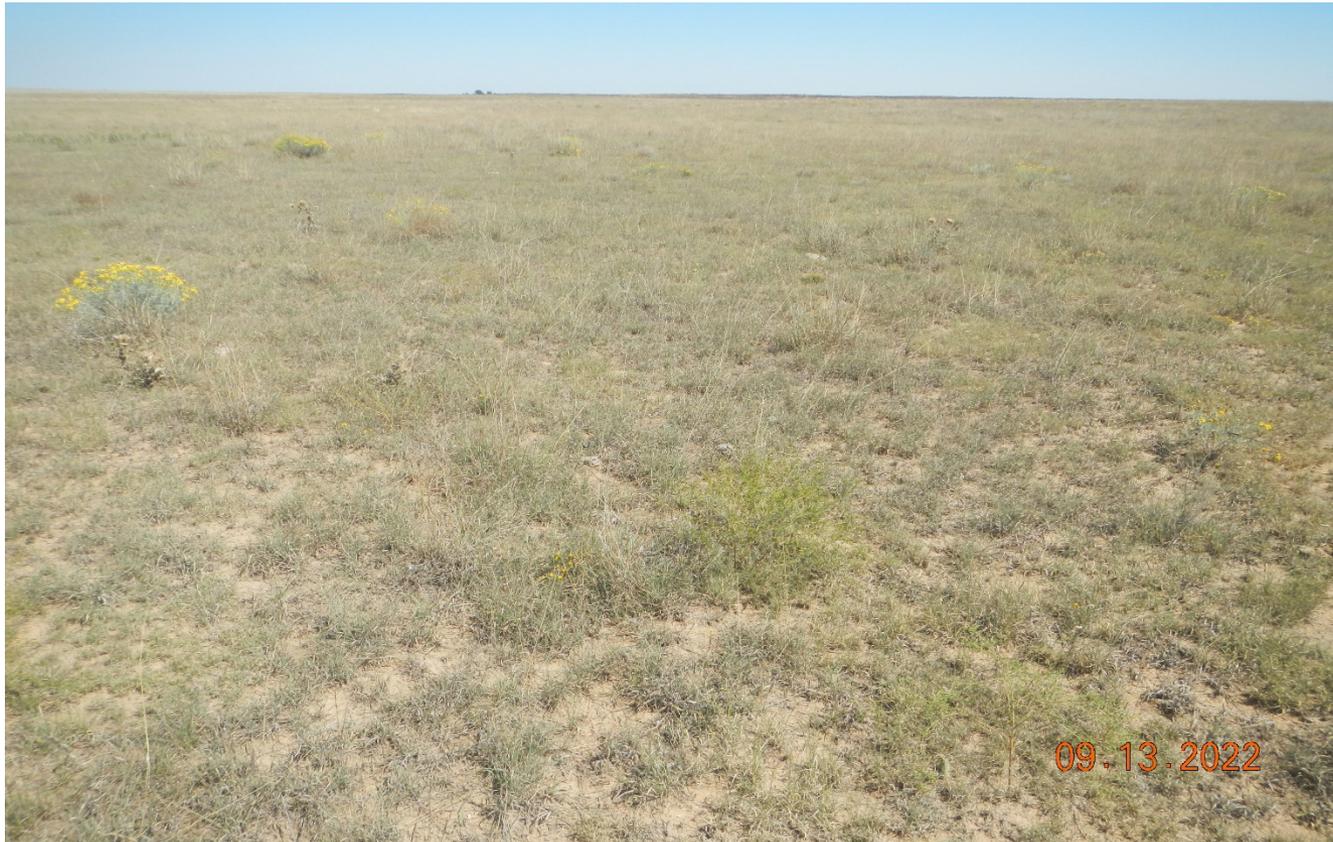
**Photo 6.** Facing north toward the surrounding undisturbed reference area.
