**SWN PRODUCTION COMPANY LLC**  
**Dawson Creek 1-25**  
**Location # 424711**

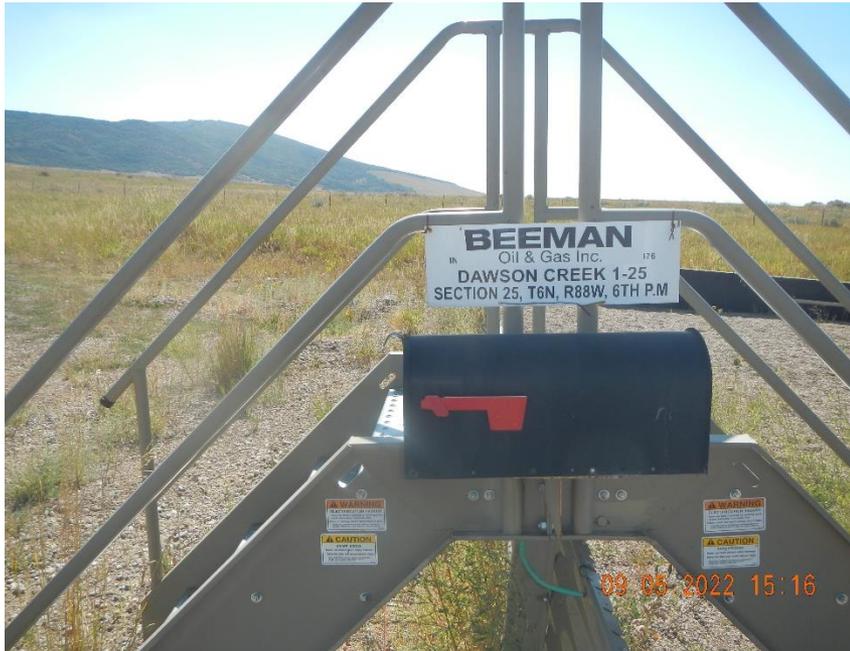
**No sign at tank battery meeting Rule 605.e.. Signs have Beeman Oil & Gas on signs.**

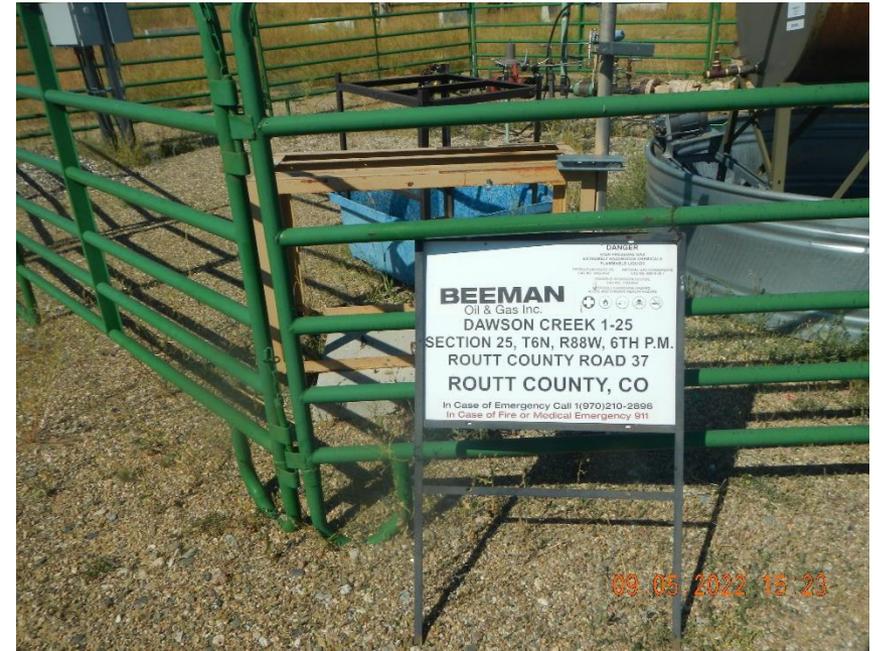
**It was observed in this inspection that wildlife protection devices to prevent wildlife, including but not limited to birds and bats from entering the secondary containment. stock tank adjacent to the wellhead are missing or insufficient.**

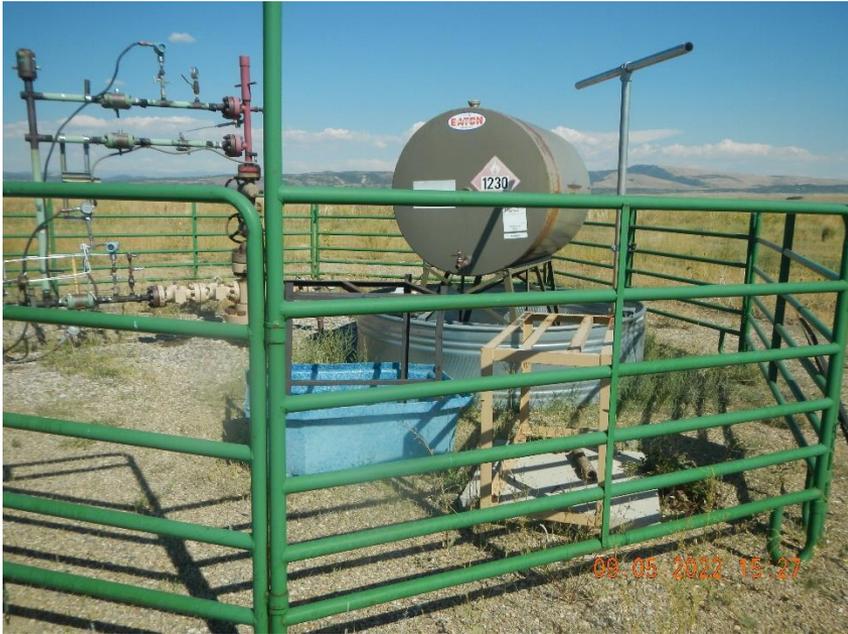
**Methanol tank label is faded and missing information required for tanks over 10 bbls. Unused equipment including 2 tank stands, and 1 secondary containment tank were observed stored at the well area.**

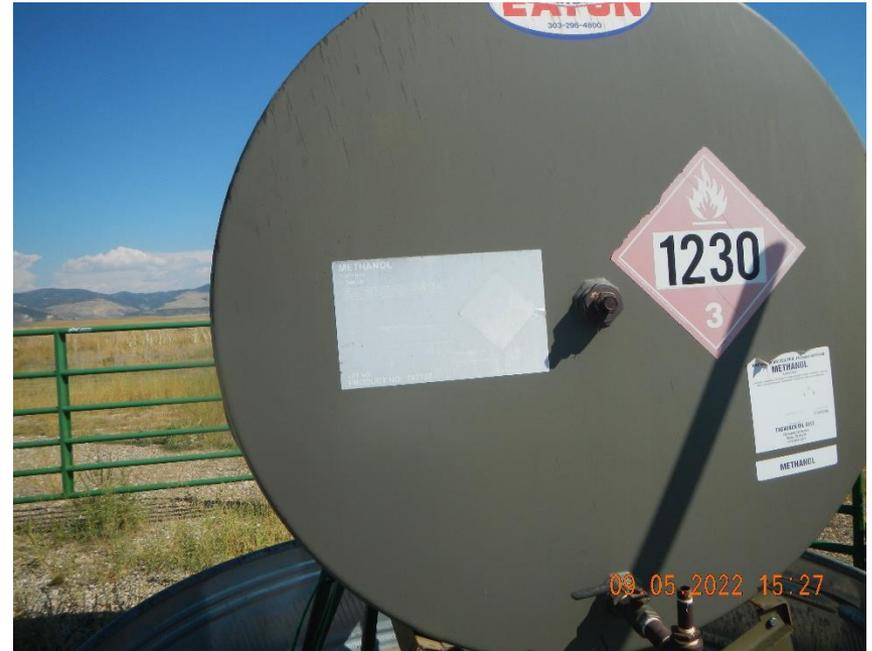
**Methanol tank label is faded and missing information required for tanks over 10 bbls.**

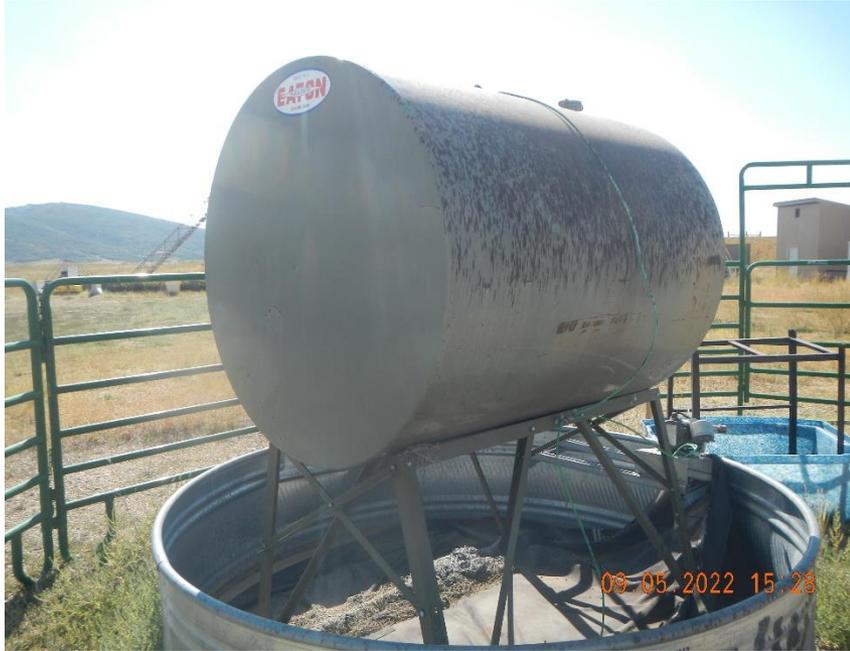
**Methanol tank label is faded and missing information required for tanks over 10 bbls. Unused equipment including 2 tank stands, and 1 secondary containment tank were observed stored at the well area.**

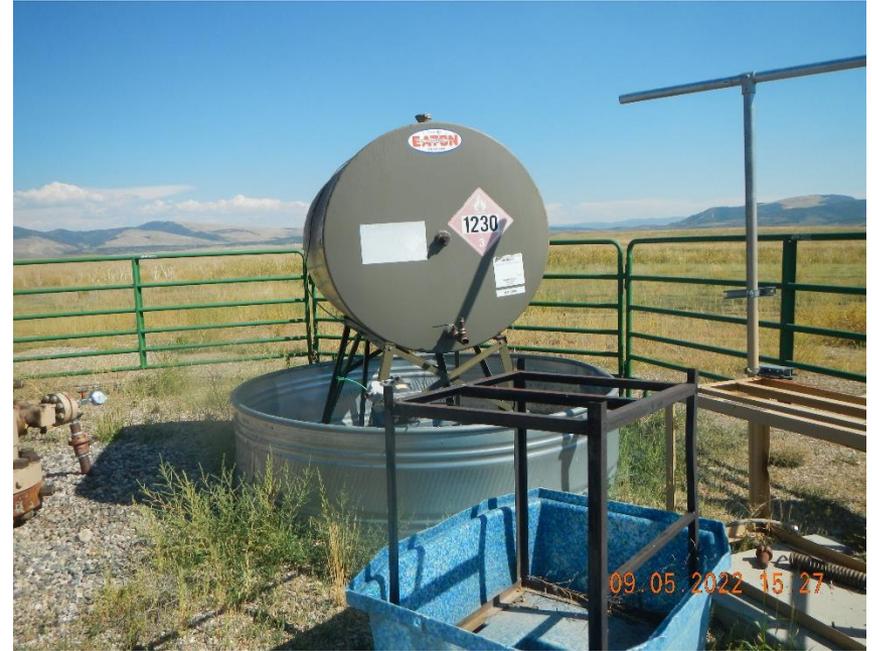
**Methanol tank label is faded and missing information required for tanks over 10 bbls. Unused equipment including 2 tank stands, and 1 secondary containment tank were observed stored at the well area.**

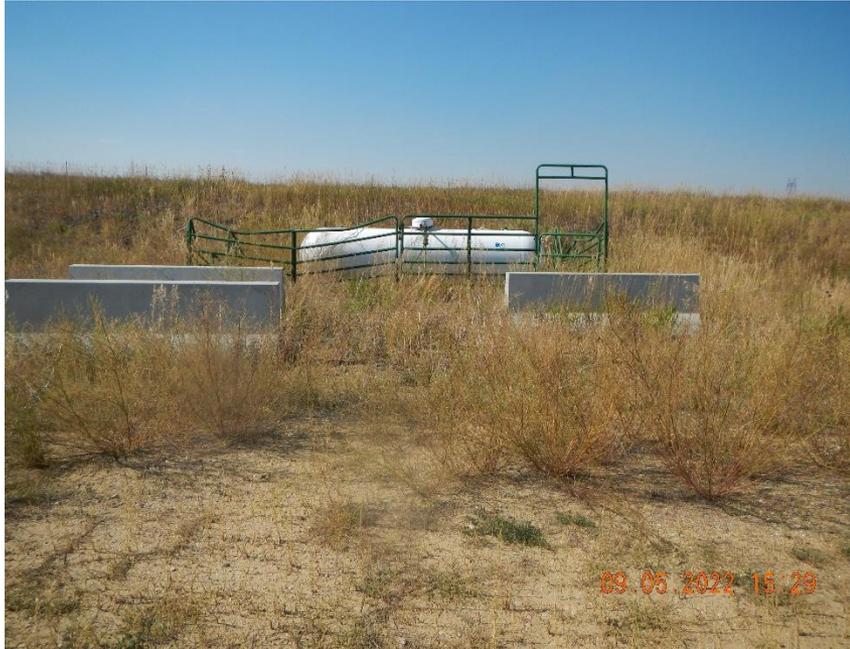
**Propane tank not identified as a hazard and appropriate warning signs posted. Propane tank missing information required for tanks over 10 bbls.**

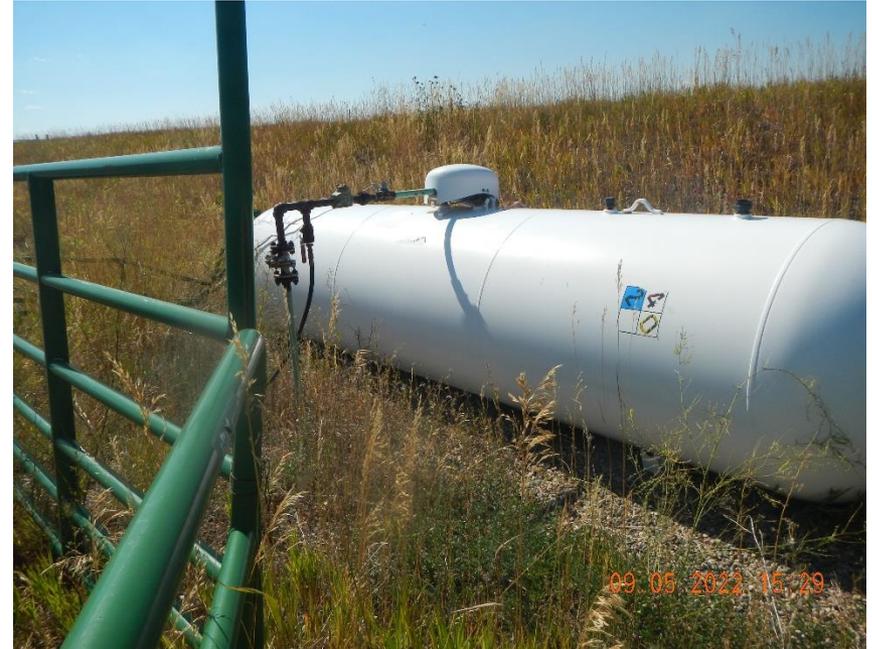
**Propane tank not identified as a hazard and appropriate warning signs posted. Propane tank missing information required for tanks over 10 bbls.**

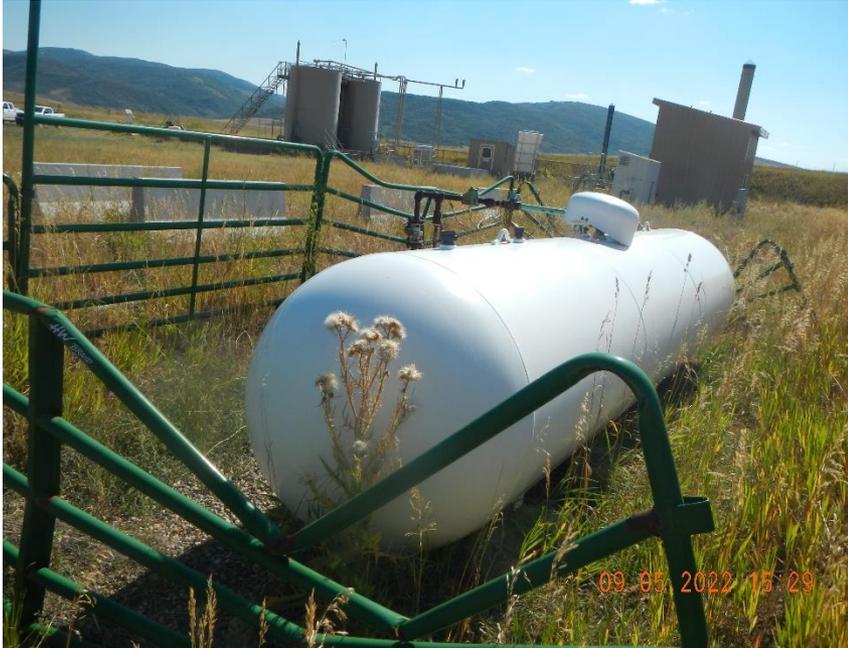
**Propane tank not identified as a hazard and appropriate warning signs posted. Propane tank missing information required for tanks over 10 bbls.**

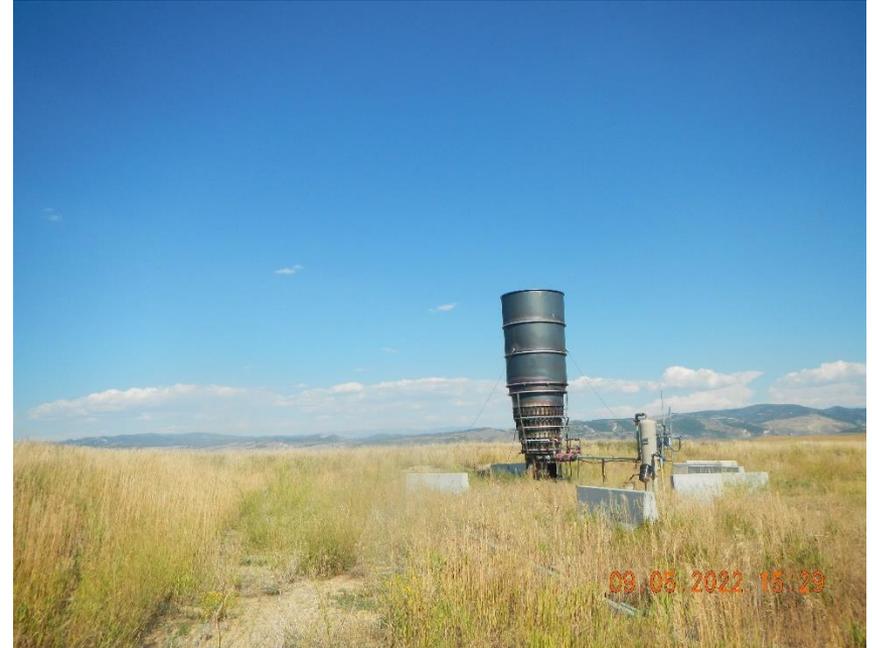
**Weeds around combustor.**

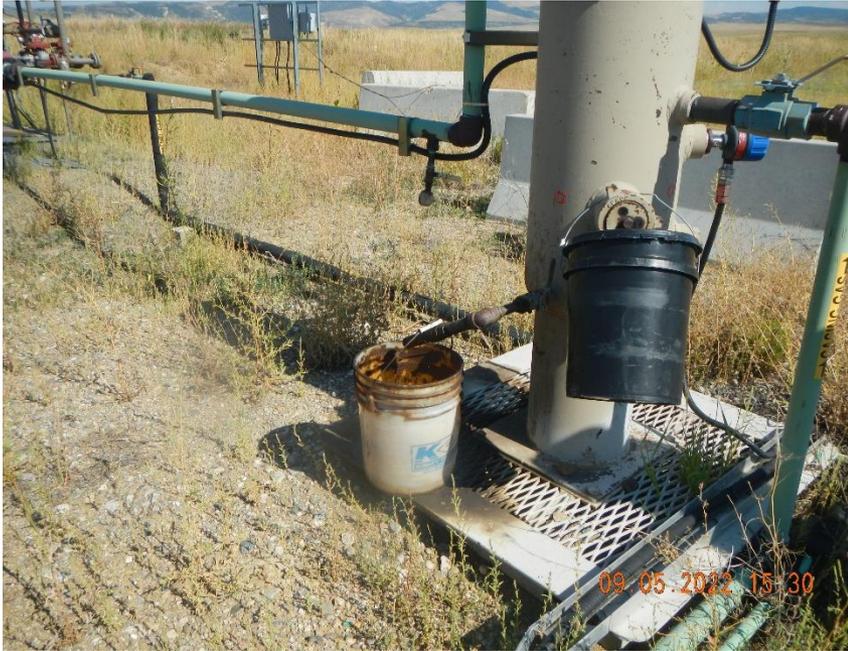
**Impacted soils observed around the production equipment at the north of the Location. The containment device at the spill at the north of the Location was observed to be insufficient.**

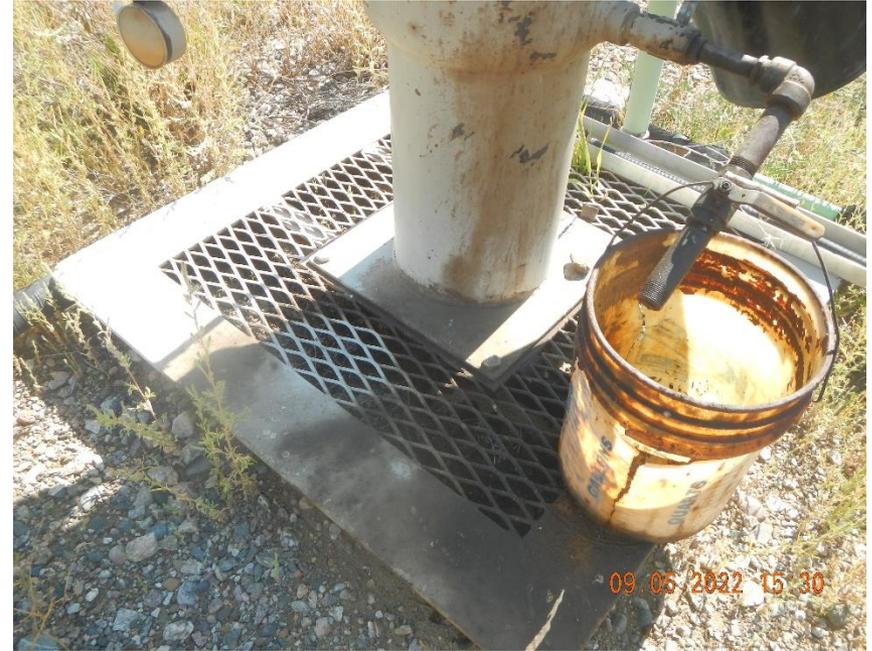
**Impacted soils observed around the production equipment at the north of the Location. The containment device at the spill at the north of the Location was observed to be insufficient.**

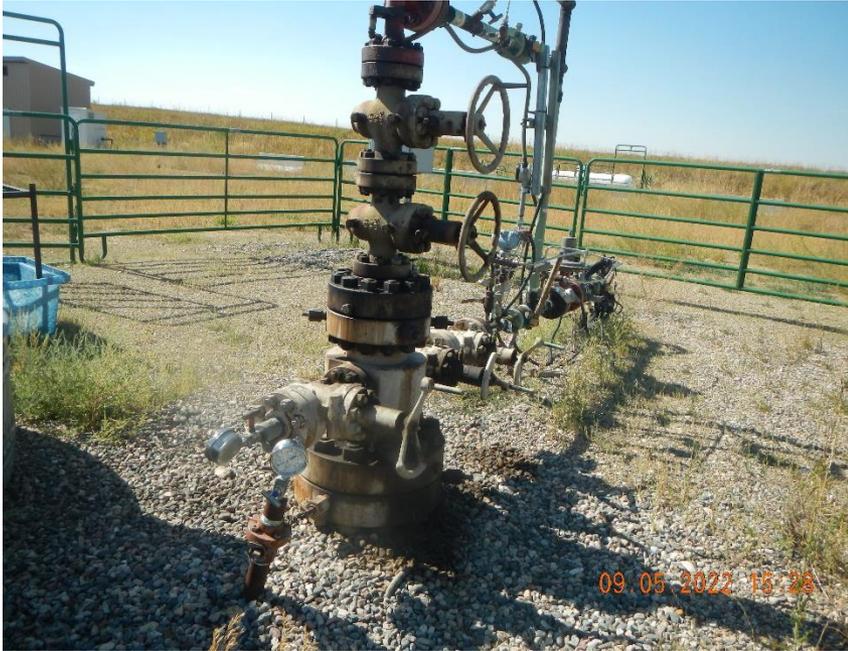
**Impacted soils observed around the wellhead**

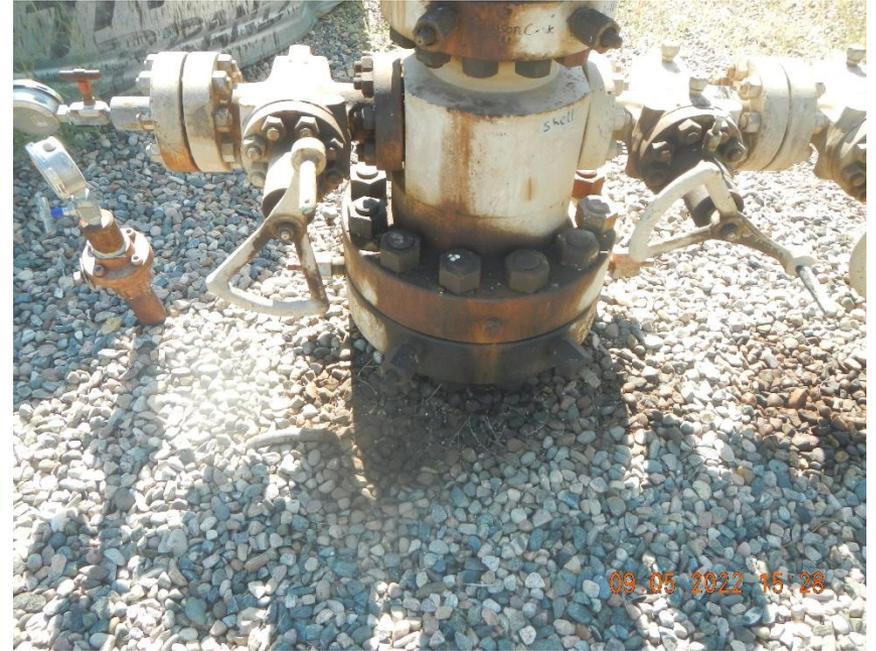
**Impacted soils observed around the wellhead**

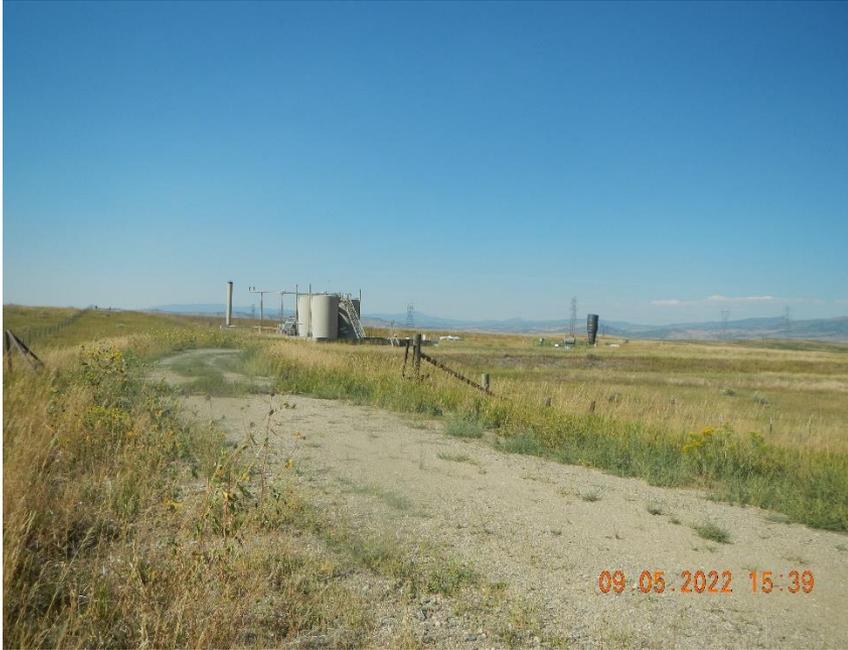
**Weeds on access road.**

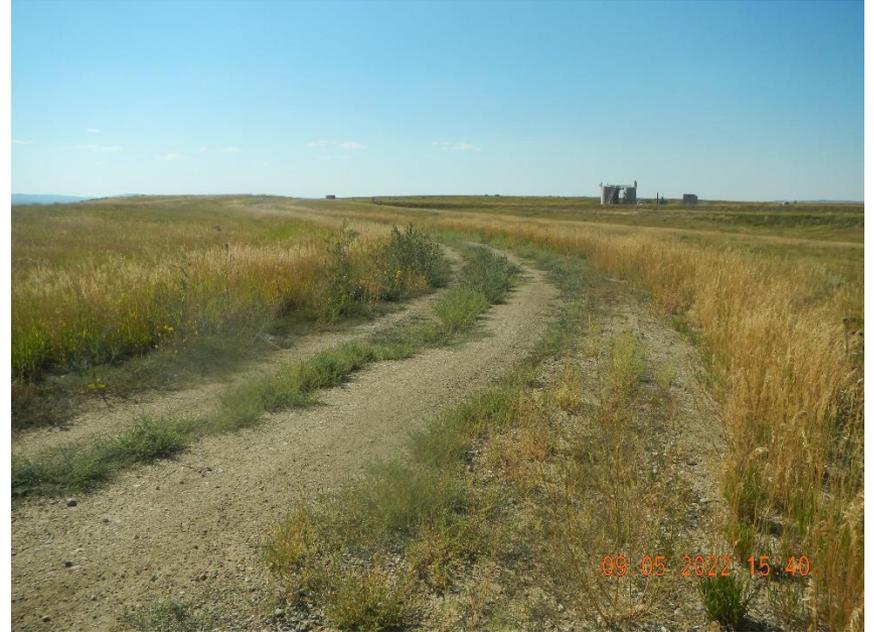
**Weeds on access road.**

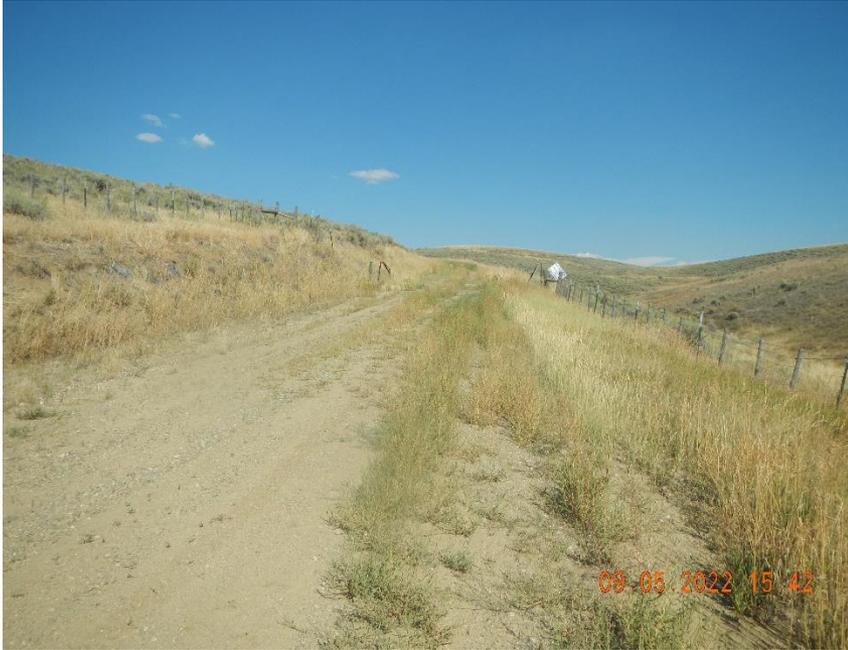
**Weeds on access road.**

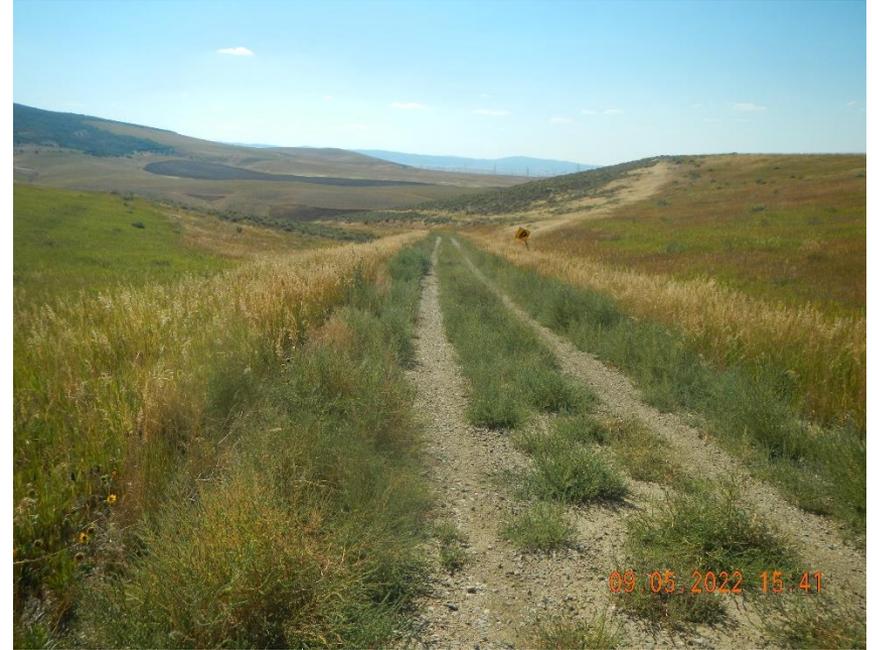
**Weeds on access road.**

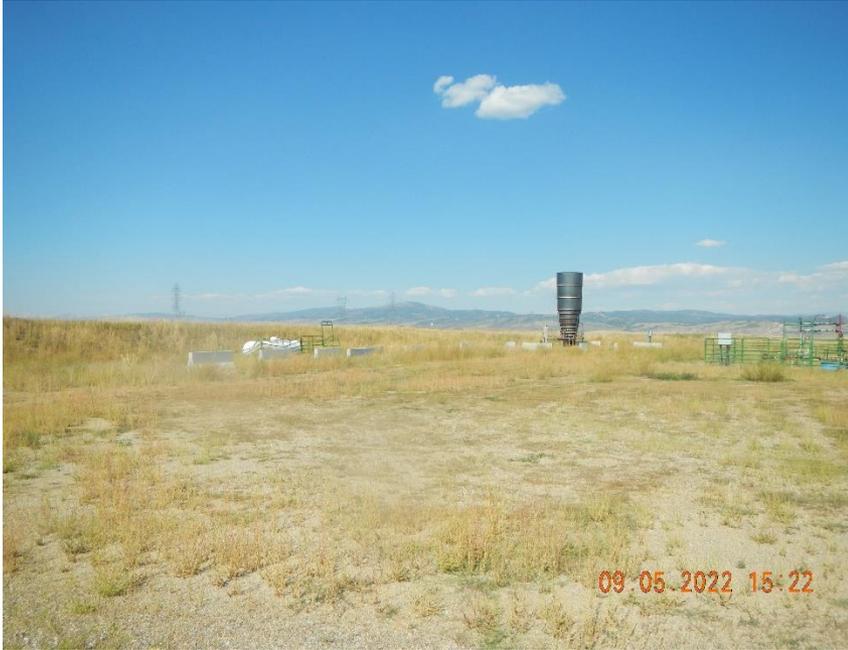
**Weeds on location.**

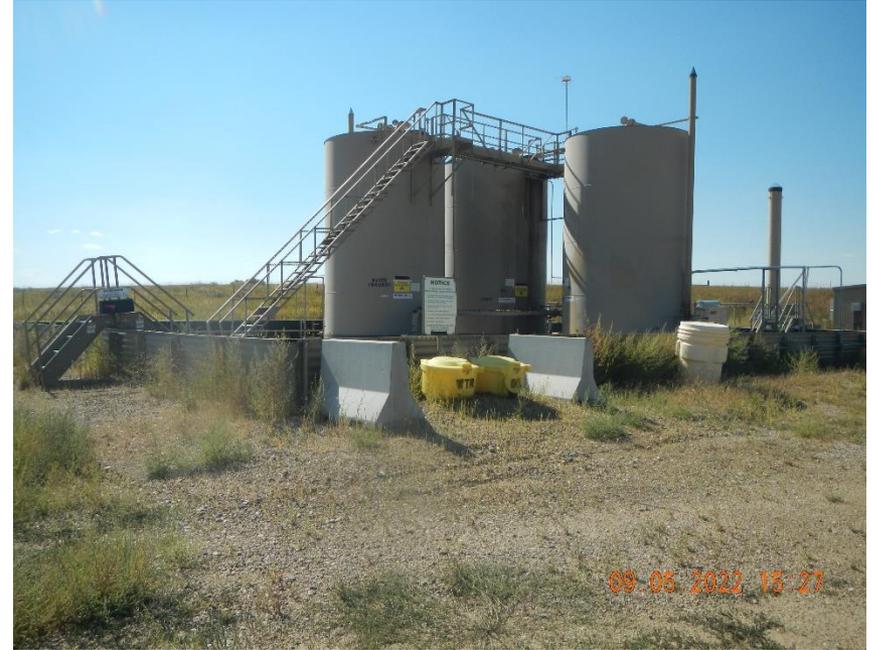
**Weeds on location.**

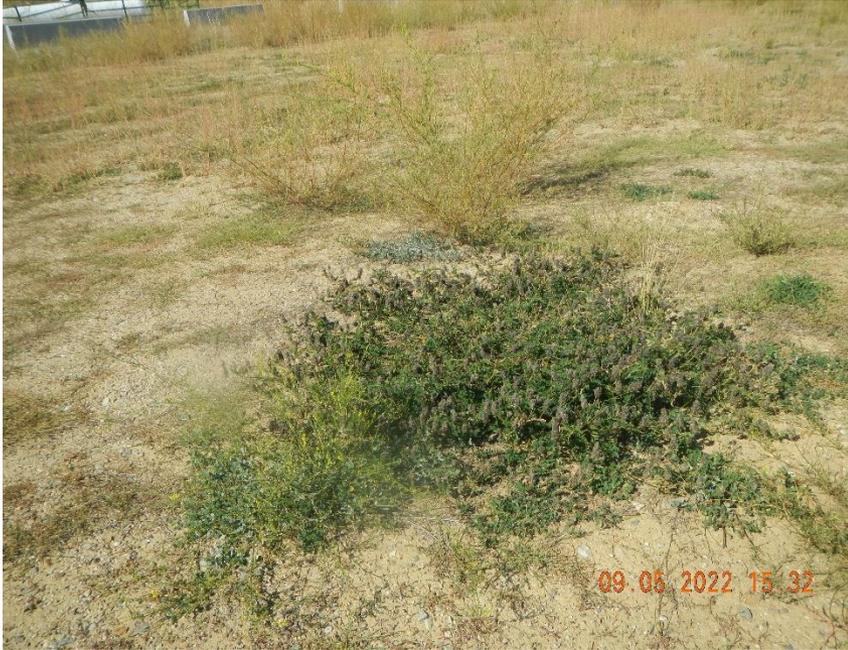
**Weeds on location.**

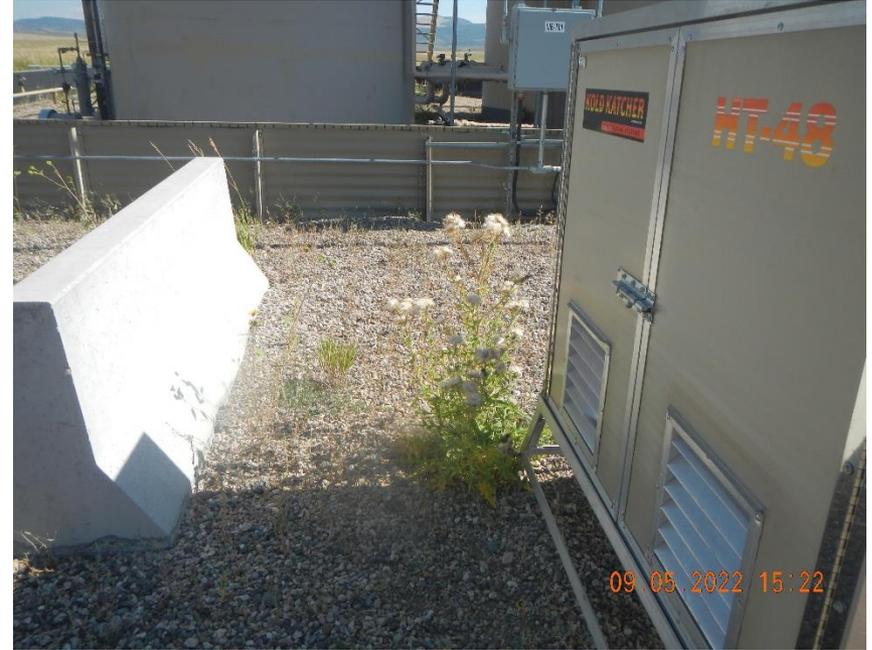
**Weeds on location.**
