Inspection Photos

API: 009-06082

Operator: DOVER ATWOOD CORPORATION

Inspection Date: 9/13/2022

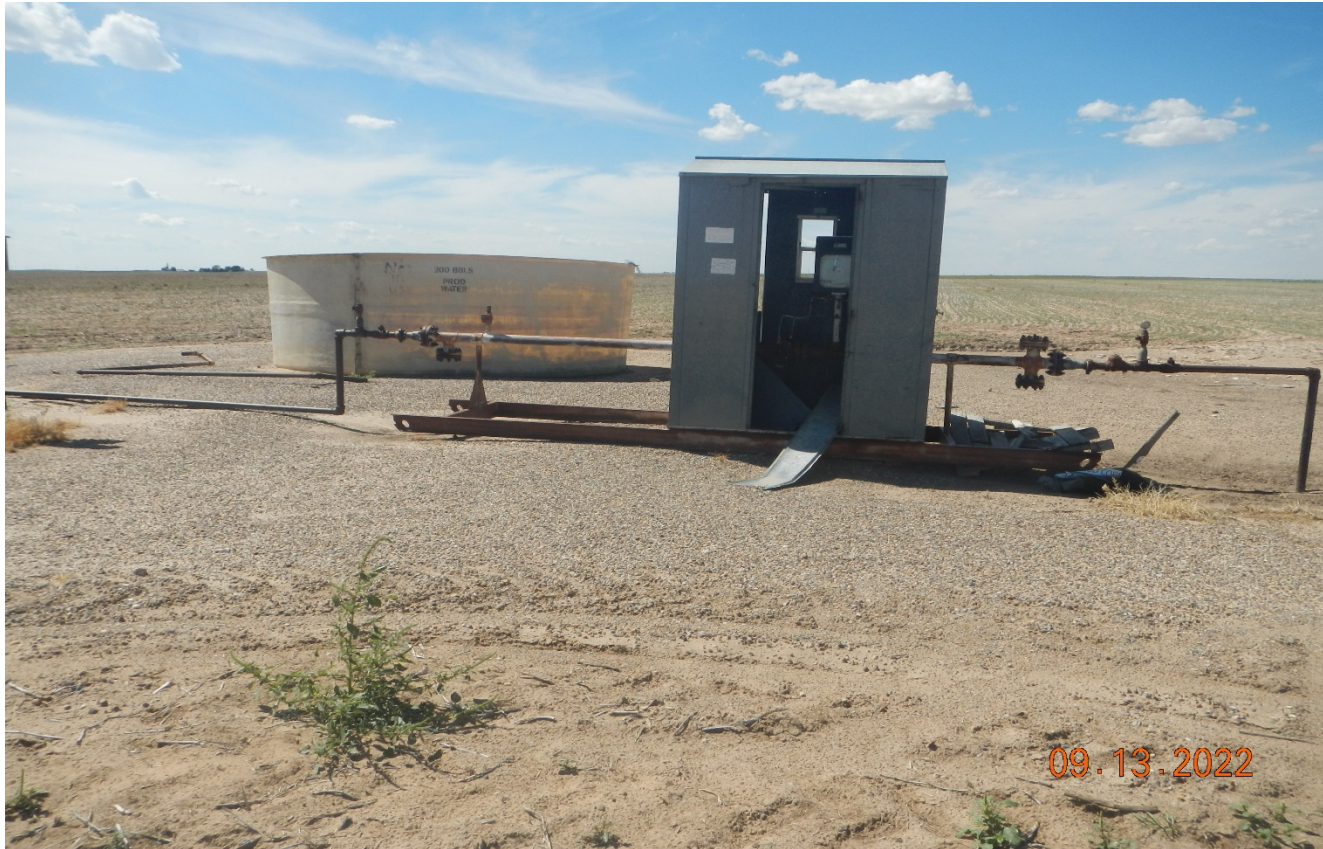
Photo 1. Facing east toward the location. The door to the meter shed is in disrepair and laying on the ground.

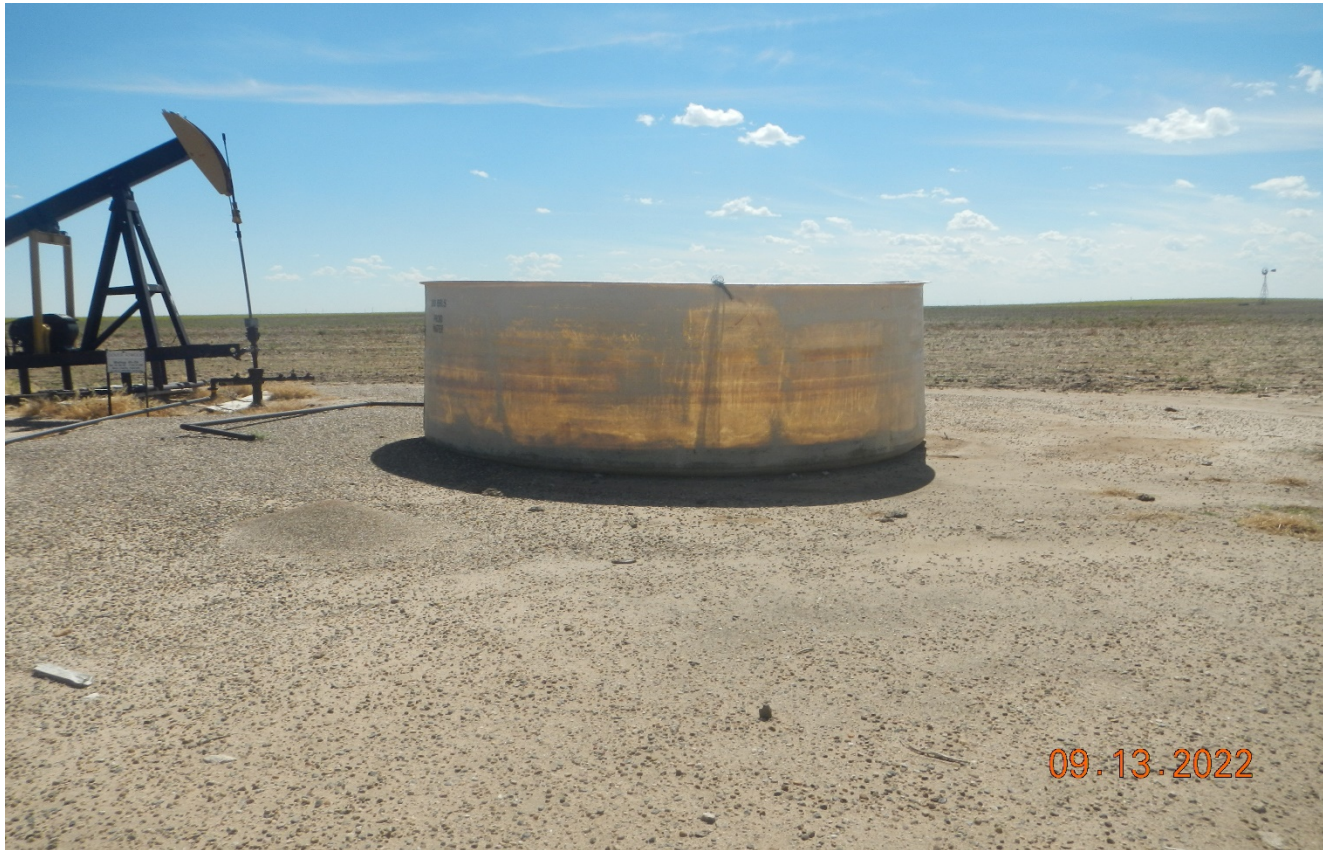
Photo 2. Missing tank NFPA labeling and missing INFO per 605.h.. Secondary containment is inadequate to contain 150% of the volume of the tank. Previous corrective action not completed.

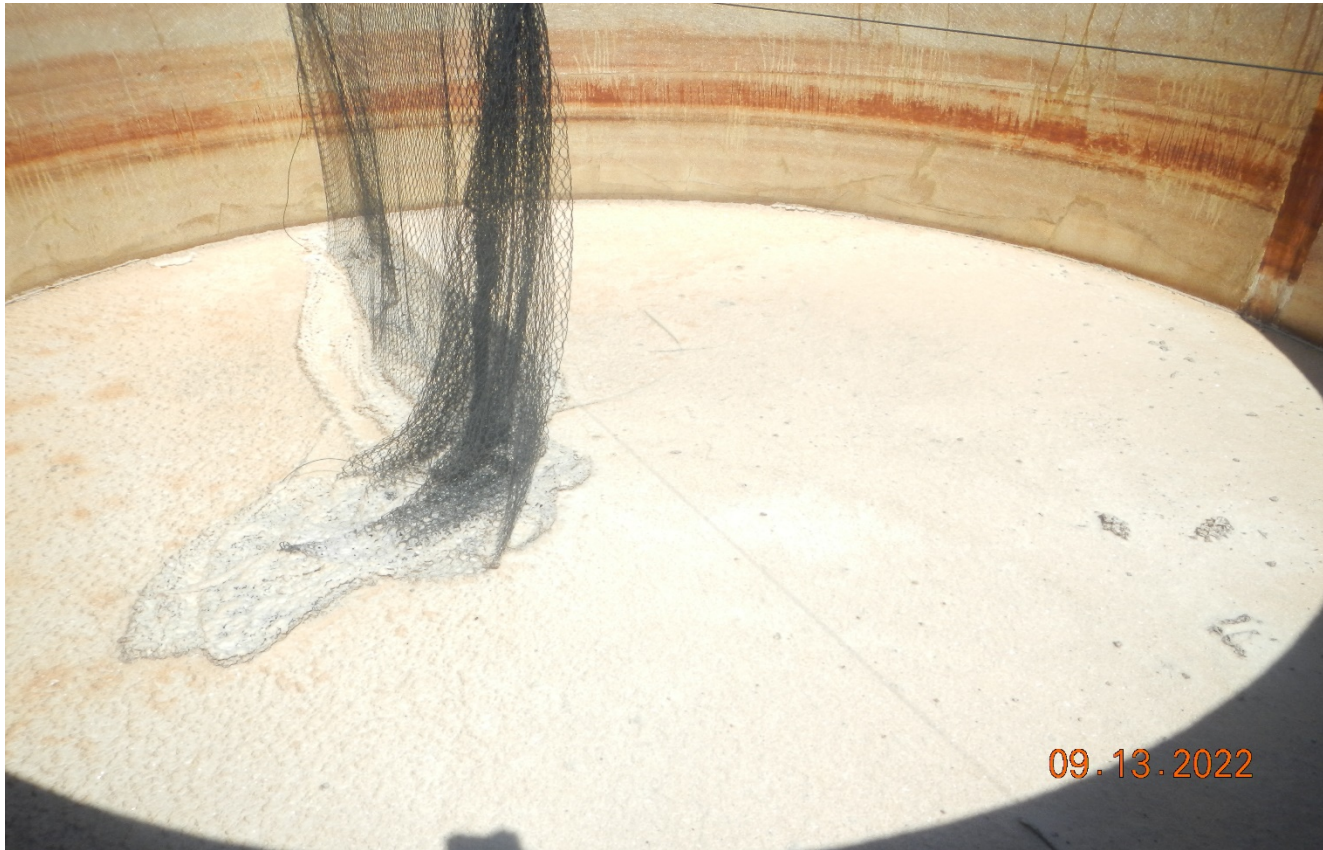
Photo 3. View of fluids inside the tank. Tank is labeled Produced Water. It appears to be solidified salty produced water. The netting on the tank is in disrepair. Previous corrective action not completed.

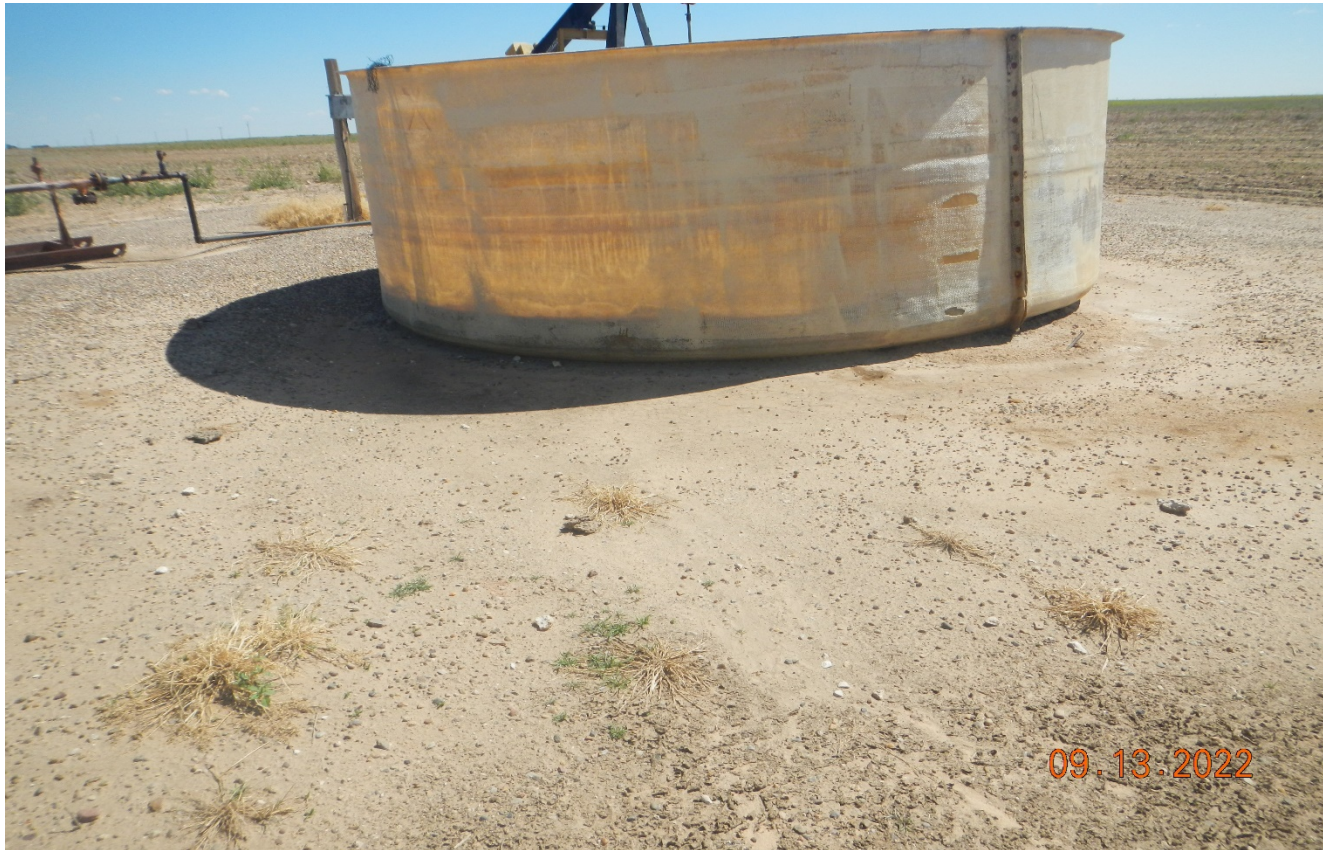
Photo 4. There appears to have been a leak at the tank due to stained soil in this area. If tank contains produced salty water, this can impact the soil and crop growth. Previous corrective action not completed.

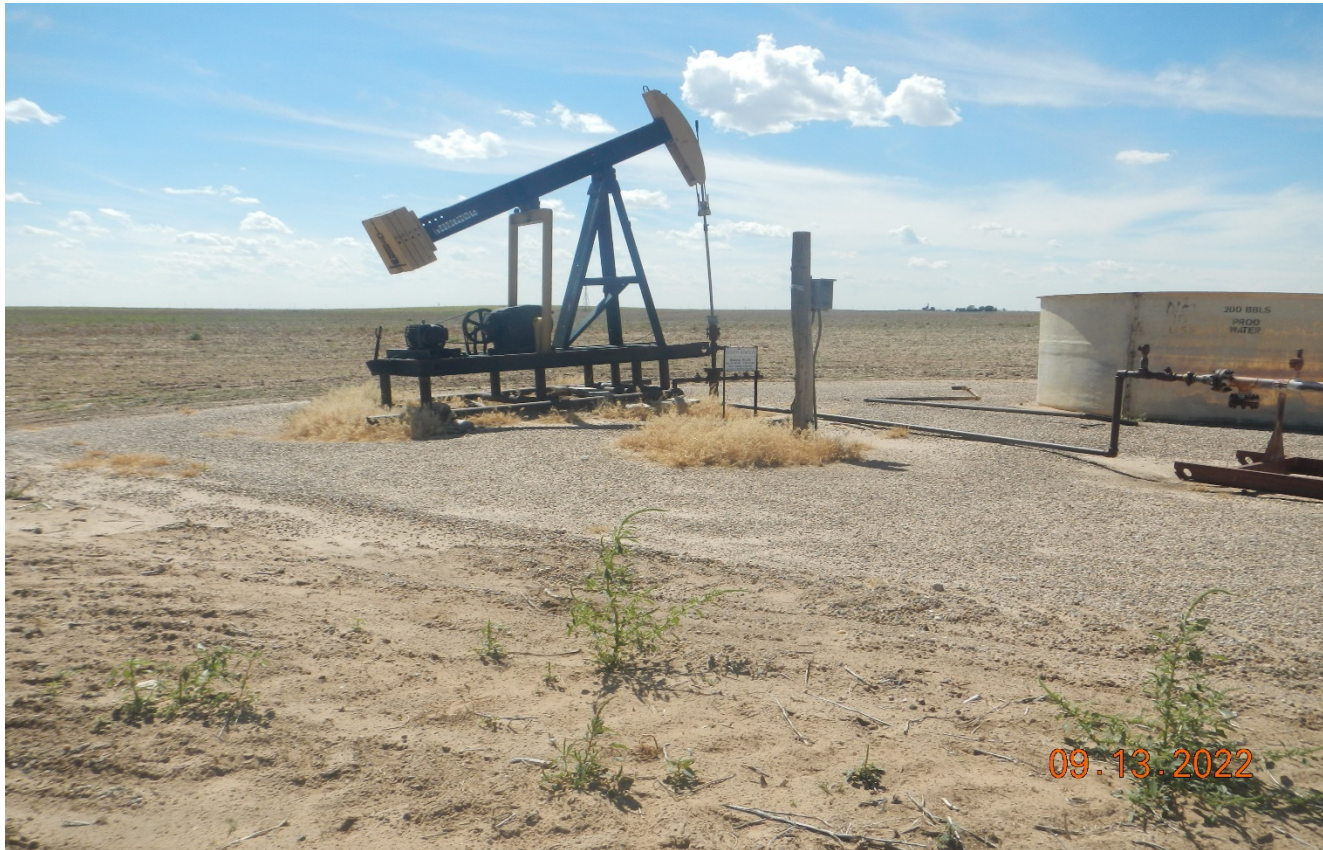
Photo 5. Well sign is posted at wellhead. Emergency contact number is not valid.
