Final Reclamation and Stormwater Inspection

Operator: AXIS EXPLORATION LLC - 10646

Location ID: 320193

Inspection Document #: 696105424

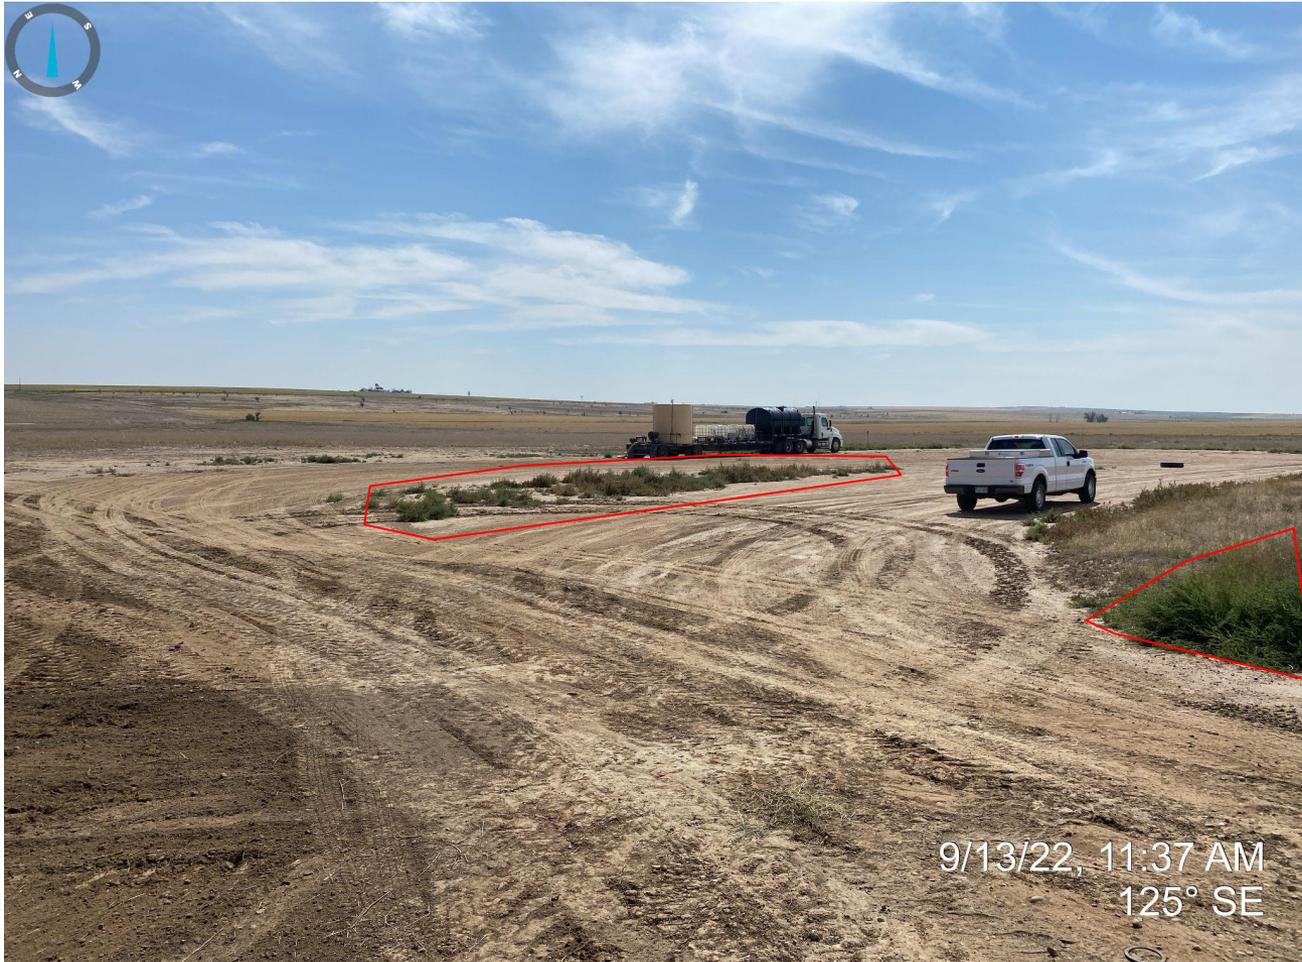
Photo 1. Tank battery location photo taken from northwest corner, facing southeast. Location has not been reclaimed; annual weedy vegetation observed and outlined in red (russian thistle).

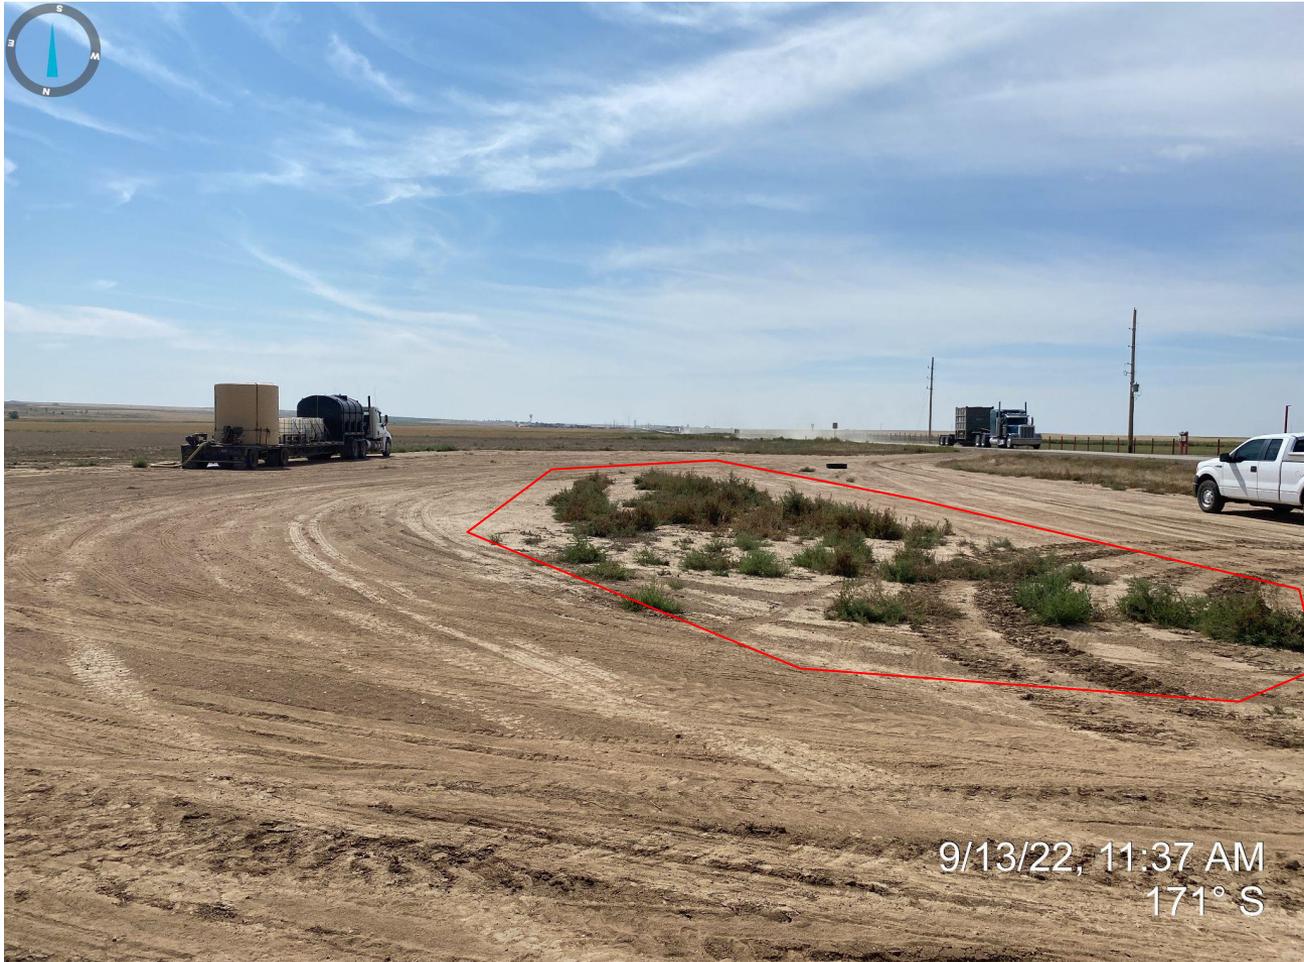
Photo 2. Facing south from northern portion of location, see comments in photo 1.

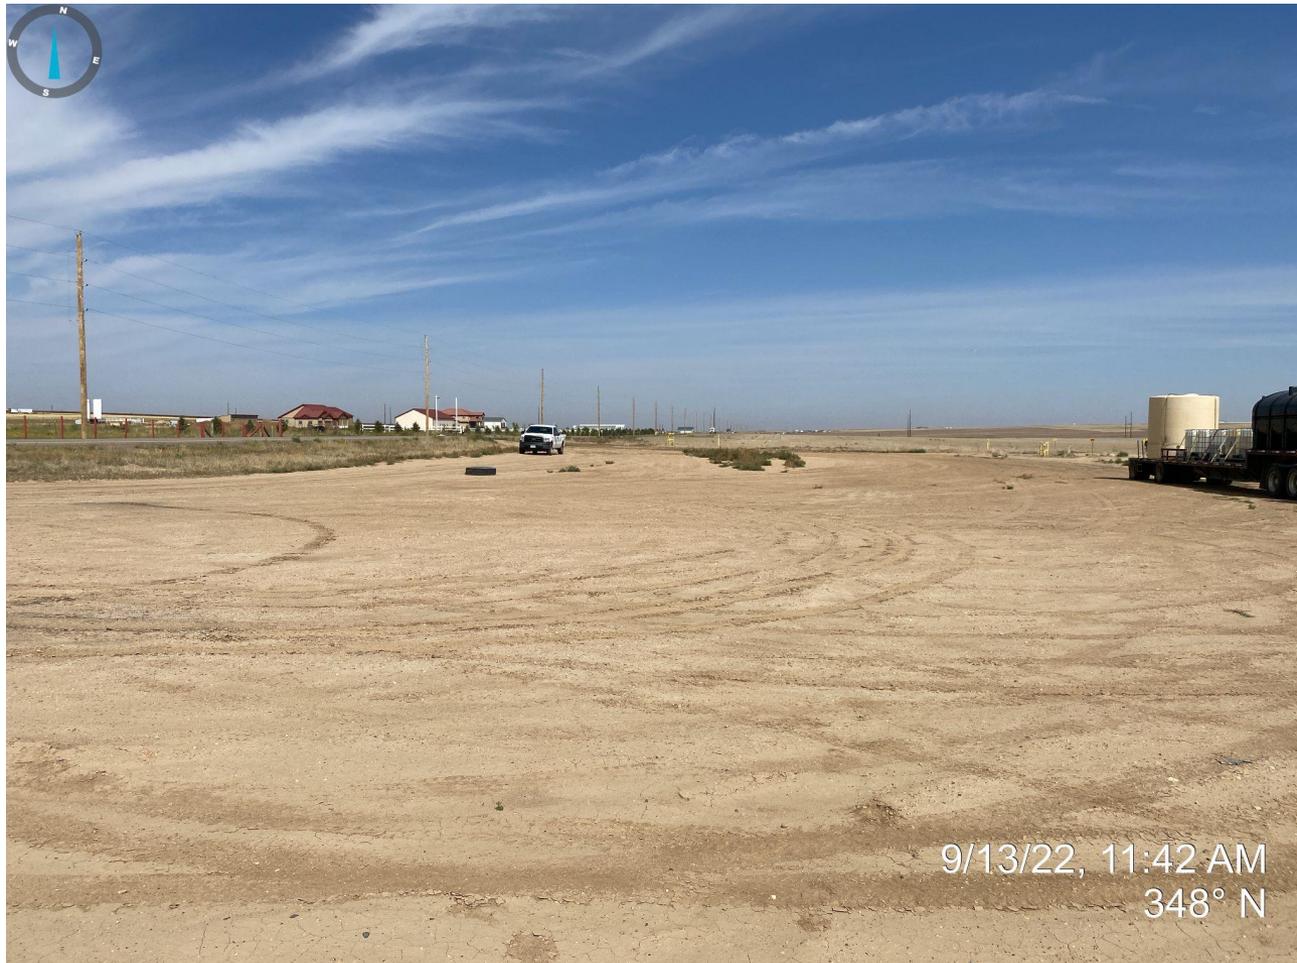
Photo 3. Facing north from southern portion of location, see comments in photo 1.

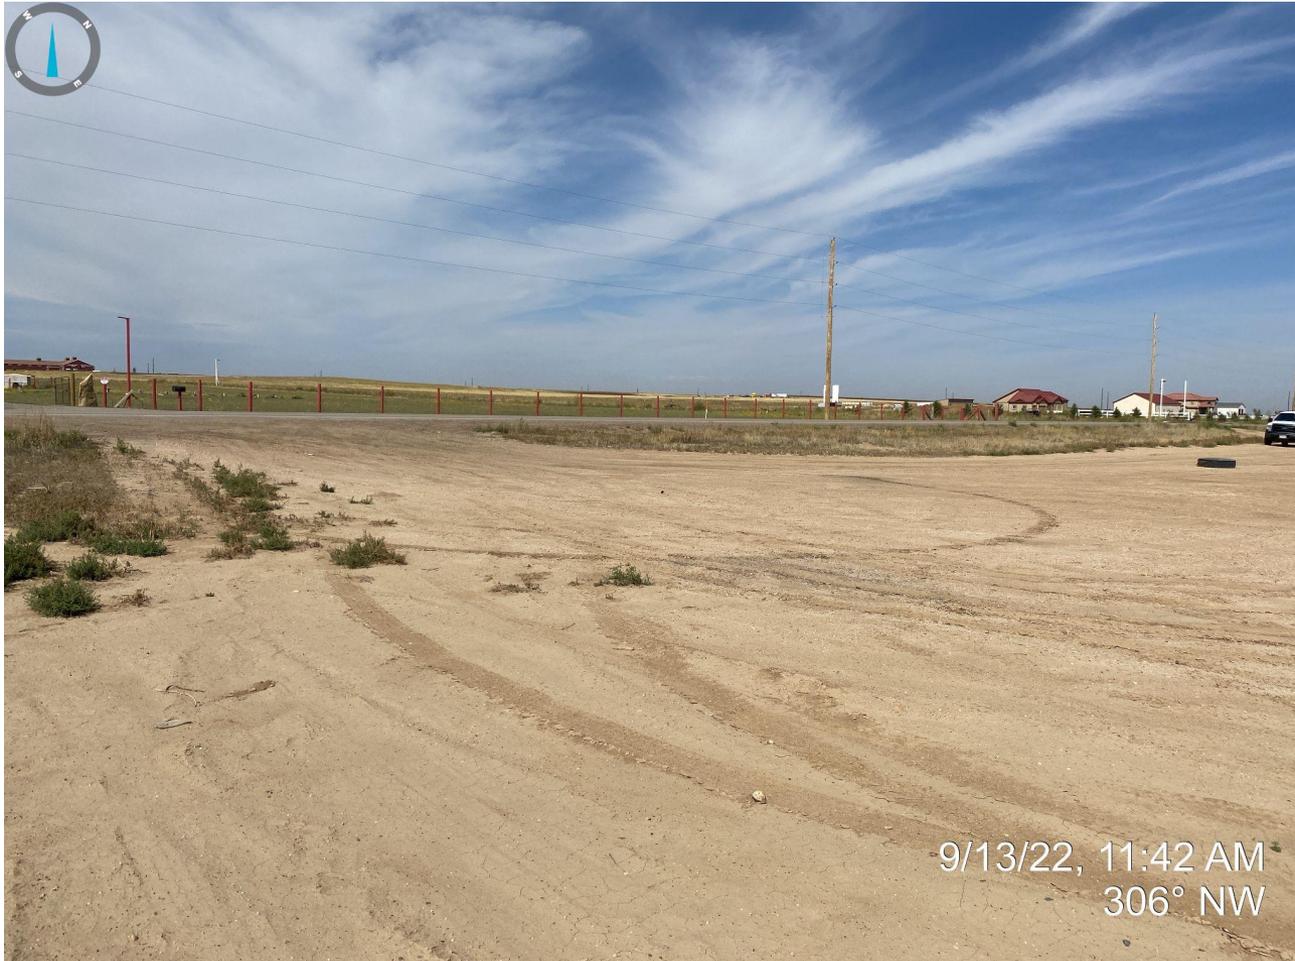
Photo 4. Facing northwest from southern portion of location, see comments in photo 1.

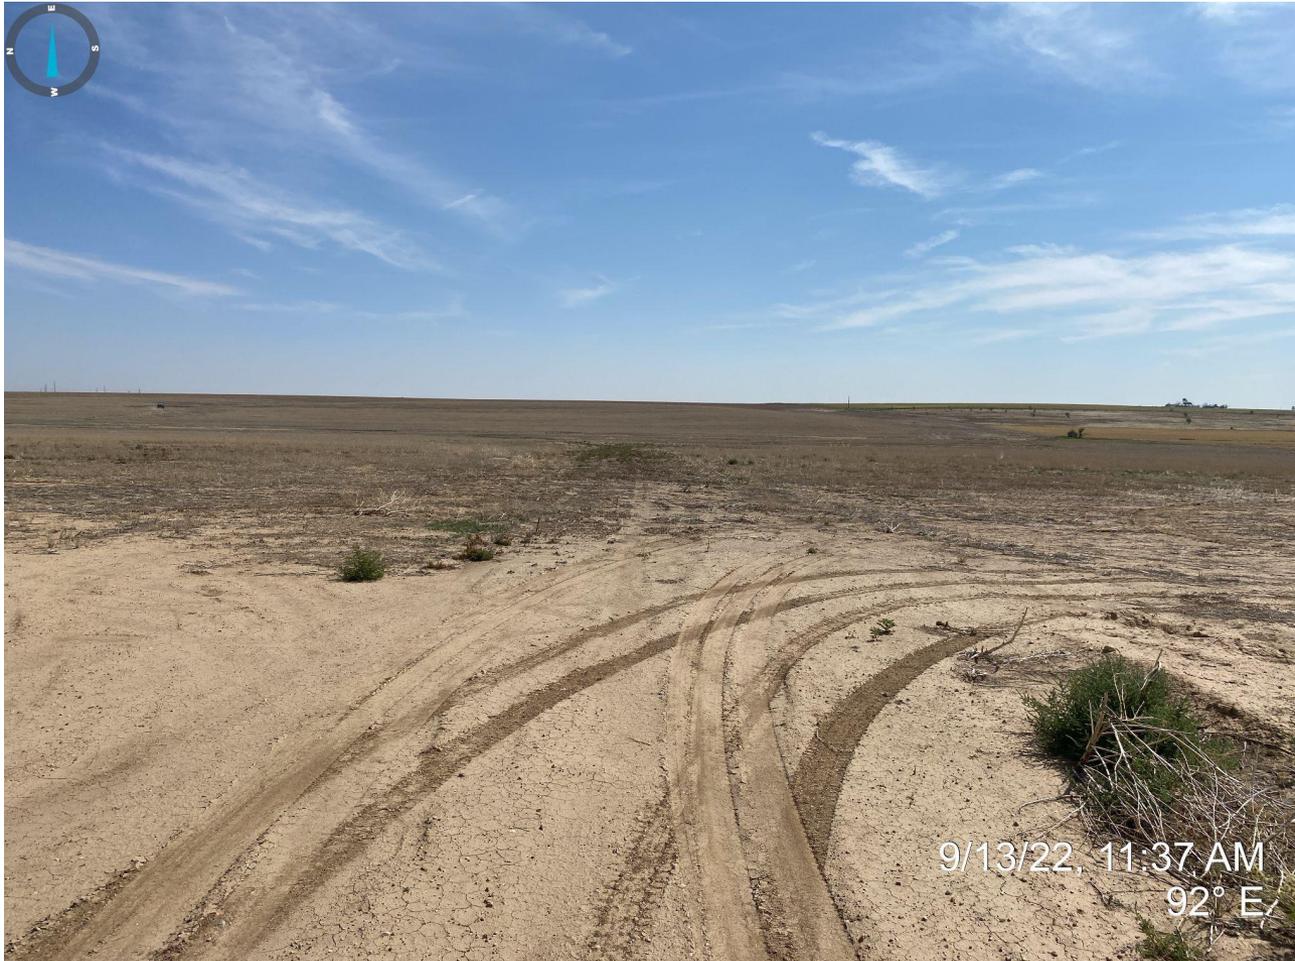
Photo 5. Photo taken from northern portion, facing east. Photo illustrates access road has not been reclaimed with presence of annual weedy vegetation (e.g. russian thistle, kochia, field bindweed) and non-uniform vegetation cover resulting in bare soil. Reference area is wheat stubble.

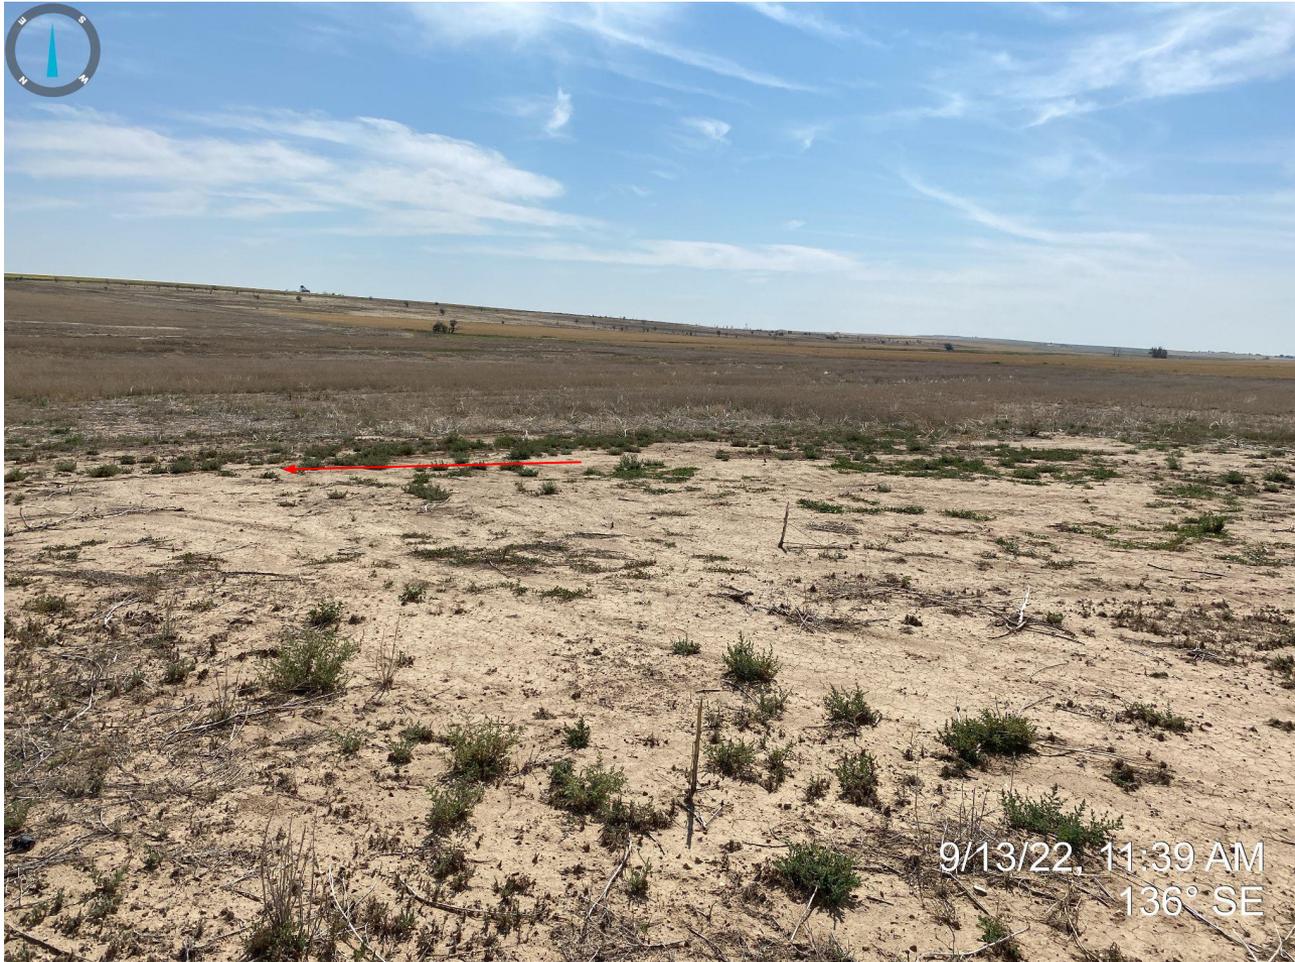
Photo 6. Well location photo taken from northern portion, facing southeast. Photo illustrates presence of annual weedy vegetation including kochia, russian thistle, and field bindweed (CO List C Noxious Weed). The eastern portion of the disturbance area drops off and is not recontoured, arrow in red.

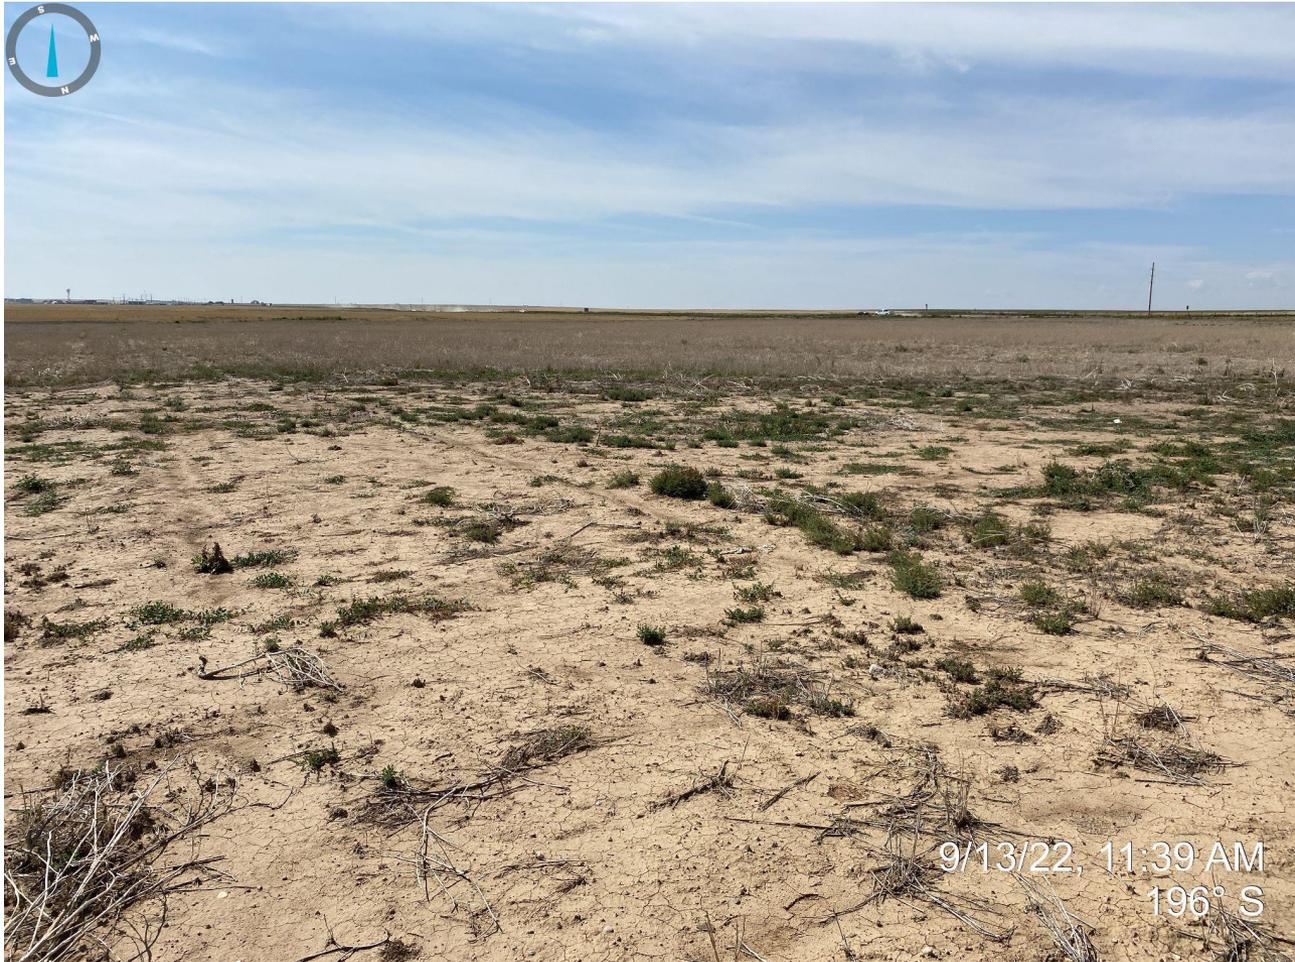
Photo 7. Facing south, see comments in photo 6.

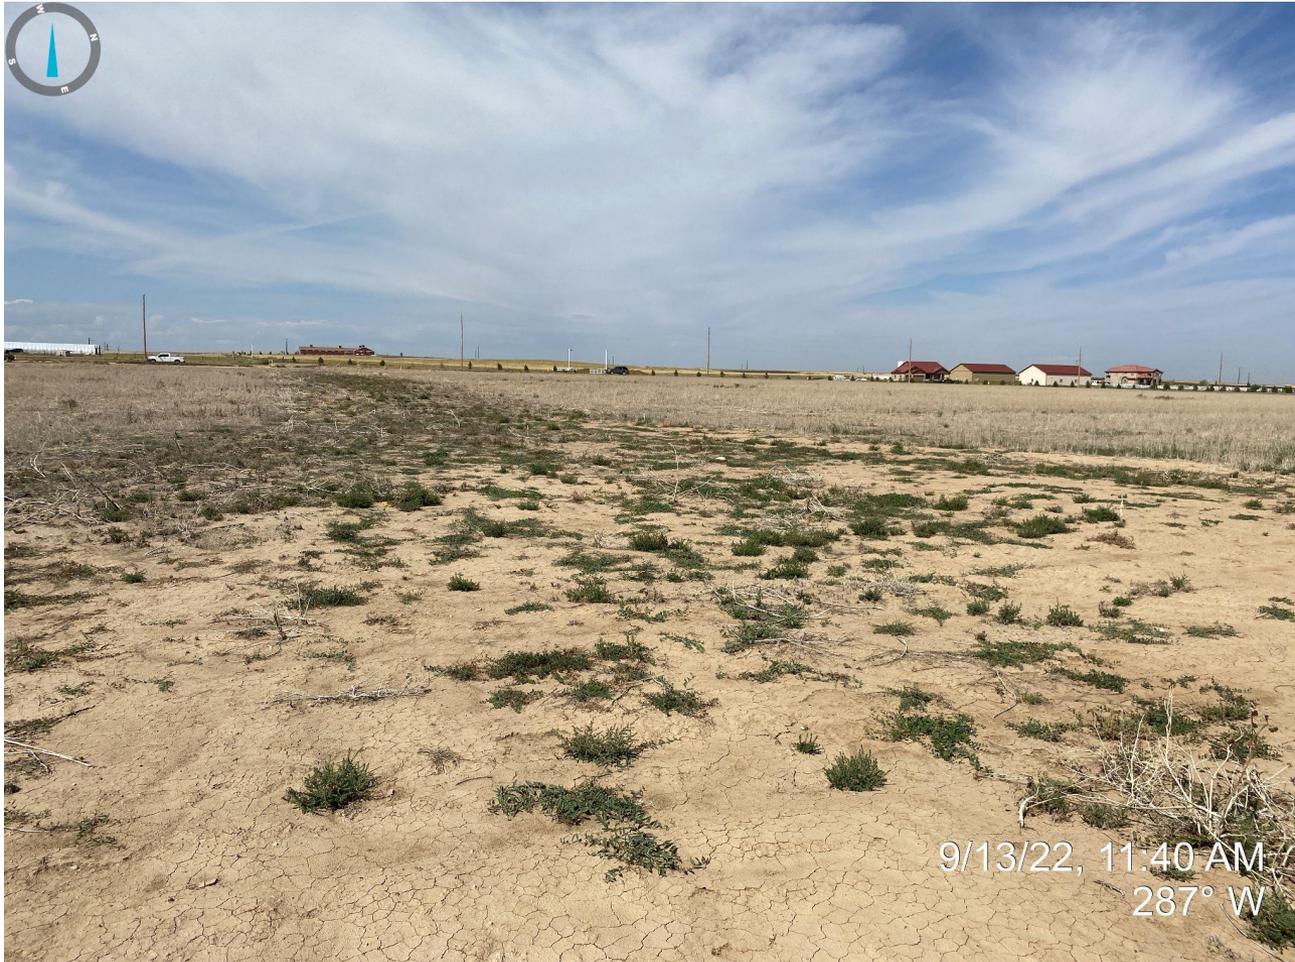
Photo 8. Facing west, see comments in photo 6.
