Inspection Photos

Location Name: TEP ROCKY MOUNTAIN LLC CHEVRON-66S96W /29NENW

Location ID: 335088

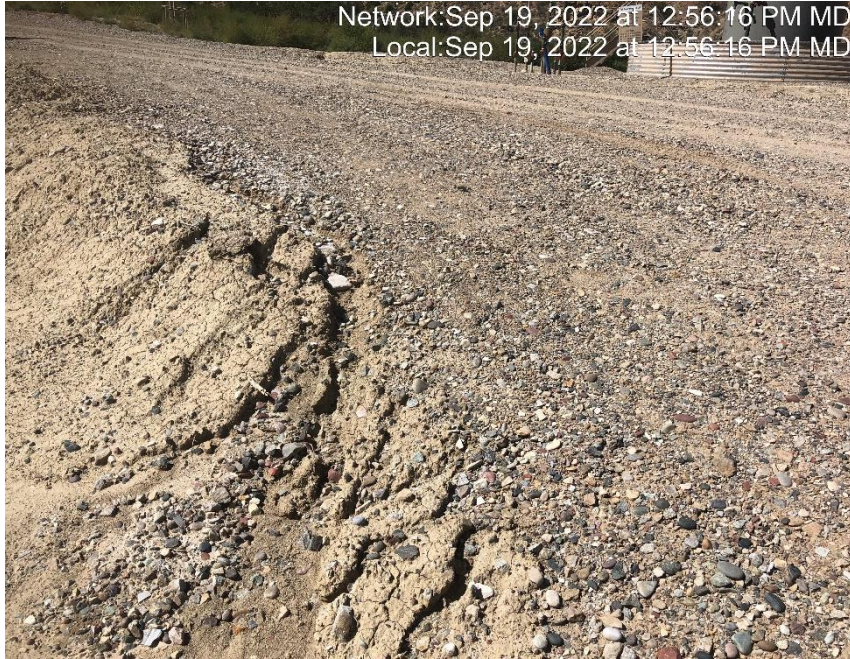
Photo #7713 Rill erosion.

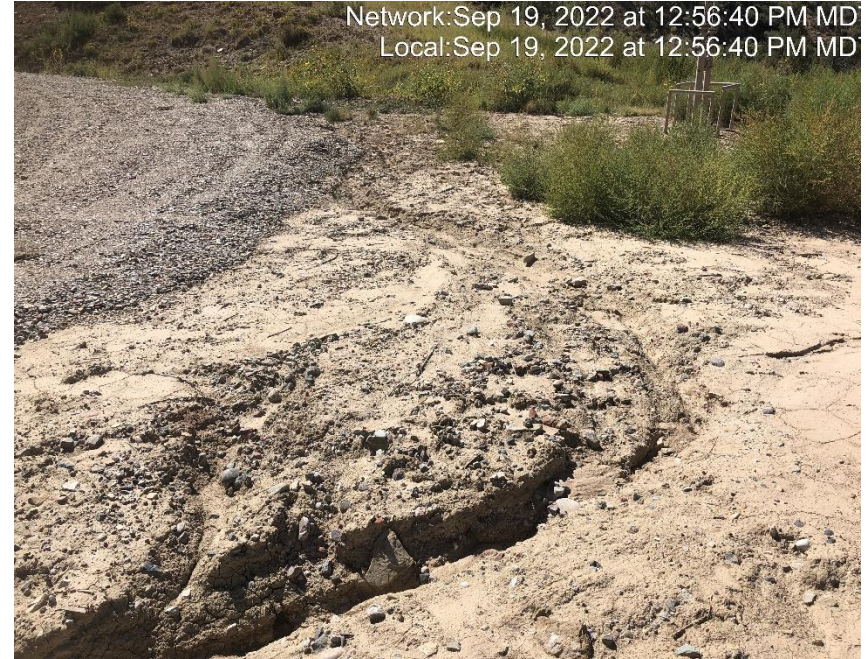
Photo #7714 Rill erosion.

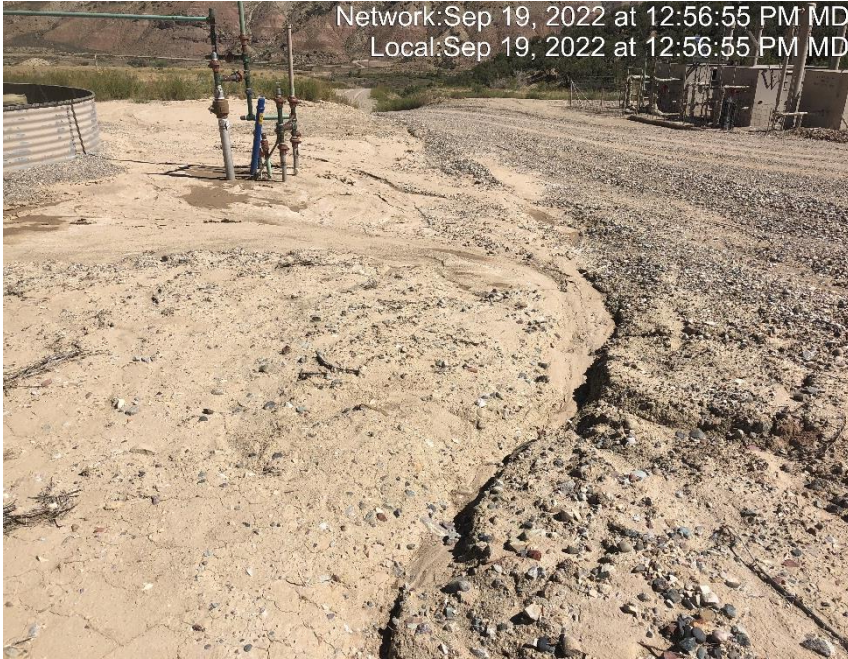
Photo #7715 Run on to location is not being controlled.

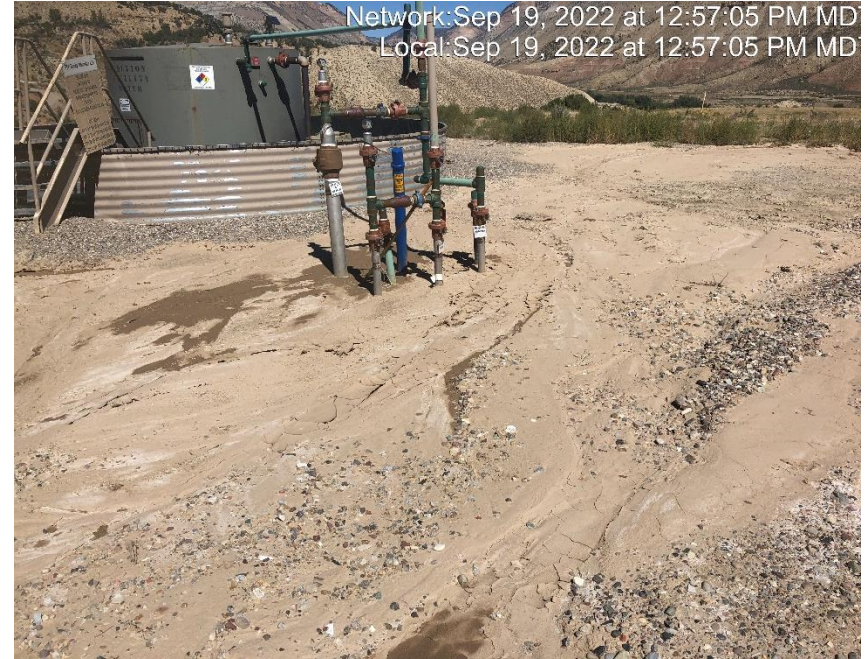
Photo #7716 Sediment is encroaching on equipment.

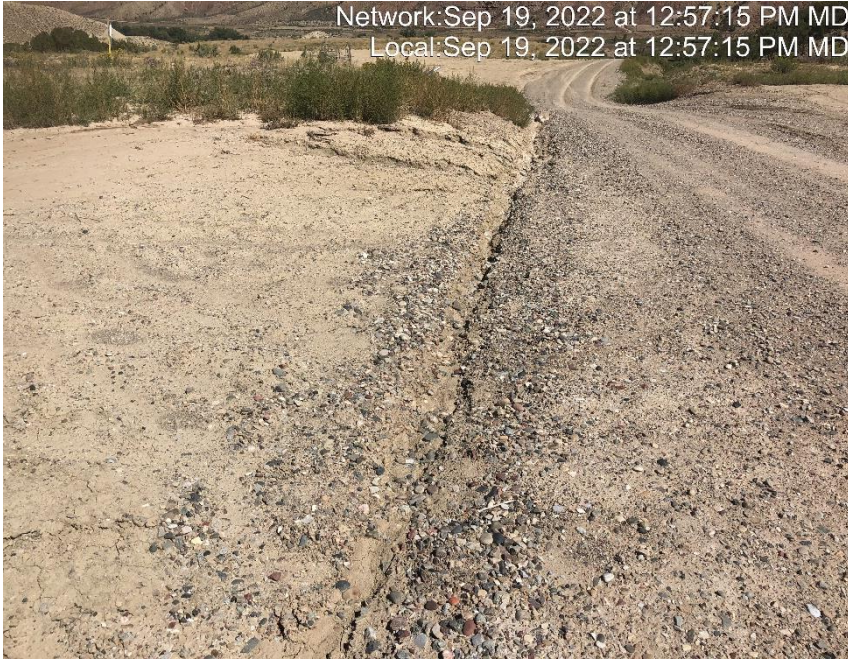
Photo #7717 Rill erosion.

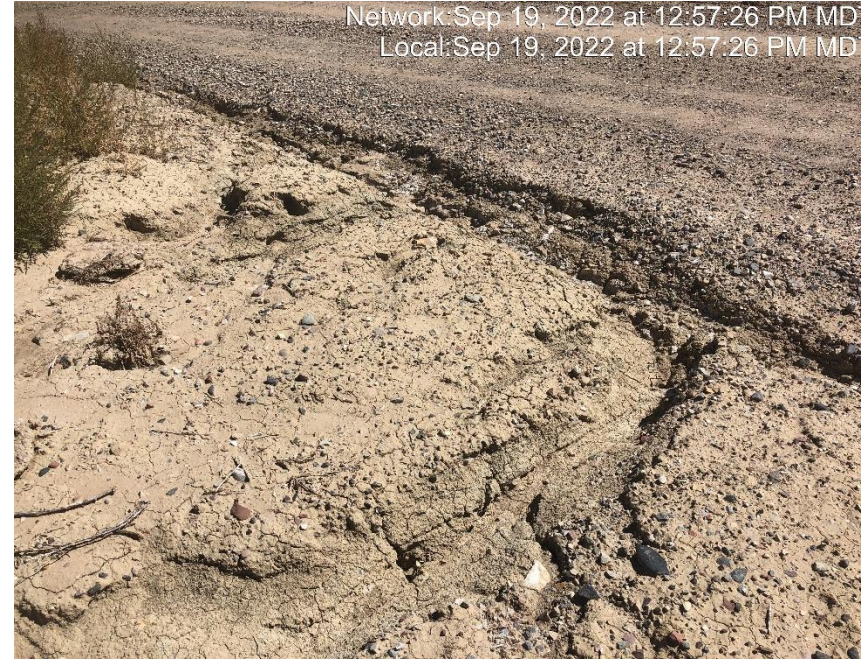
Photo #7718 Rill erosion.

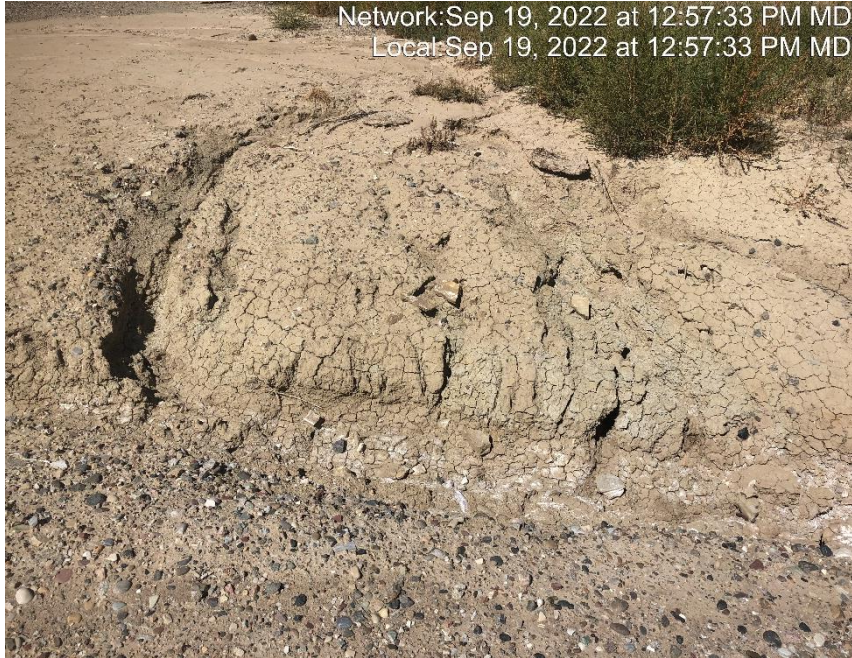
Photo #7719 Rill erosion.
