#1 - Phelps 11-32CHZ AST Release Site

Photo Log

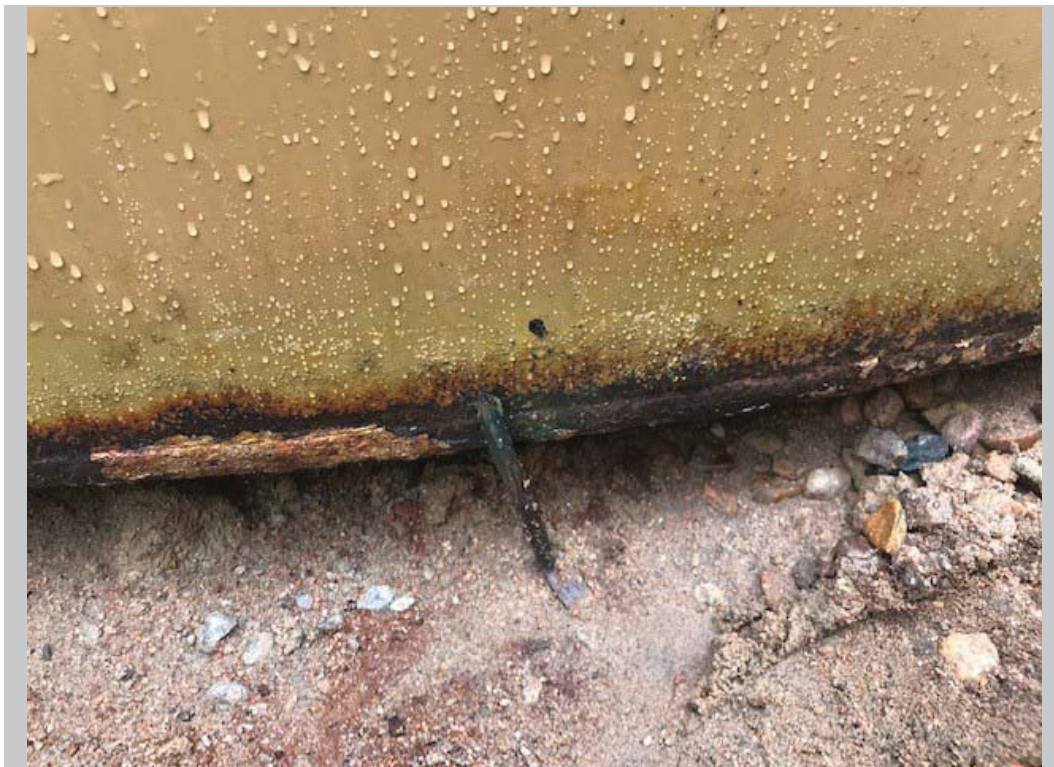
#2 - A Pinhole Failure in the AST Shell Caused the Release

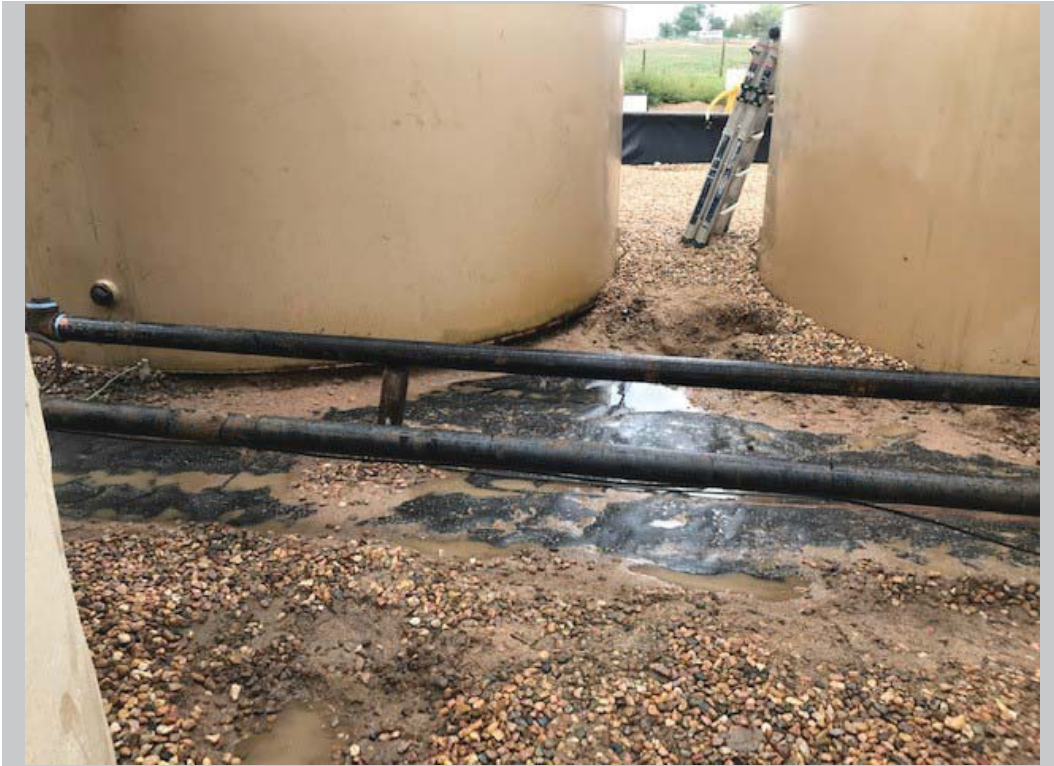
#3 - Looking North at AST that Failed. Note Synthetic Liner Beneath ASTs.

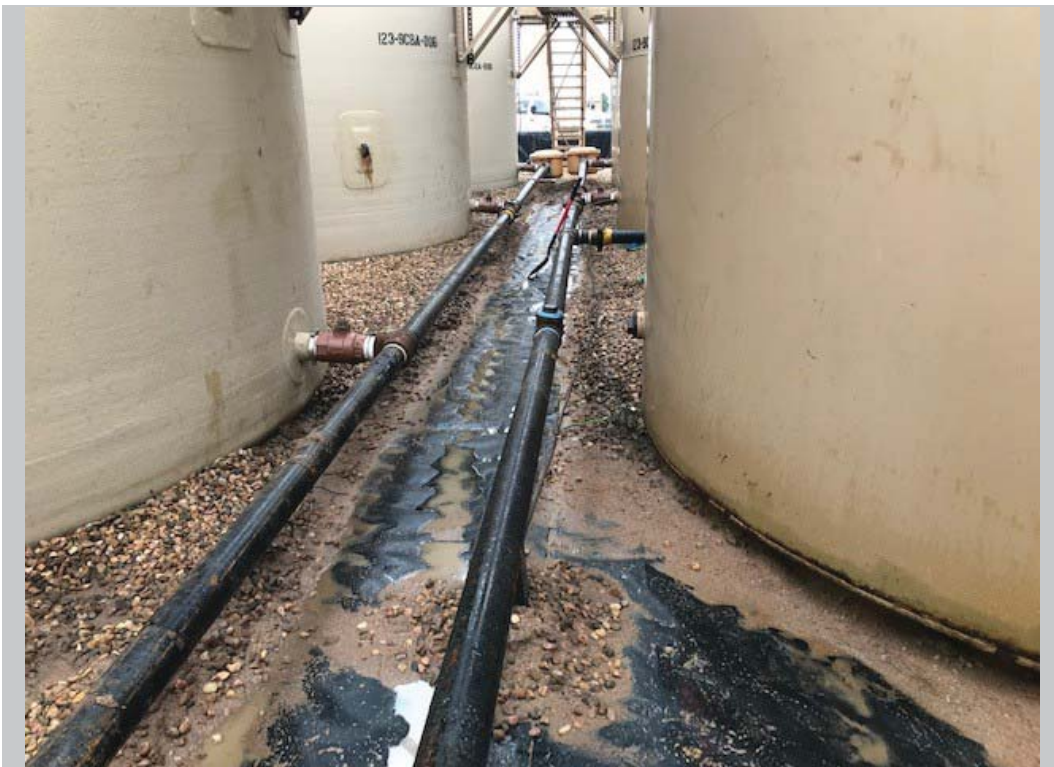
#4 - Looking West at AST that Failed. Impacted Soil has been removed above the liner and partially beneath the AST.

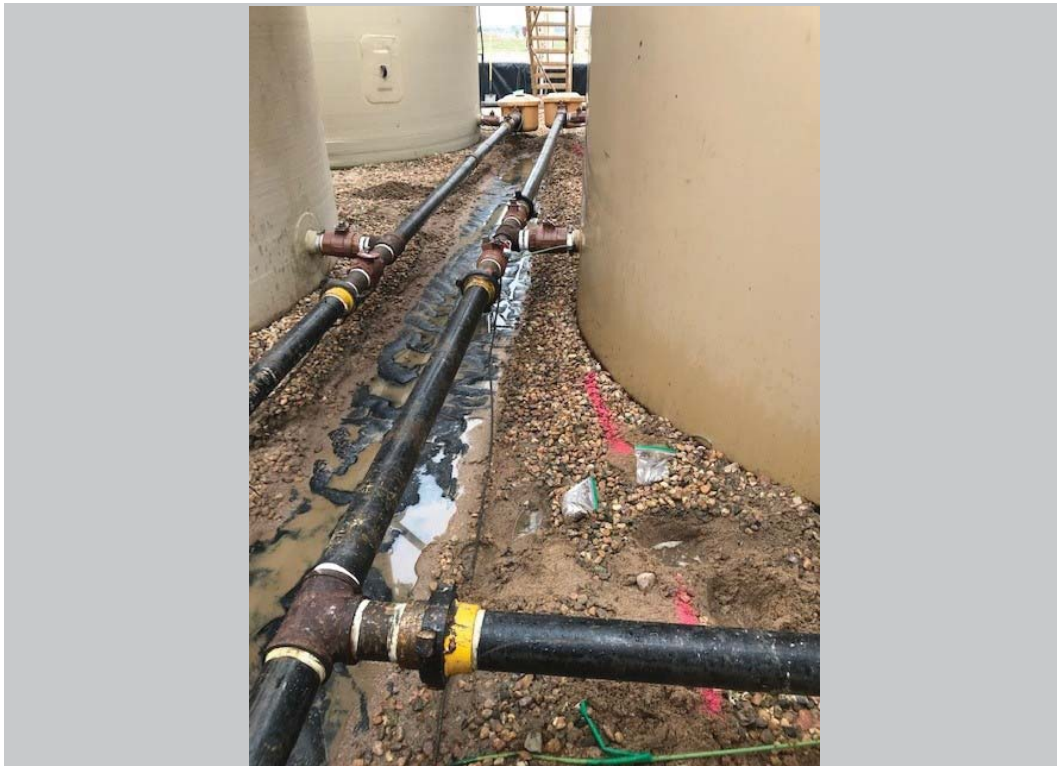
#5 - Looking West at Impacted Area. Pink Line Represents Further Excavation Required.
