# Inspection Photos and Issue Report

Operator: CAERUS PICEANCE LLC - 10456

Location #448472

Garfield County, CO

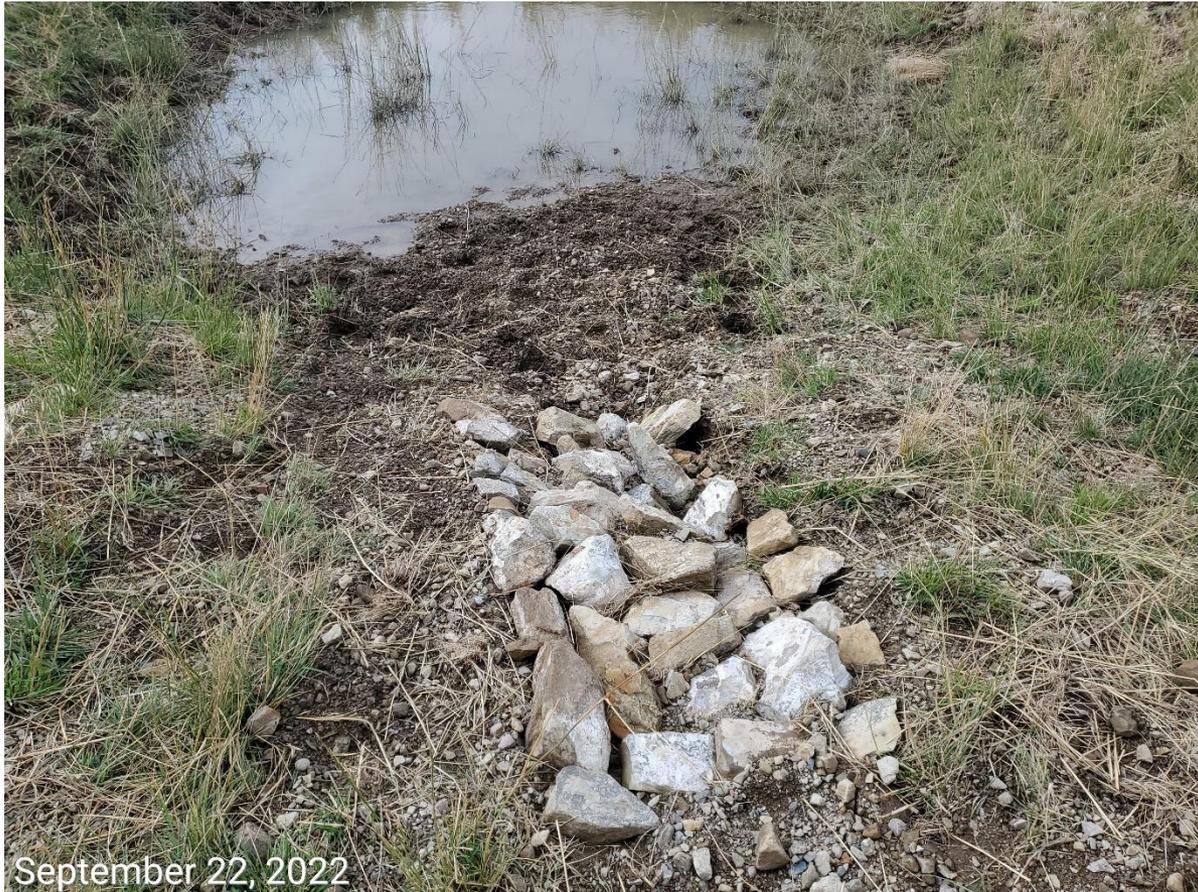
**Photo 1:** Photo taken from the sediment trap on the southwest end of the Location. Photo shows Operator repaired the gully erosion and installed rock (rip-rap) to armor the inlet.

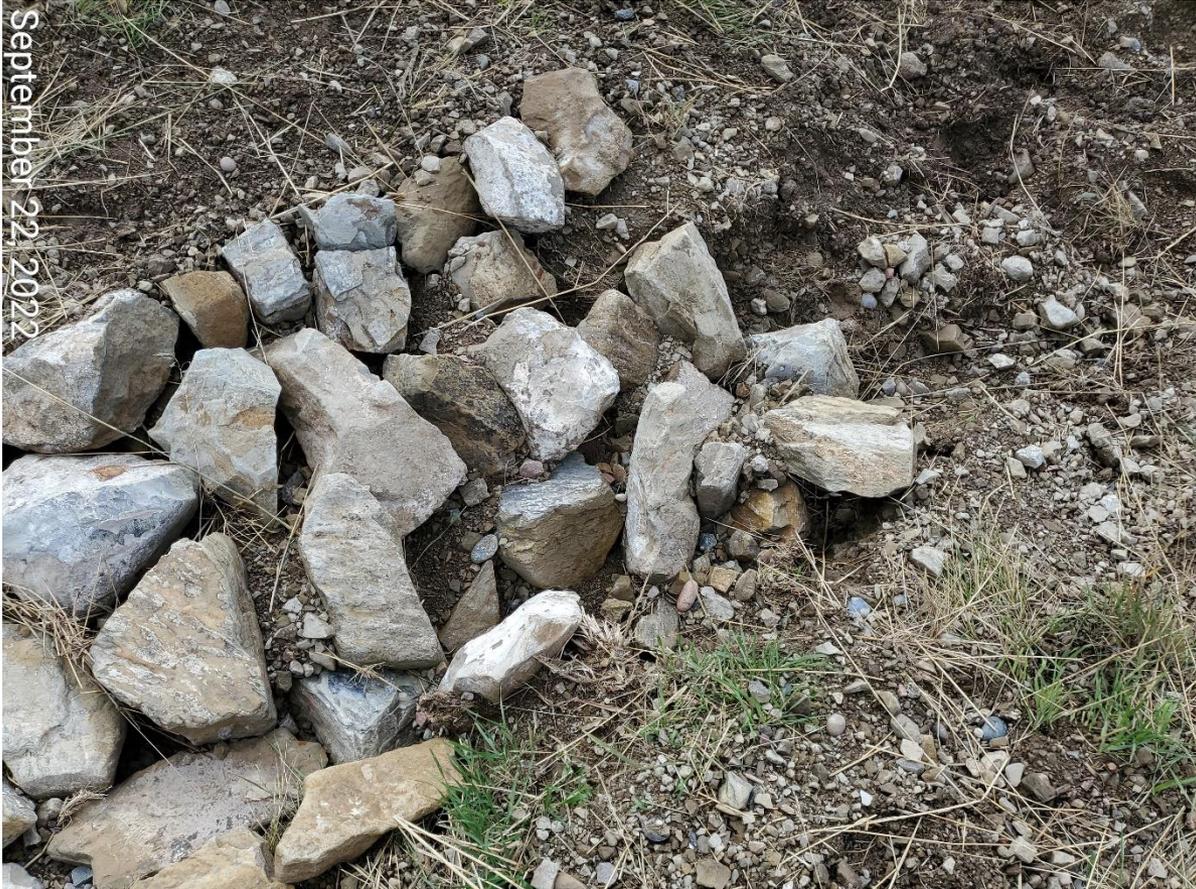
**Photo 2:** Continue from photo 1. Photo shows Operator installed rock (rip-rap) to armor inlet, however, geotextile lining has not been used as part of the armoring in accordance with good engineering practices, resulting in recurring stormwater degradation beneath and around the rip-rap material.

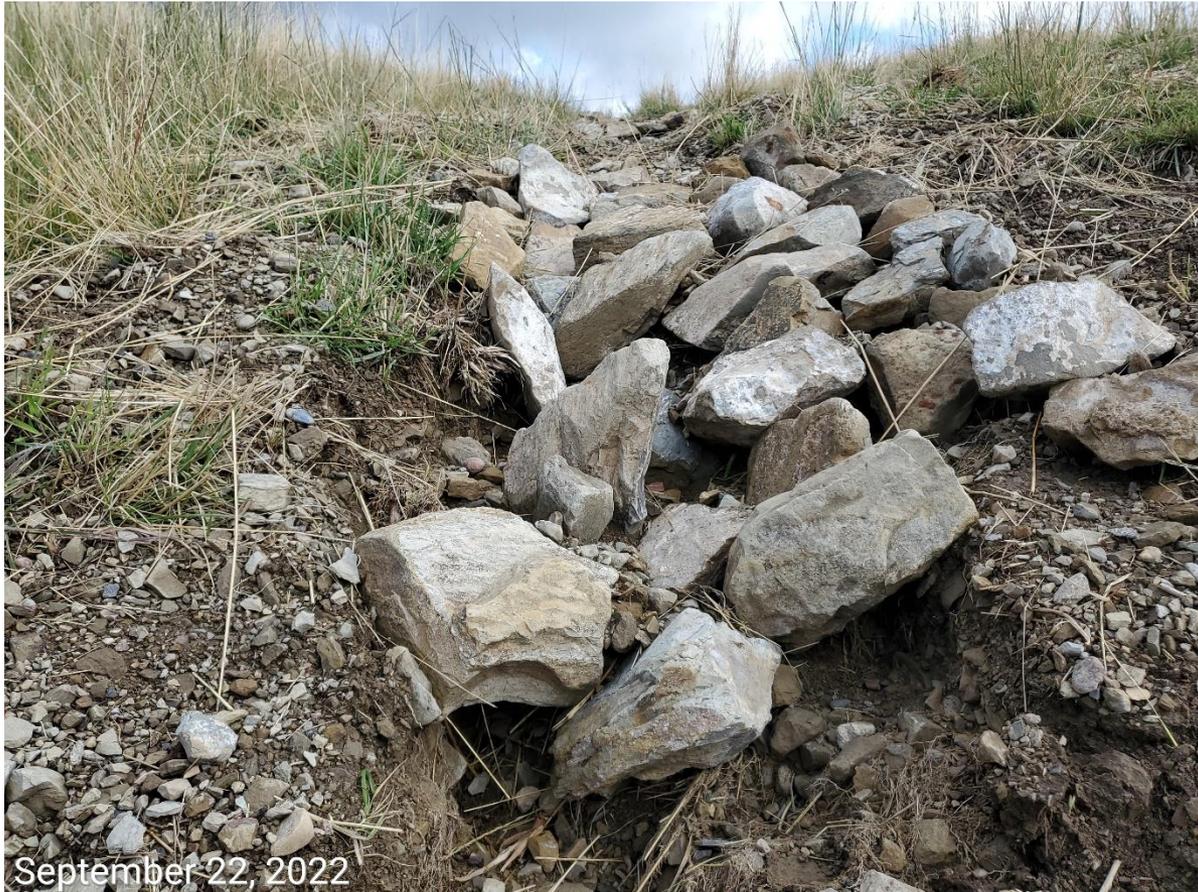
**Photo 3:** Continue from photo 2. Photo shows Operator installed rock (rip-rap) to armor inlet, however, geotextile lining has not been used as part of the armoring in accordance with good engineering practices, resulting in recurring stormwater degradation beneath and around the rip-rap material.

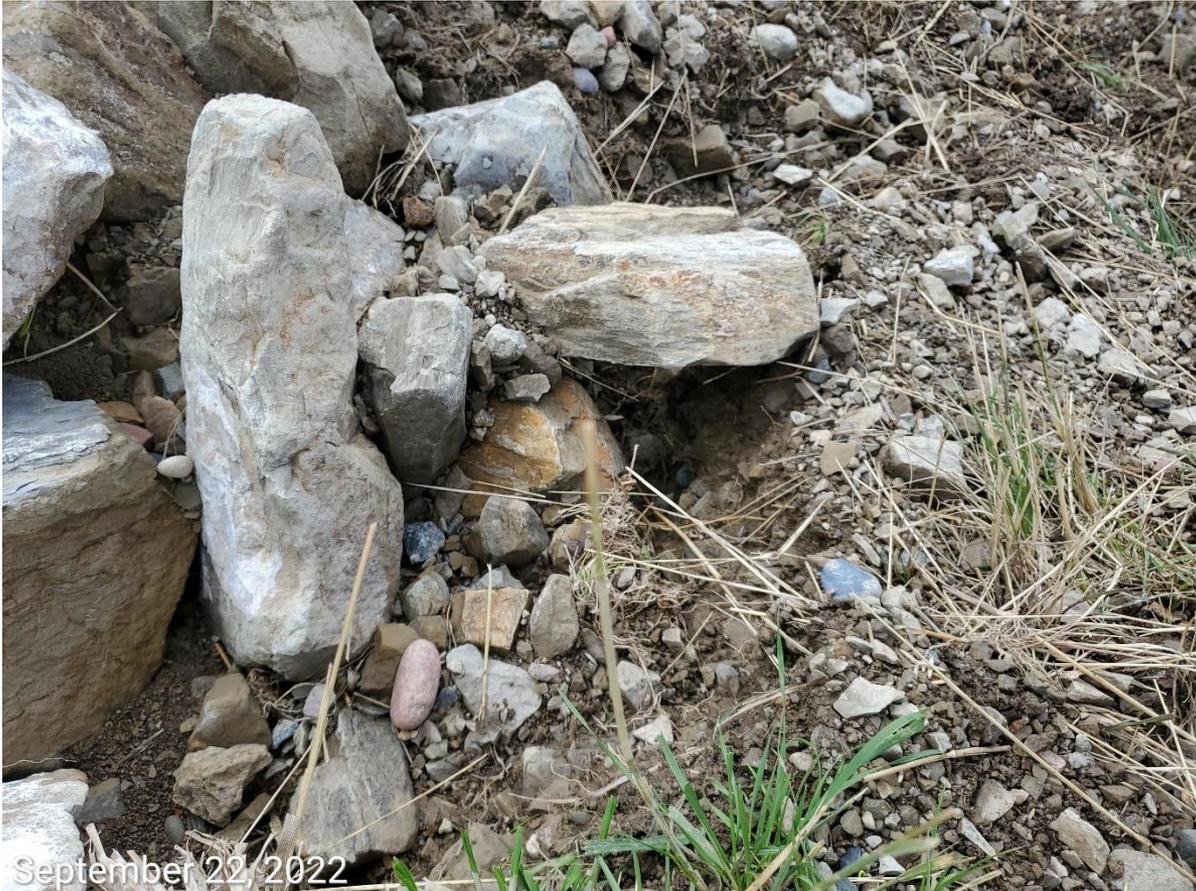
**Photo 4:** Continue from photo 3. Photo shows Operator installed rock (rip-rap) to armor inlet, however, geotextile lining has not been used as part of the armoring in accordance with good engineering practices, resulting in recurring stormwater degradation beneath and around the rip-rap material.

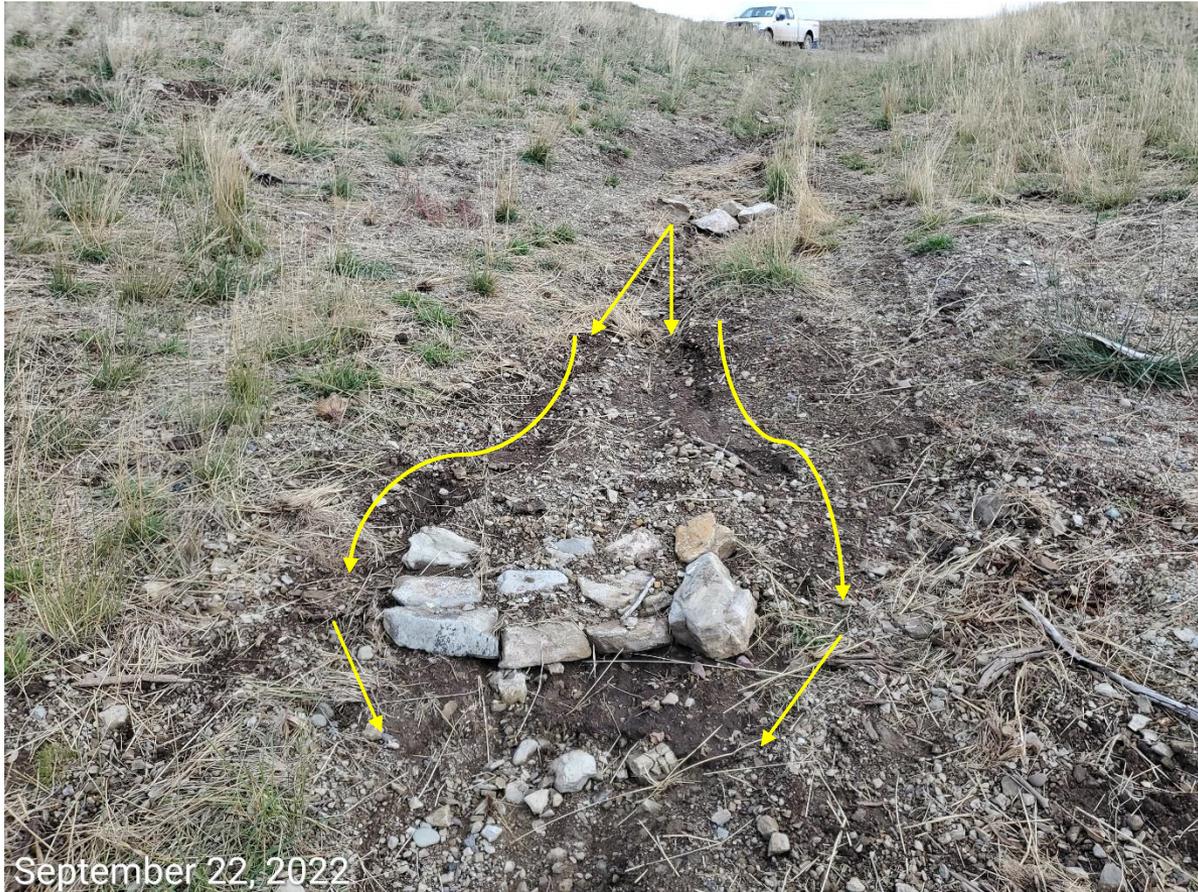
**Photo 5:** Photo shows rock-checks installed along ditch leading from the southwest end of the Location, leading to the sediment trap observed in photo 1. Rock-checks appear to be inadequate and not per good engineering. Arrows show stormwater appears to be traveling around the checks resulting in further degradation.

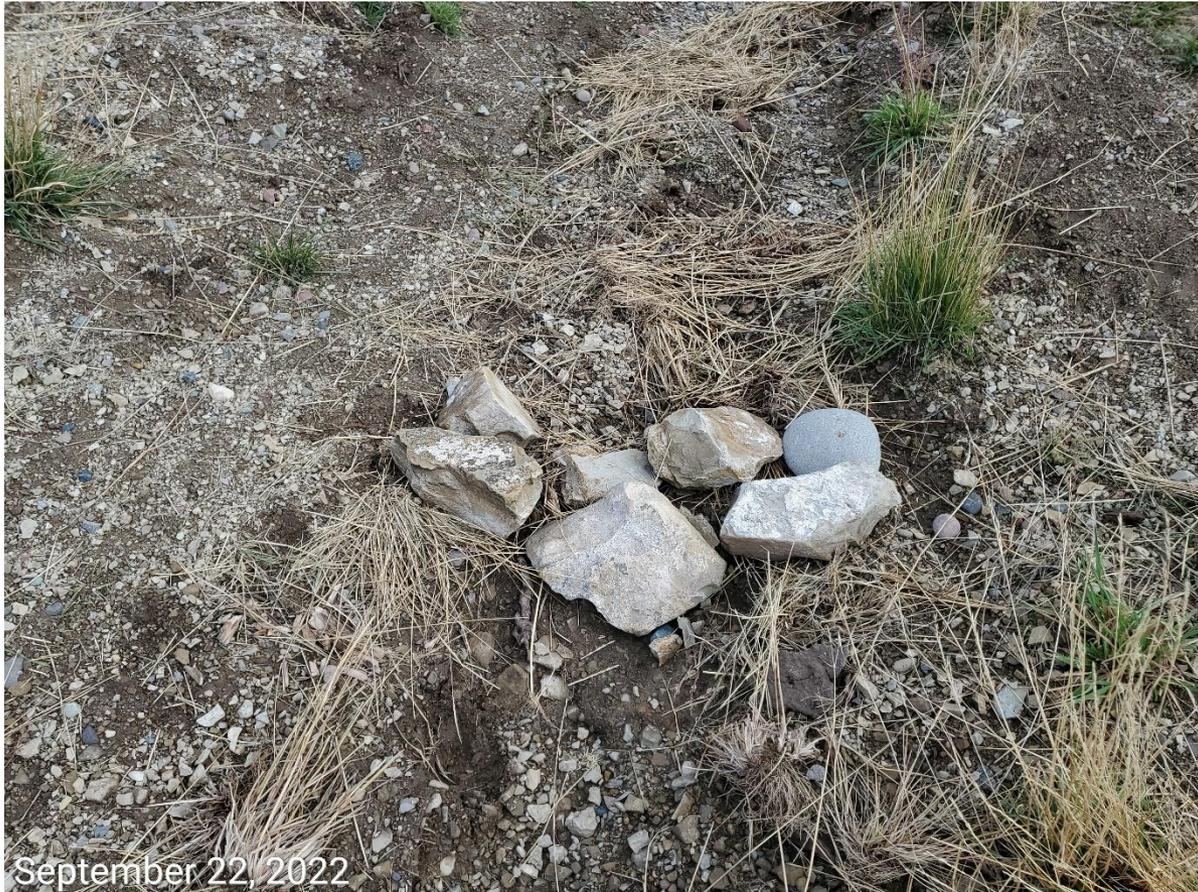
**Photo 6:** Photo shows example of rock-checks within ditch. BMP is not per good engineering practices and will facilitate degradation within the diversion ditch.

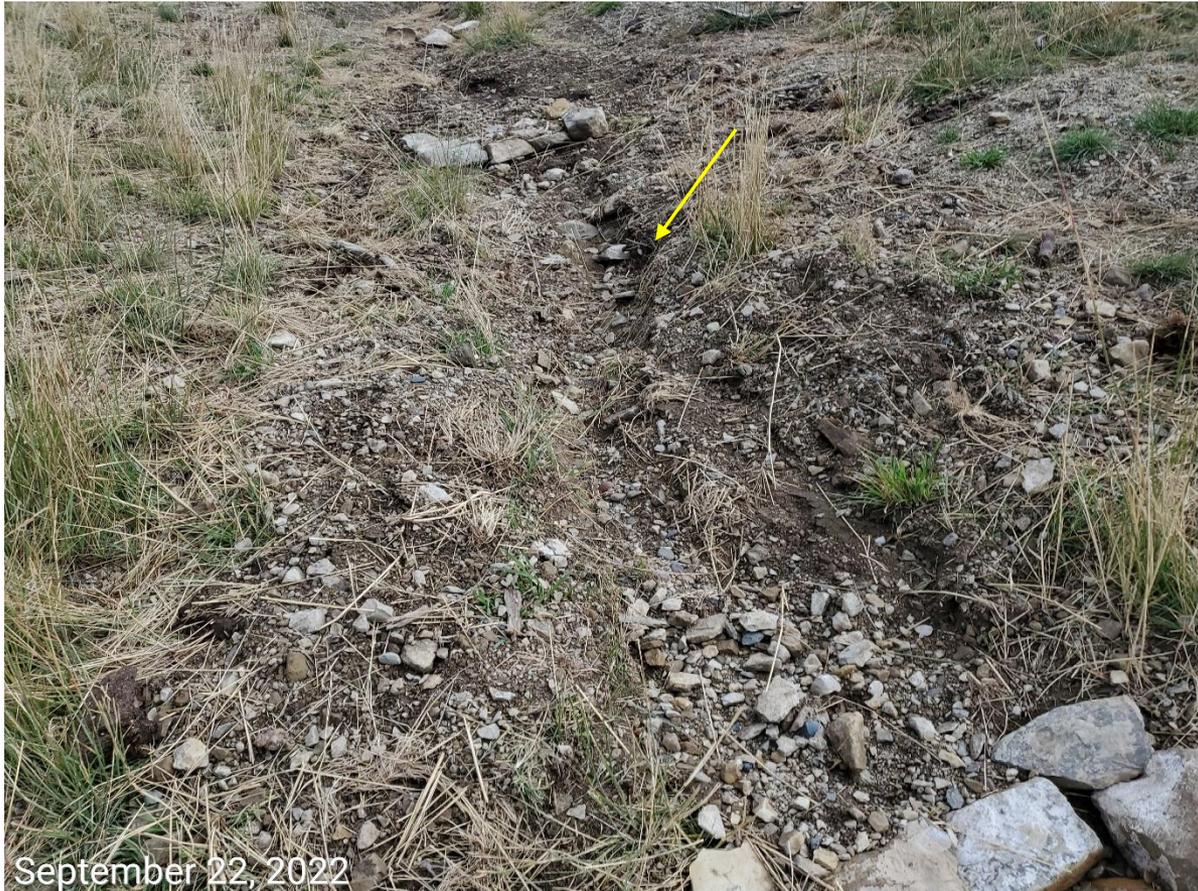
**Photo 7:** Photo example showing recurring stormwater erosion within the ditch.

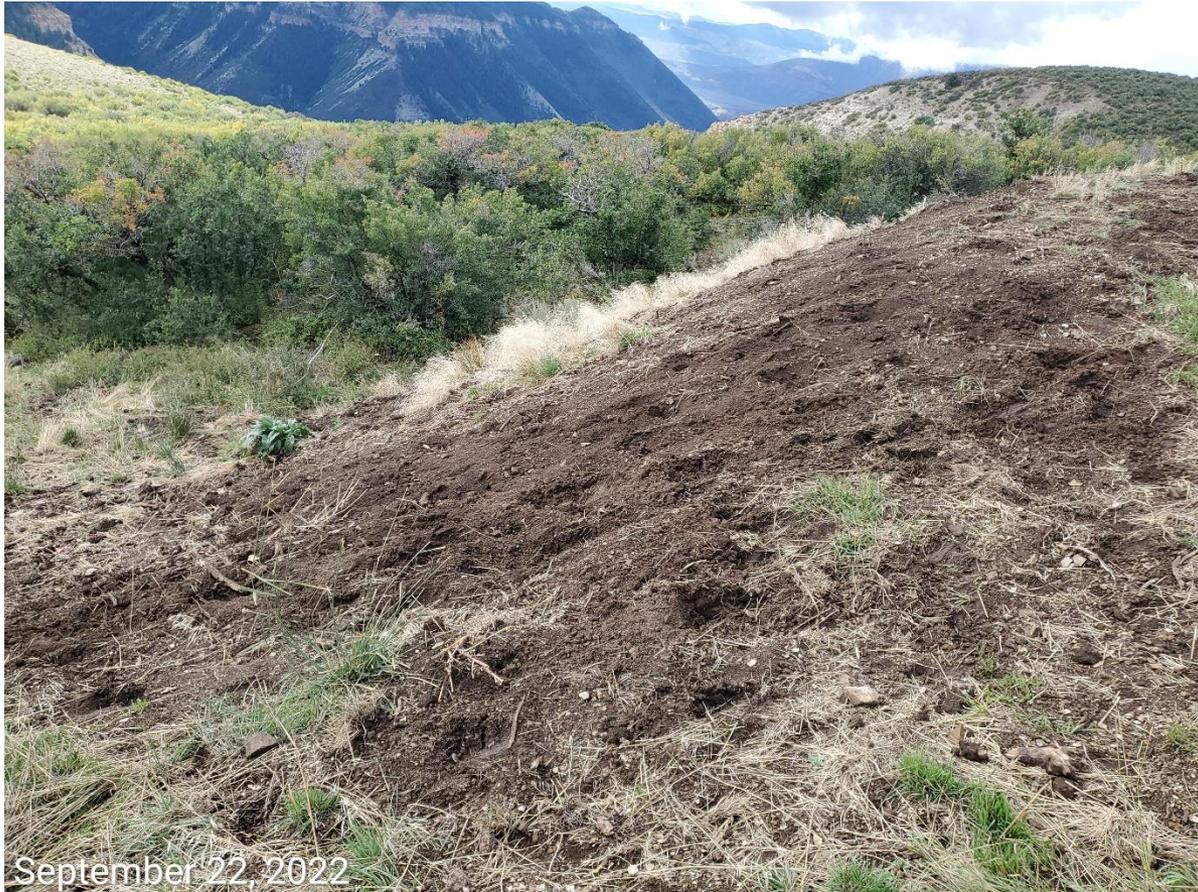
**Photo 8:** Photo taken from the southern slope of the southwester sediment trap. Photo shows work to repair the erosion degradation has been conducted, however soils have been left exposed and at risk to erosion; BMPs to stabilize soils until long term stabilization is achieved have not been installed.

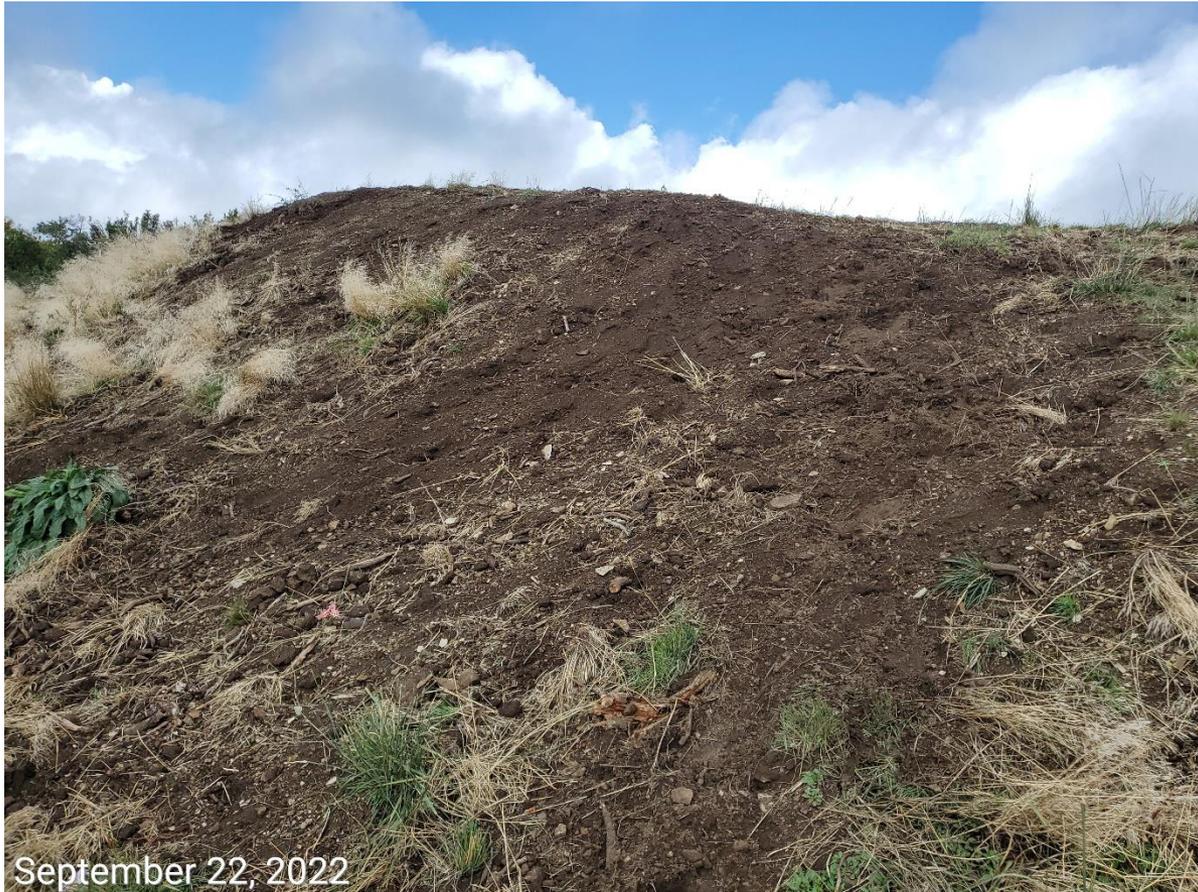
**Photo 9:** Photo taken from the southern slope of the southwest sediment trap. Photo shows work to repair the erosion degradation has been conducted, however soils have been left exposed and at risk to erosion; BMPs to stabilize soils until long term stabilization is achieved have not been installed.
