Inspection Photos

API: 071-07915

Operator: WAPITI OPERATING LLC

Inspection Date: 9/23/2022

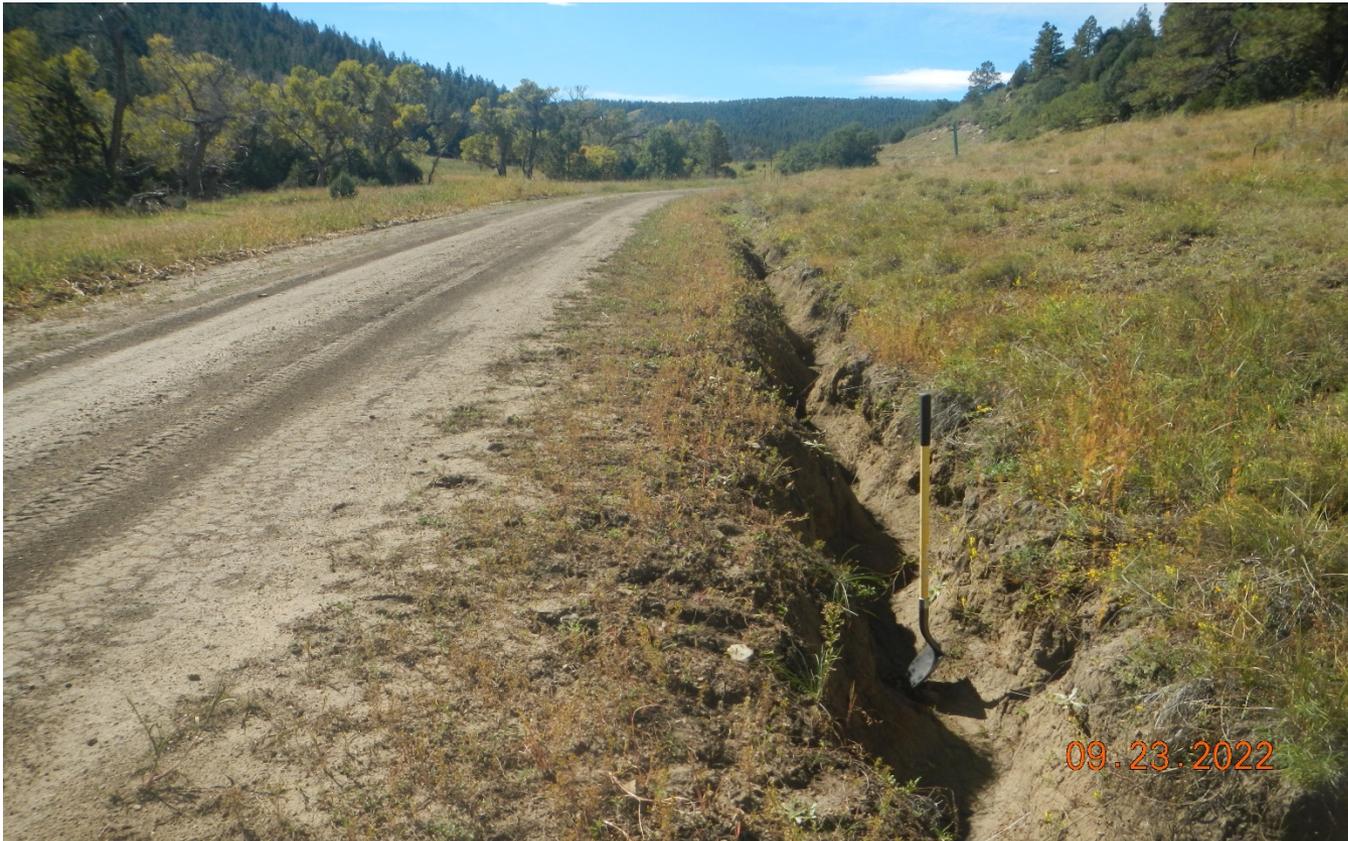
Photo 1. Facing south along the main road. There is erosion occurring along the road side. BMP's need to be installed to prevent erosion.

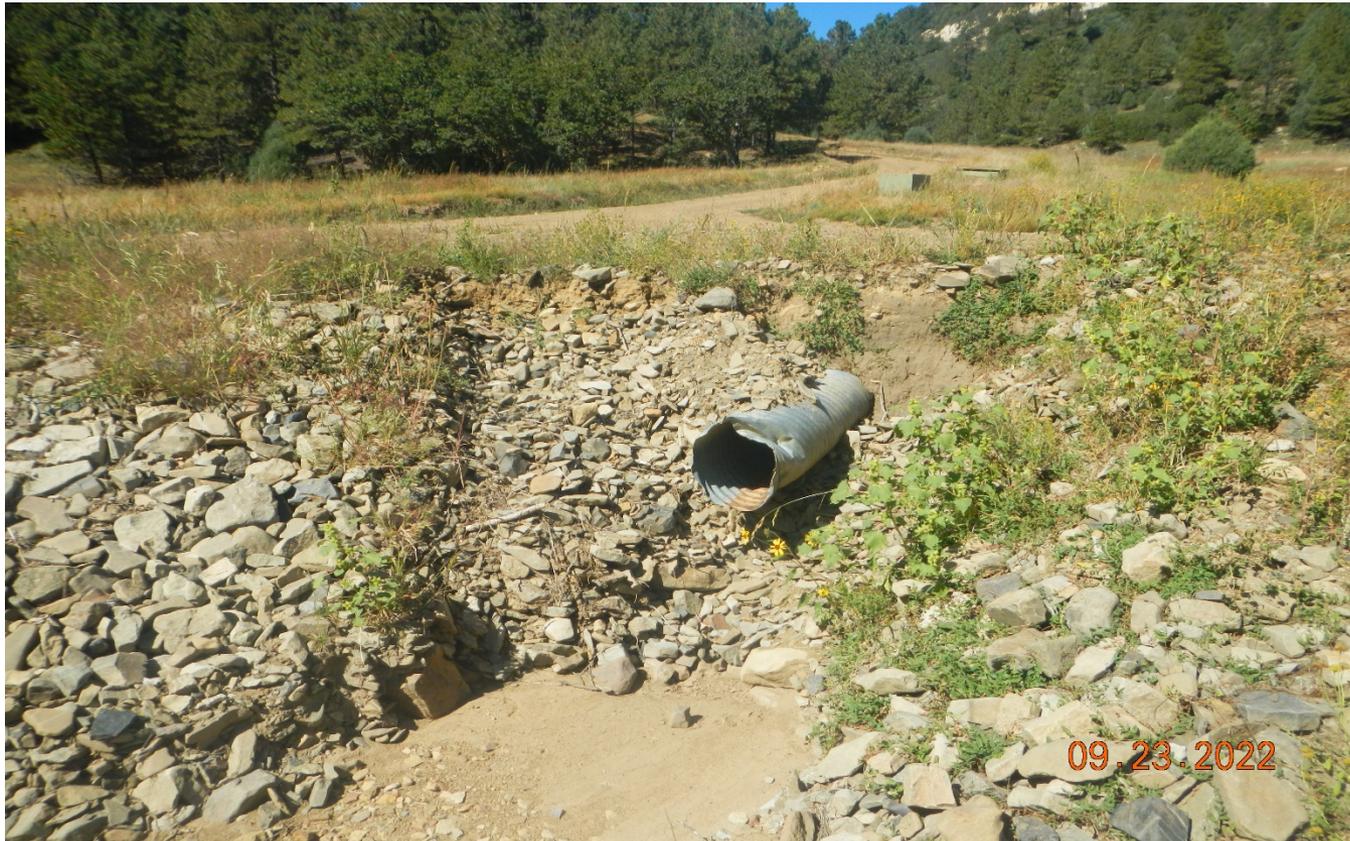
Photo 2. Facing west toward near the access road ascending the hillside. The culvert outlet has been washed out from recent storm event. It appears a larger culvert is needed along with larger rock rip/rap outlet protection.

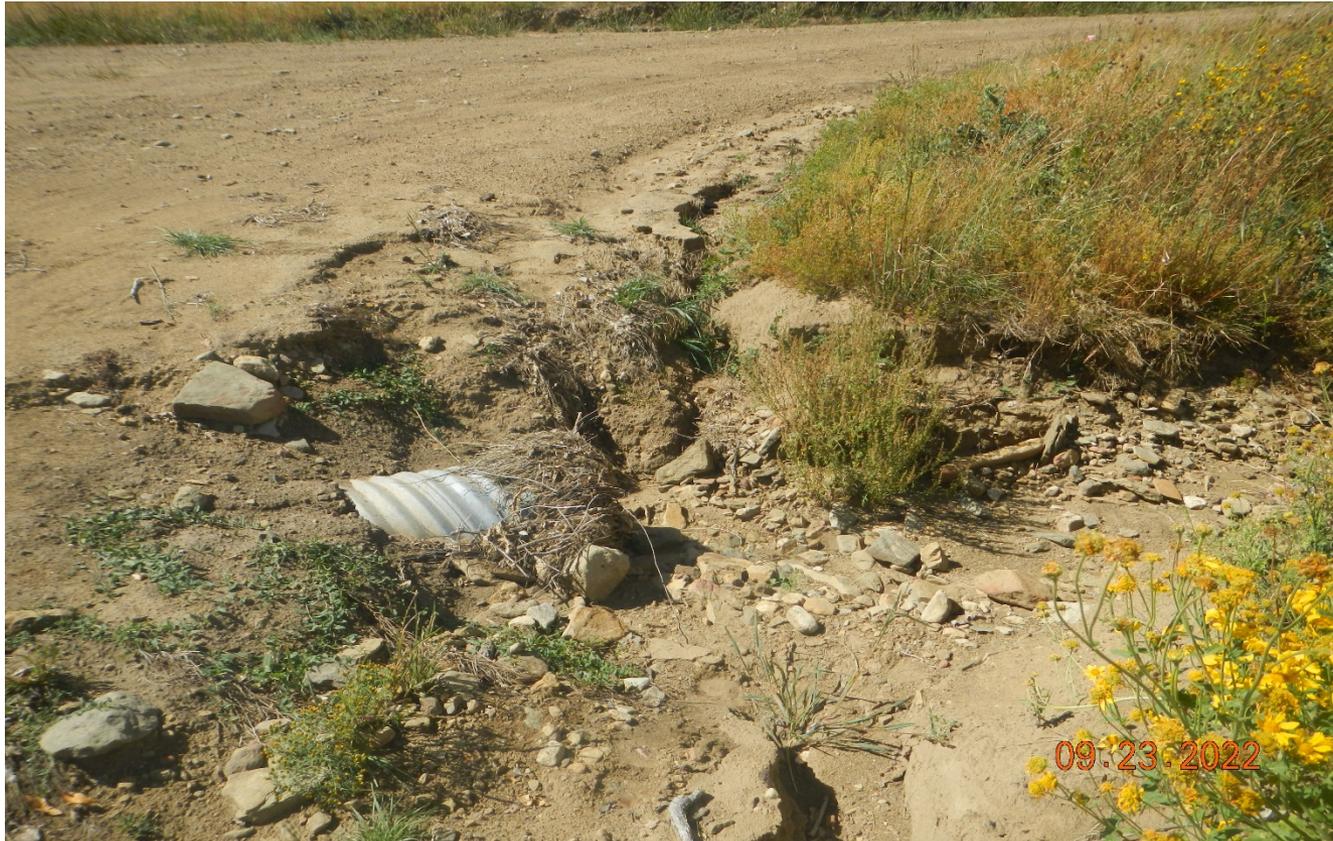
Photo 3. The culvert inlet is filled in with sediment and debris. It appears a larger culvert is needed at this area to handle stormwater coming off the road and drainage.

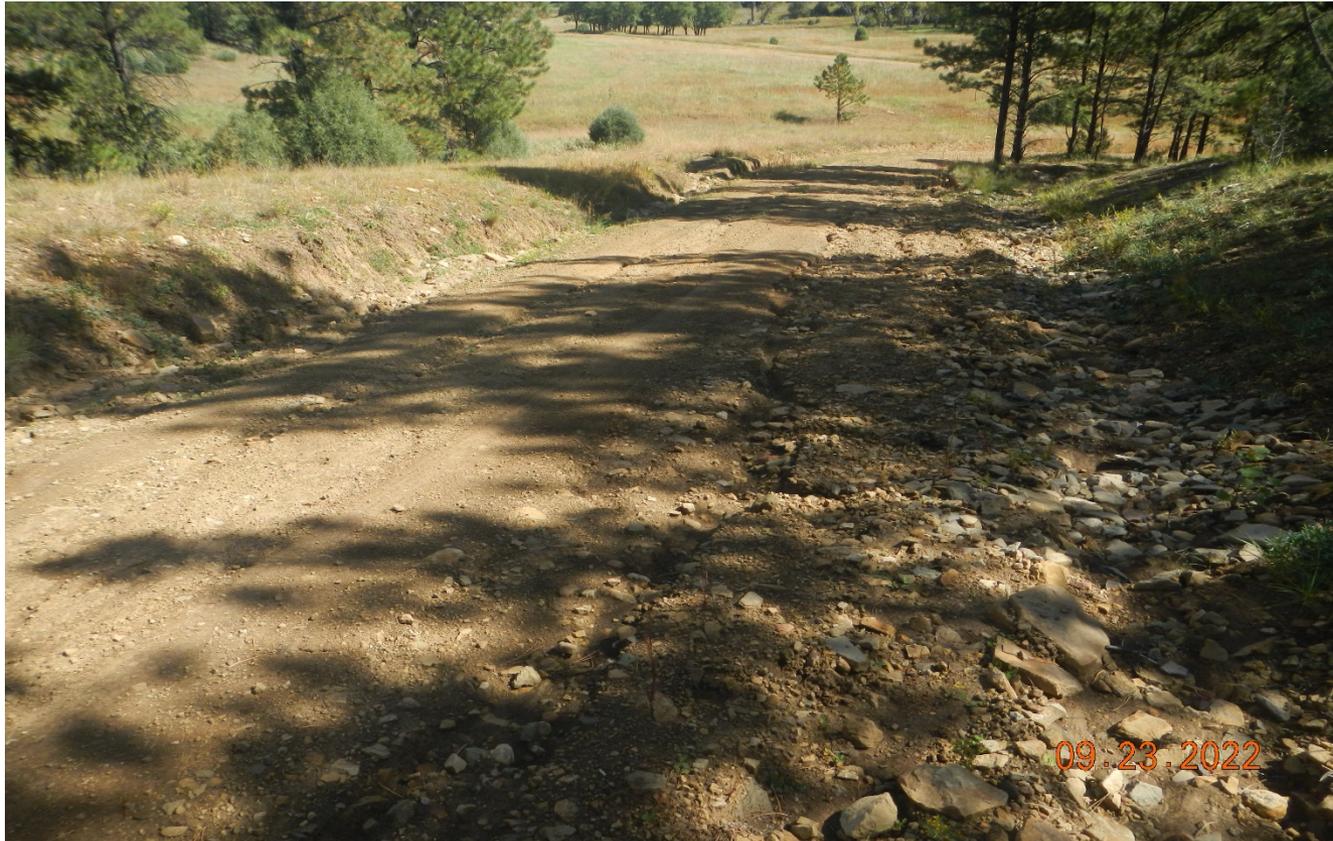
Photo 4. There are signs stormwater is flowing down the road causing erosion. This area has been a problem before. Stormwater is not being properly diverted off the road.

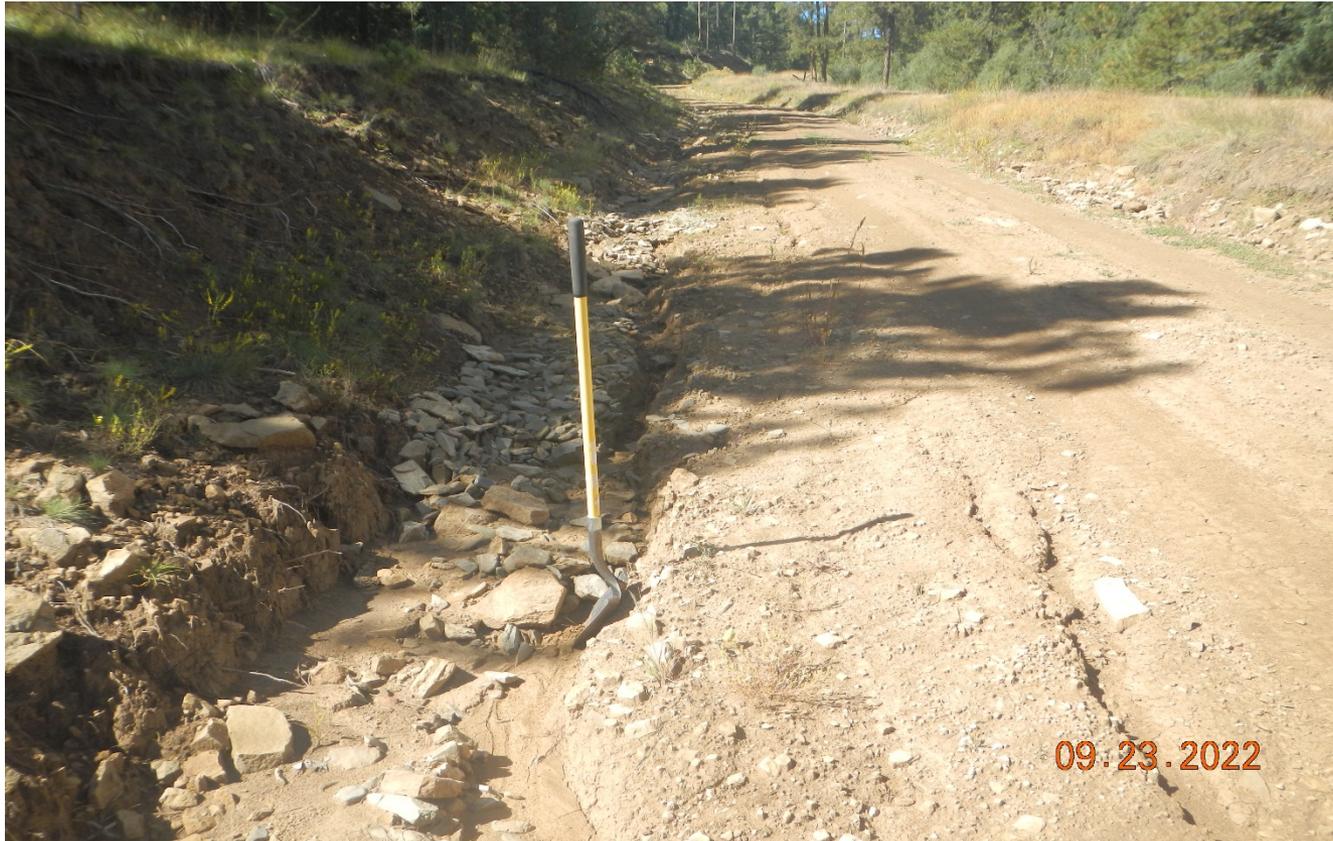
Photo 5. Facing west along the access road. Some of the rock check dams previously installed have washed out. Larger rock was likely needed. A 4.5 ft. shovel shows scale of erosion.

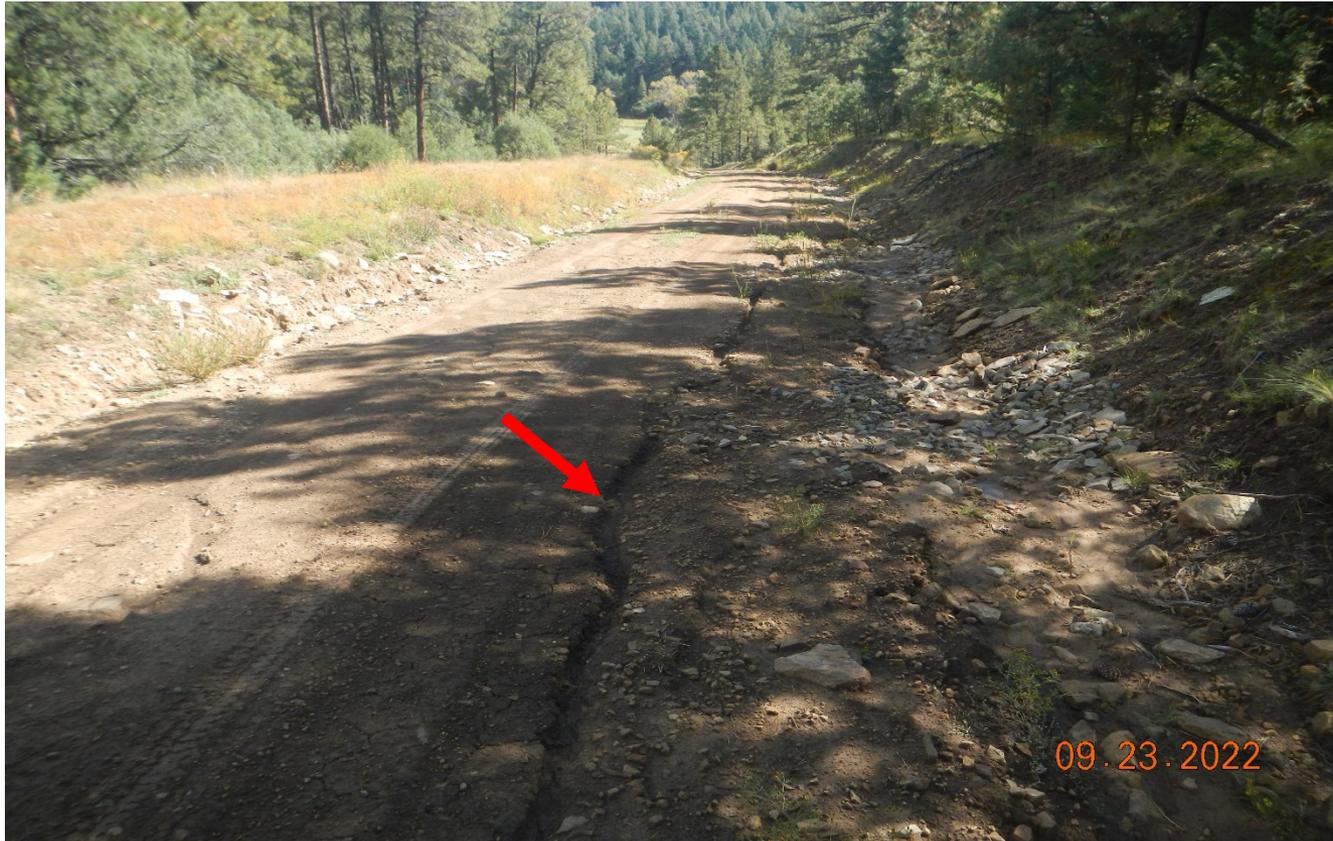
Photo 6. Further along the road facing back east. There is stormwater erosion occurring down the road which will continue to worsen since the previous inspection.

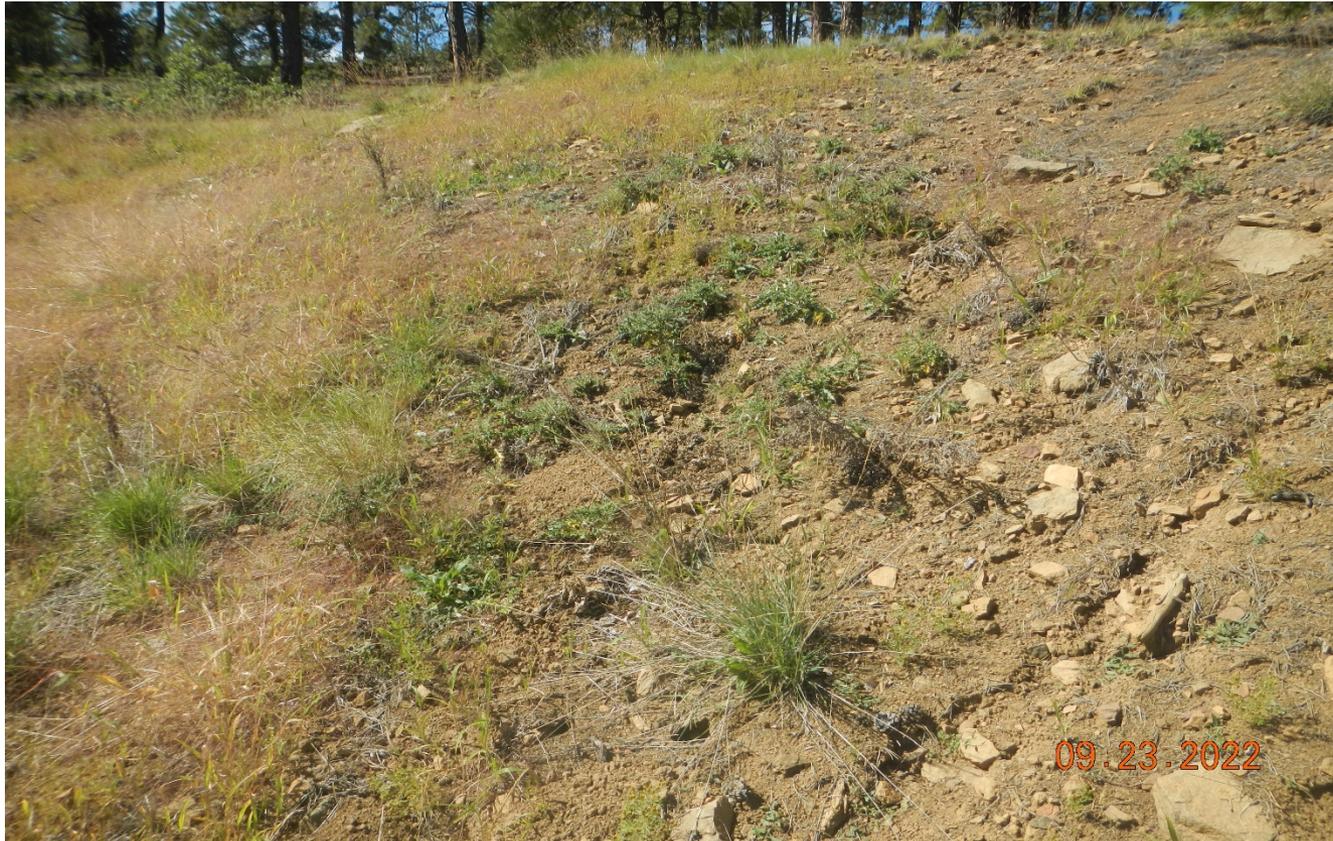
Photo 8. There are still noxious weeds Hounds tongue and Canada thistle which have not been controlled. The noxious weeds have produced seed so the weeds should also be bagged and removed.

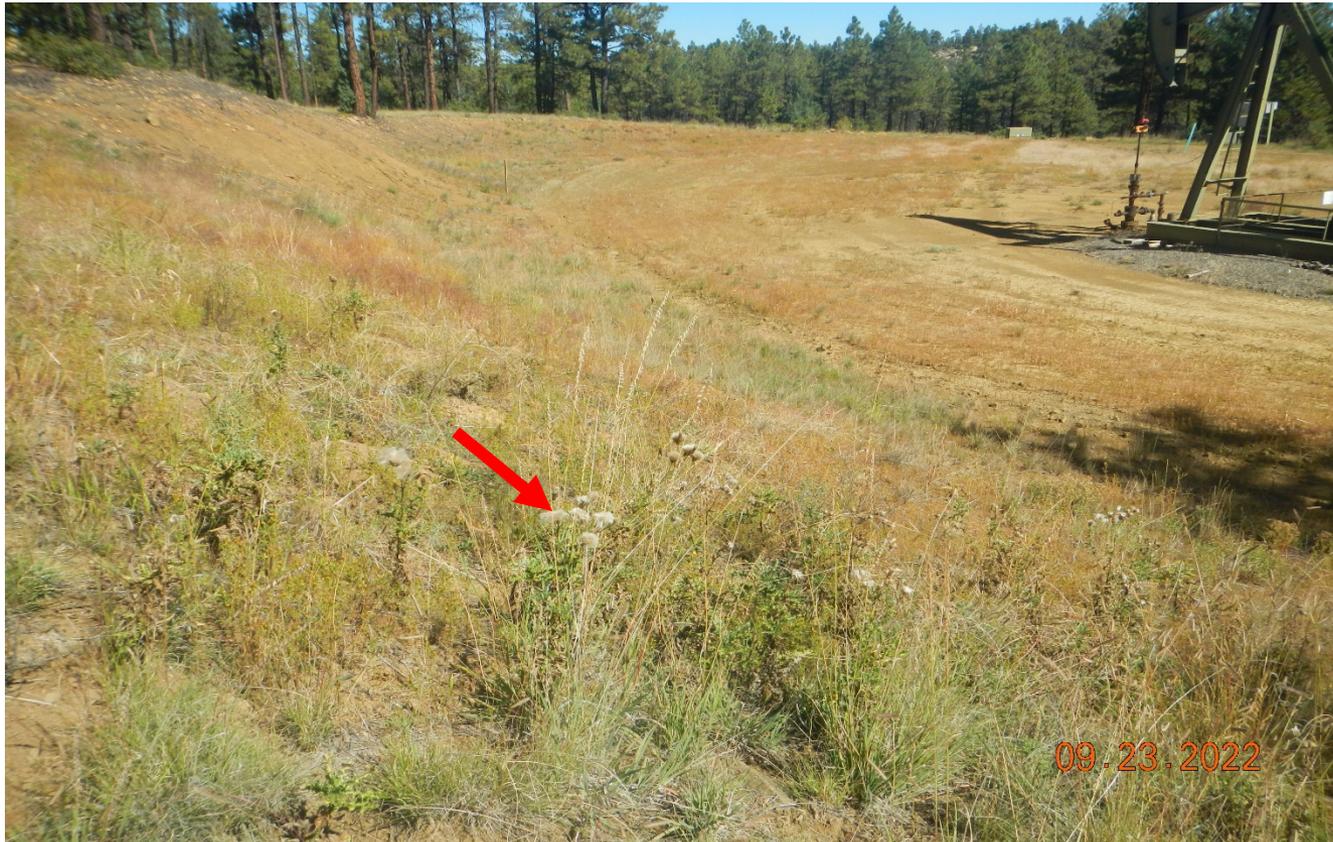
Photo 9. There numerous noxious weeds along the cut slope which have begun to seed out. Red arrow points to Canada thistle.
