Inspection Photos

API: 071-08769

Operator: WAPITI OPERATING LLC

Inspection Date: 9/23/2022

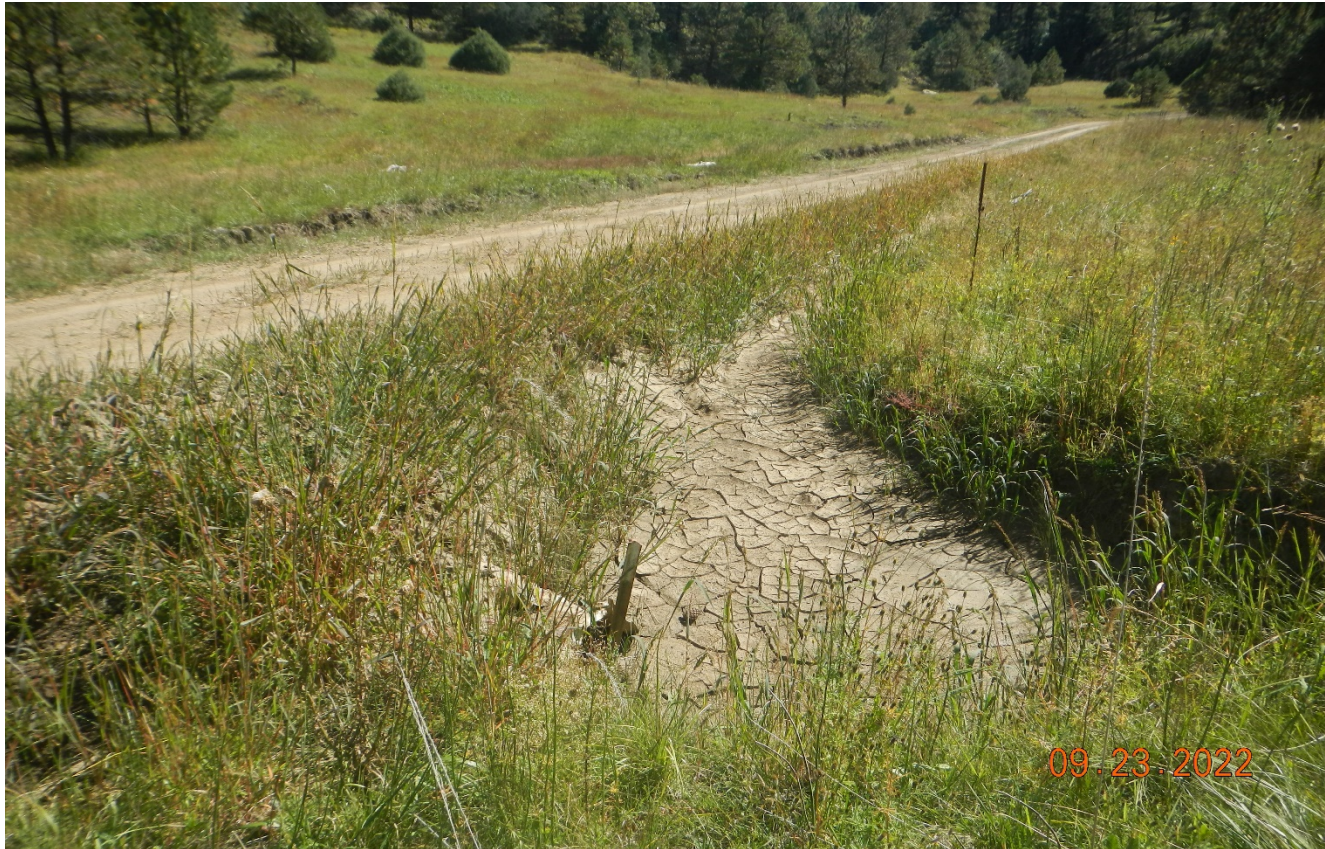
Photo 1. This culvert inlet was cleaned out however, the culvert is full of sediment. Previous corrective action was not completed. Lat/Long:37.00581,-104.83861.

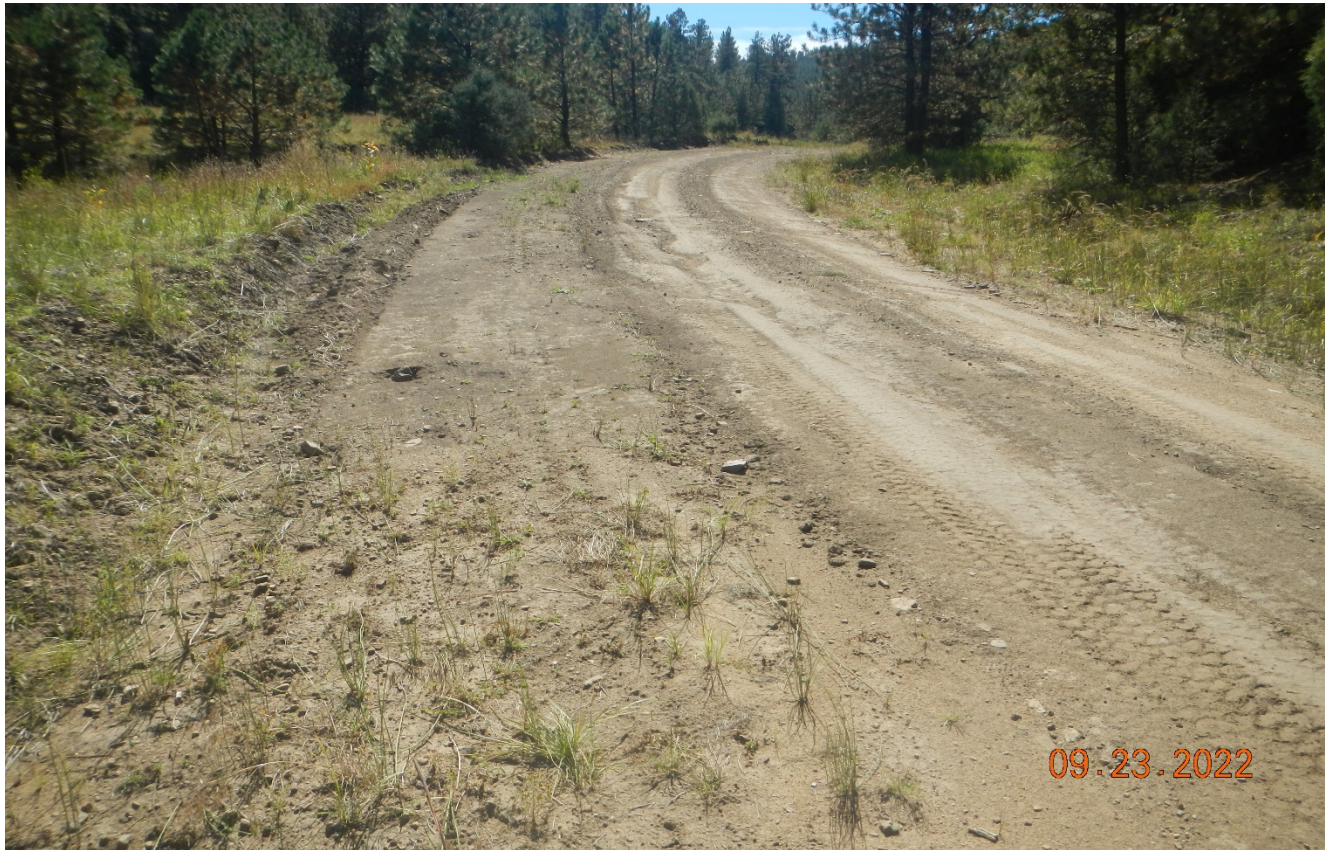
Photo 2. The main road has recently been graded including the access road to a nearby wellsite.

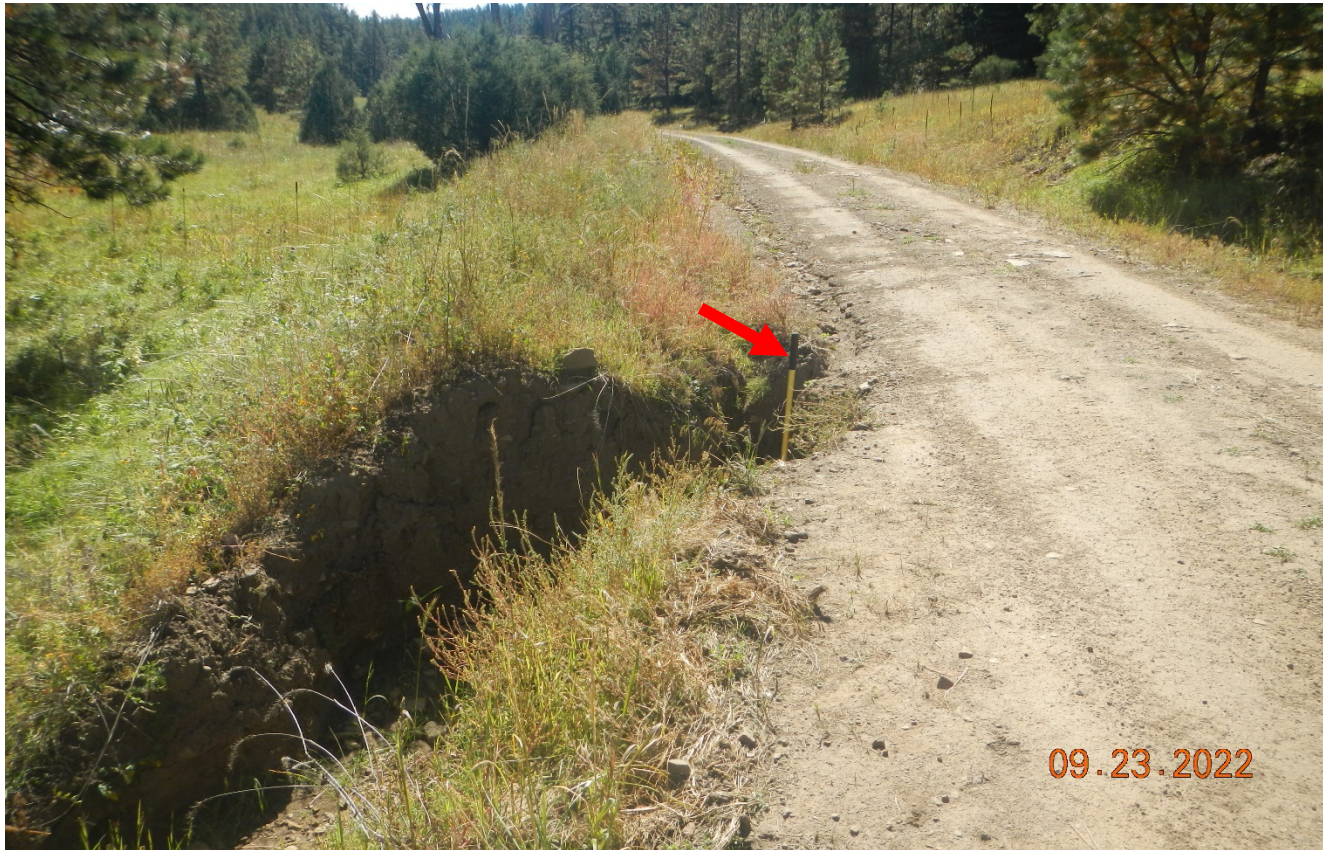
Photo 3. There is an erosion gully along the road that needs to be repaired and stabilized. Previous corrective action was not completed. Red arrow points to 4.5 ft. shovel.

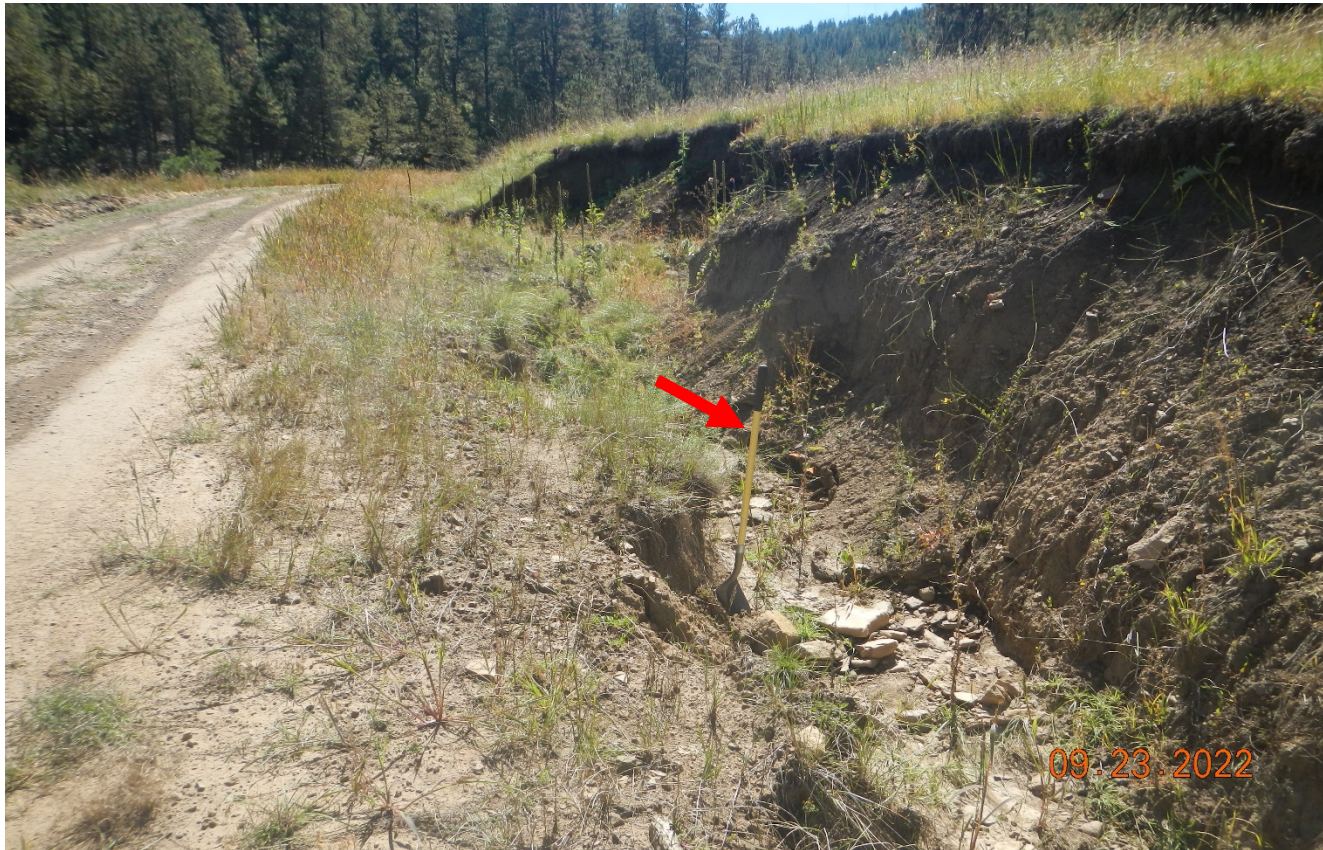
Photo 4. The side of the road is eroded and not stabilized. This area needs to be repaired and stabilized. Previous corrective action not completed. Red arrow points to 4.5 ft. shovel. Lat/Long:36.99952,-104.83425.

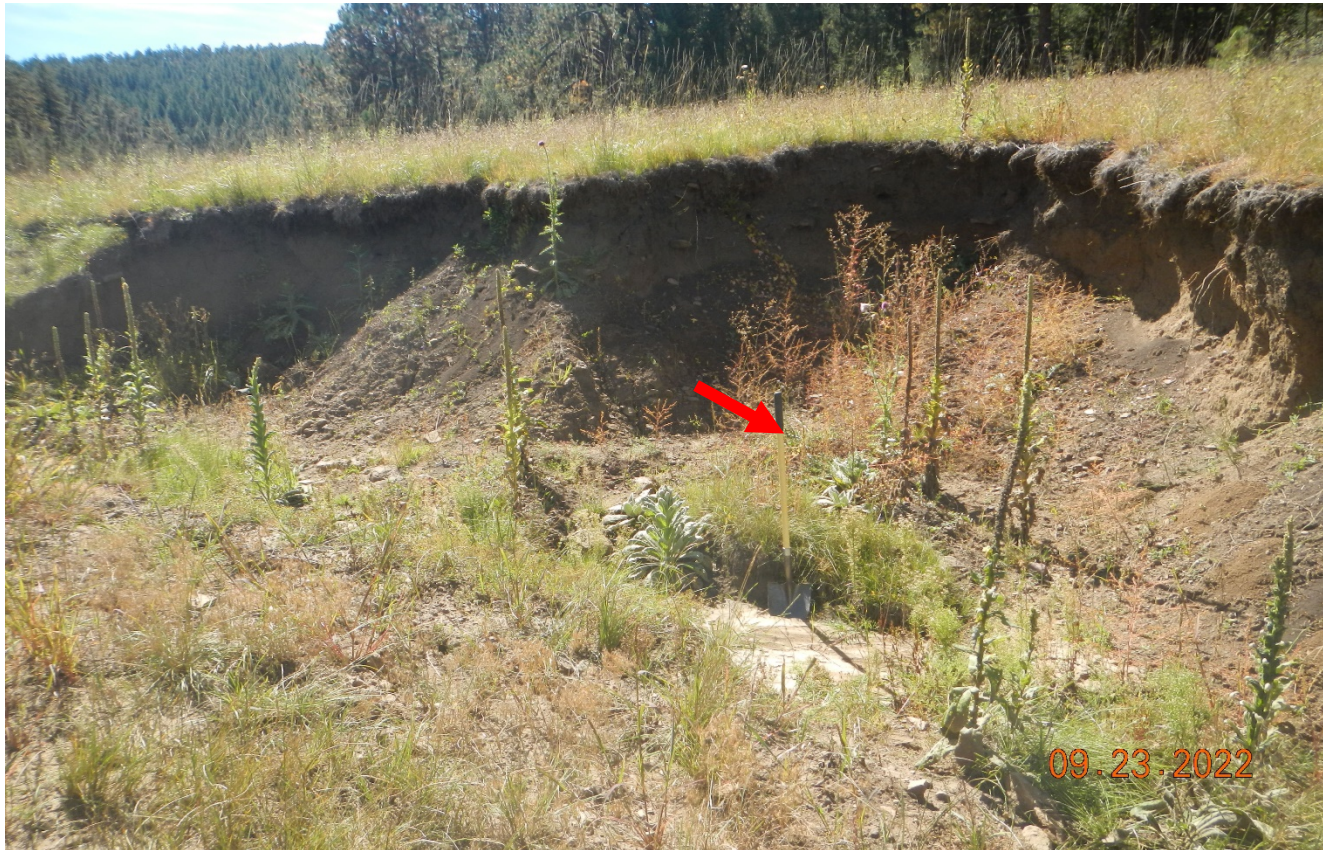
Photo 5. The side of the road is eroded and not stabilized. Erosion head cutting is continuing to occur further back. This area needs to be repaired and stabilized. Previous corrective action not completed. Red arrow points to 4.5 ft. shovel. Lat/Long:36.99952,-104.83425. There are also noxious shown in the photo.

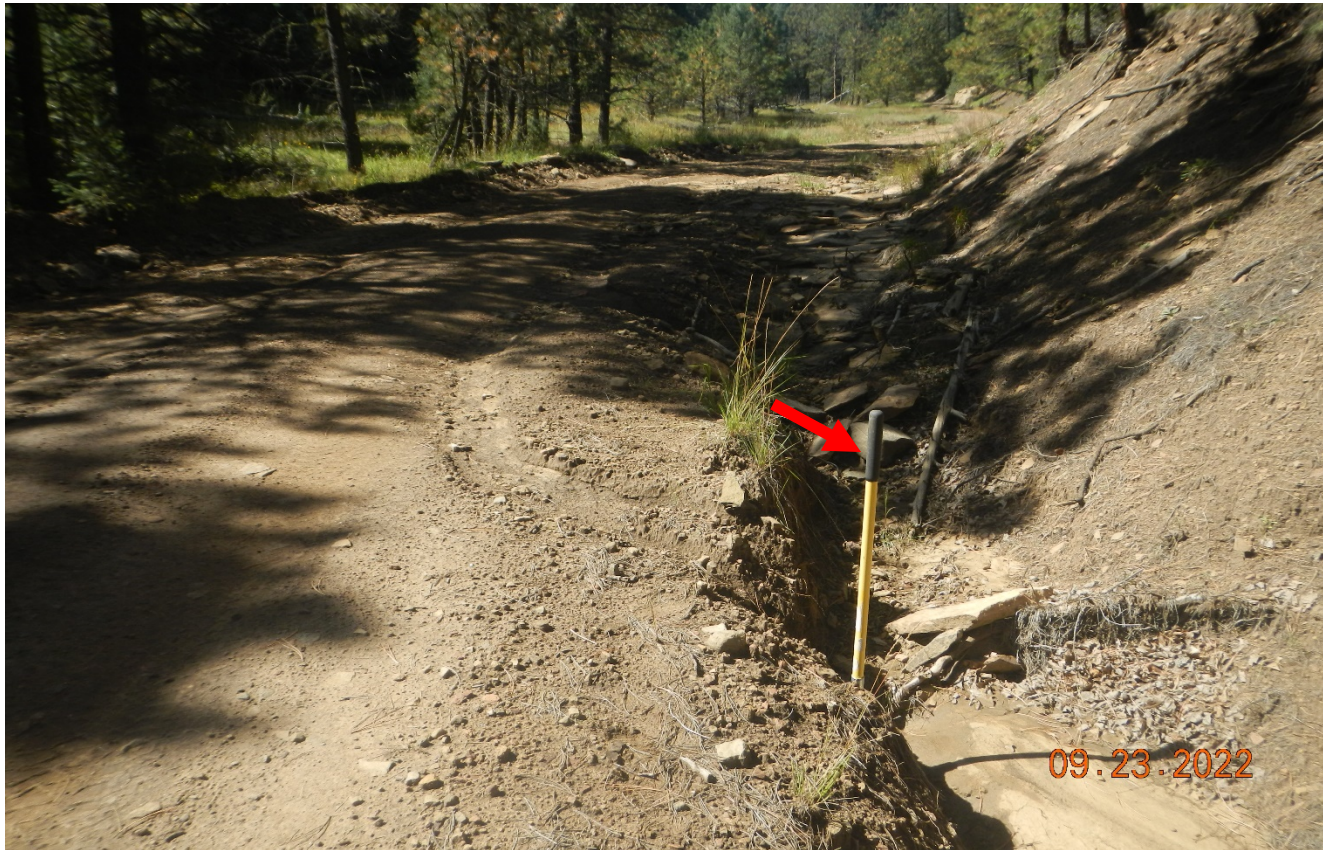
Photo 6. Further along the road near the Colorado line. The roadside and road is eroded and needs to be repaired and stabilized. Red arrow points to 4.5 ft. shovel.

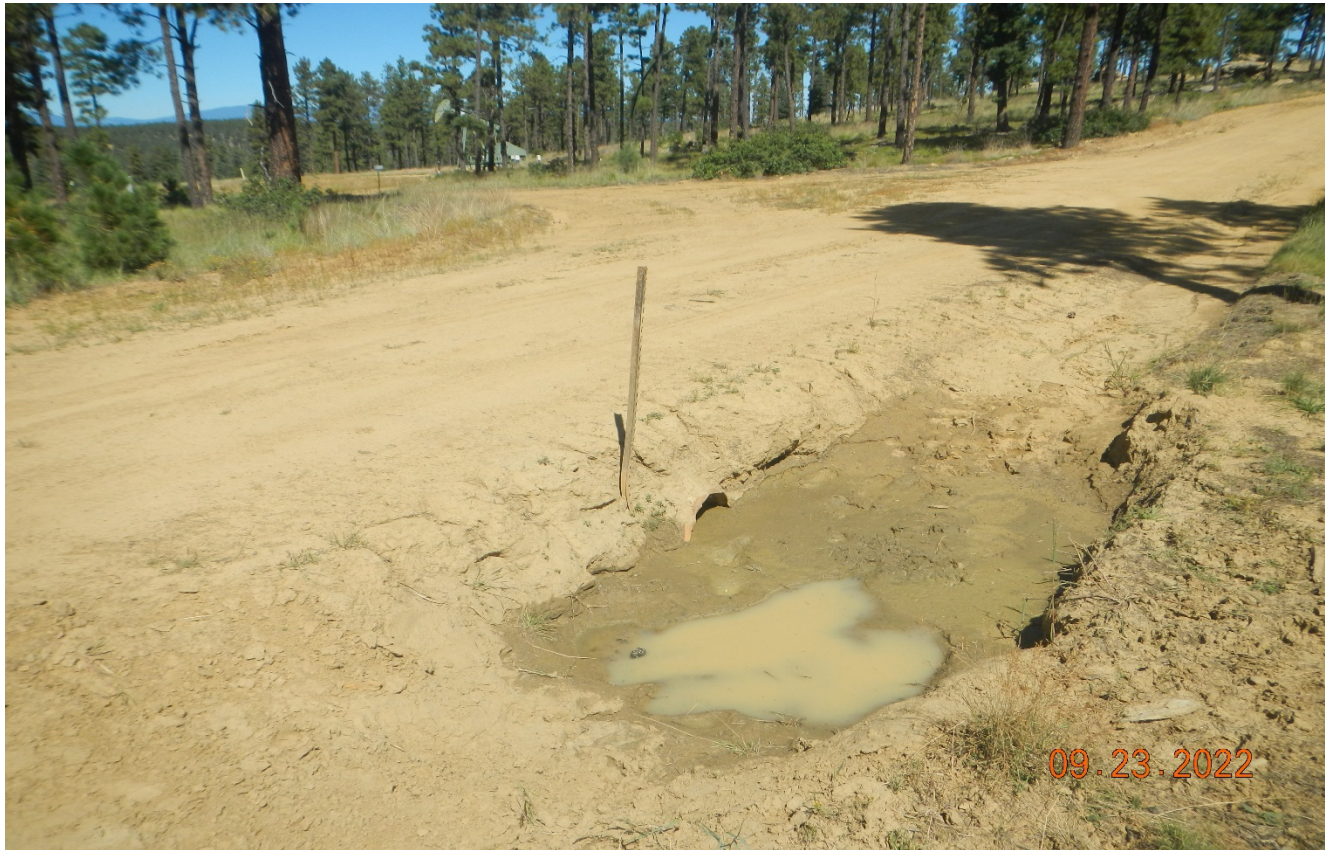
Photo 7. This culvert inlet was cleaned out however, the culvert is full of sediment which needs to be cleaned out. Lat/Long:36.99405,-104.84710.

Previous corrective action not completed.

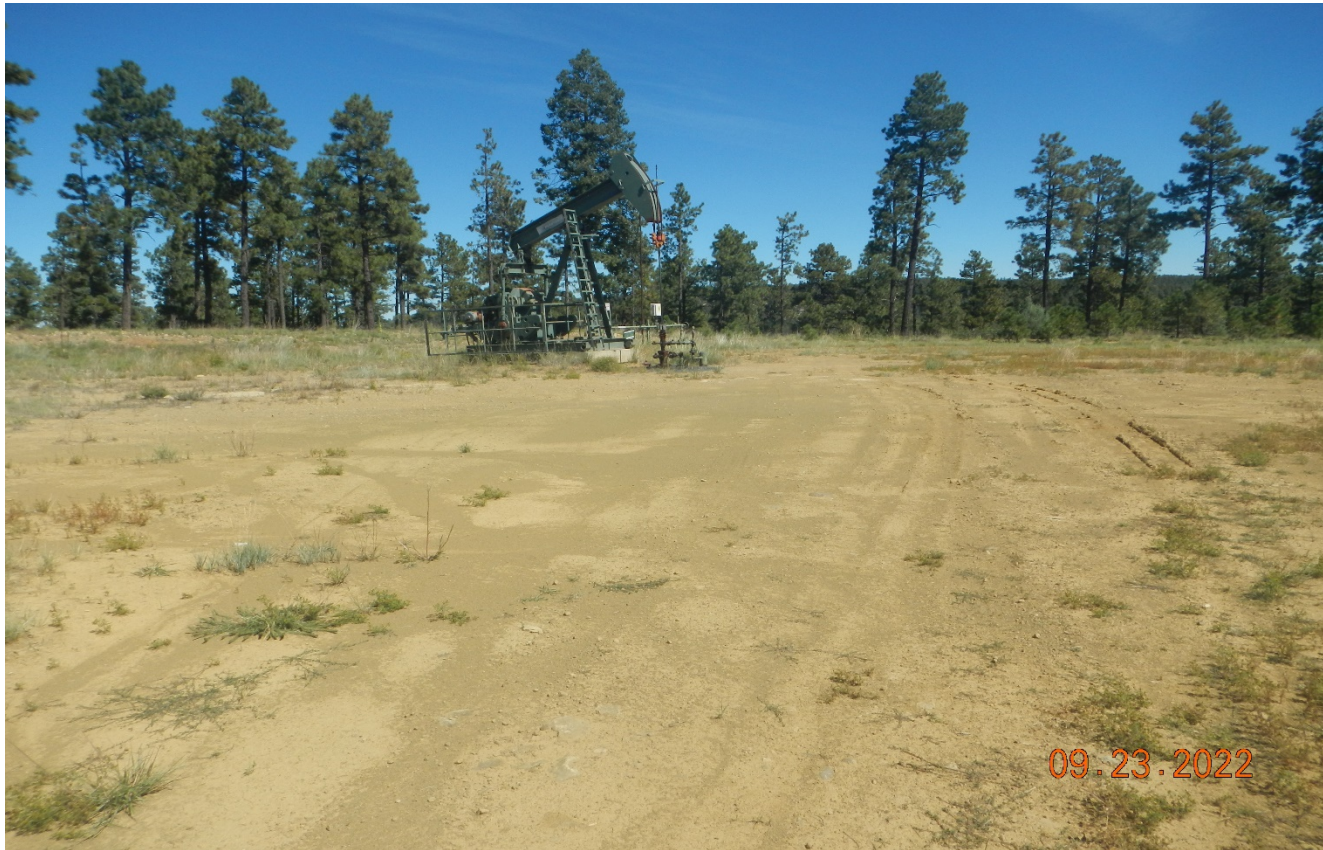
Photo 8. Facing northeast toward the well site.
