Inspection Photos

API: 071-09838

Operator: WAPITI OPERATING LLC

Inspection Date: 9/23/2022

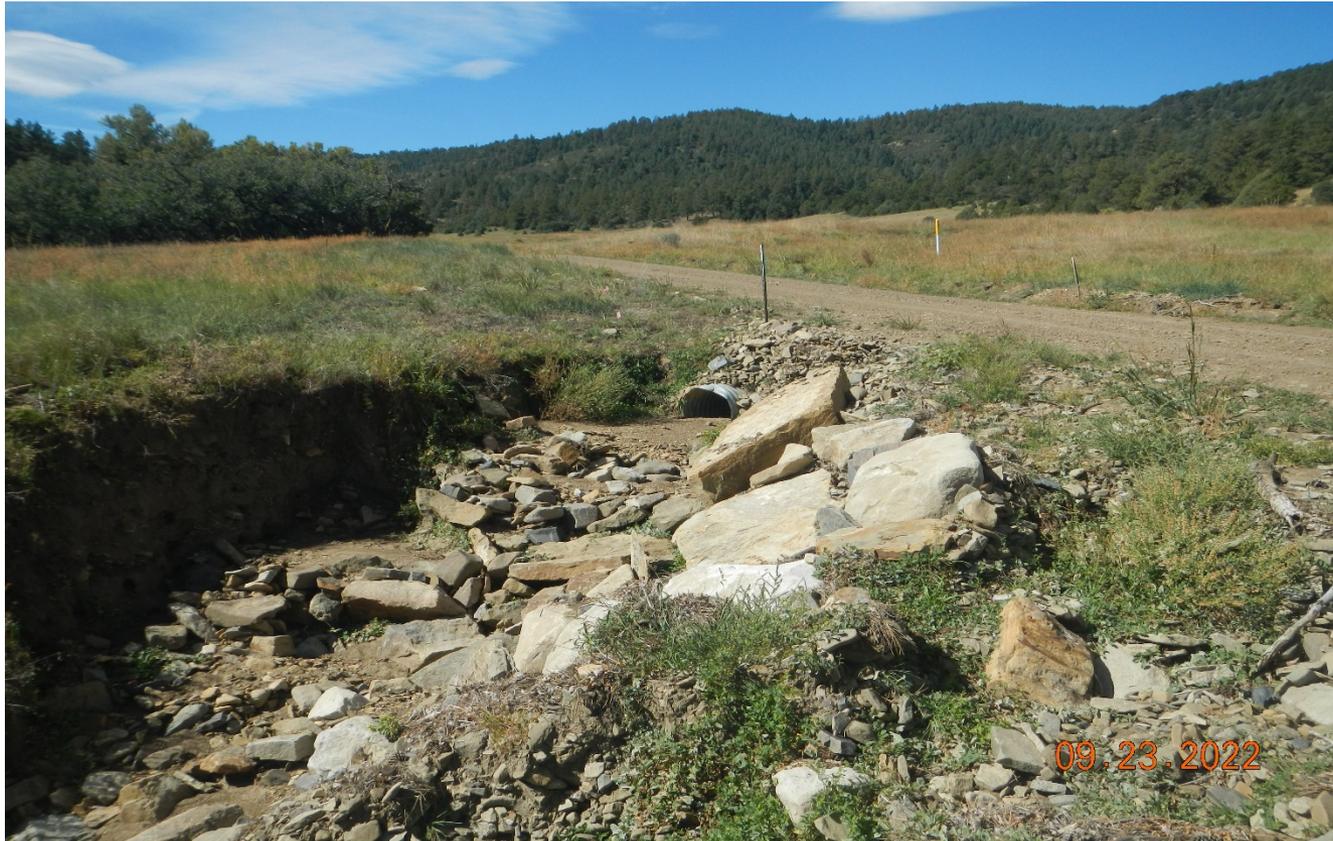
Photo 1. The culvert outlet has eroded and needs to be repaired. Previous corrective action was not completed.

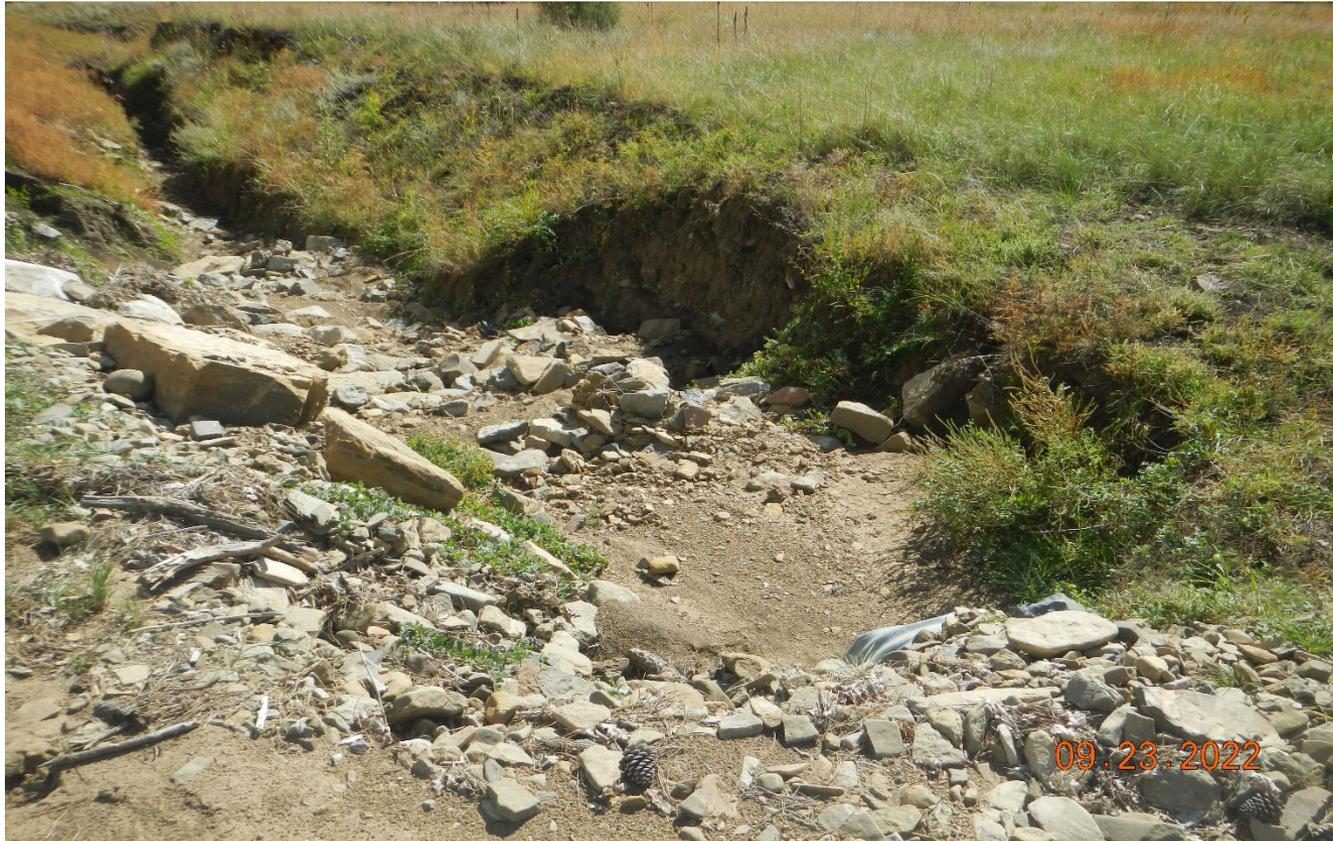
Photo 2. Facing toward the culvert outlet. The culvert outlet has eroded and needs to be repaired. Previous corrective action was not completed. BMP's must be installed per good engineering practice. (E.g. Rock outlet protection should include geotextile fabric)

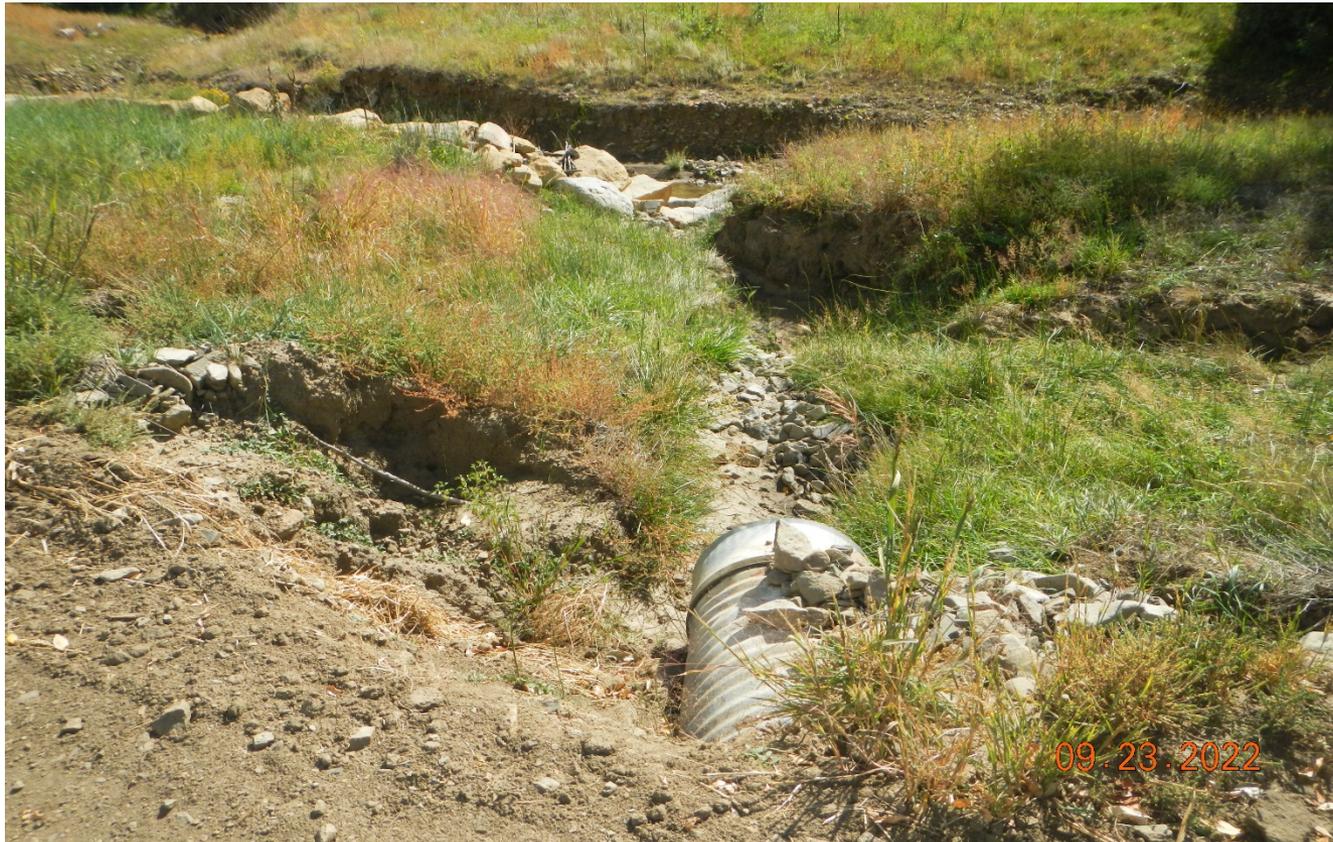
Photo 3. The next culvert along the road is also eroded at the culvert outlet with no outlet protection.

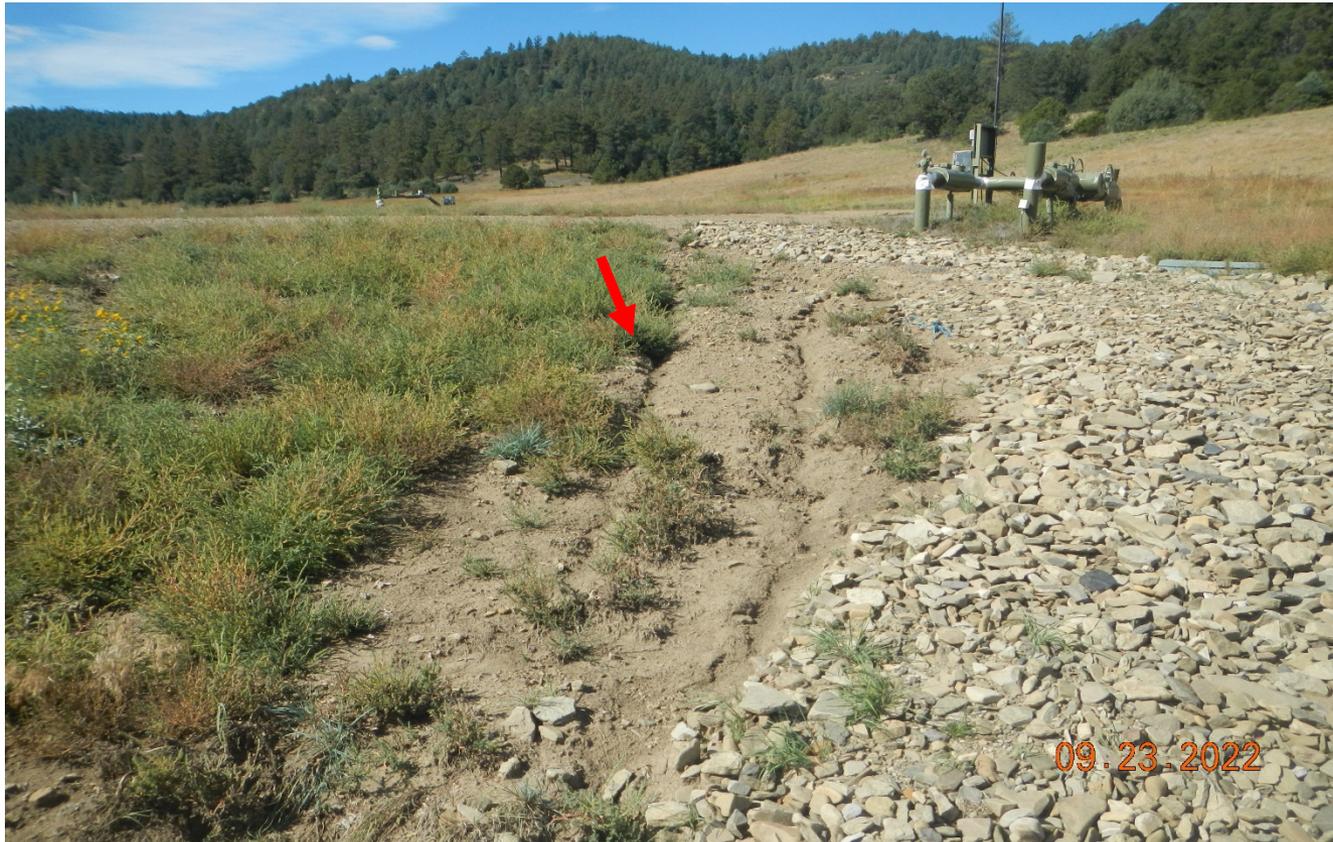
Photo 5. Facing southwest. There was rock rip/rap placed in this area where erosion had occurred. Stormwater is now going outside of the rip/rap area causing erosion at red arrow. Additional BMP's need to be installed in this area.

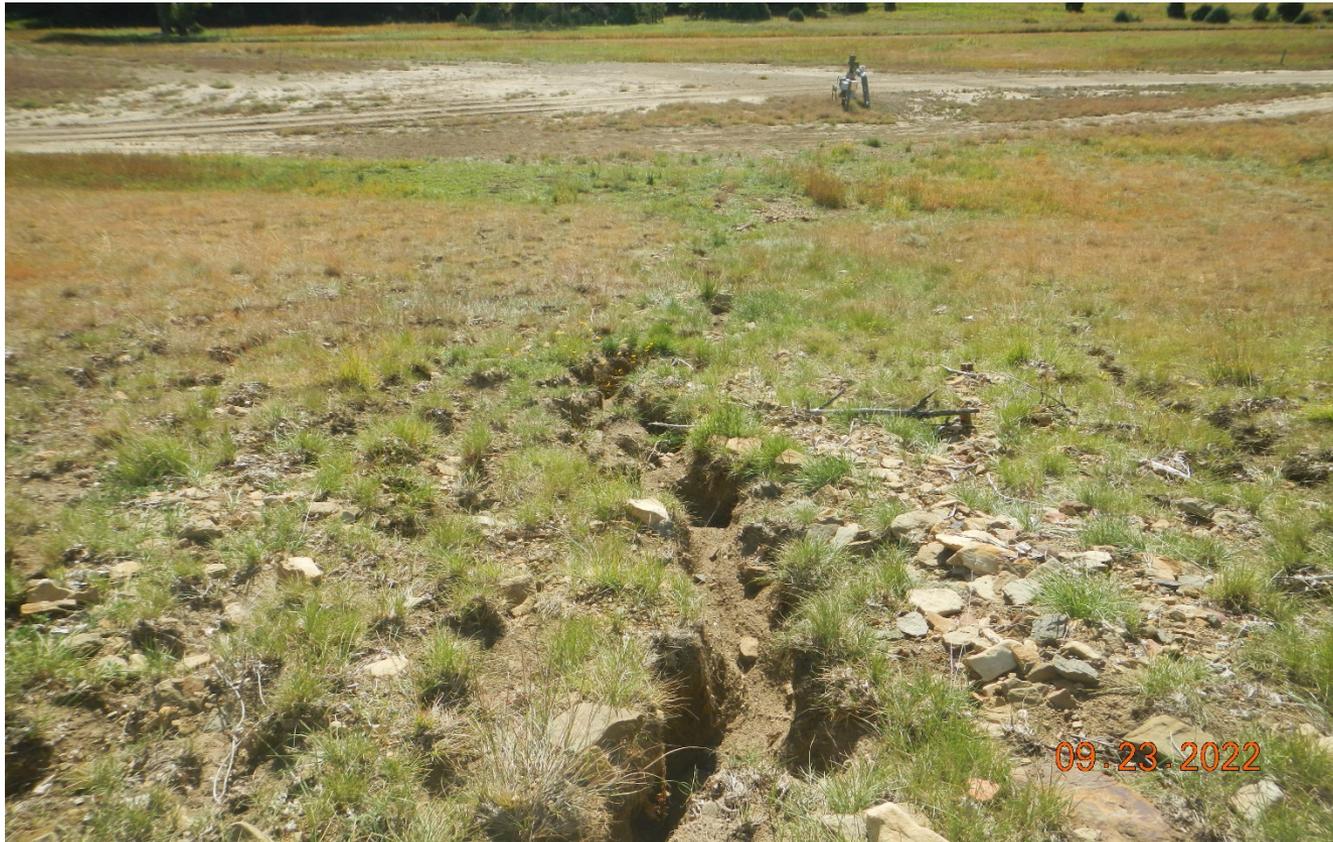
Photo 6. Facing east toward the location at the upper cut slope area. Stormwater run-on is causing erosion and is not properly diverted by the perimeter ditch. This area needs to be repaired and stabilized. Previous corrective action is not completed.
