Inspection Photos

ID: 412161

Operator: WAPITI OPERATING LLC

Inspection Date: 9/23/2022

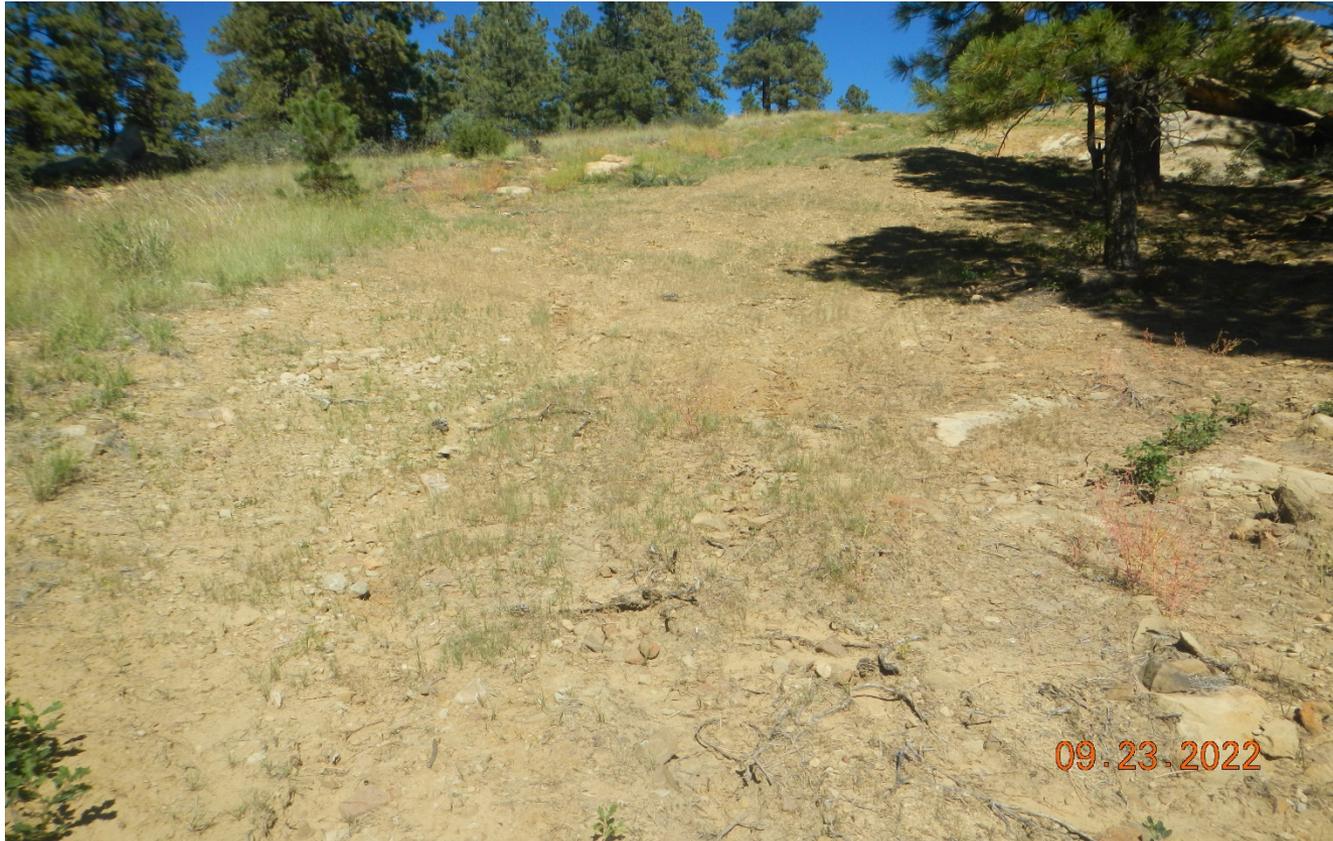
Photo 1. Facing northwest at the disturbance along the gathering pipeline at Lat/Long:37.05440,-104.76614. This area has been reseeded however, soils are not stabilized and there is now erosion occurring. Previous corrective action not completed.

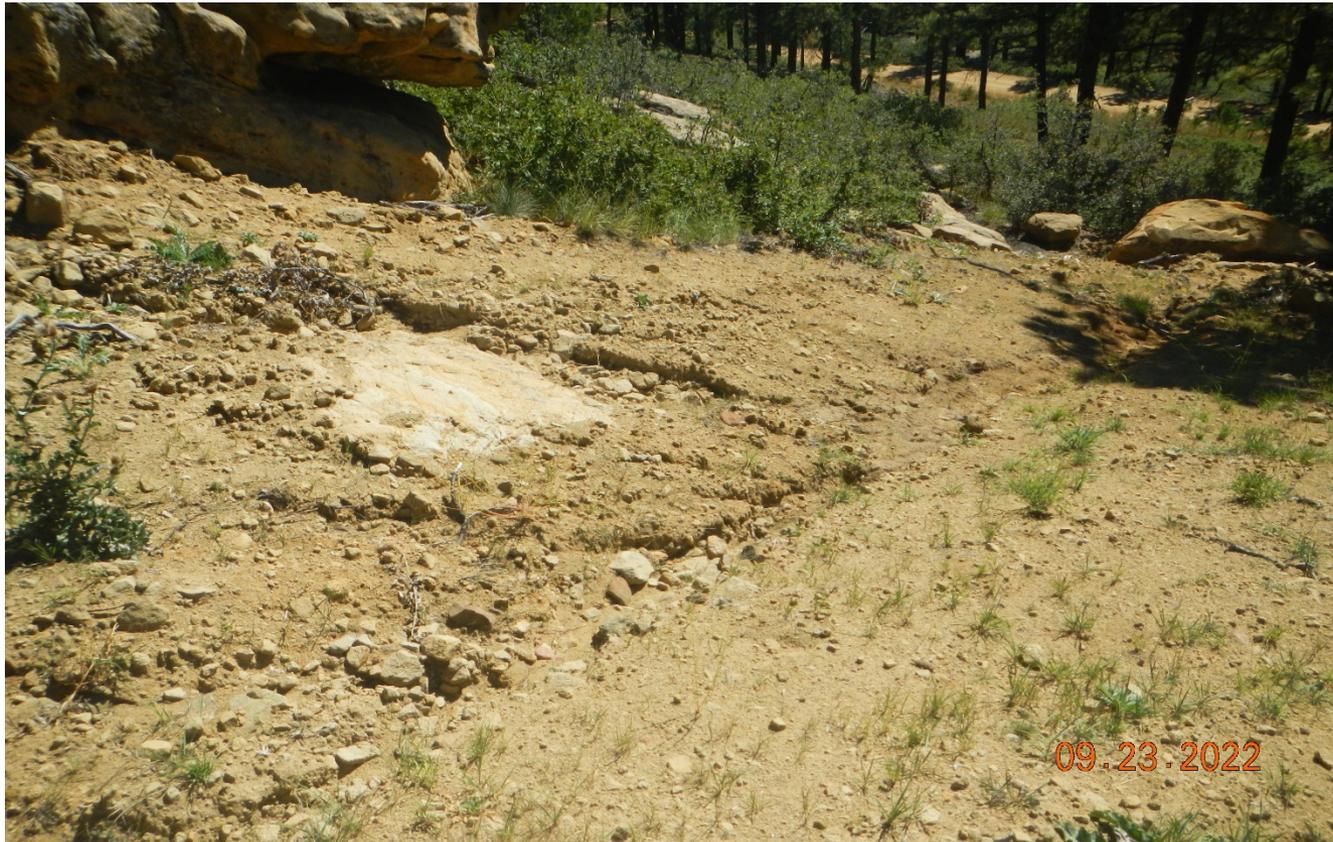
Photo 2. Facing southeast along the pipeline disturbance. There are signs of erosion occurring. Previous corrective action not completed.

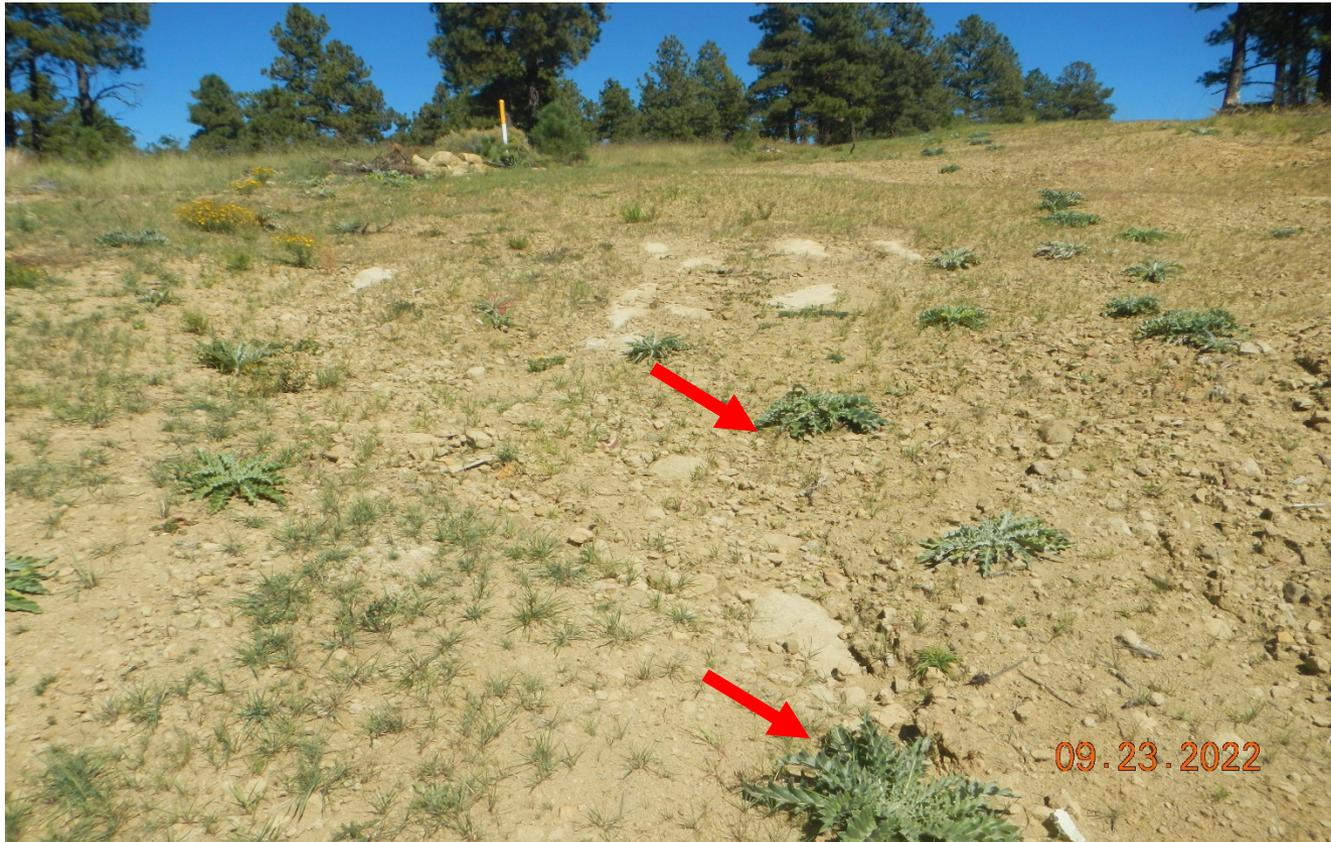
Photo 3. Facing northwest along the pipeline disturbance. There are noxious weeds beginning to establish which must be controlled. Previous corrective action not completed.

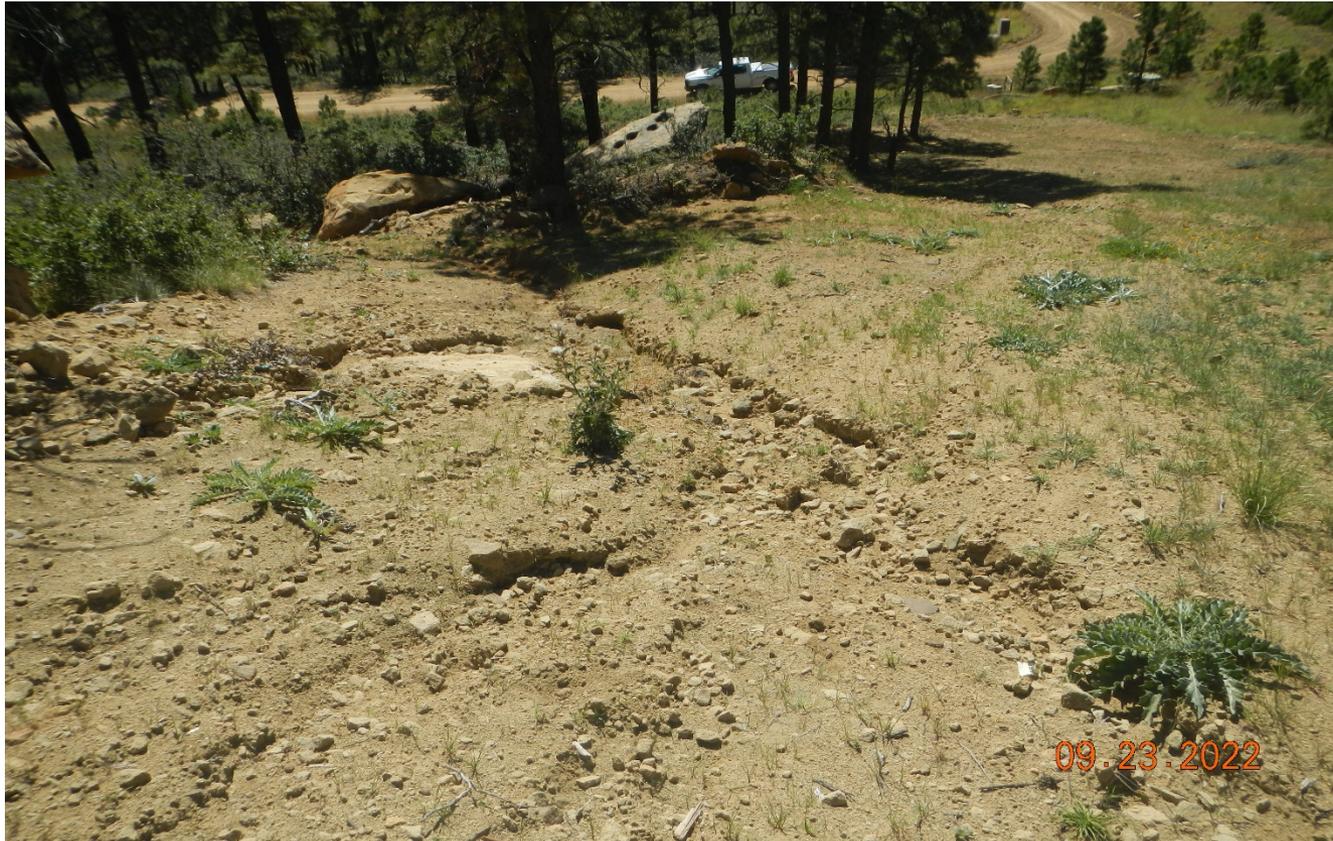
Photo 4. View of some of the erosion occurring. Additional BMP's are needed to prevent erosion. Previous corrective action not completed.

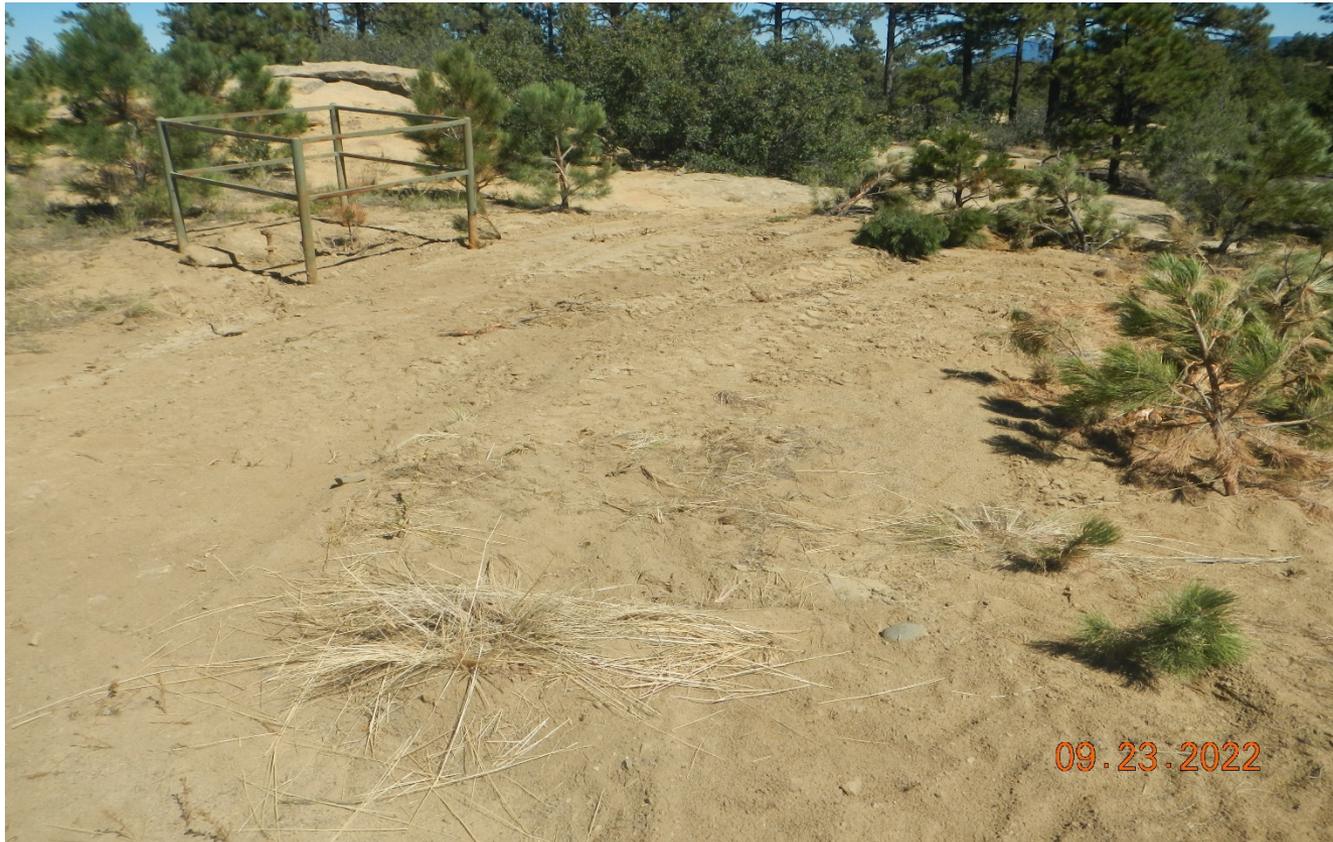
Photo 5. There was disturbance that occurred along the main road that needs to be seeded and stabilized. Lat/Long:37.05647,-104.76314.
