Central Operating INC, State 1
121-08118

Inspection #688313166

9/21/2022

Routine Field Inspection

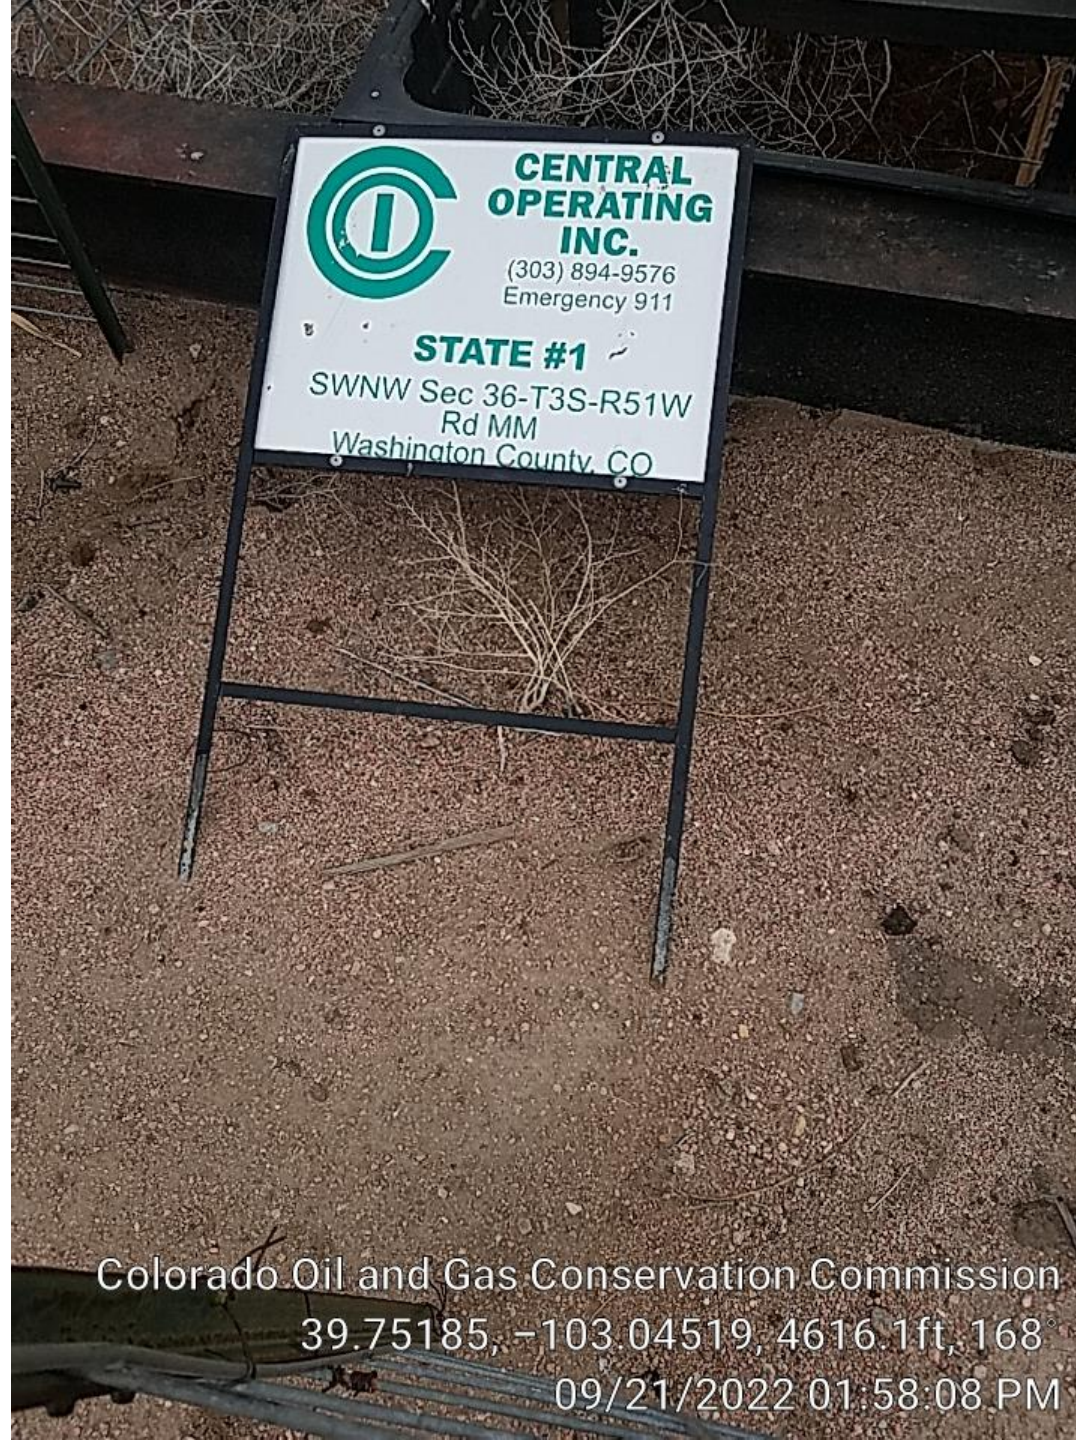
Sign is on
ground.

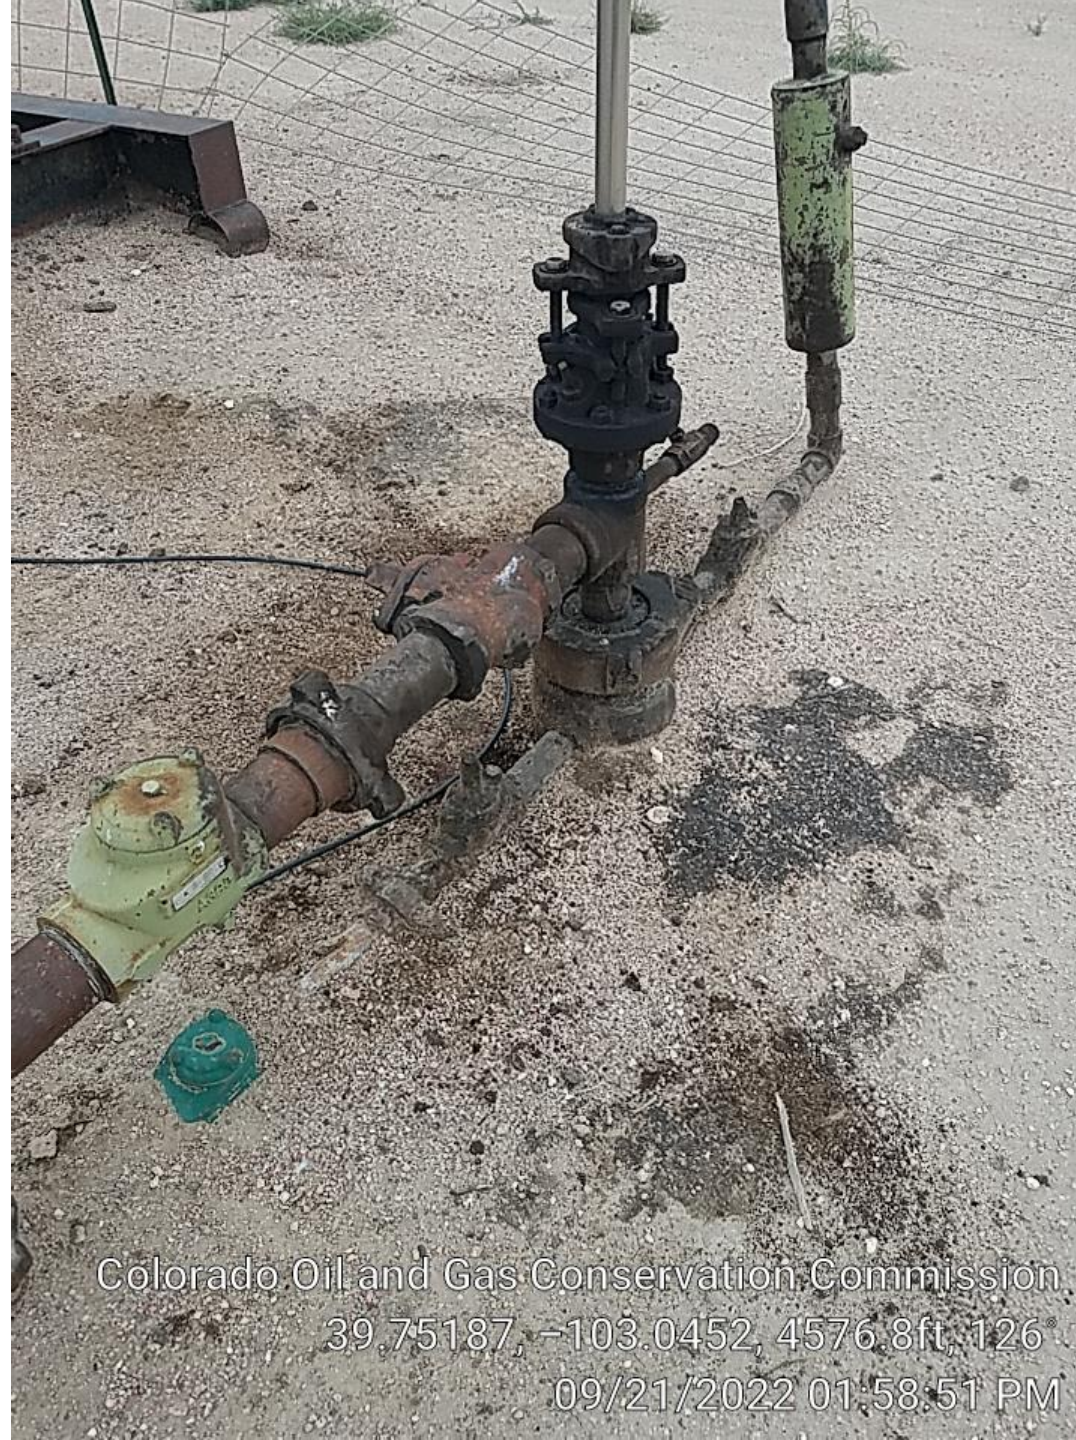
Stained soil at wellhead.

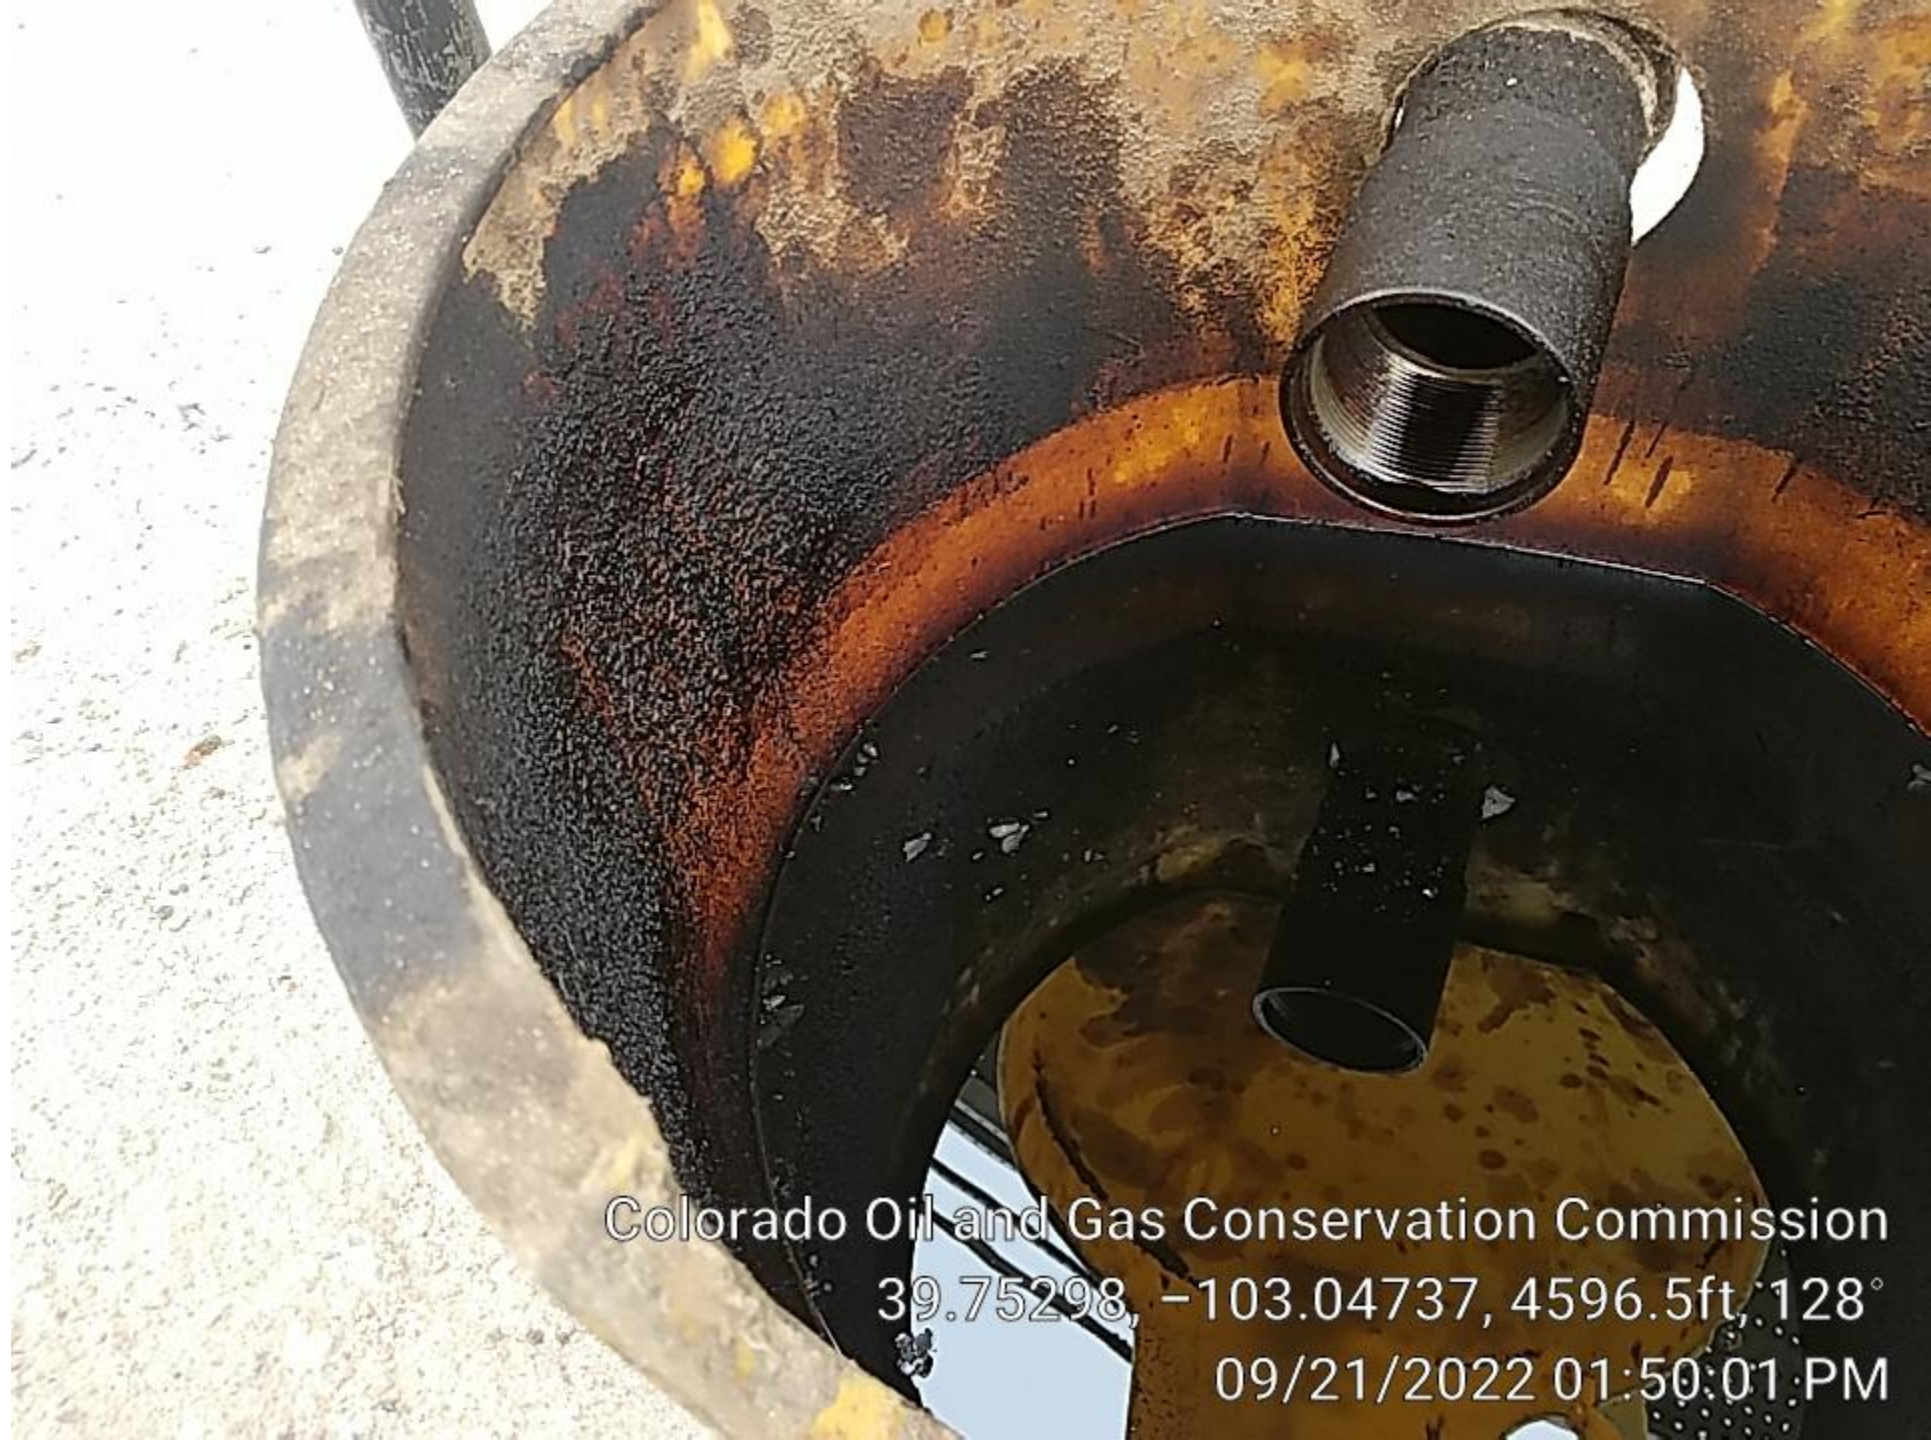
No
bullplug
or cap on
loudout.

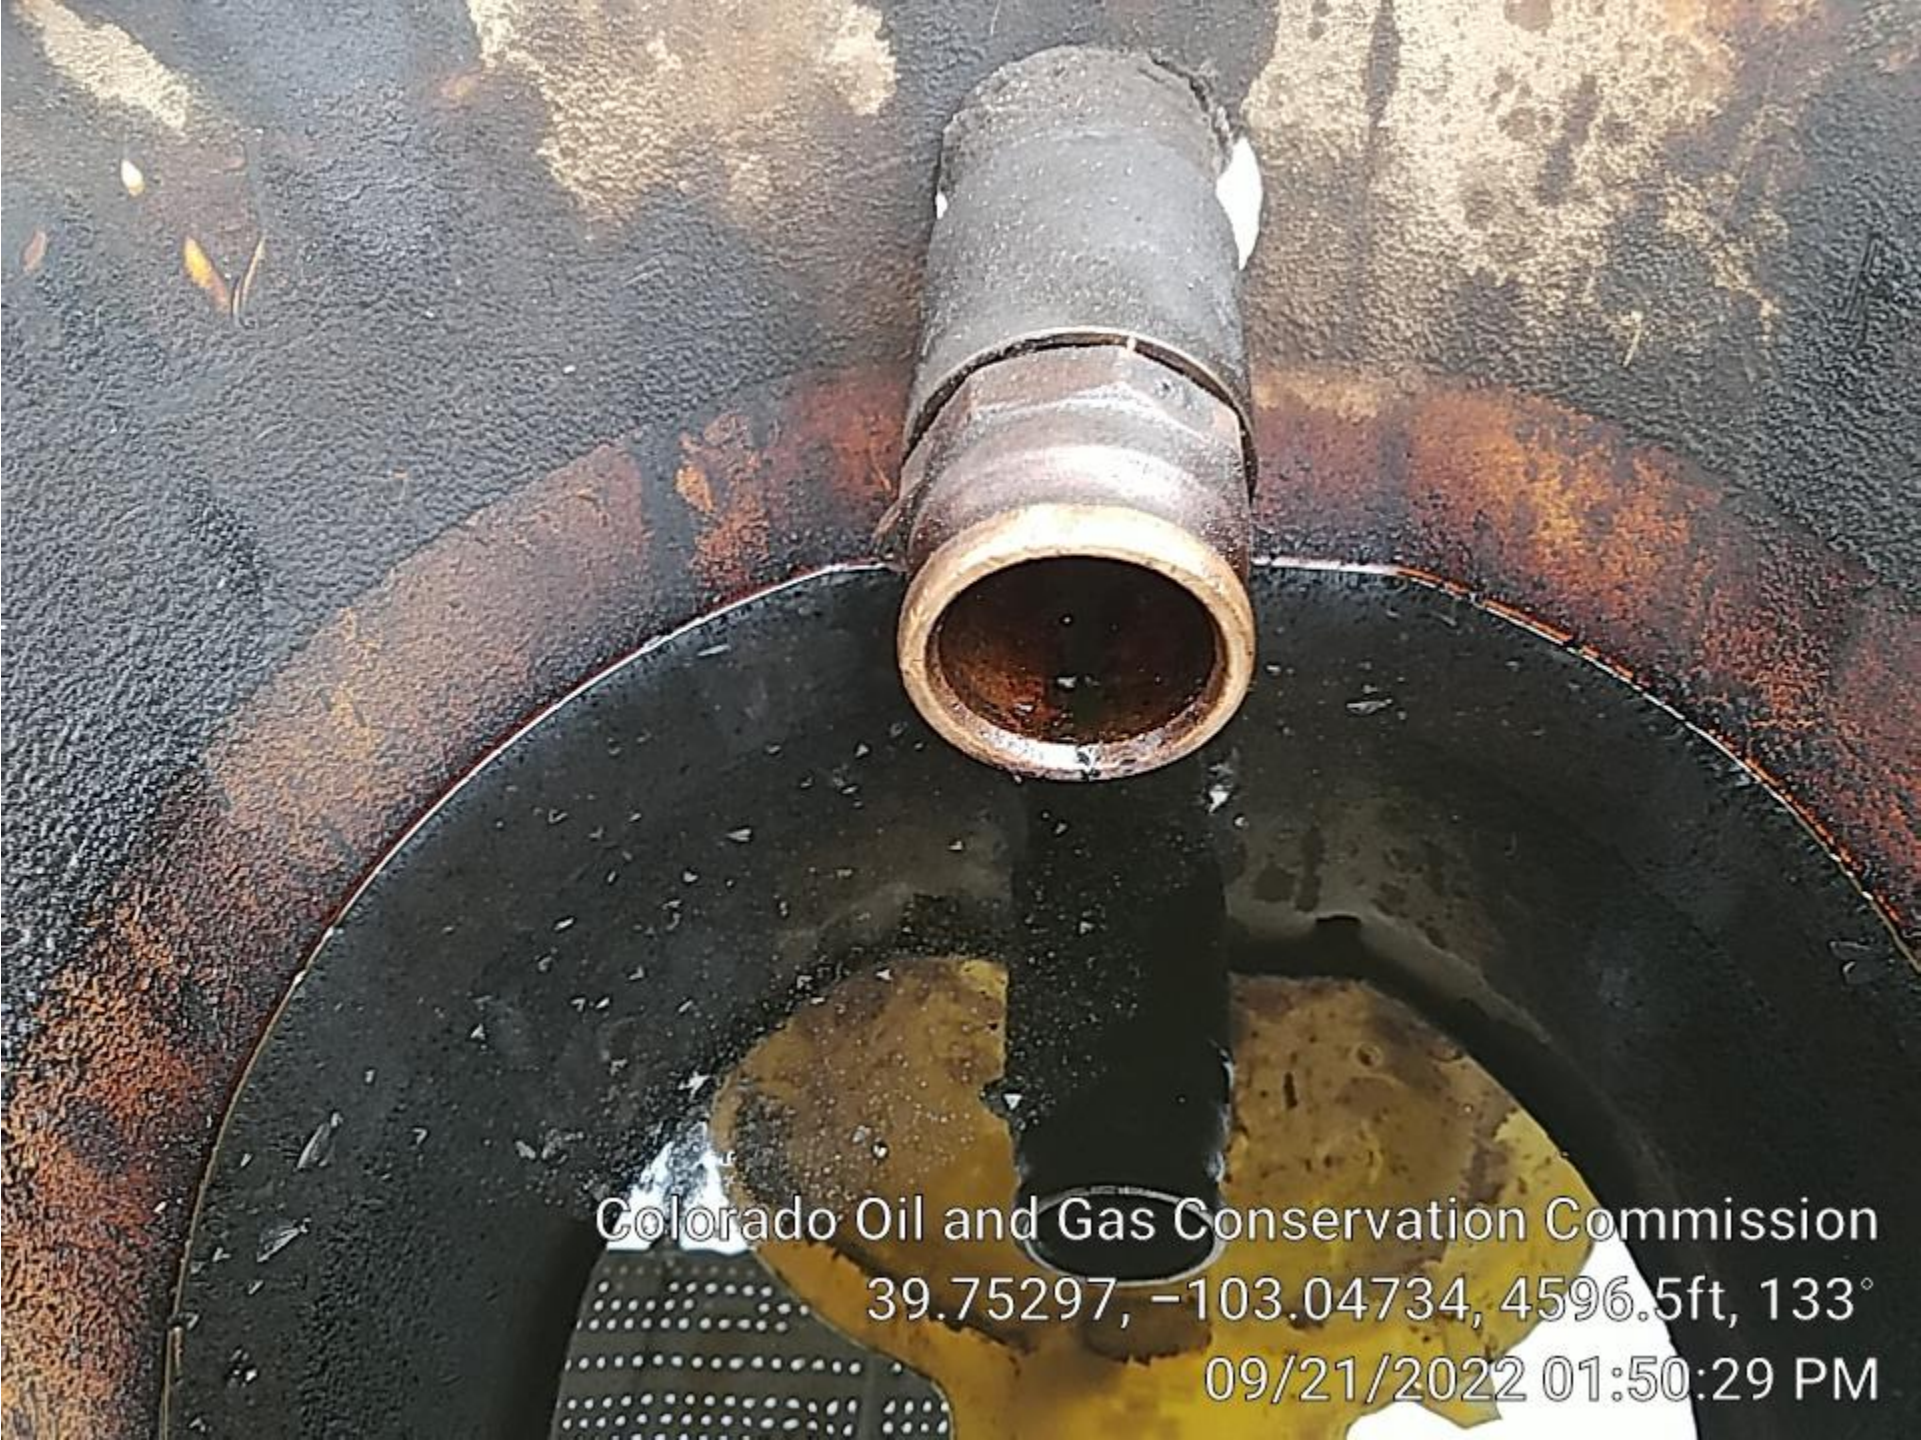
No
bullplug
on
loadout.

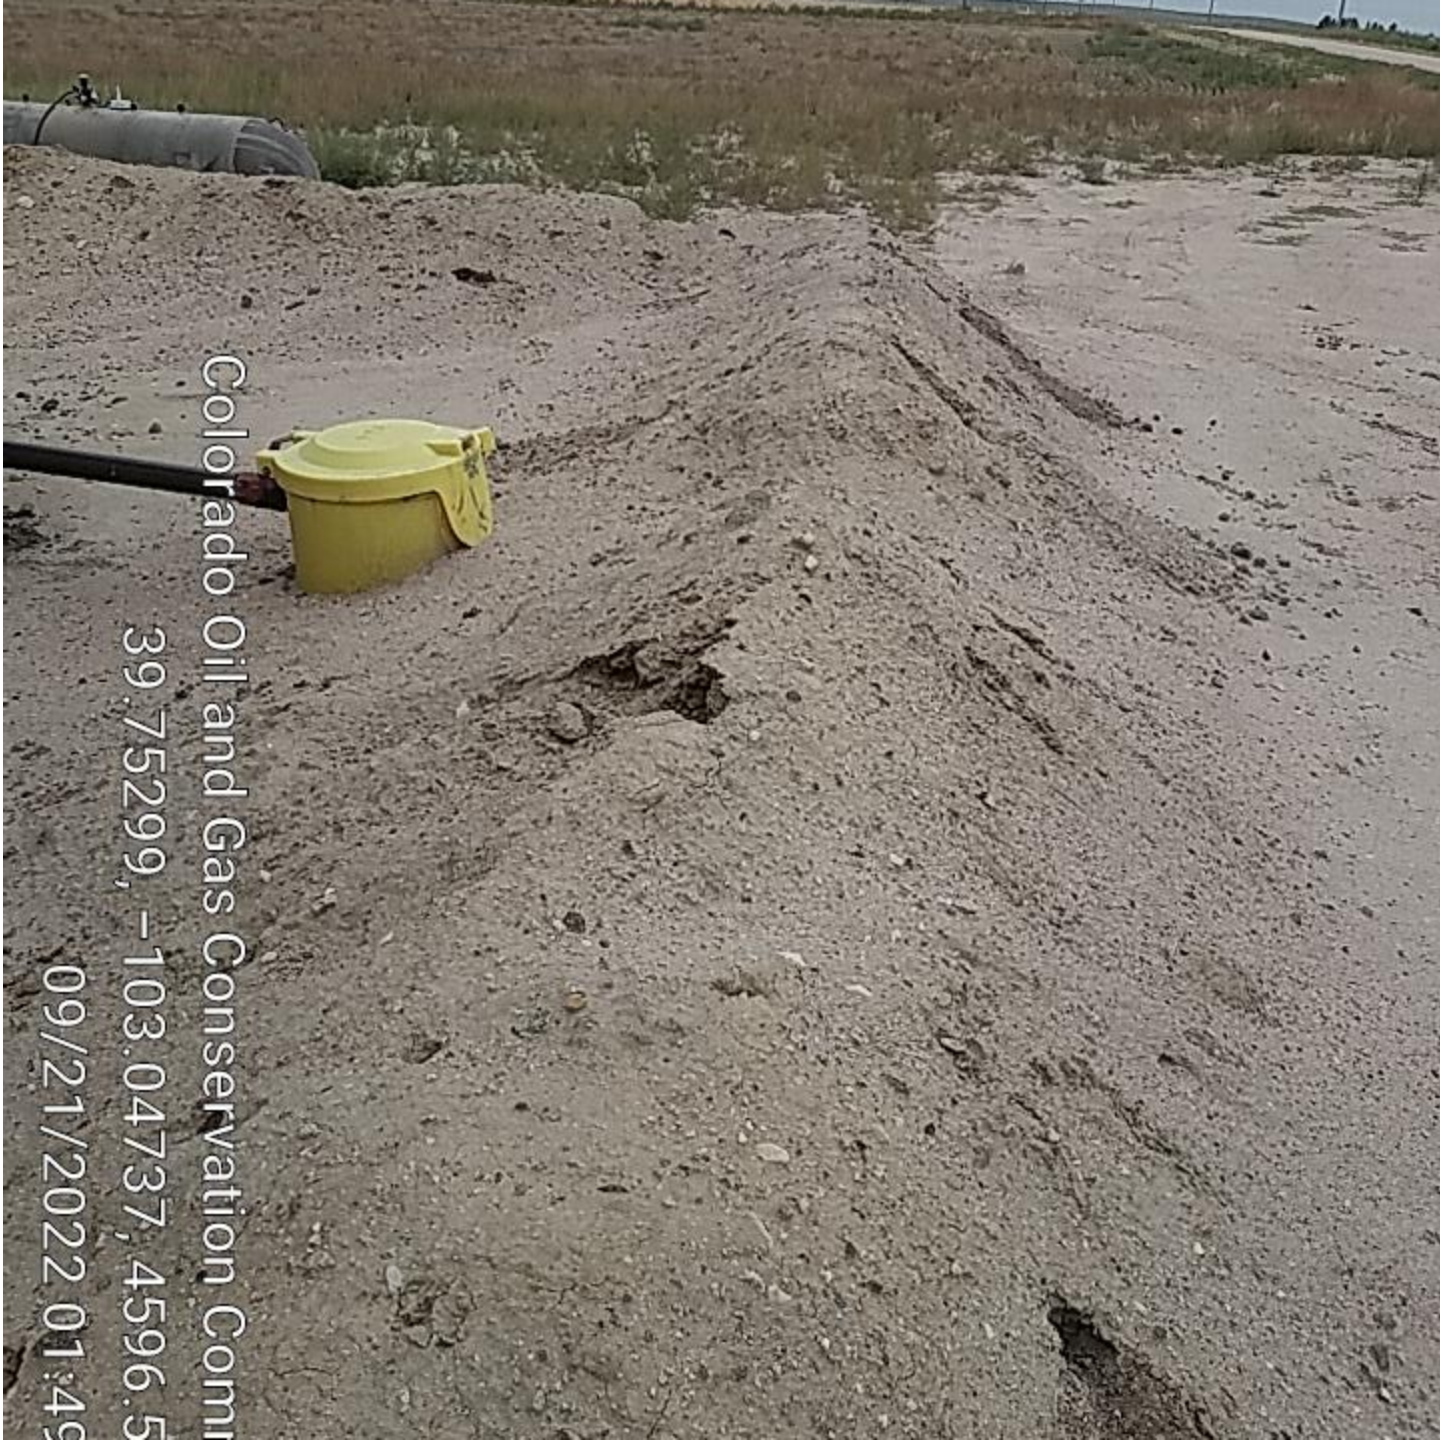
Animal holes in tank berms.

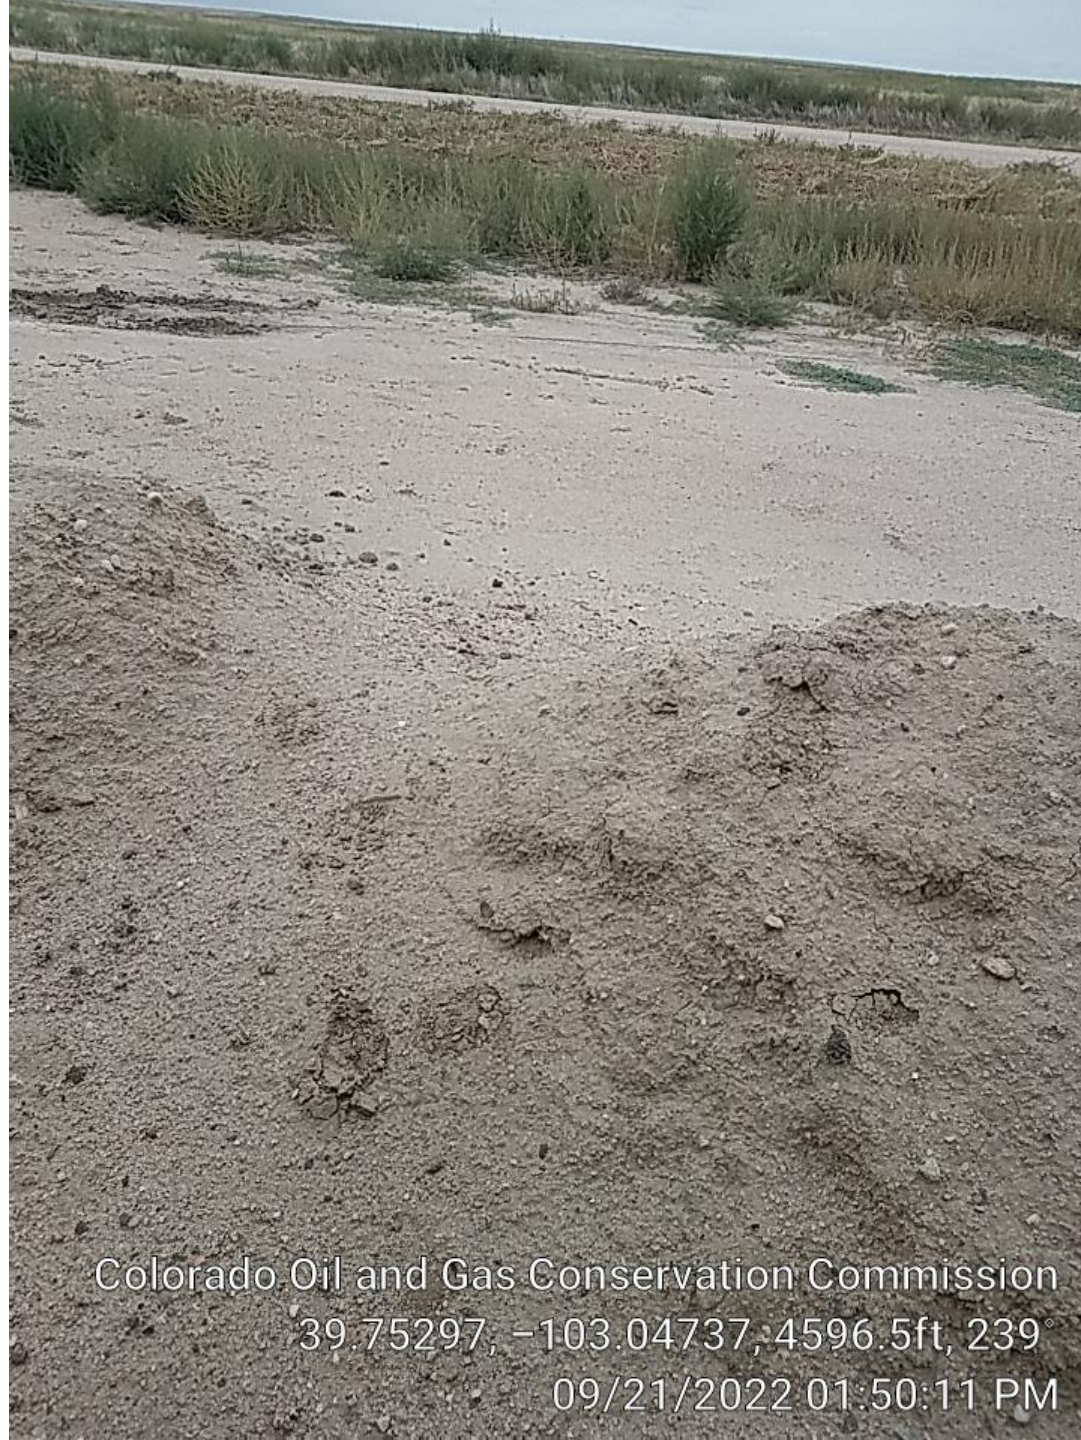
Crude oil
tank berm
near CR
MM is
worn
down.

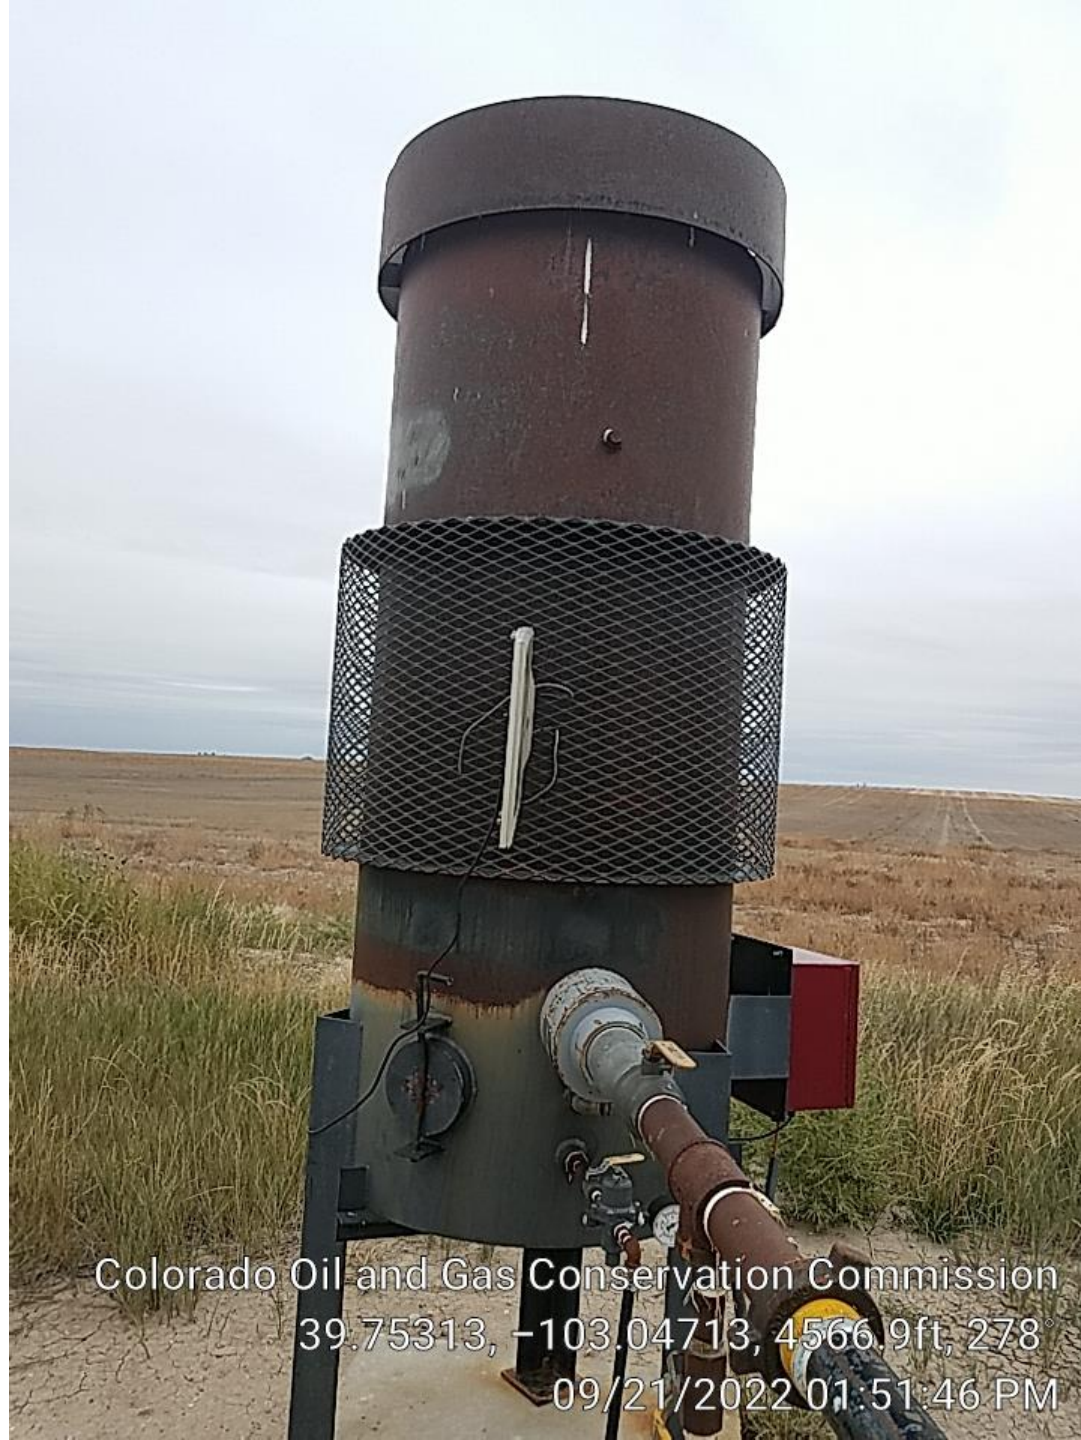
ECD not on, not required.

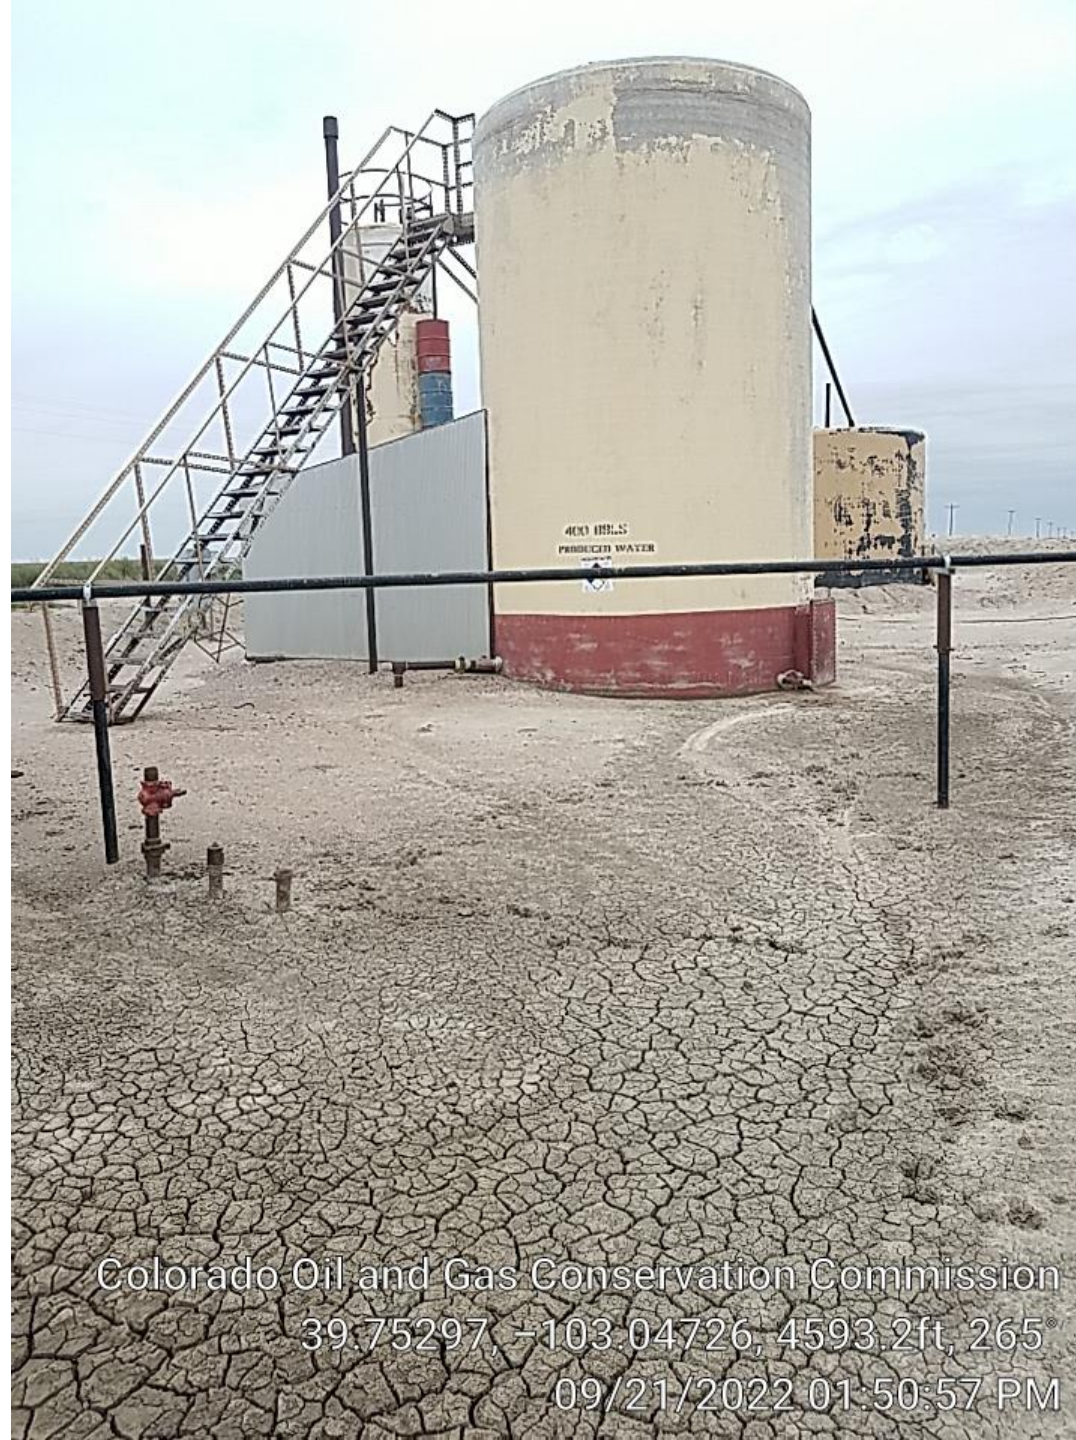
The 400 bbl PW tank is leaking at tank valve (see next photo) and has run down hole per this photo.

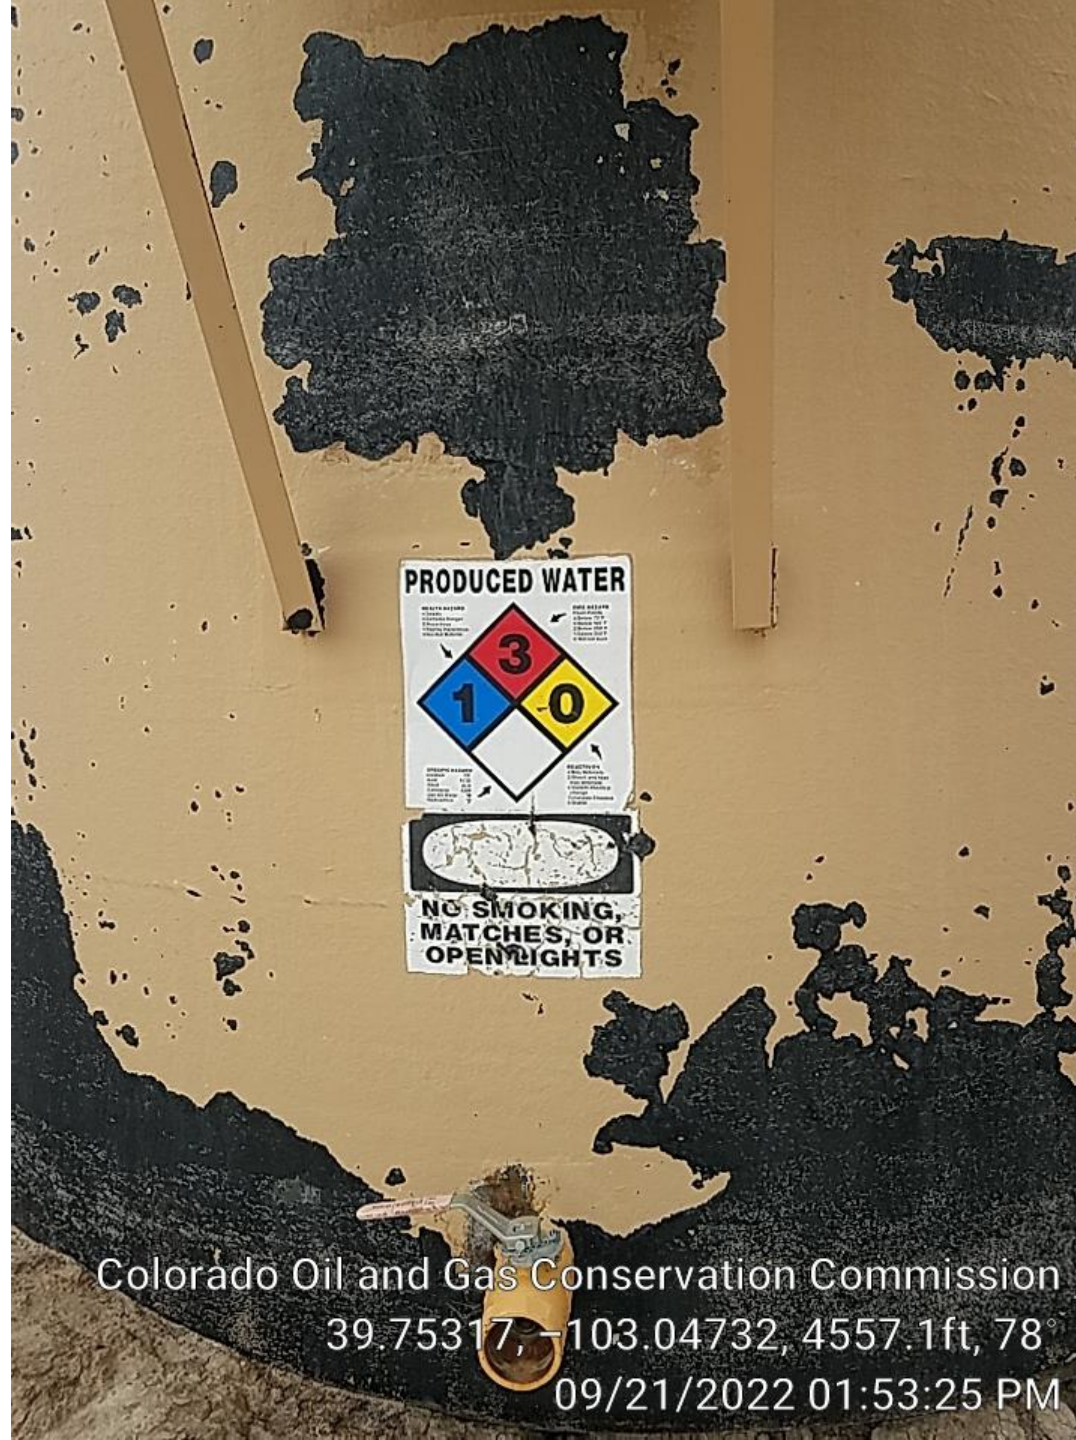
Tank quantity label is needed.

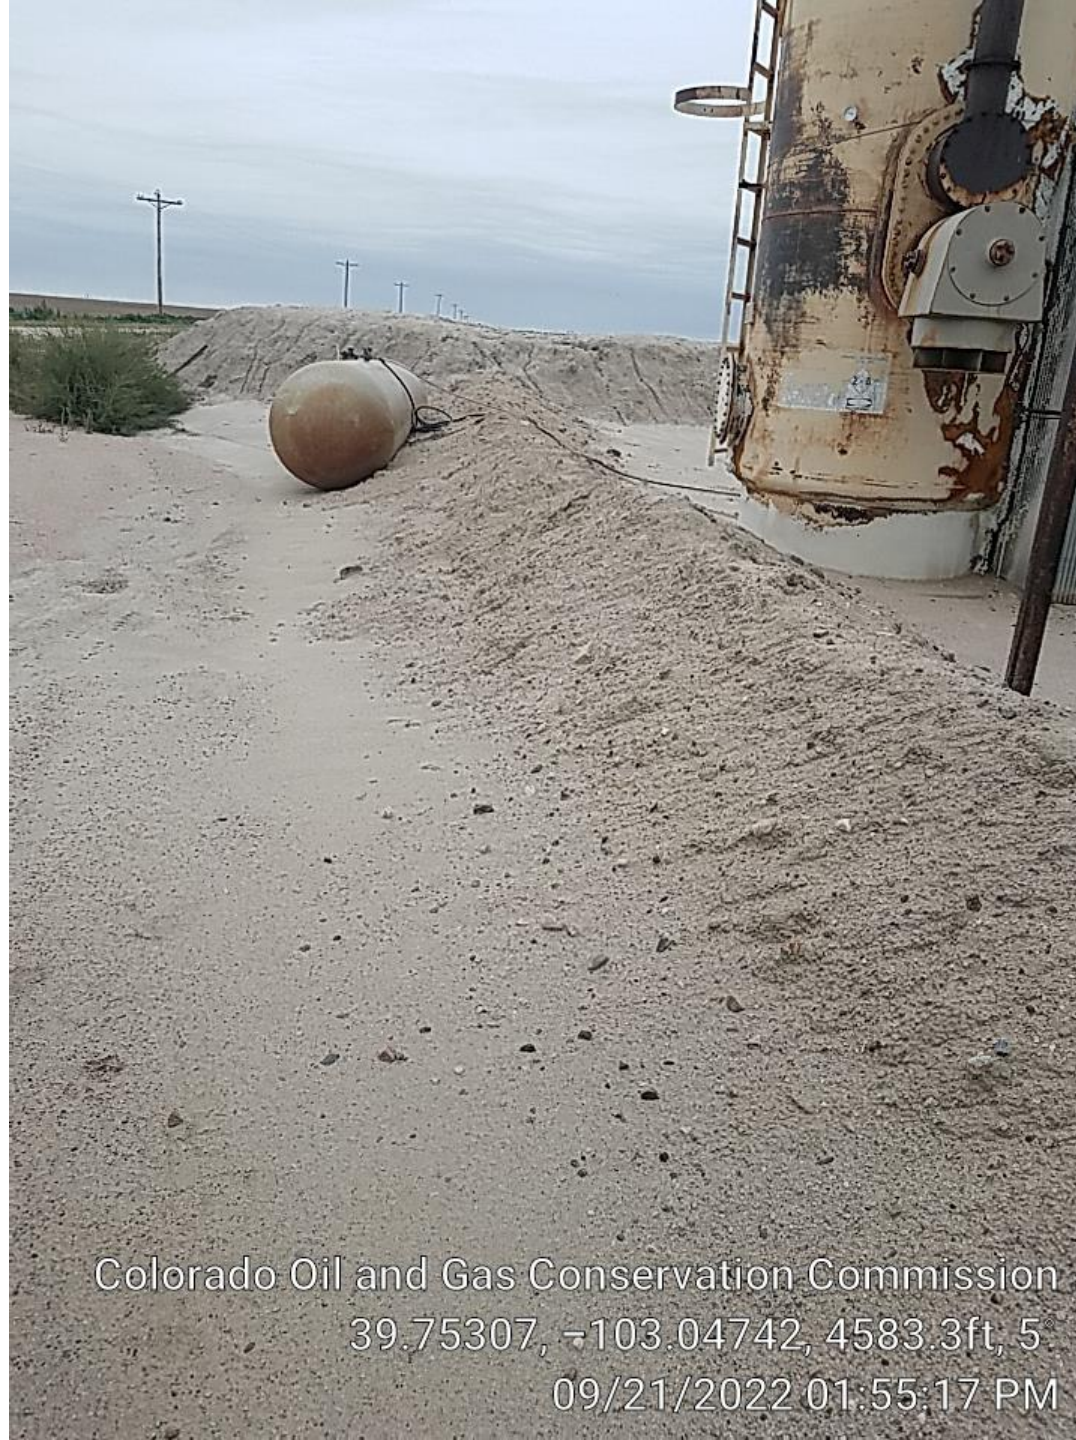
Tank berms are eroding.
