Inspection Photos

API: 071-06819

Operator: WAPITI OPERATING LLC

Inspection Date: 9/23/2022

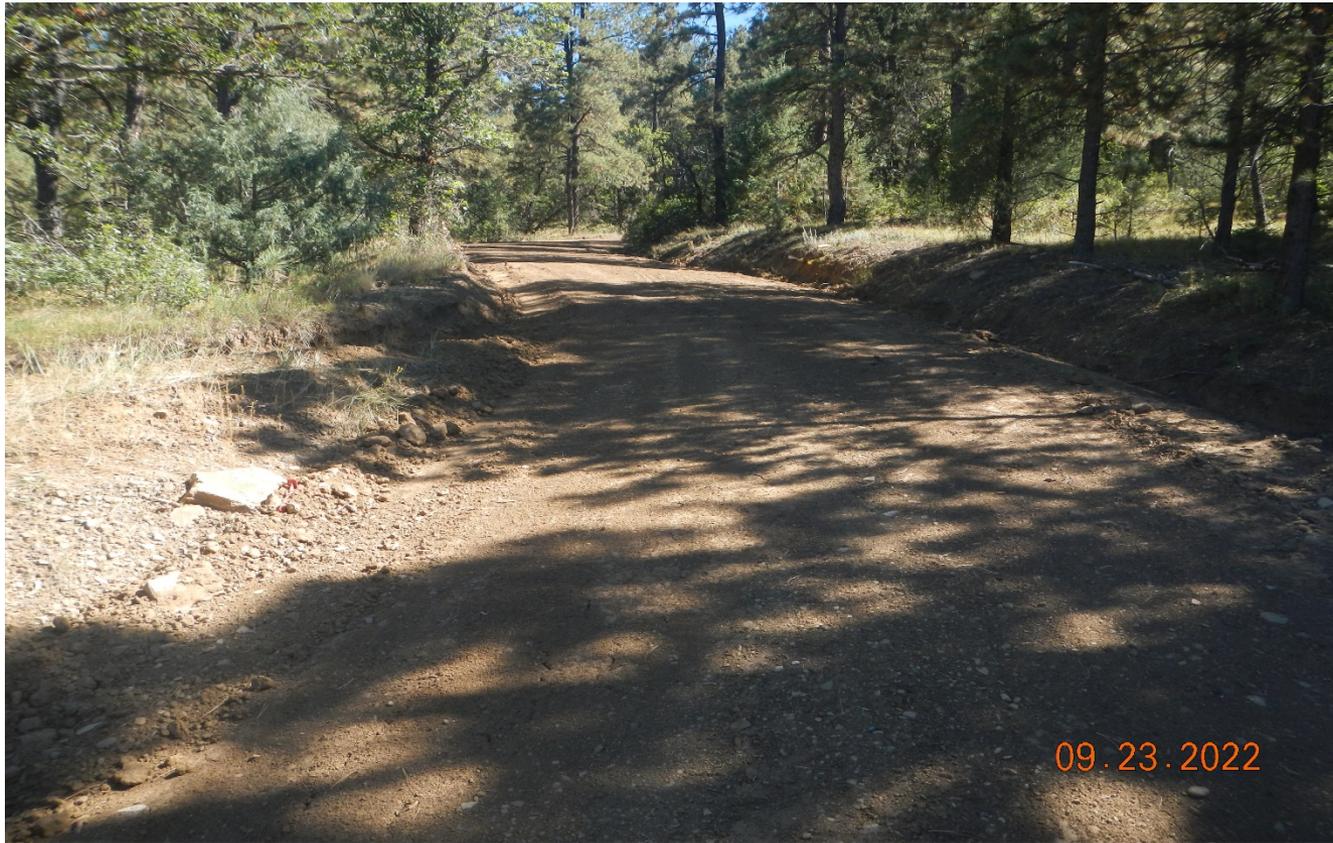
Photo 1. Facing southeast along the access road. The road has recently been graded.

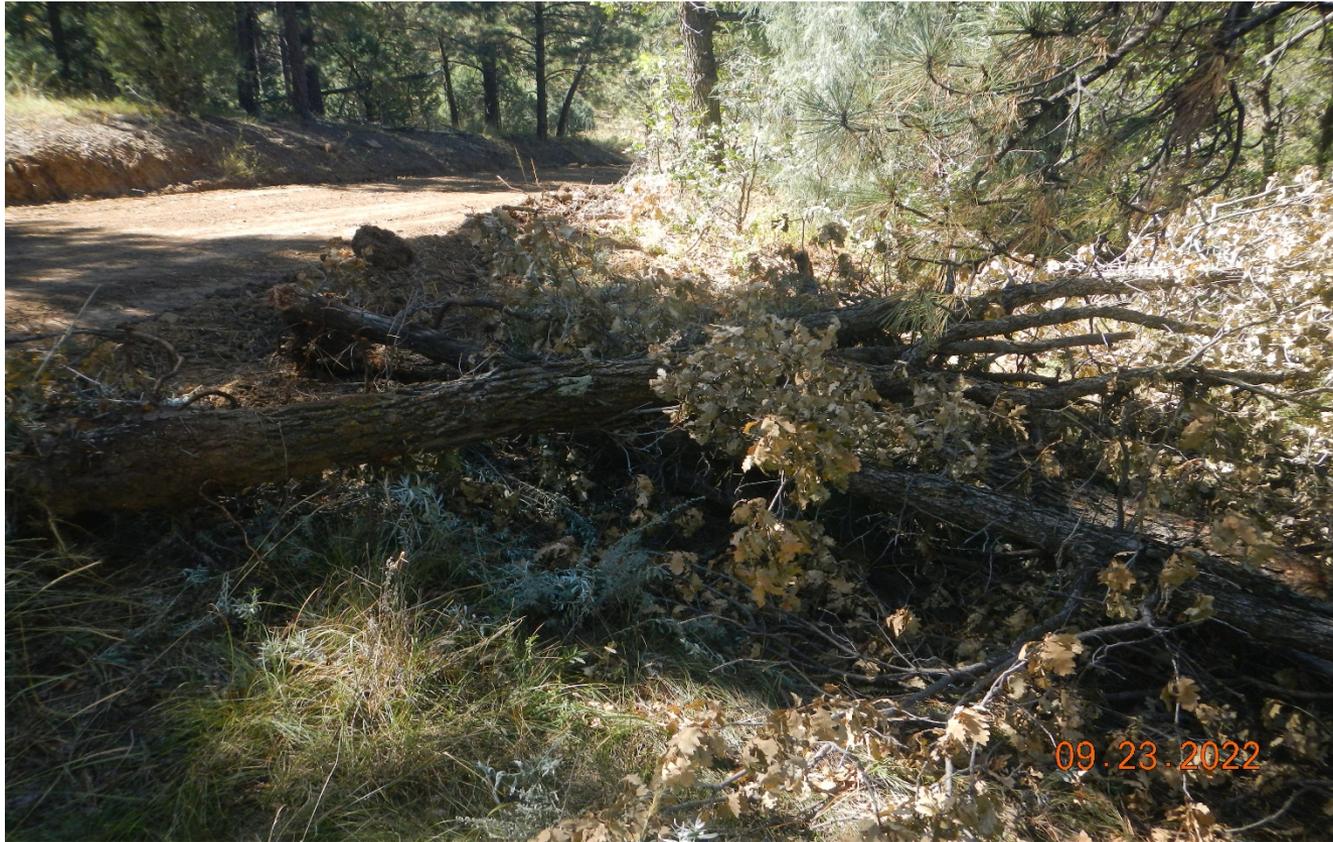
Photo 2. The grading of the road pushed over these large oaks causing additional disturbance and widening of the road. The tree debris will need to be removed.

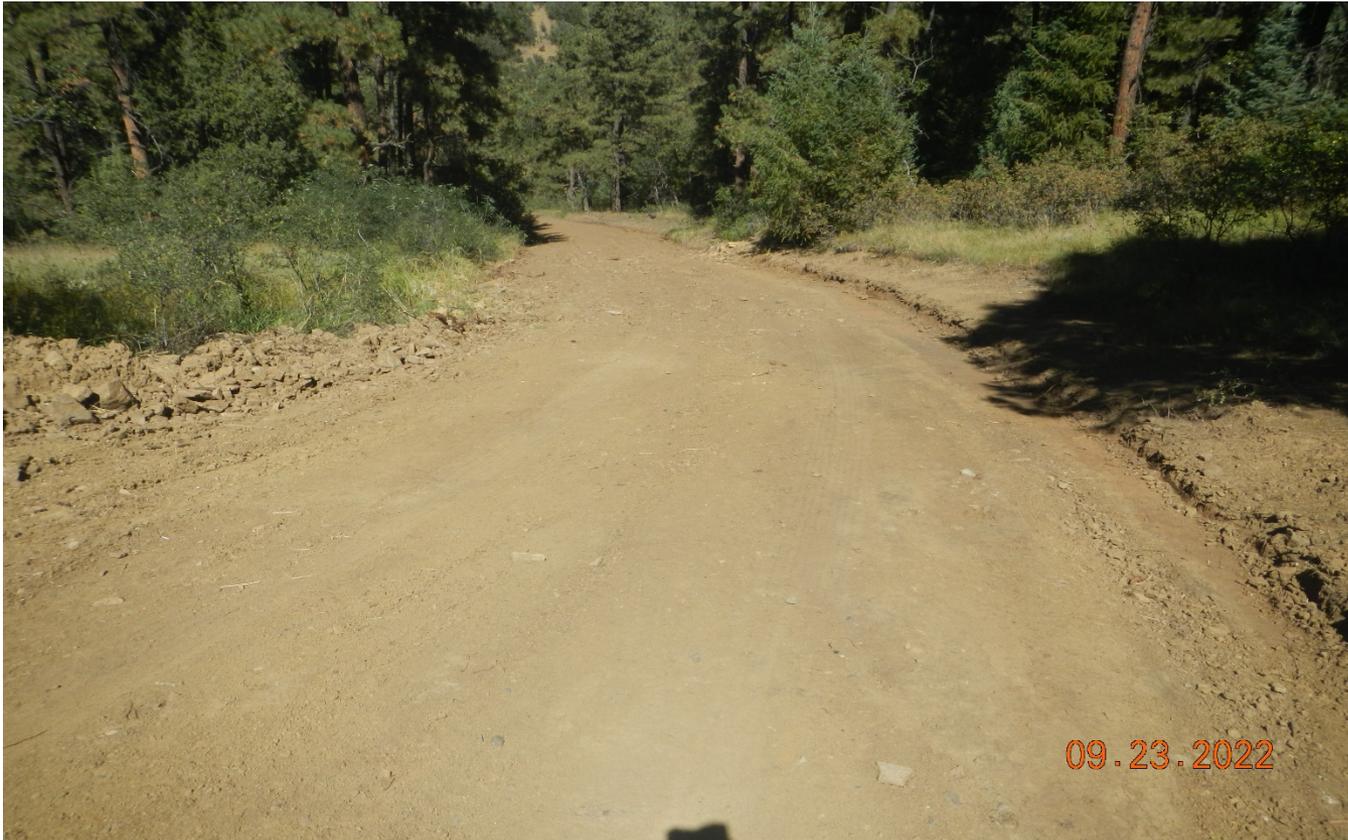
Photo 3. Facing back to the north facing down toward the access road. There are no BMP's along the road side to prevent erosion along the long steep grade of the road. Stormwater will cause erosion of the roadside and BMP's must be installed.

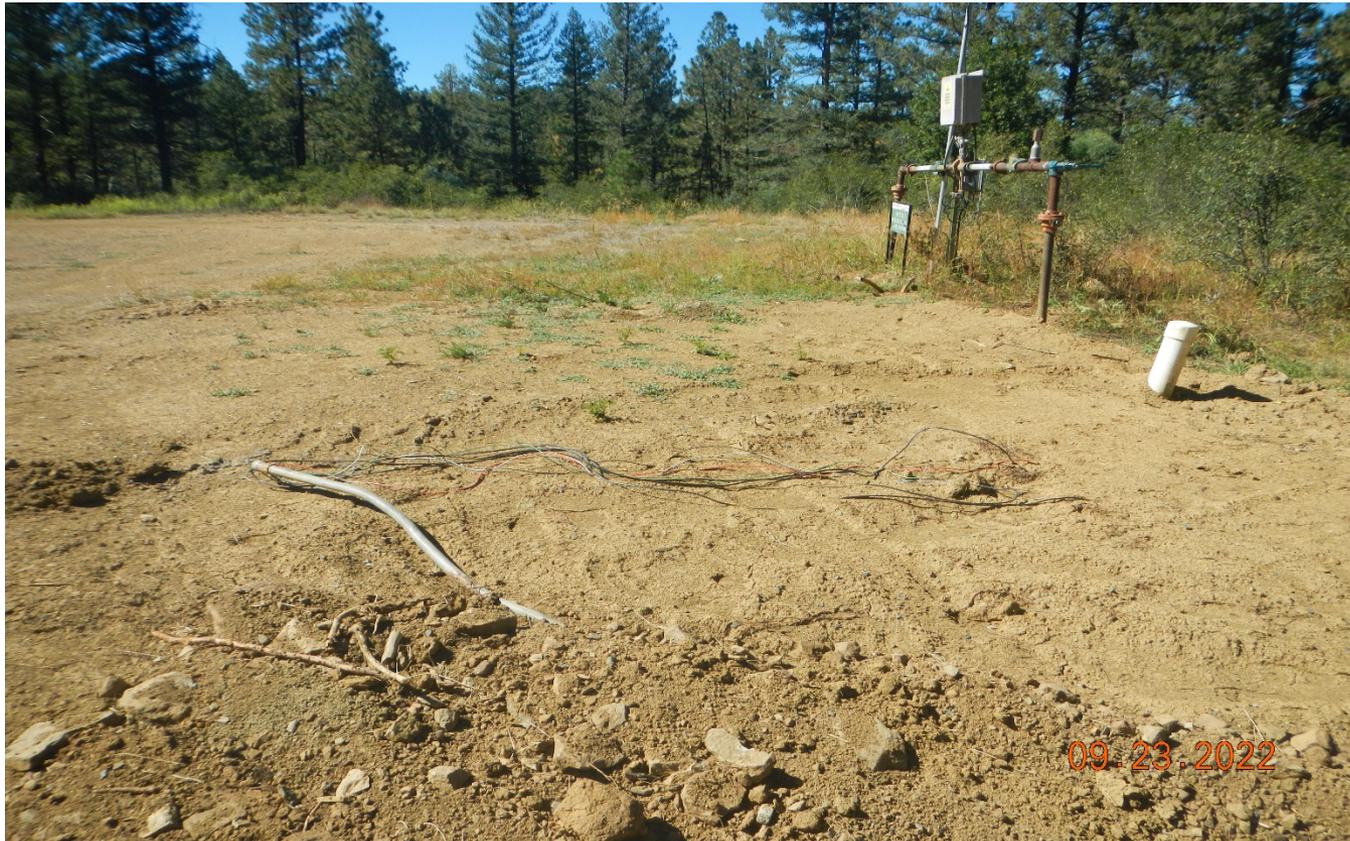
Photo 4. Facing northwest toward the wellsite. There are exposed electric lines on the surface. The lines need to be removed or repaired and protected. This area of disturbance needs to be seeded and stabilized.

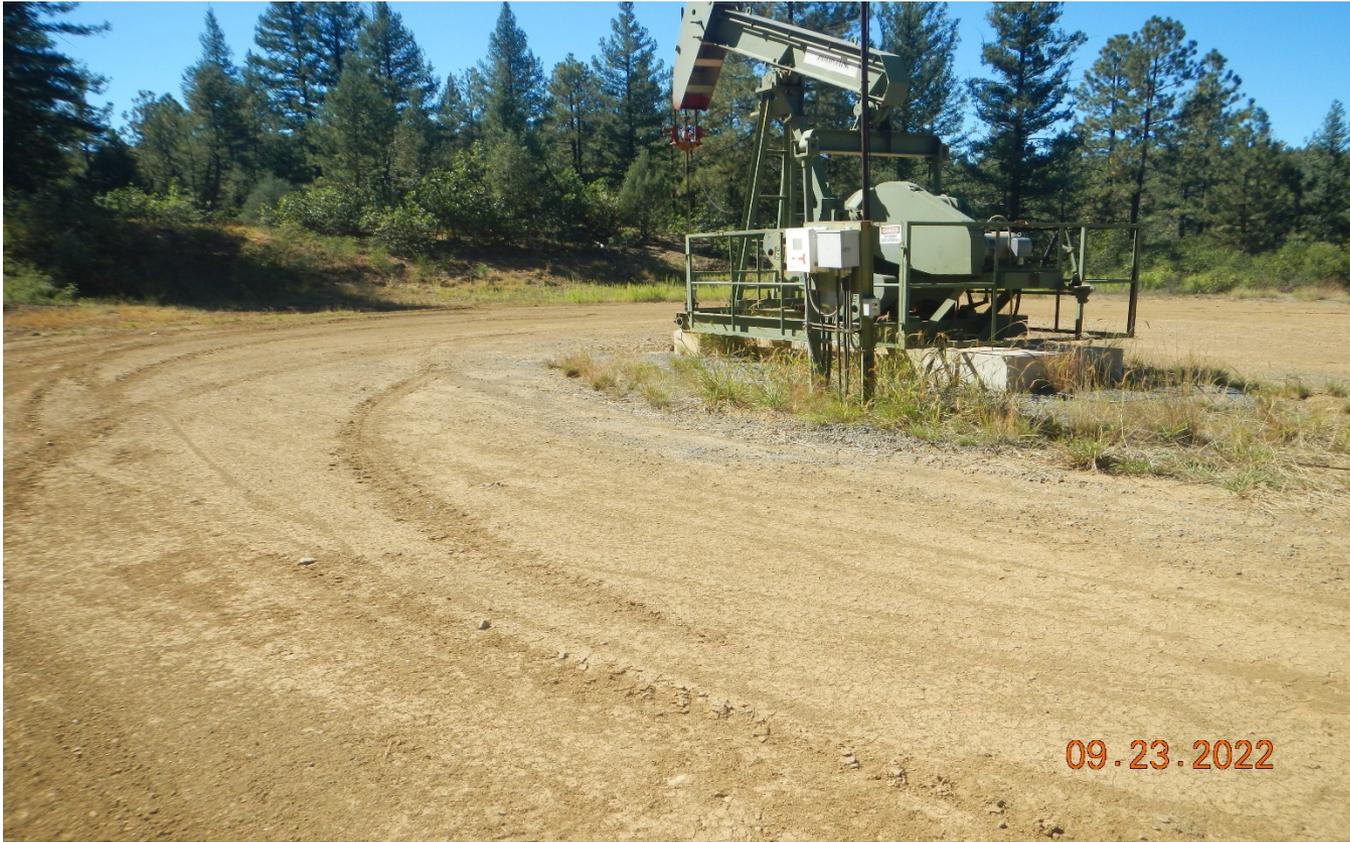
Photo 5. Facing northwest toward the wellsite.
