## Inspection Photos

Location Name: Walters-Wedco-Ryland SW 21 Pad

Location ID: 319437

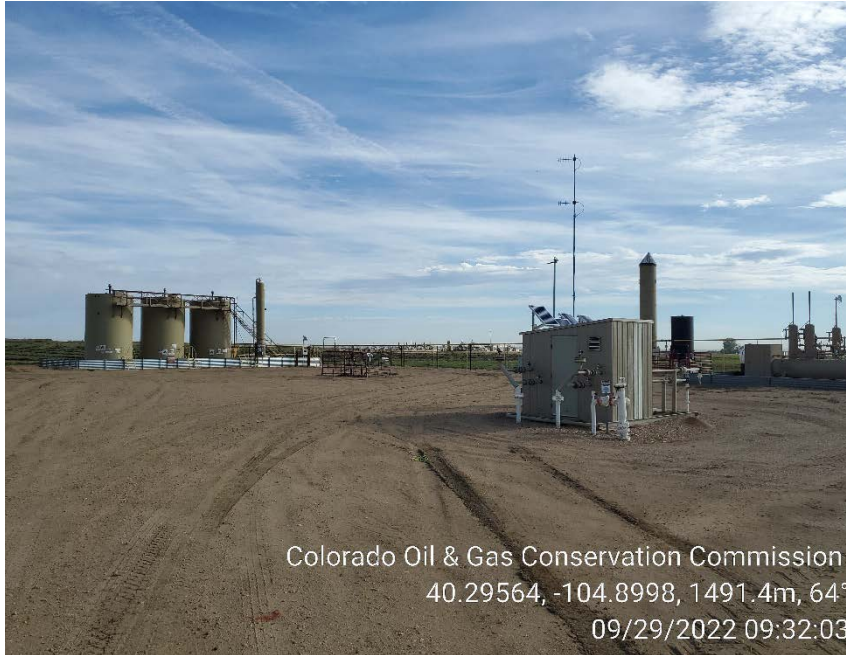
**Production facility**

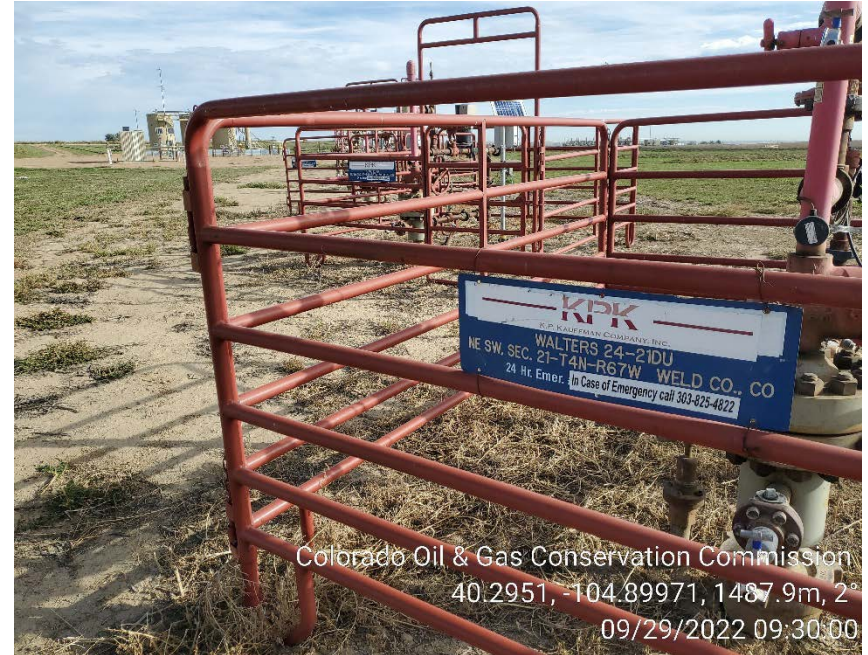
**Wellheads**

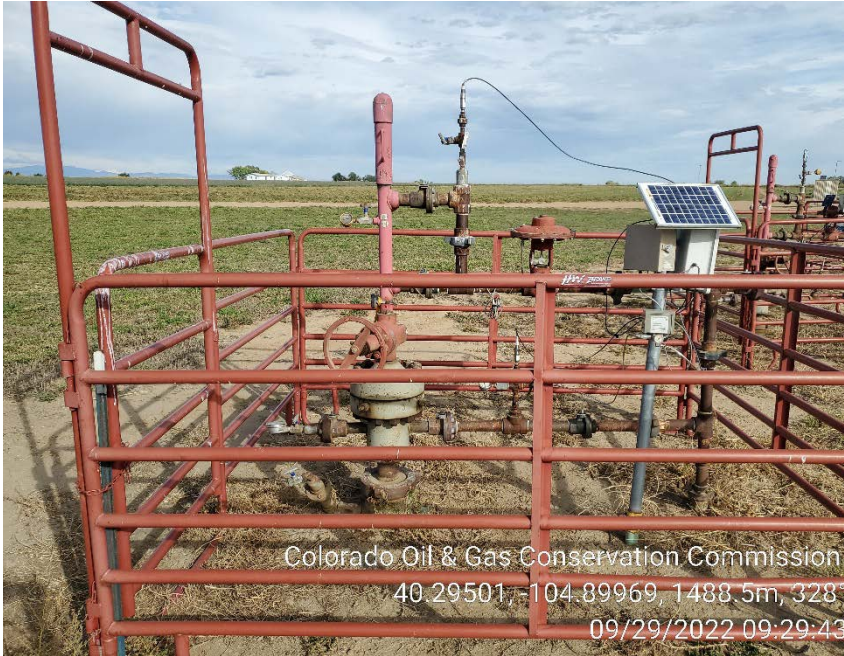
**Walters 21LDU wellhead lacking sign**

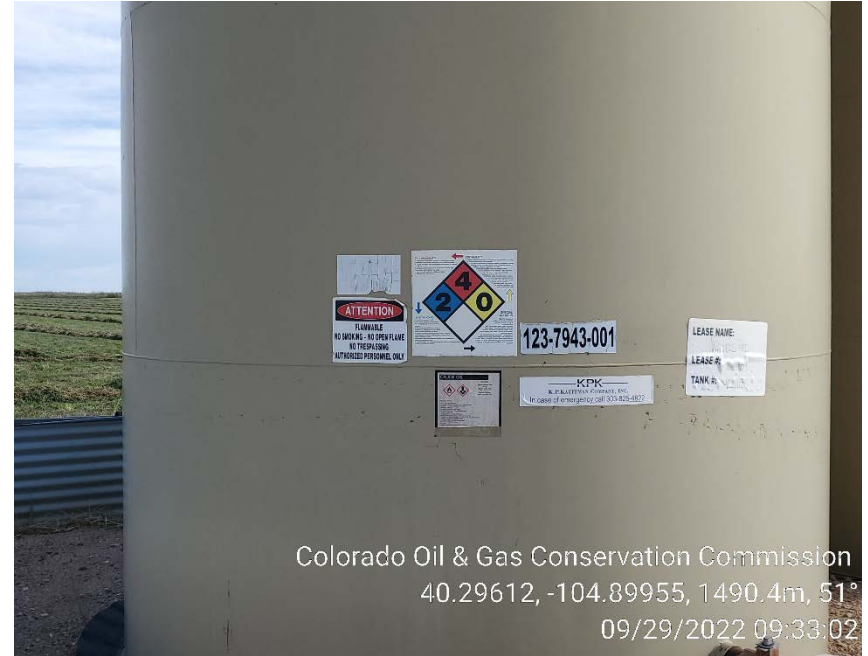
**Crude oil contents and capacity placards**

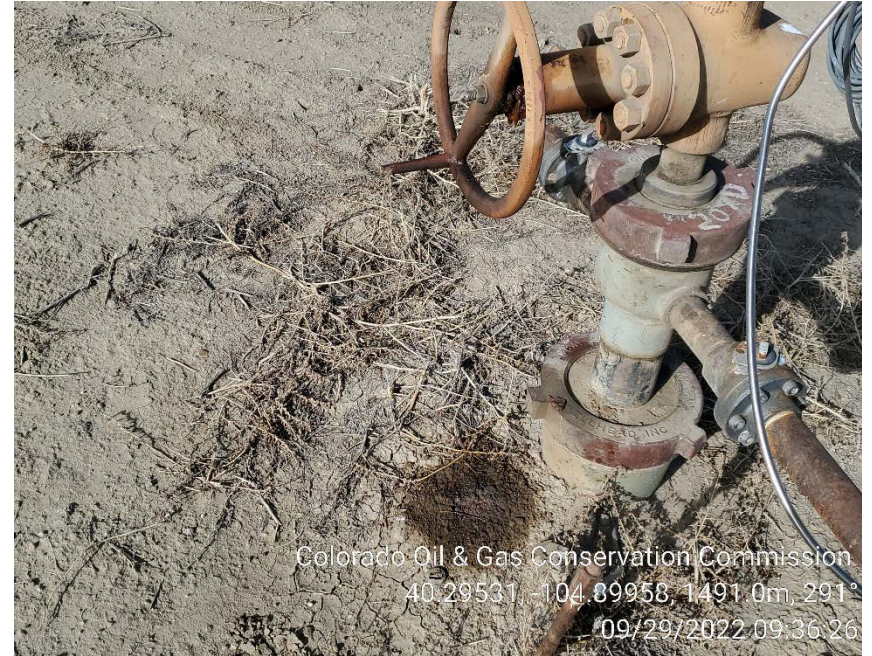
**Ryland 20XD master valve leak and stained soil**

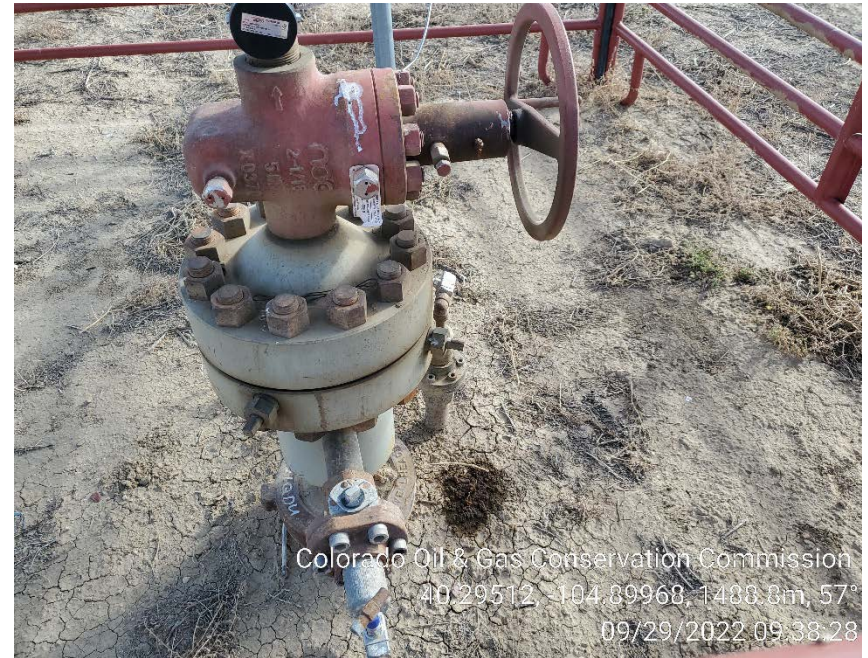
Walters 21DQU master valve leak and stained soil

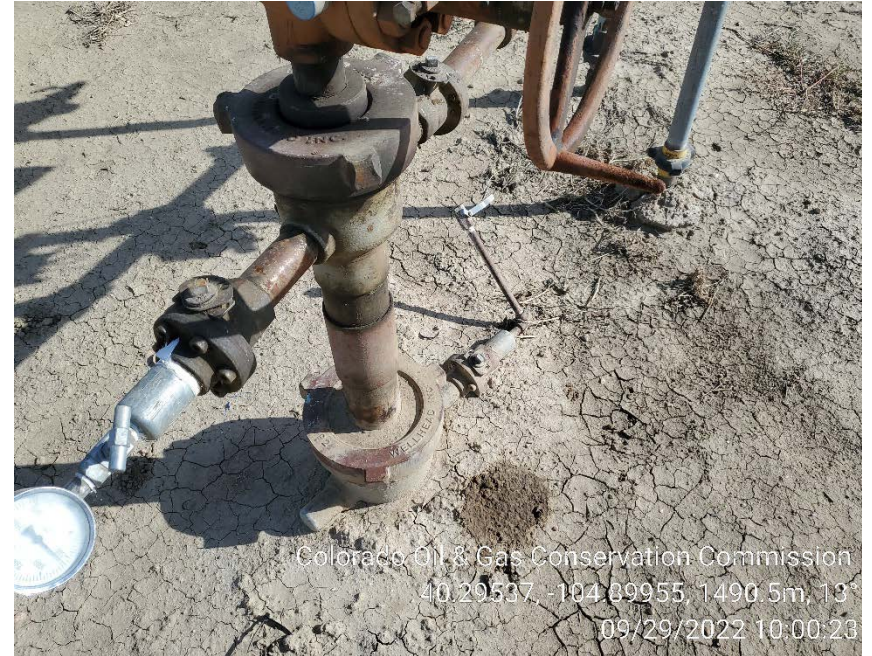
**Walters 23-21DU master valve leak and stained soil**
