Construction and Stormwater Inspection

Operator: KERR MCGEE OIL & GAS ONSHORE LP #47120

Location ID: 478972

Inspection Photos
Location Name: GADDIS /3-36HZ PAD
Location ID: 478972

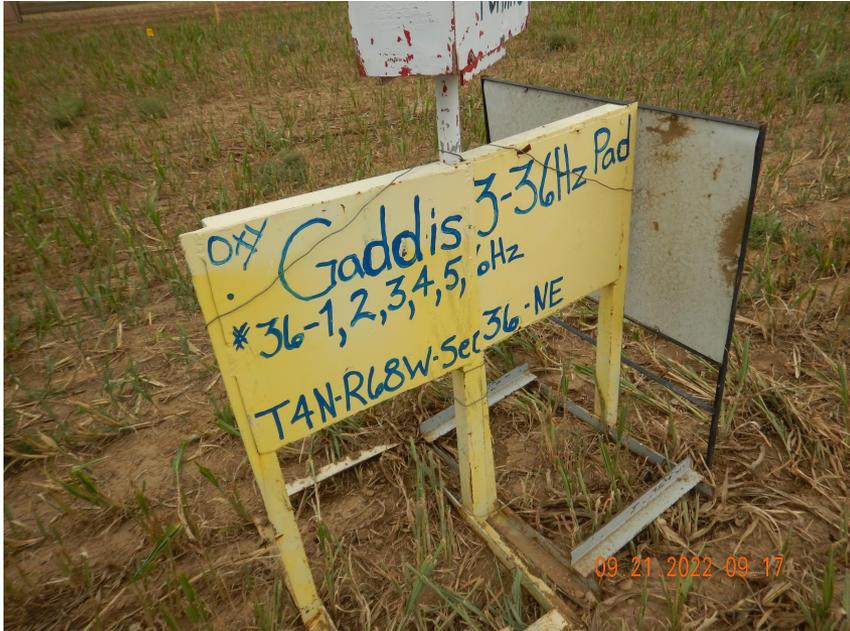
Photo 1. Photo taken from the entrance of location. Photo illustrates the Operator sign and mailbox. This mailbox only had the Weld County Grading permit.

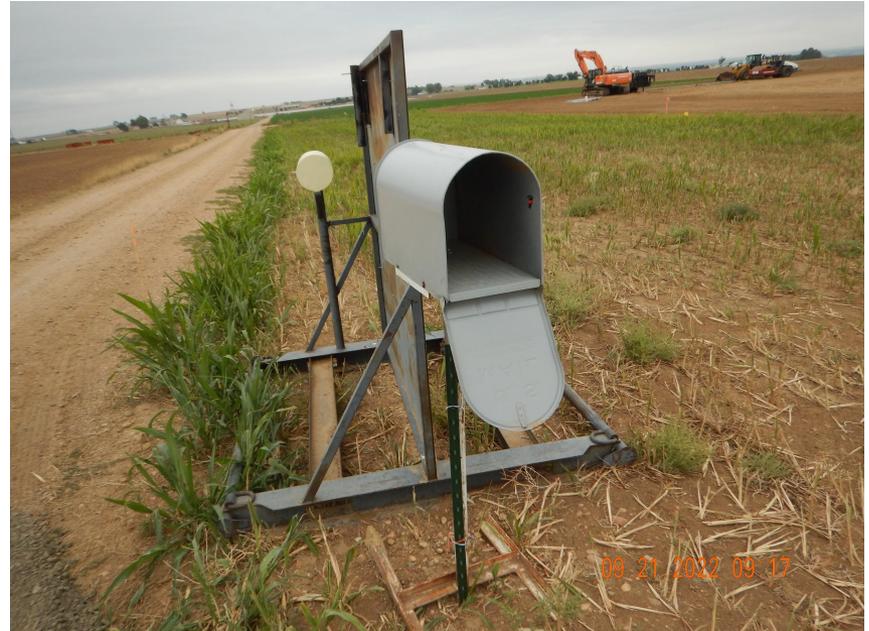
Photo 2. Photo taken from the entrance of location, facing East. Photo illustrates mailbox was open and without the required permits.

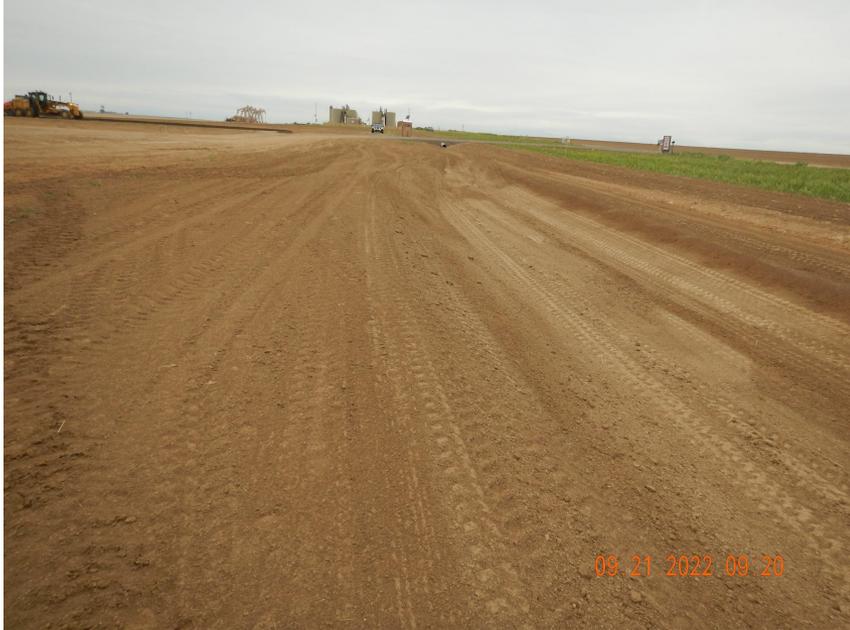
Photo 3. Photo taken from the eastern location, facing North. Photo illustrates a ditch and berm BMP installed around the perimeter of location which is directed to a retention area.

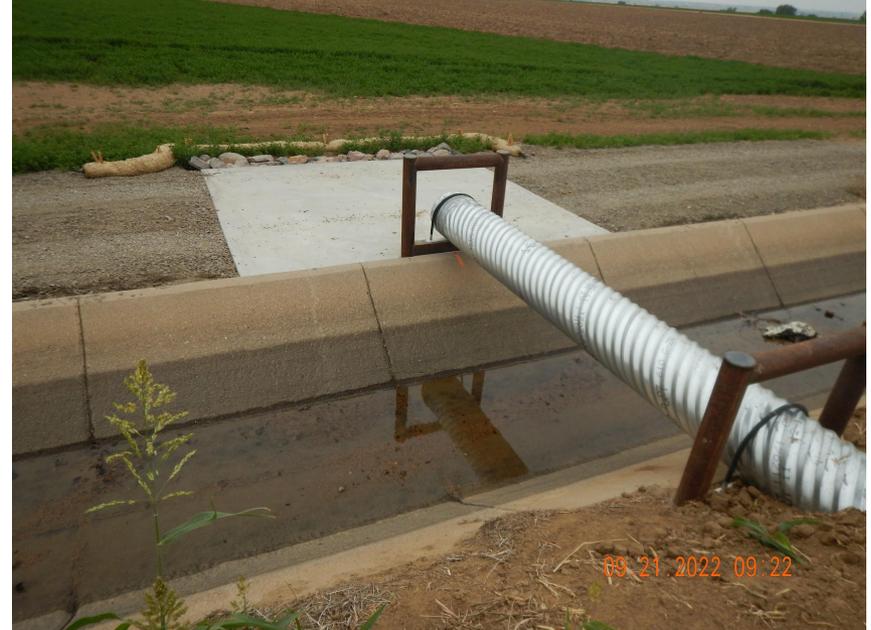
Photo 4. Photo taken from the eastern location, facing East. Photo illustrates the overflow outlet. Stormwater discharge would not be accepted into the irrigation ditch.

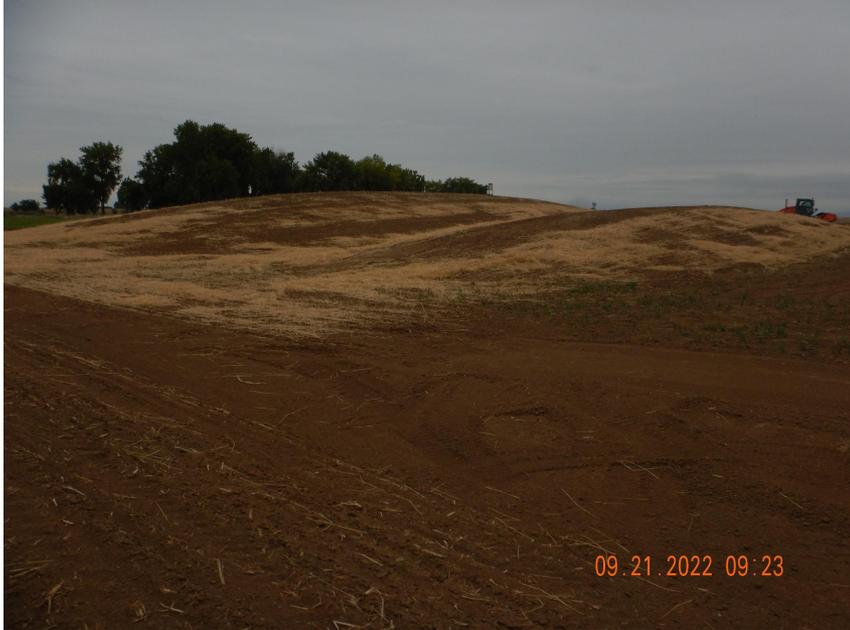
Photo 5. Photo taken from the southeastern location, facing Southwest. Photo illustrates the topsoil stockpile has been seeded and straw crimped with mulch. However, the straw crimped mulch has blown off most of the stockpile; therefore, CDPHE is requiring a corrective action.

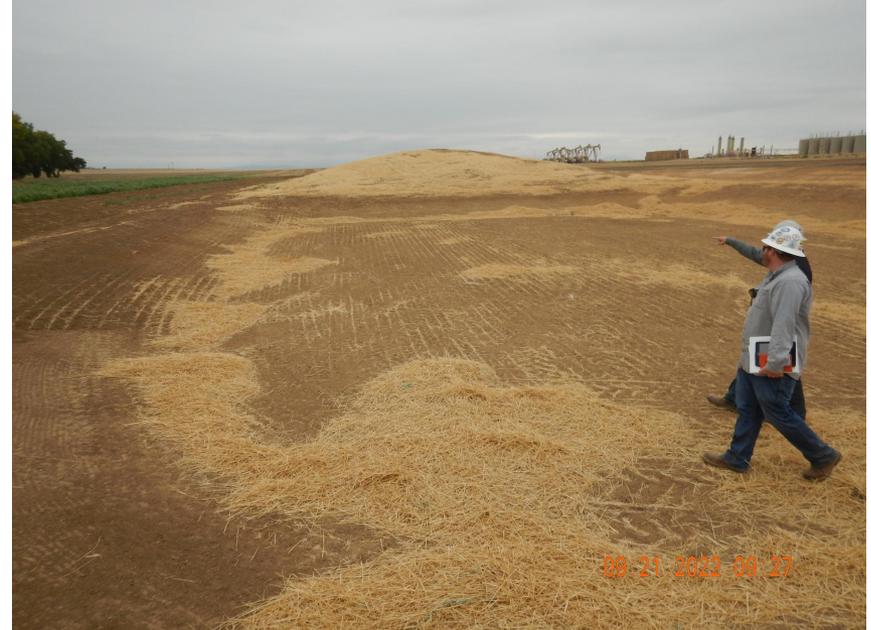
Photo 6. Photo taken from the southeast location, facing West. Photo illustrates the retention area.

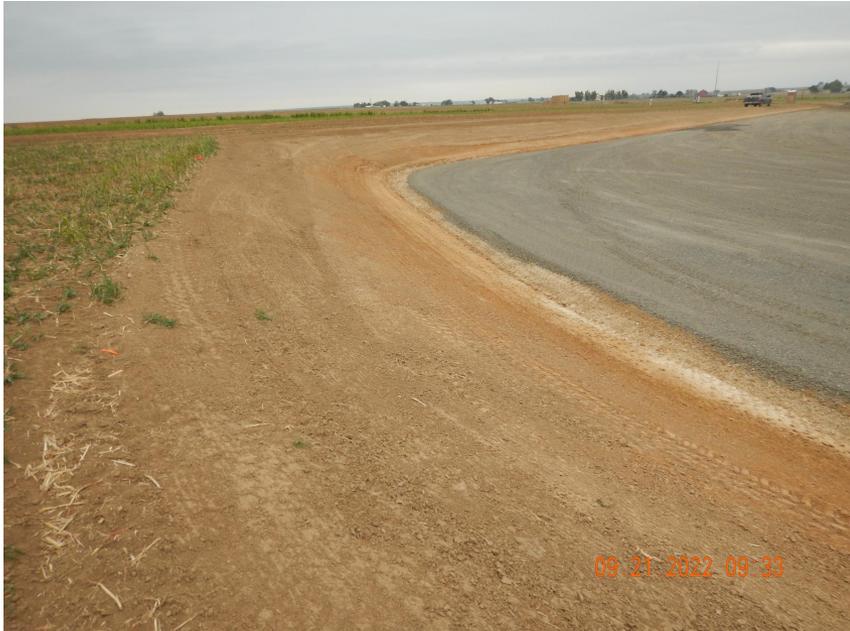
Photo 7. Photo taken from the northwestern location, facing North. Photo illustrates the cut slope may need further stabilization to ensure long-term stabilization.

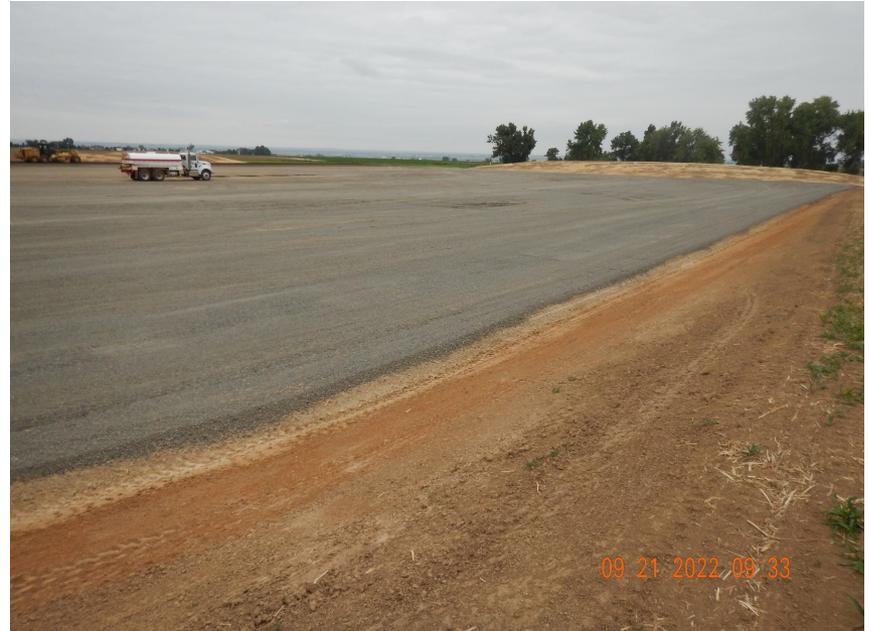
Photo 8. Photo taken from the northwestern location, facing Southeast. See comments under Photo 7.
