Inspection Photos

Location Name: TEP ROCKY MOUNTAIN LLC BROOME-66S91W /30SESE

Location ID: 335227

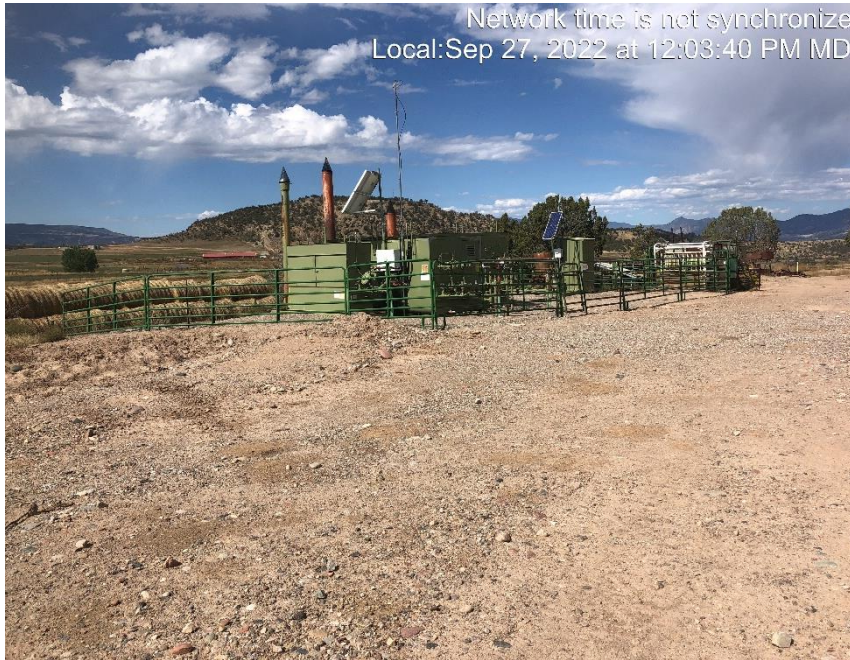
Photo #7795 From entrance to location.

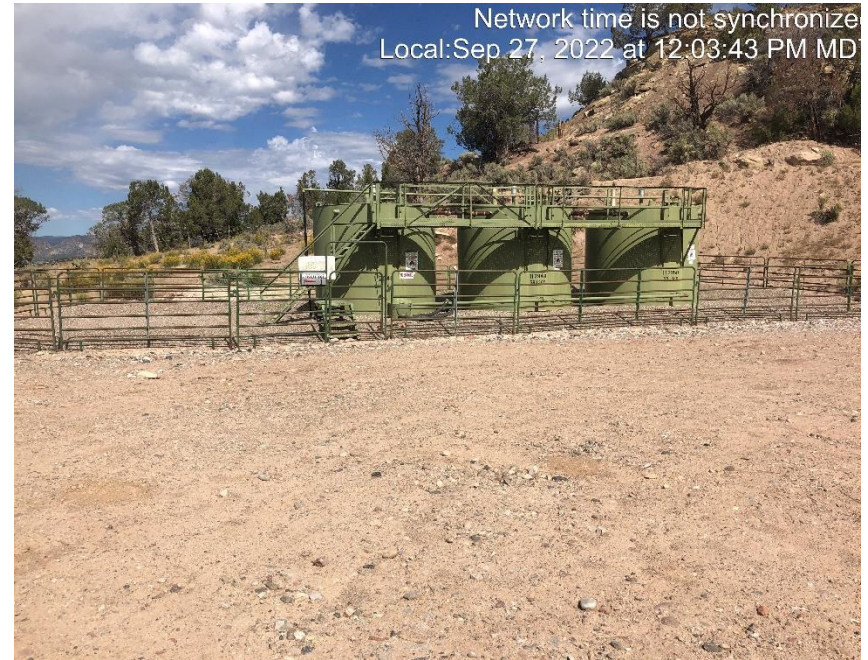
Photo #7796 From entrance to location.

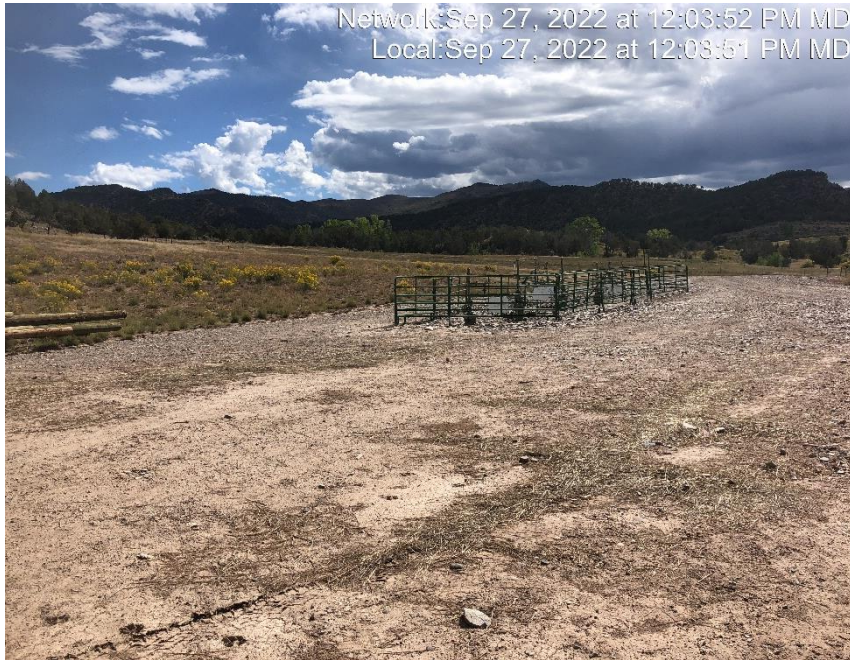
Photo #7797 From entrance to location.

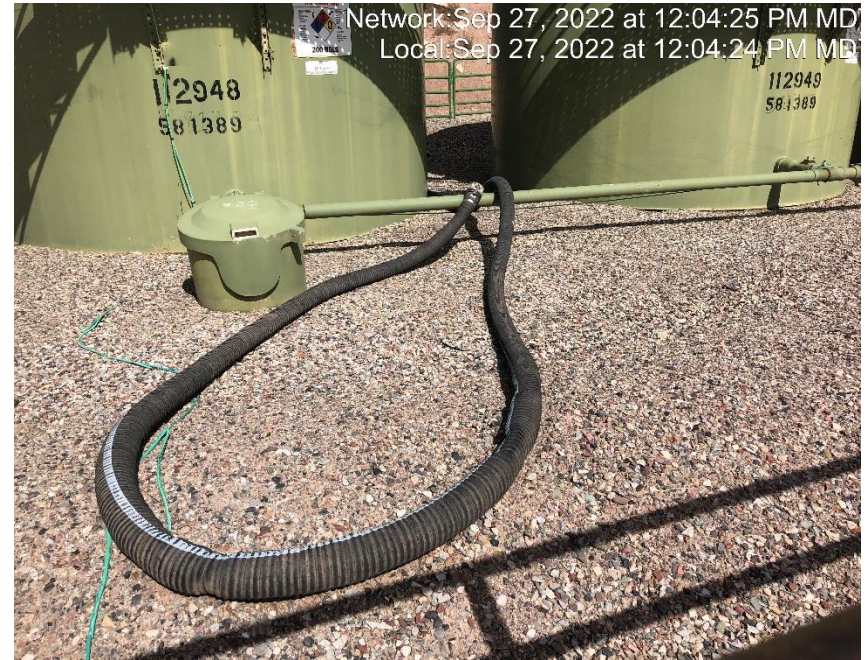
Photo #7798 Unused equipment.

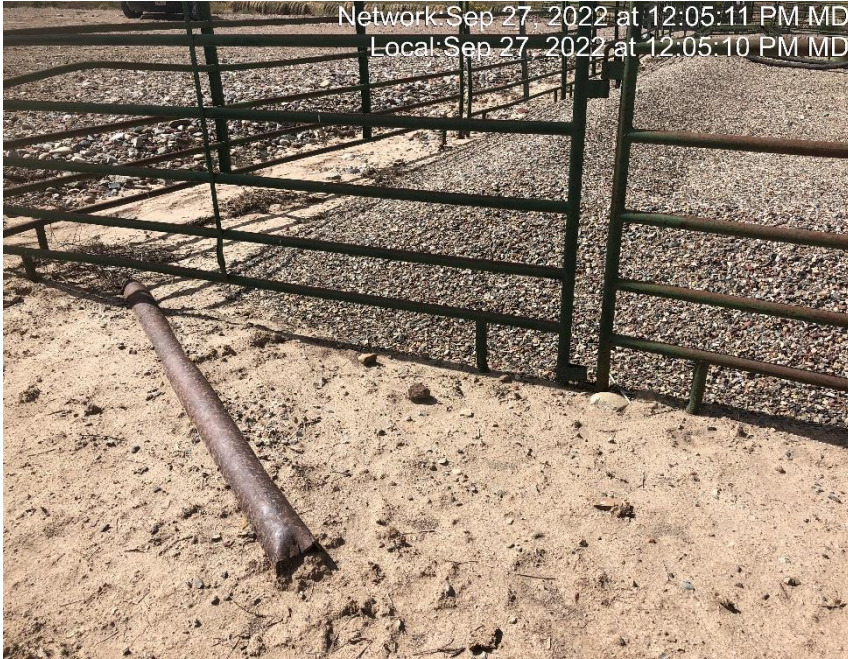
Photo #7799 Unused equipment.

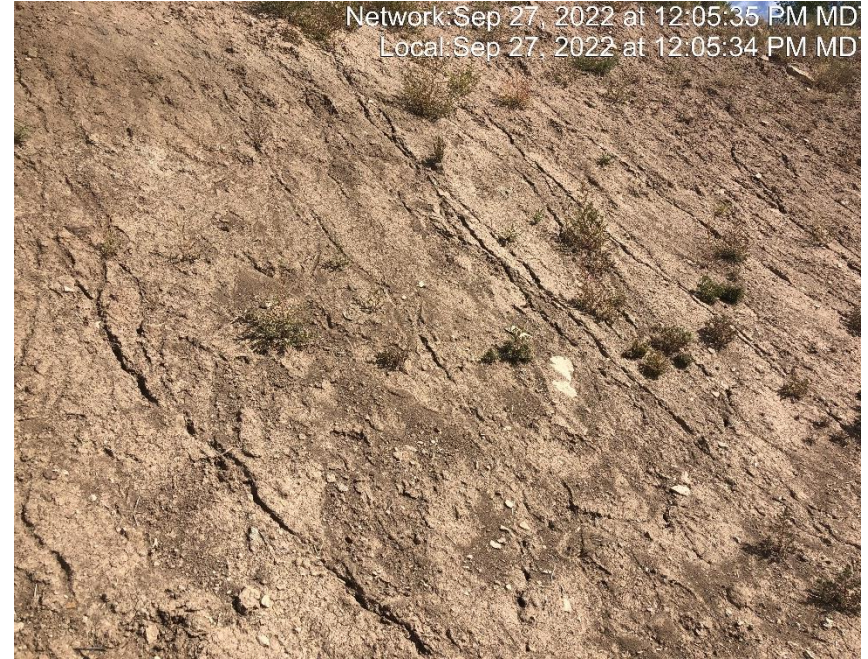
Photo #7800 Rill erosion occurring on cut slope.

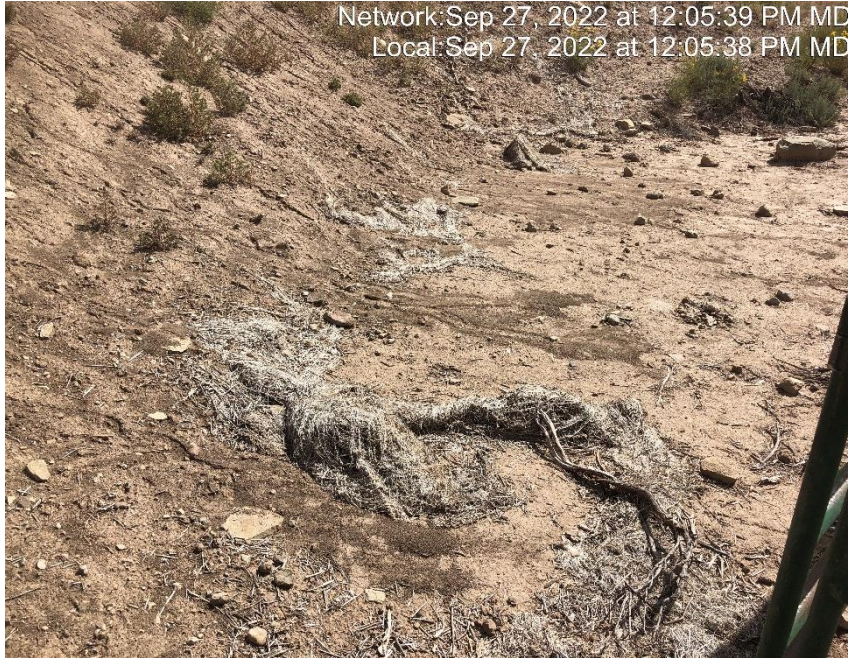
Photo #7801 Run on to location is not being controlled.

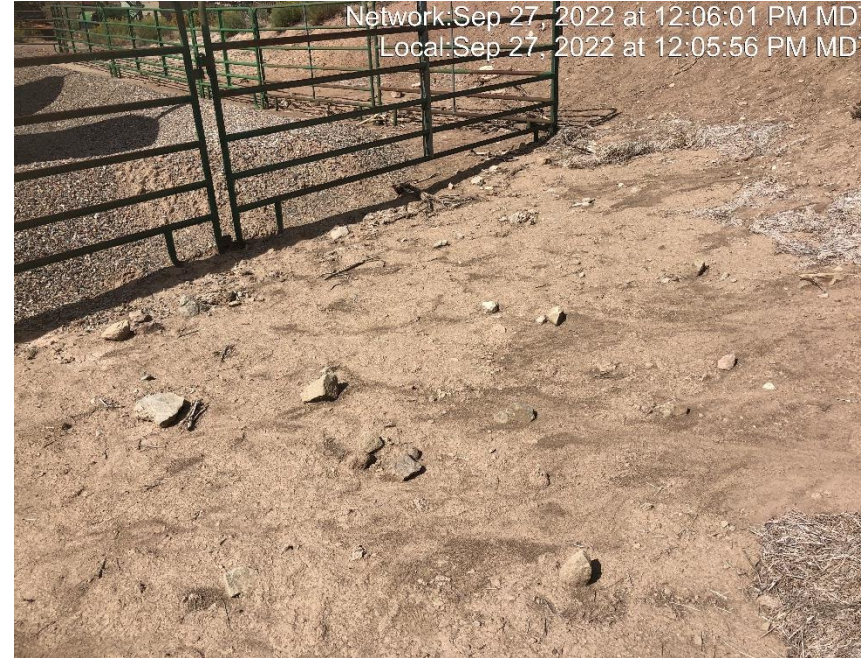
Photo #7802 Run on to location is not being controlled.

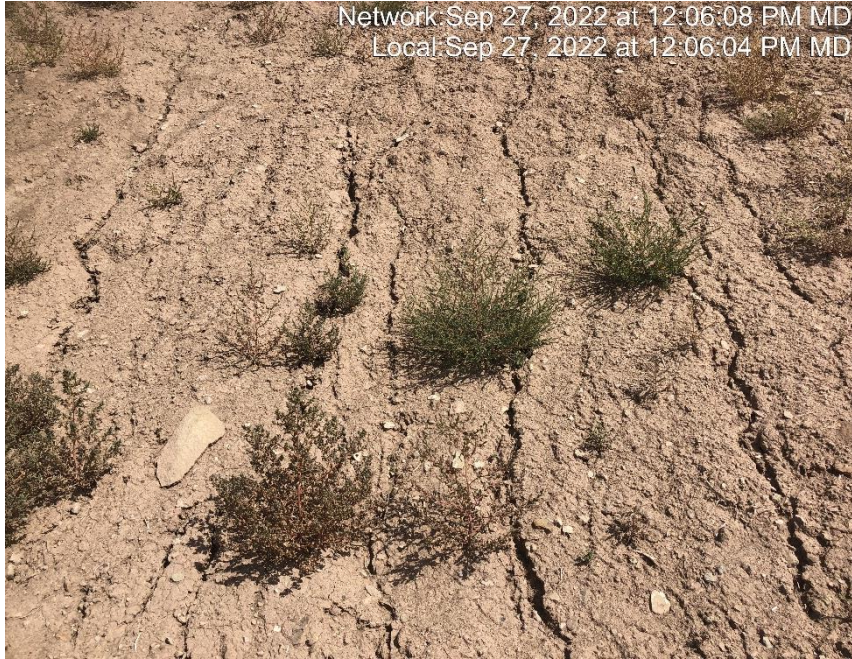
Photo #7803 Rill erosion occurring on cut slope.
