Inspection Photos

Location Name: CAERUS PICEANCE LLC GMU-66S93W /23SENE

Location ID: 335444

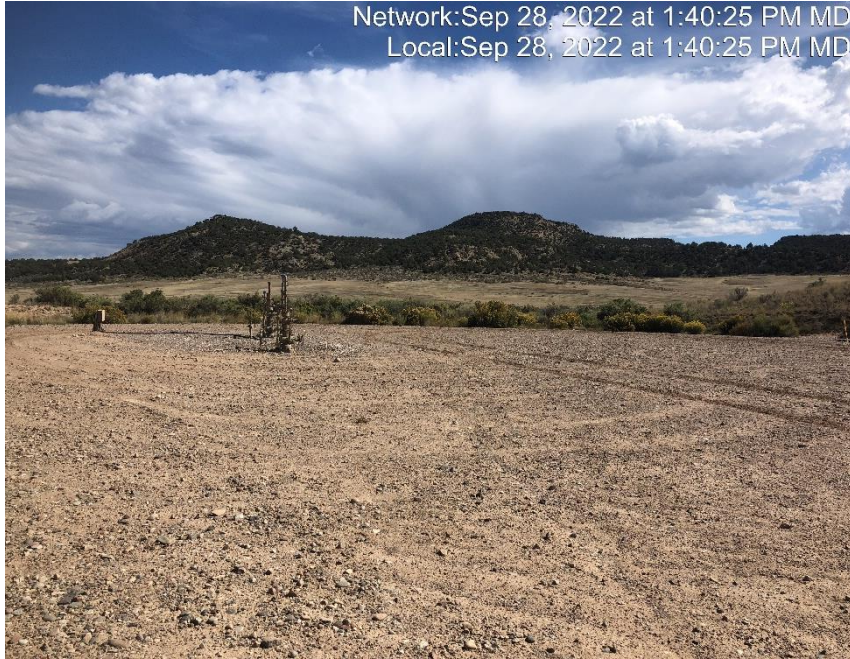
Photo #7829 From entrance to location.

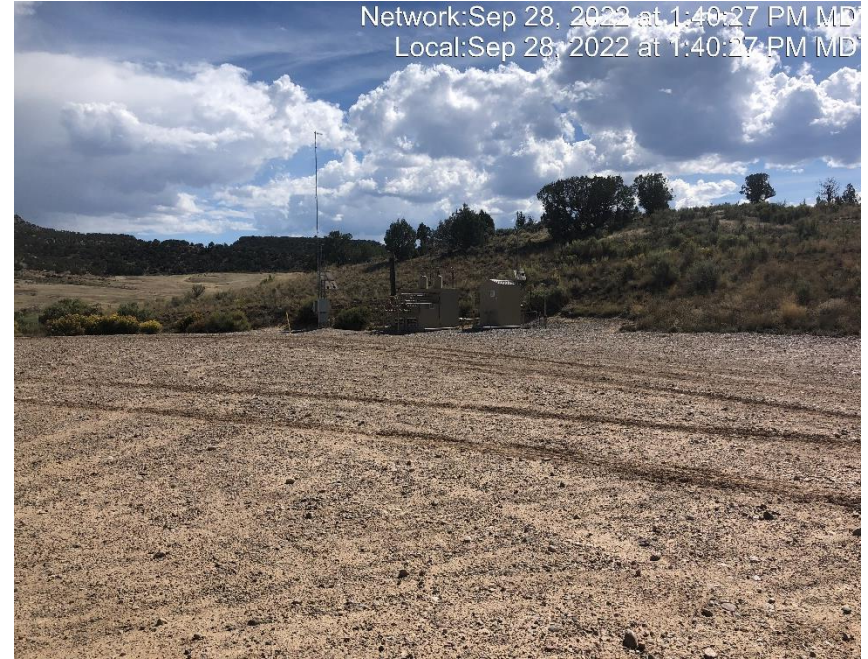
Photo #7830 From entrance to location.

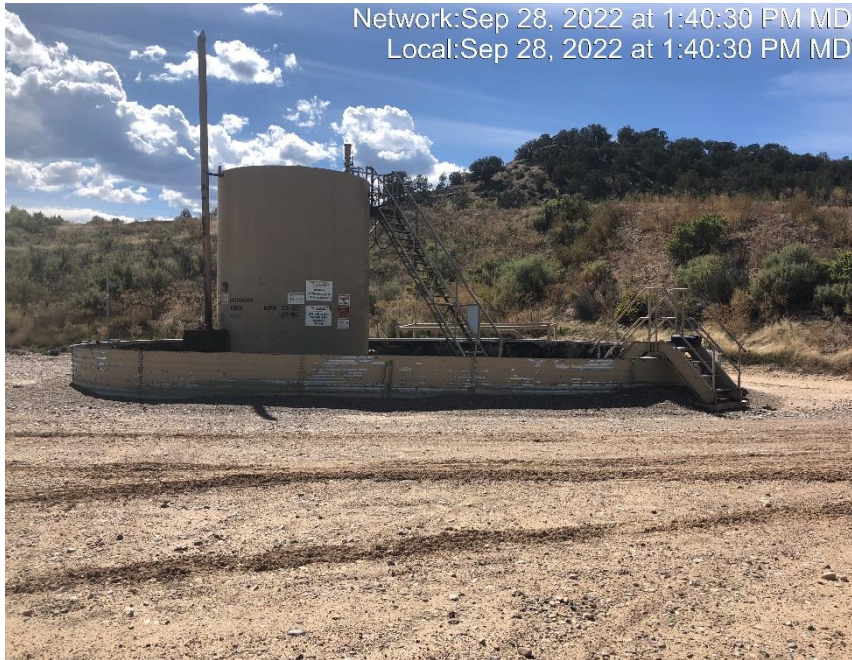
Photo #7831 From entrance to location.

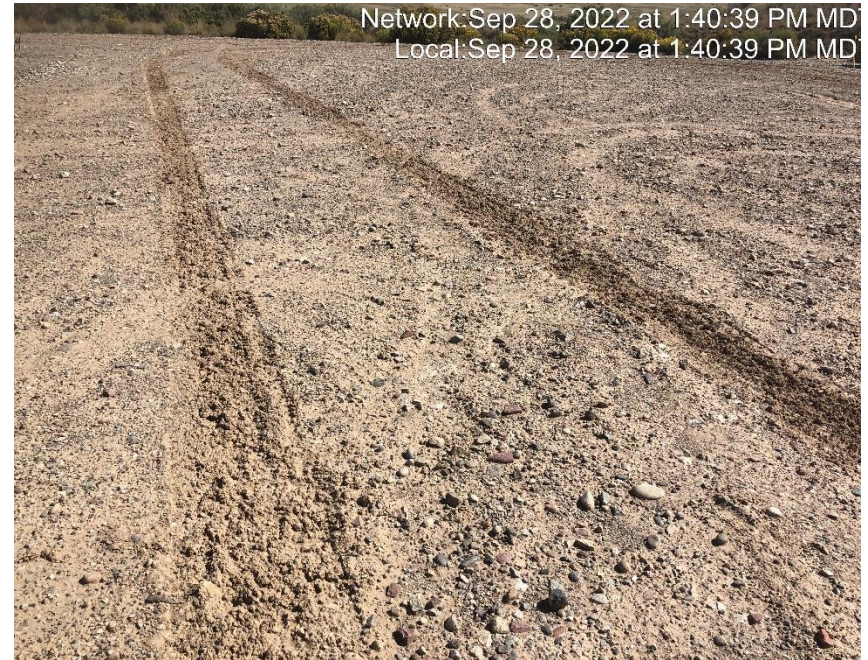
Photo #7832 Location lacks stabilization.

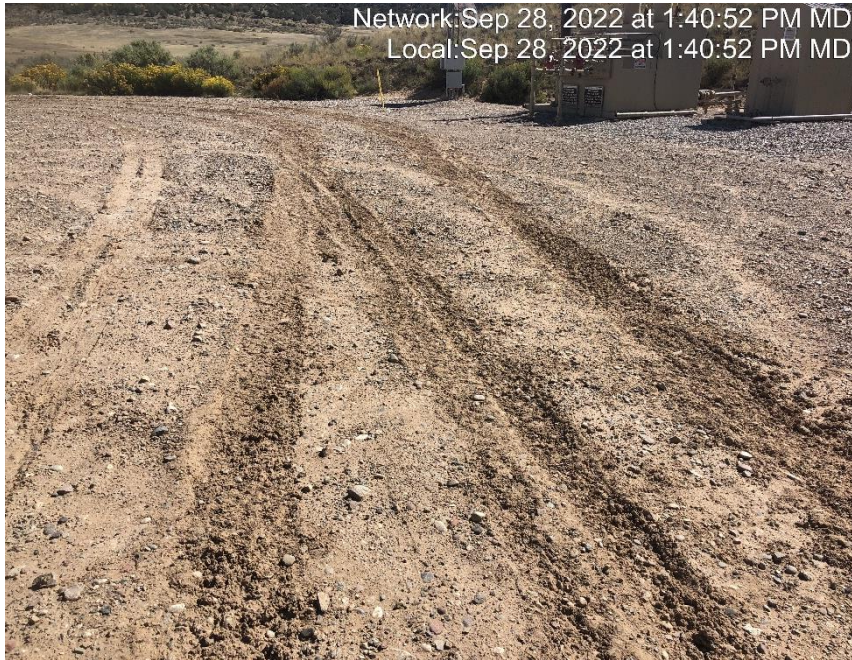
Photo #7833 Location lacks stabilization.

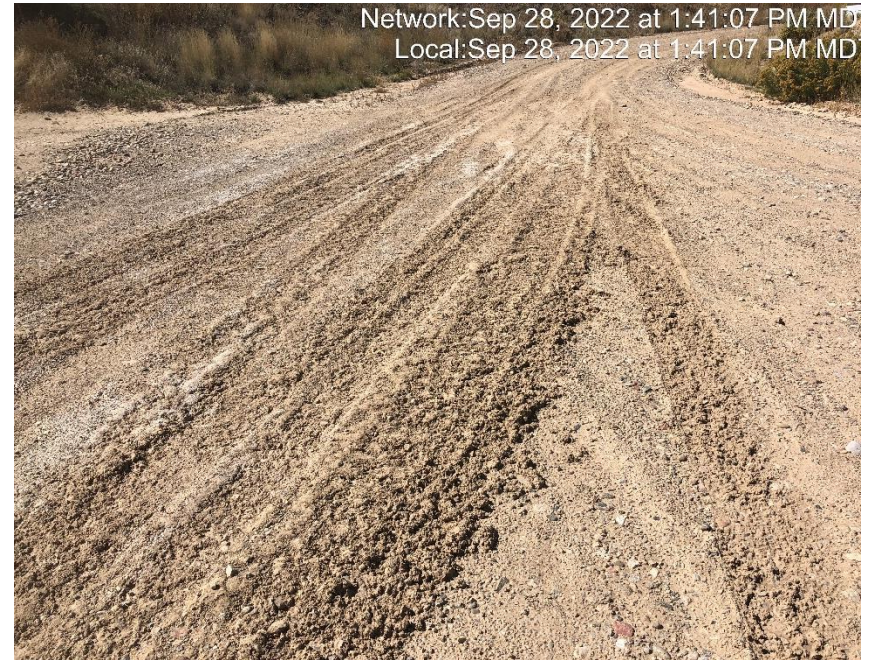
Photo #7835 Insufficient tracking BMP at entrance to location
