Inspection Photos

Location Name: CAERUS PICEANCE LLC BJM-66S92W /30L4NW

Location ID: 335401

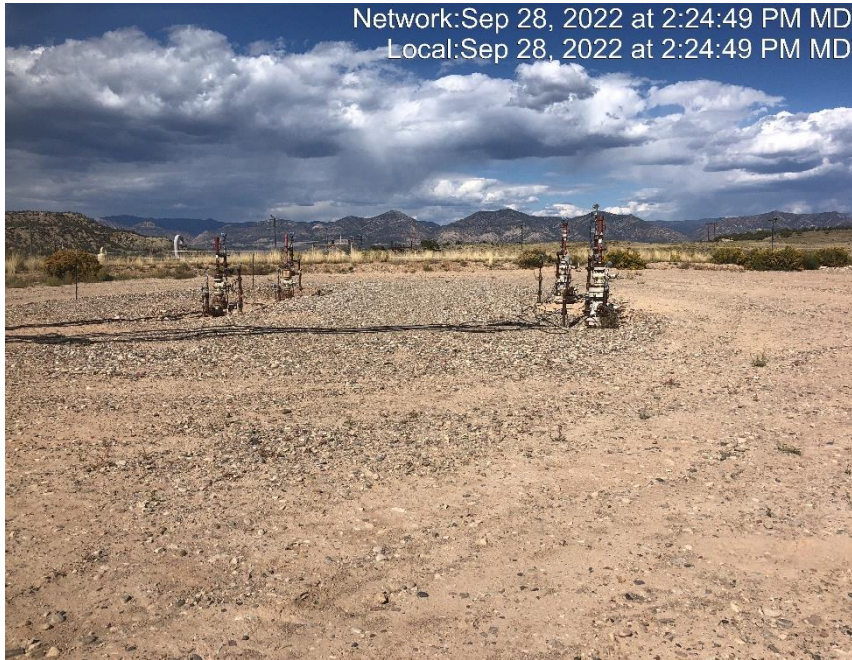
Photo #7841 From entrance to location.

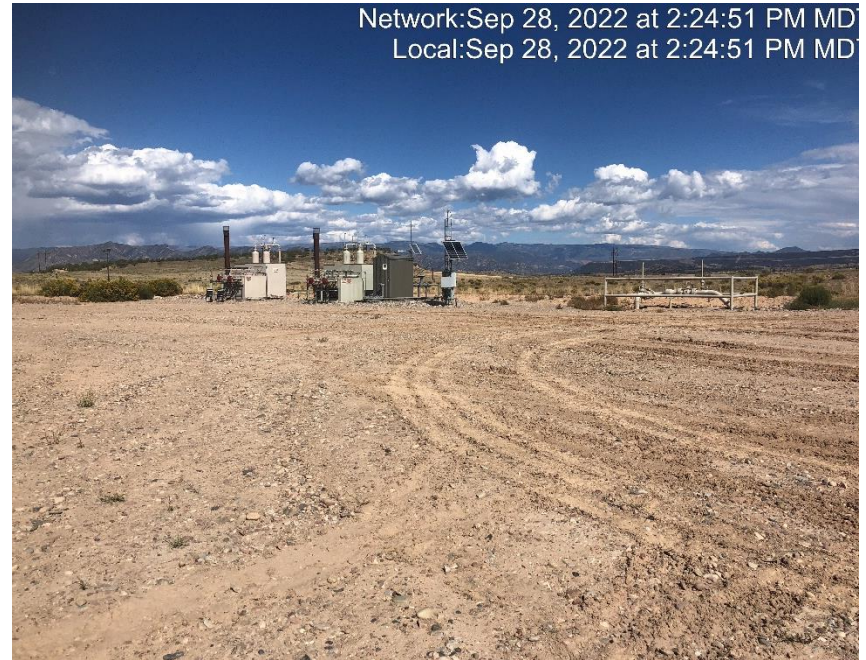
Photo #7842 From entrance to location.

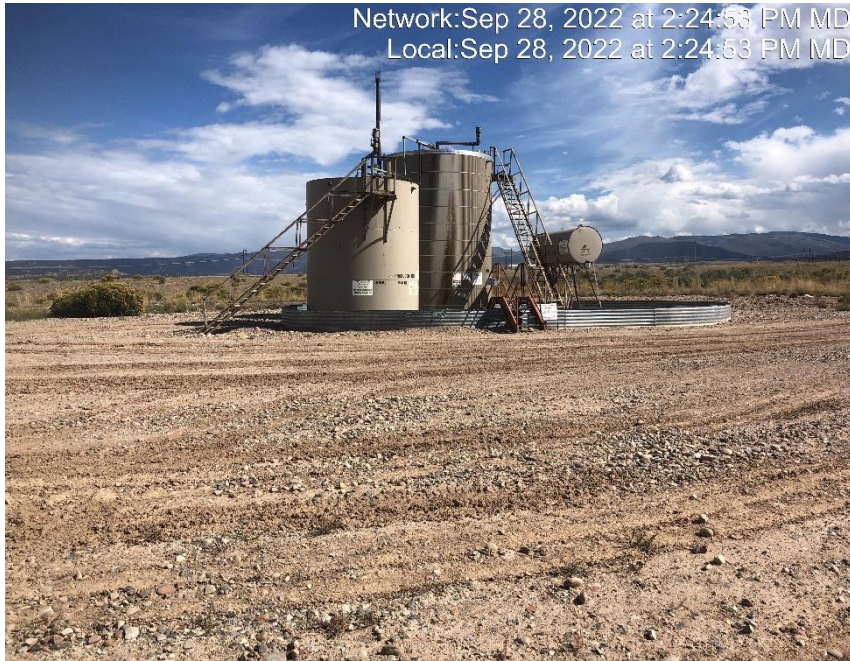
Photo #7843 From entrance to location.

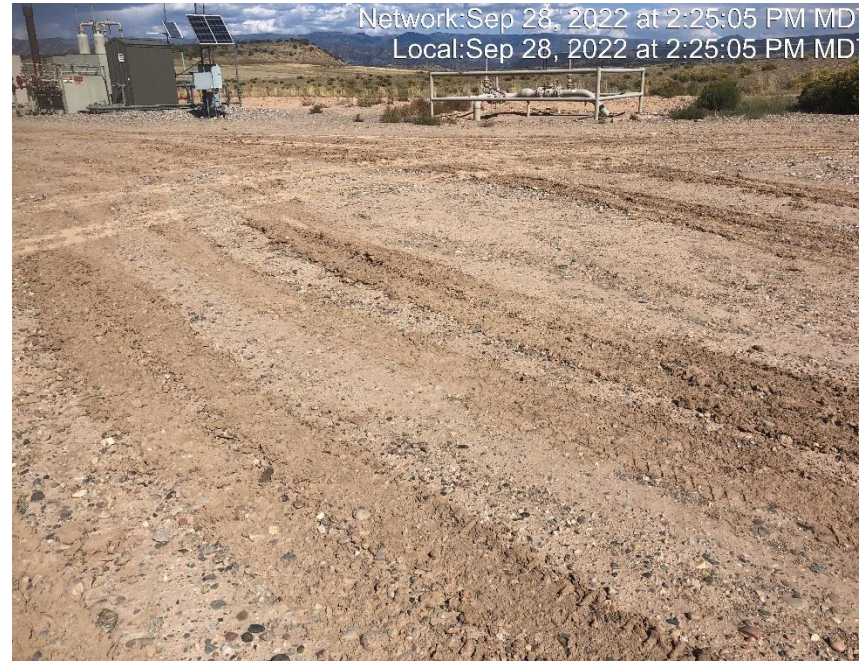
Photo #7844 Location lacks stabilization.

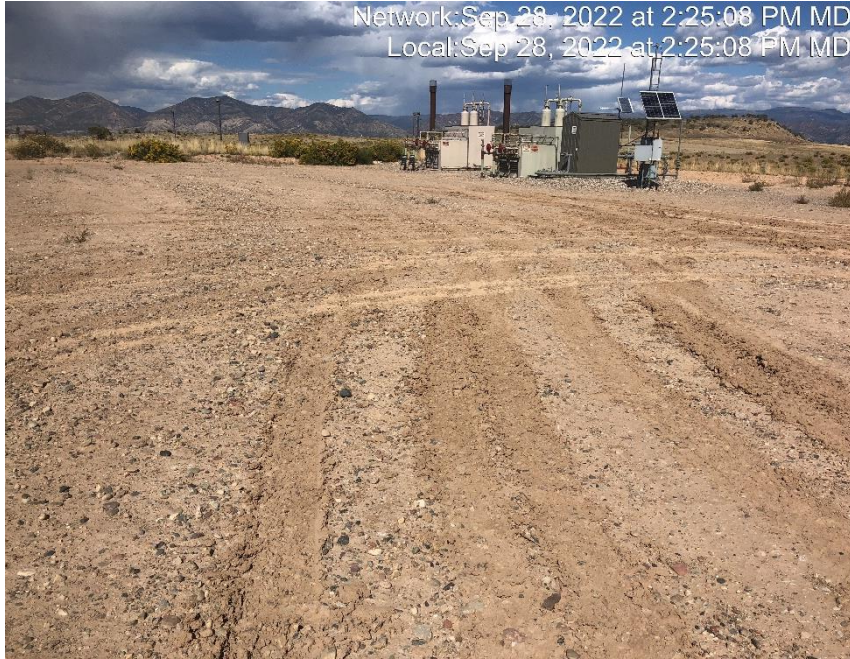
Photo #7845 Location lacks stabilization.

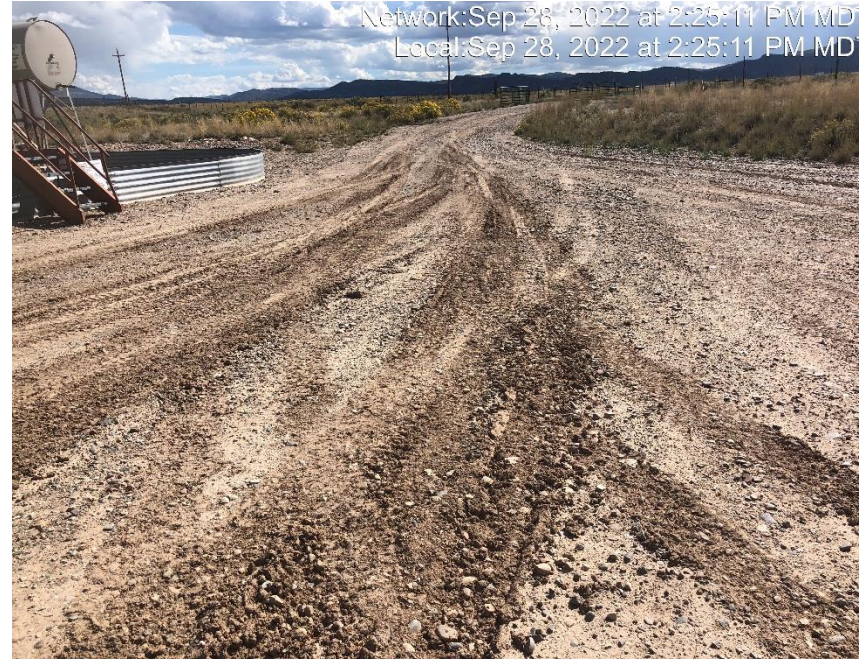
Photo #7846 Location lacks stabilization.

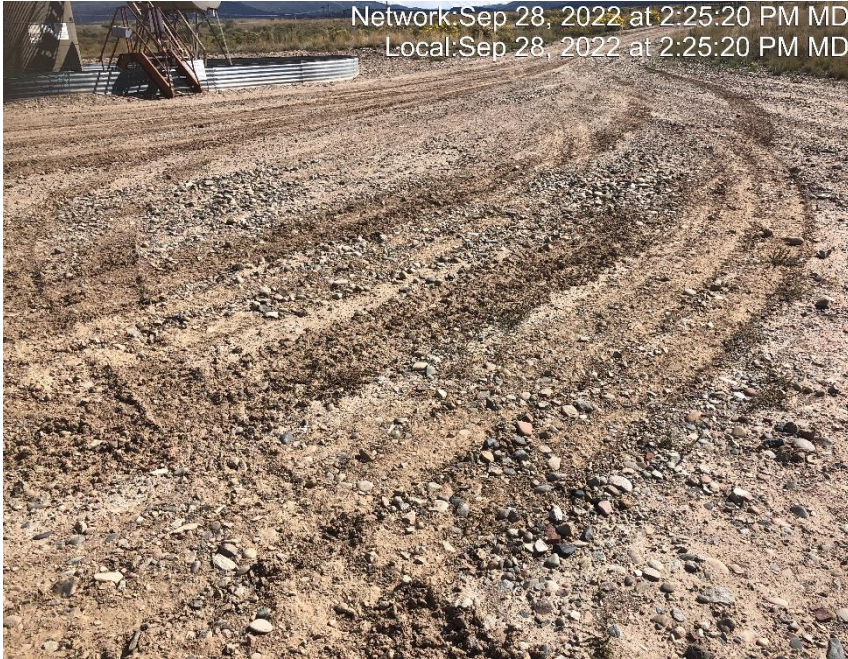
Photo #7847 Location lacks stabilization.

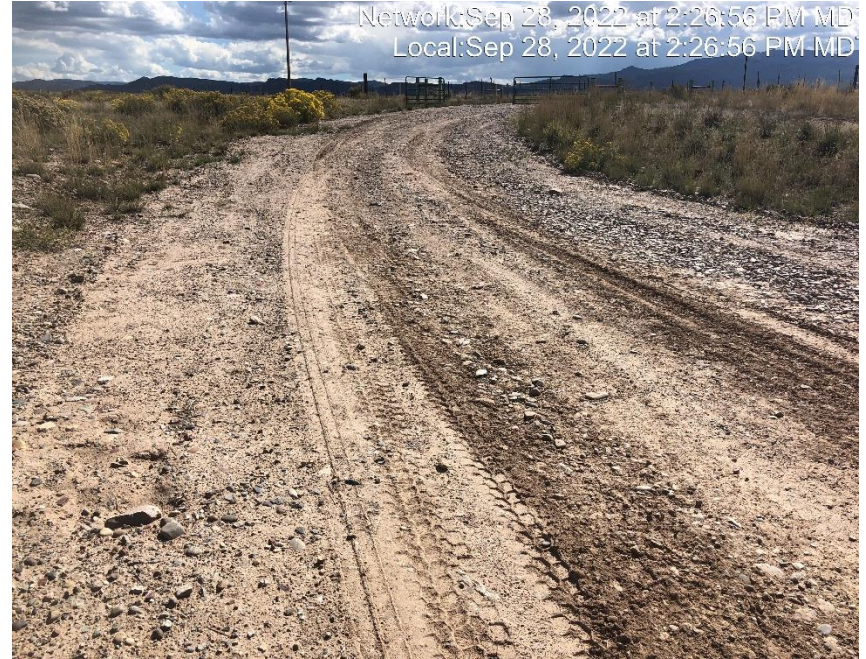
Photo #7850 Insufficient tracking BMP at entrance to location
