Inspection Photos

Location Name: CAERUS PICEANCE LLC COUEY-67S92W /8NWSE

Location ID: 334821

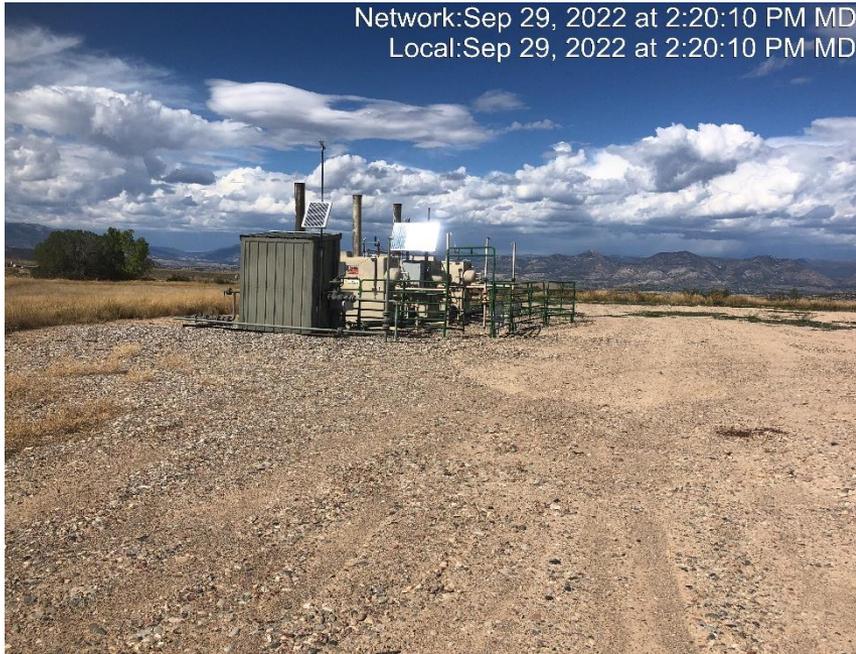
Photo #7856 From entrance to location.

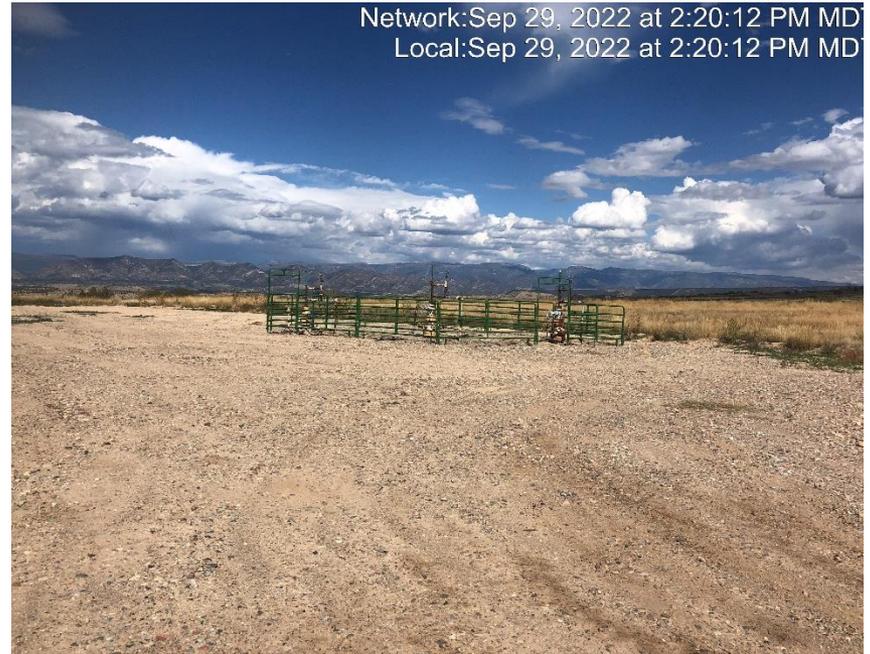
Photo #7857 From entrance to location.

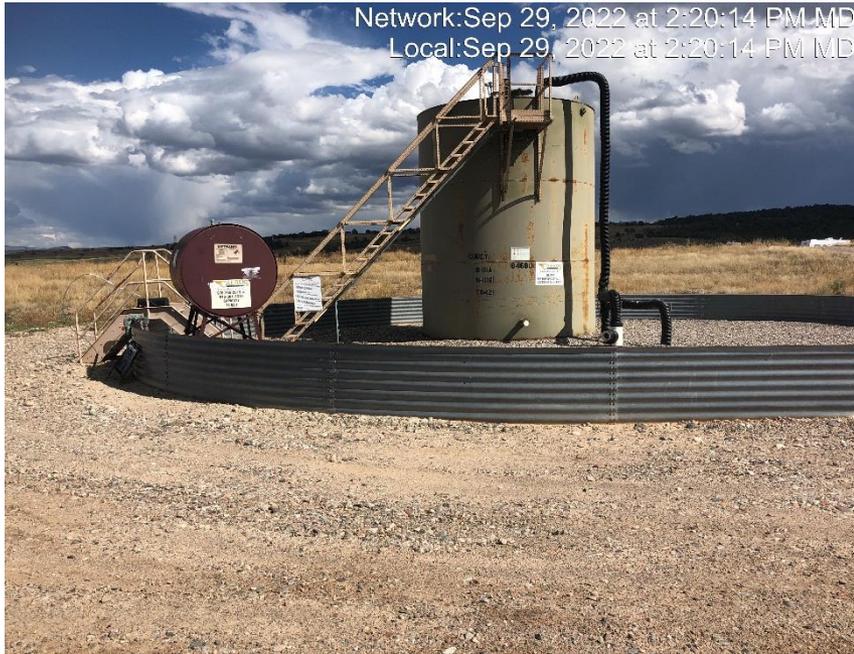
Photo #7858 From entrance to location.

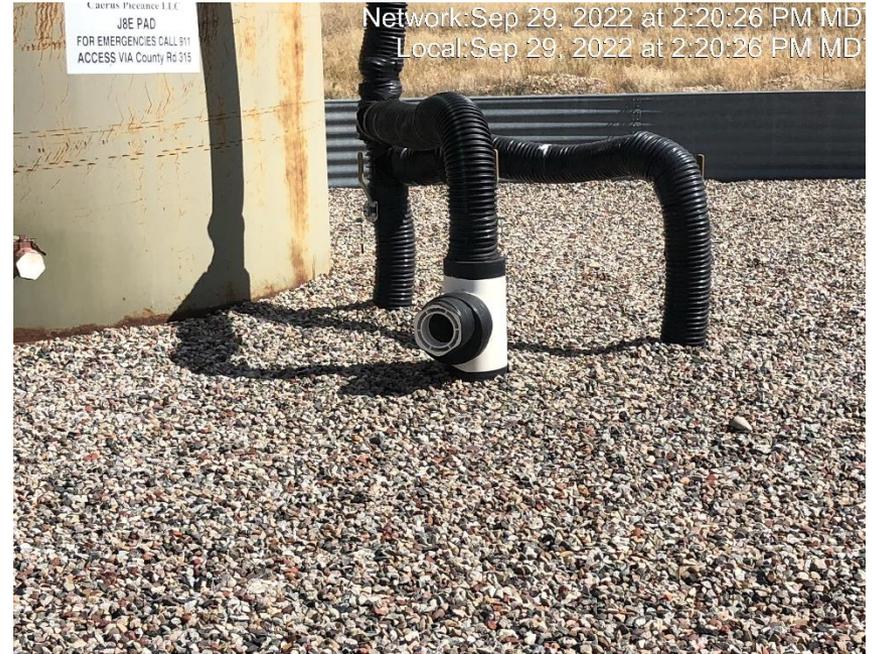
Photo #7859 Multiple places with heating insulation open ended and not capped.

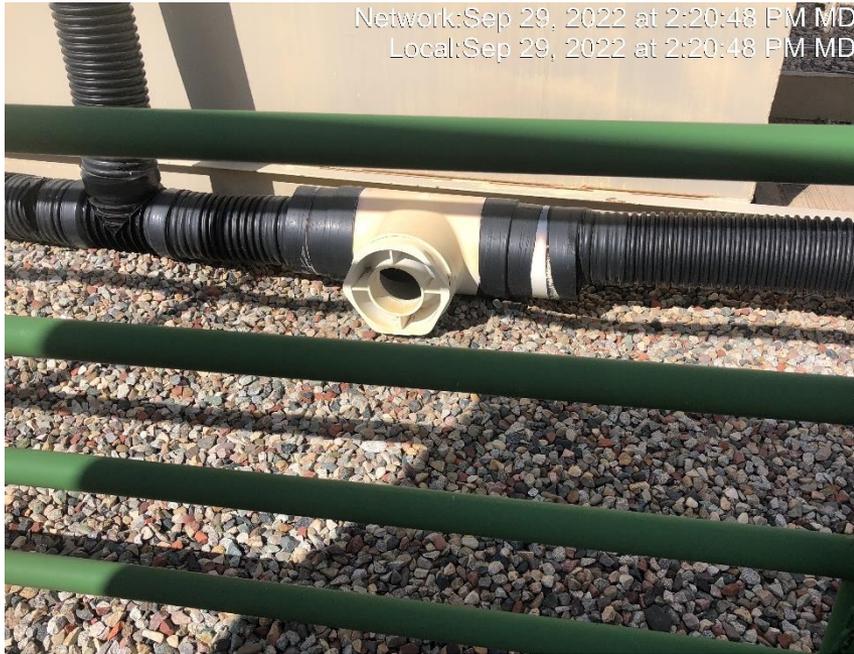
Photo #7860 Multiple places with heating insulation open ended and not capped.

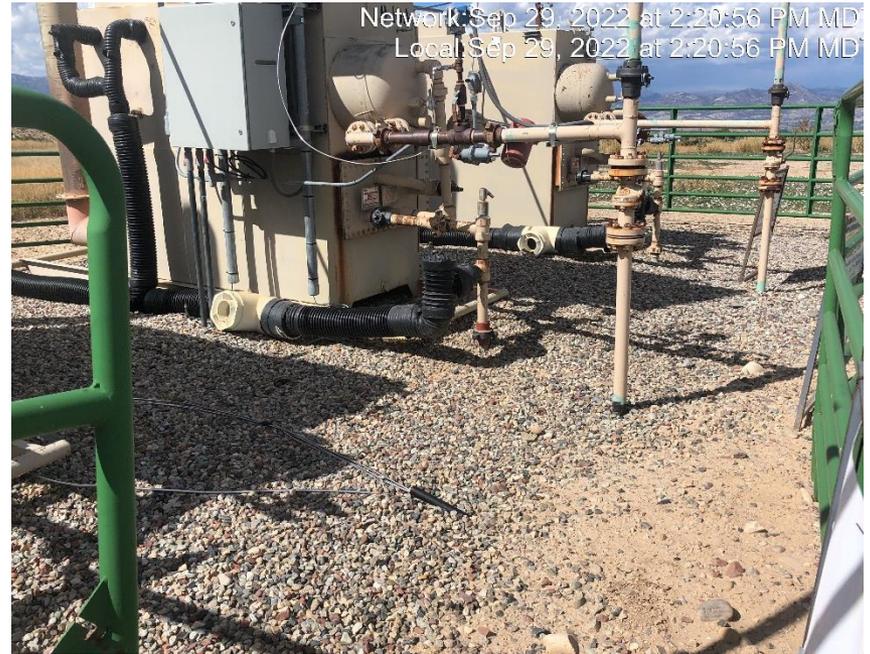
Photo #7861 Multiple places with heating insulation open ended and not capped.
