Inspection Photos

September 26, 2022

Location Name: Baldy Creek-Federal-67S90W /20NWNE

Inspection Document #: 702800744

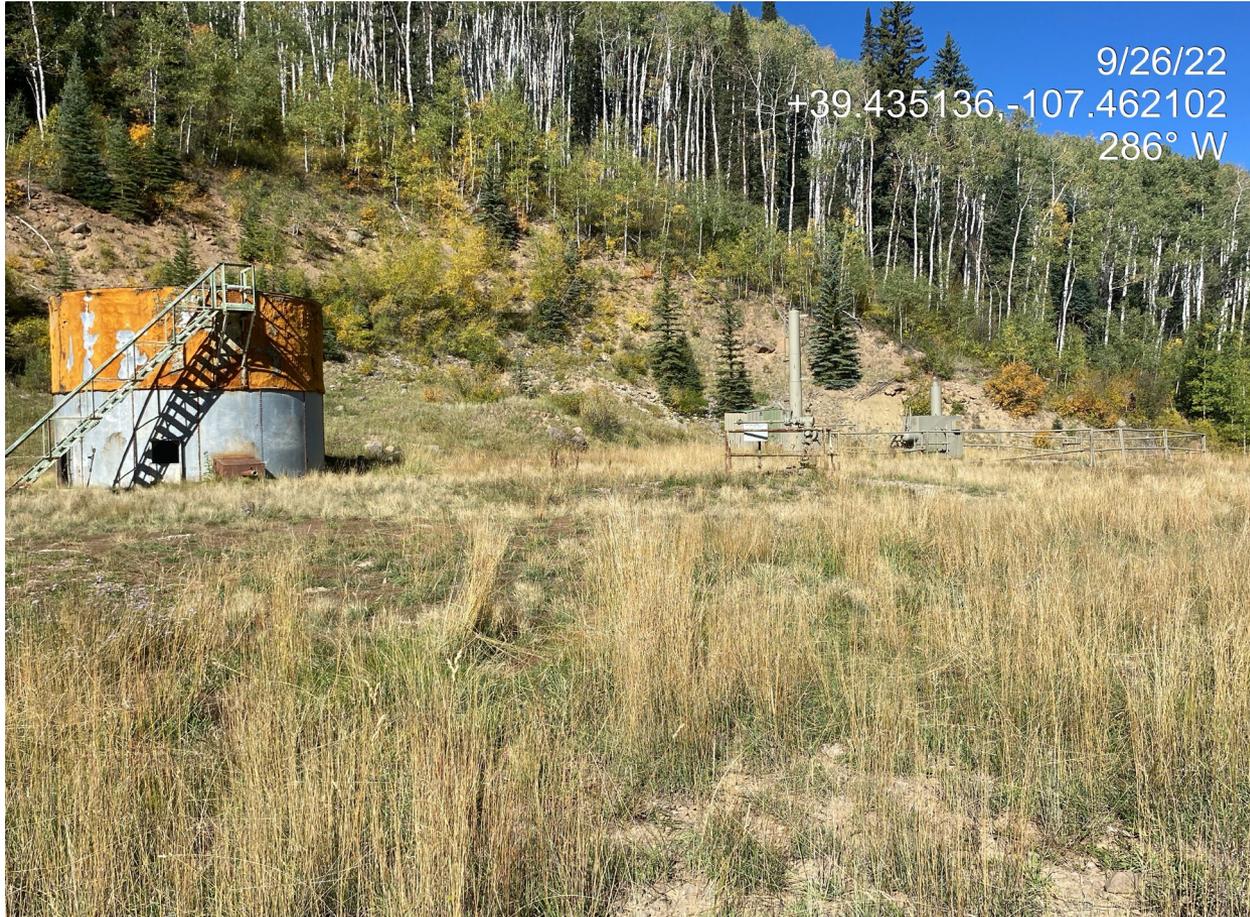
Photo 1. Photo taken from the south shows an overview of the Location. Note unused tank and overgrown production areas.

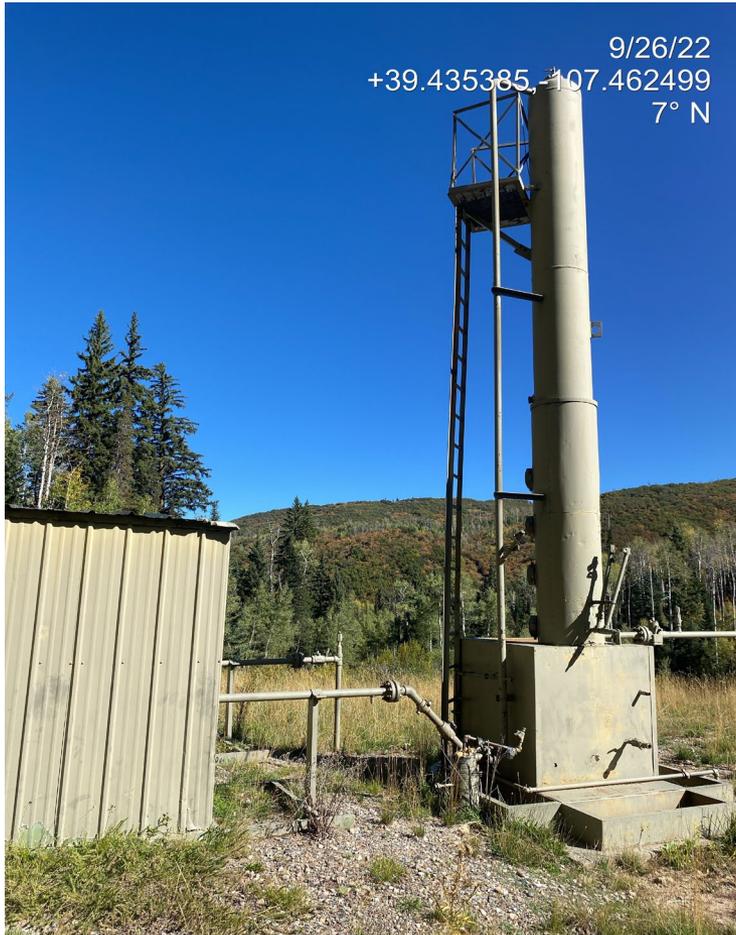
Photo 2. Photo shows unused production equipment at the north of the Location.

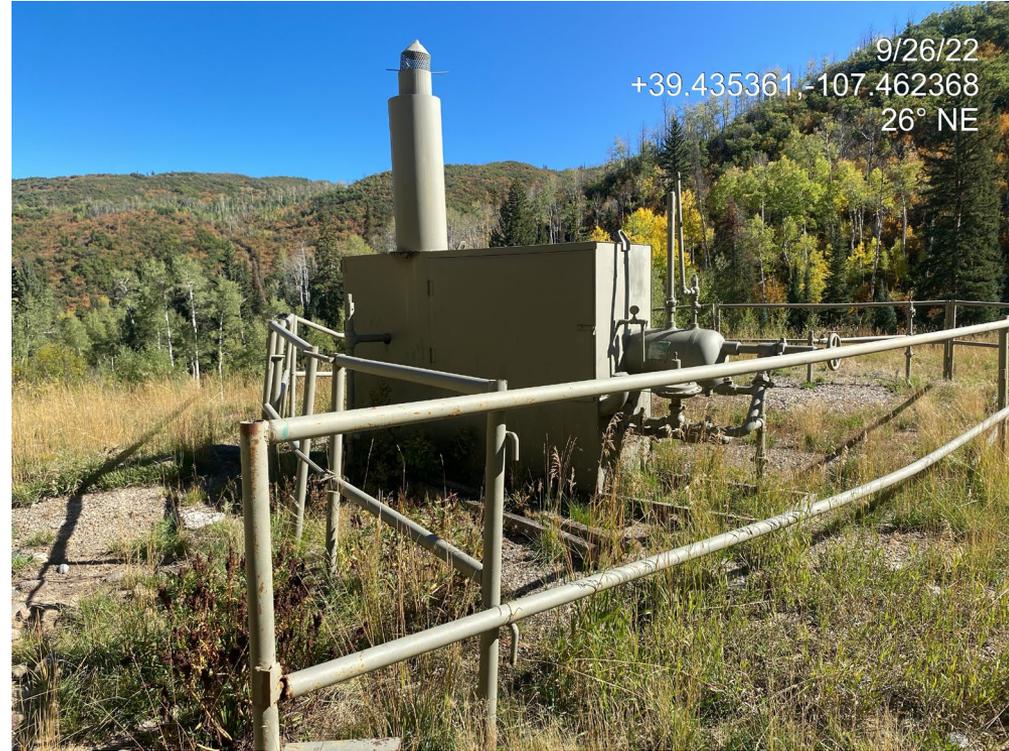
Photo 3. Photo shows an unused horizontal separator on Location.

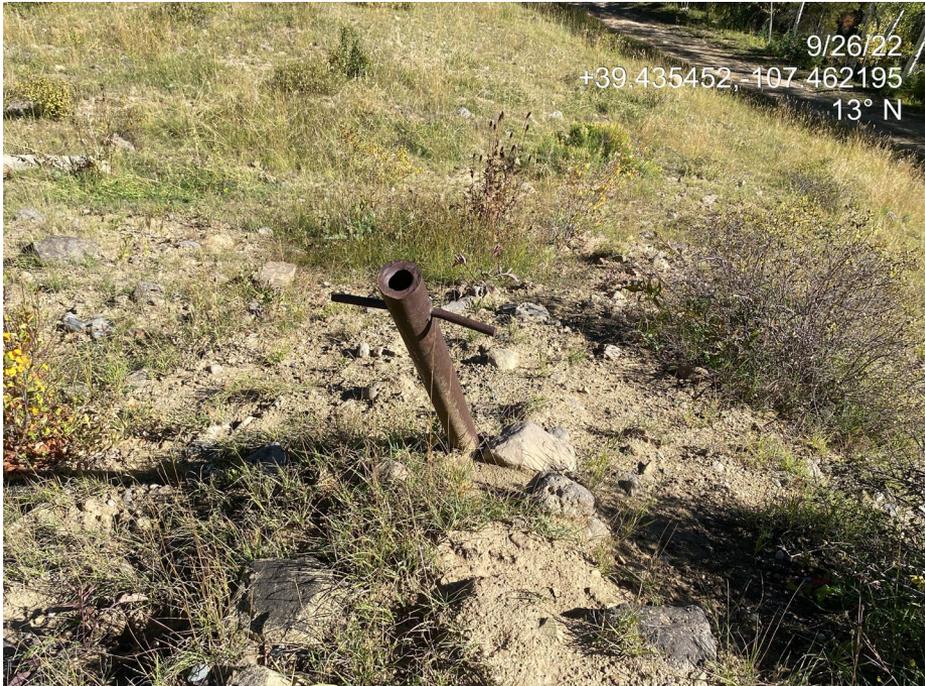
Photo 4. Photo taken from the north of the Location shows an example of unmarked anchor. All anchors on Location are unmarked.

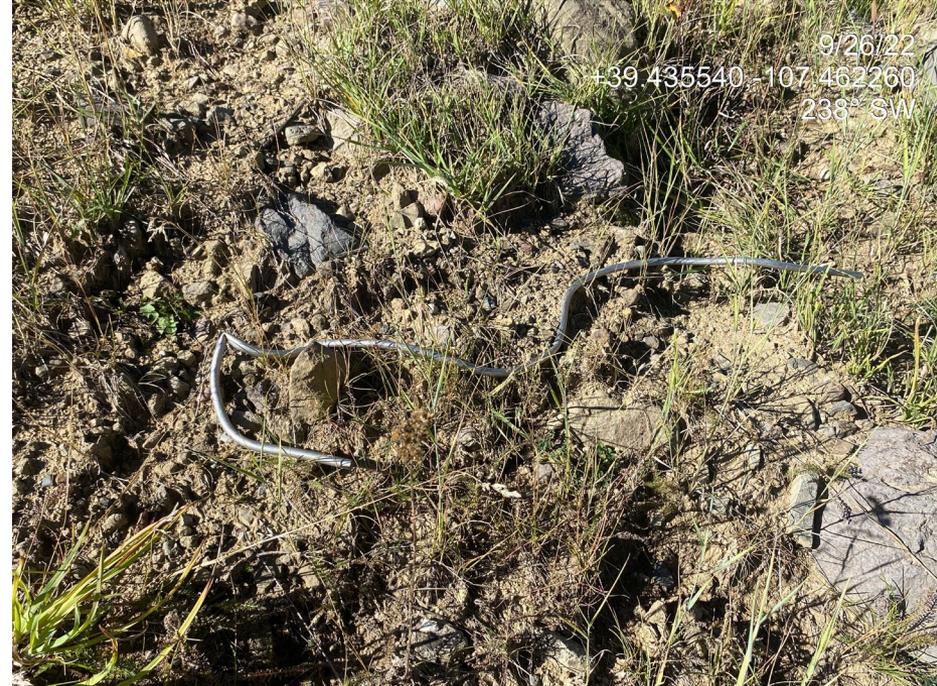
Photo 5. Photo taken from the north of the Location shows an example of trash/debris.

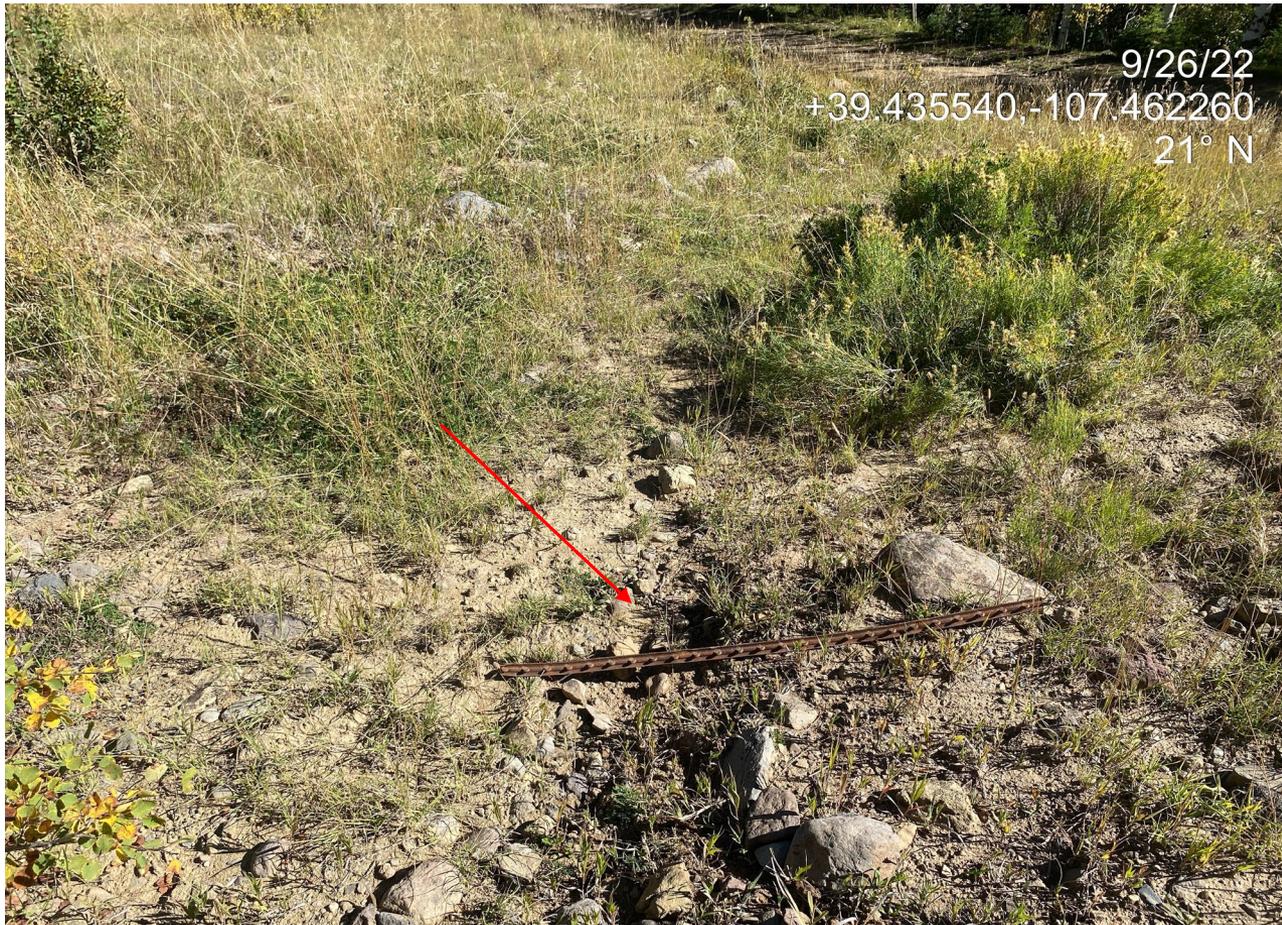
Photo 6. Photo taken from the north of the Location shows trash/debris. Photo also shows sediment deposition from the nearby cut slope and erosion occurring to the fill slope from stormwater flows coming off the cut.

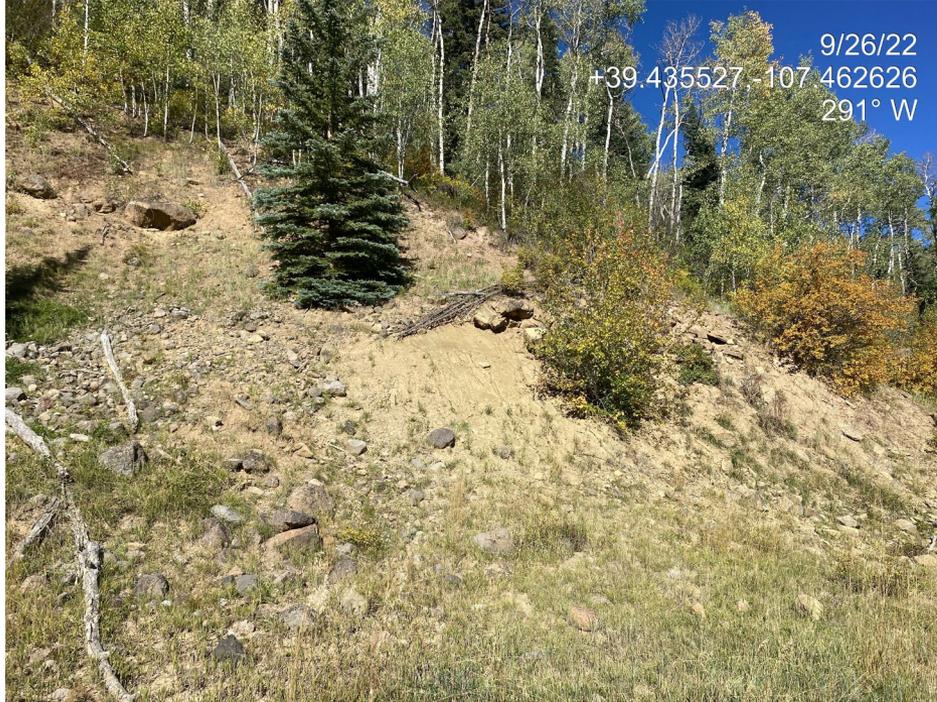
Photo 7. Photo taken from the north of the Location shows the eroding cut slope.

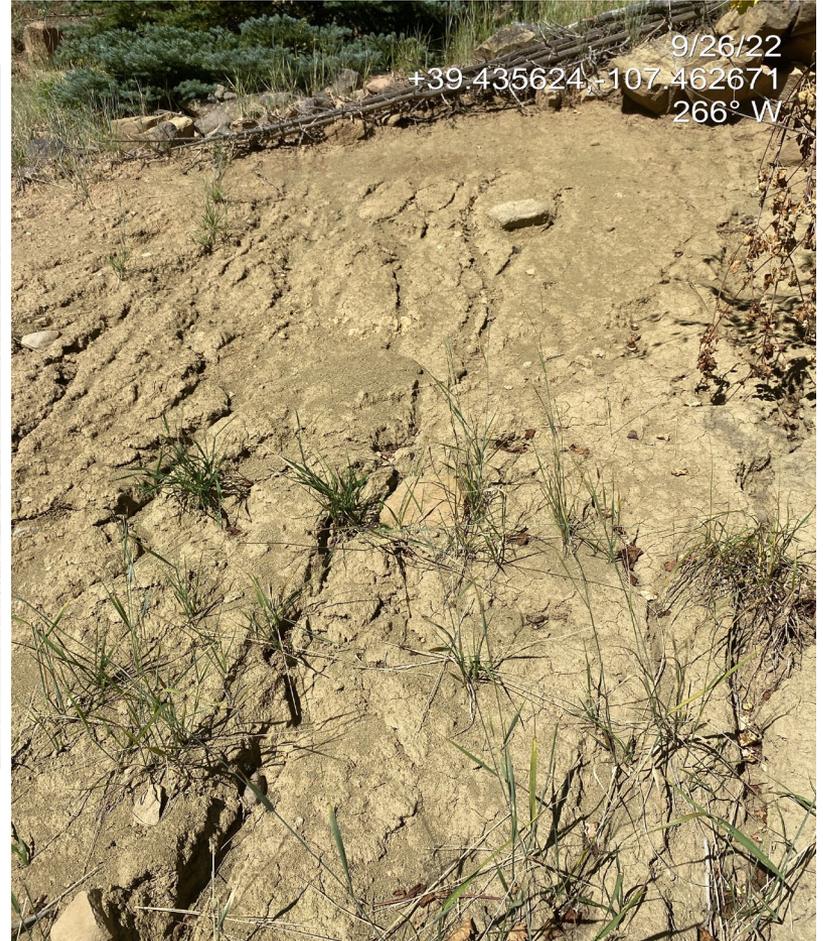
Photo 8. Photo taken from the north of the Location shows rill erosion occurring on the eroding cut slope.

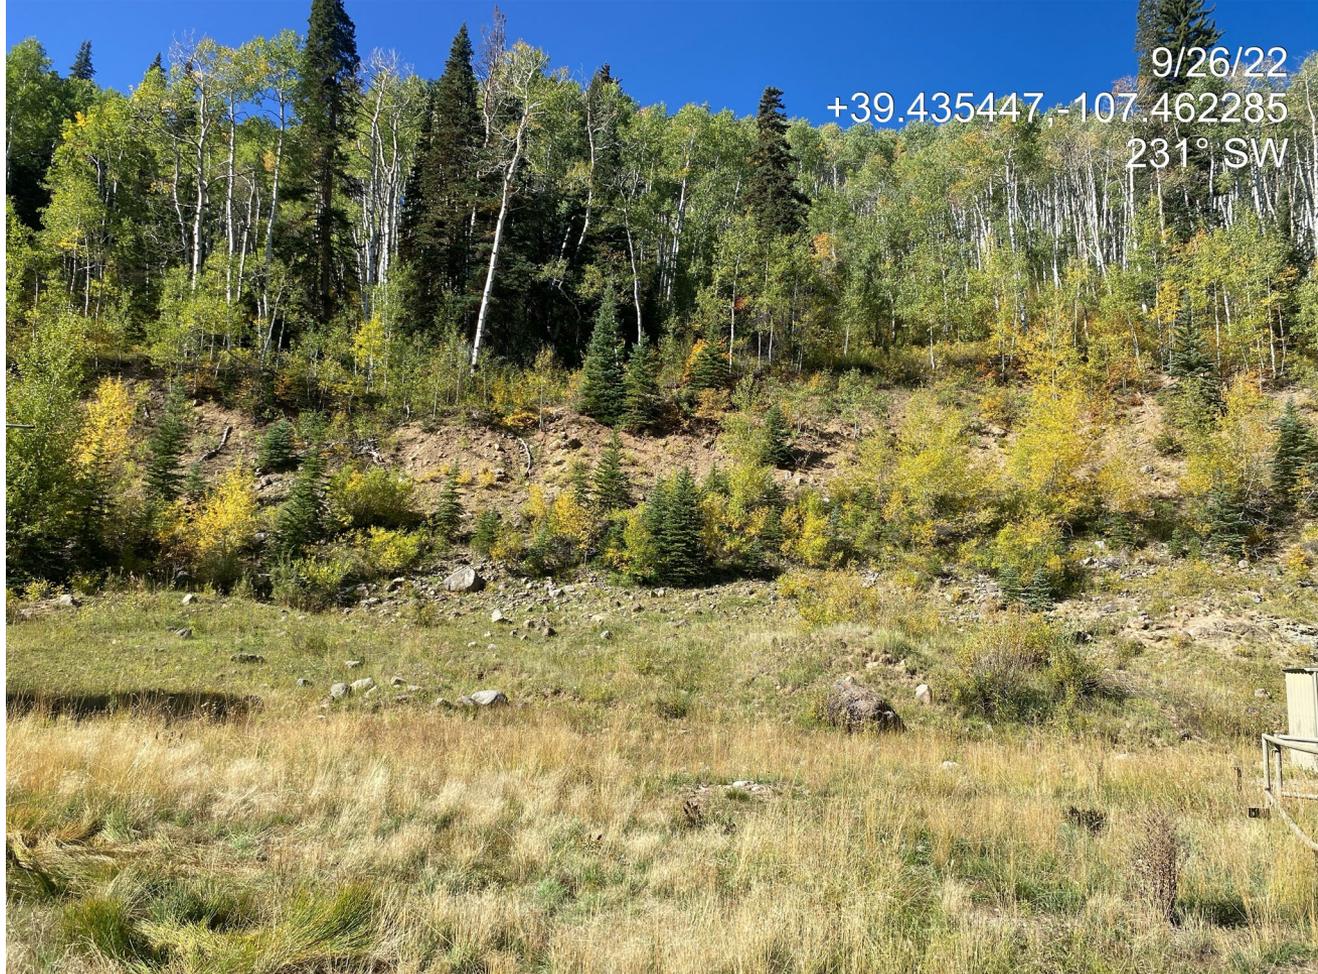
Photo 9. Photo from the center of the Location shows an overview of the eroding cut slope.

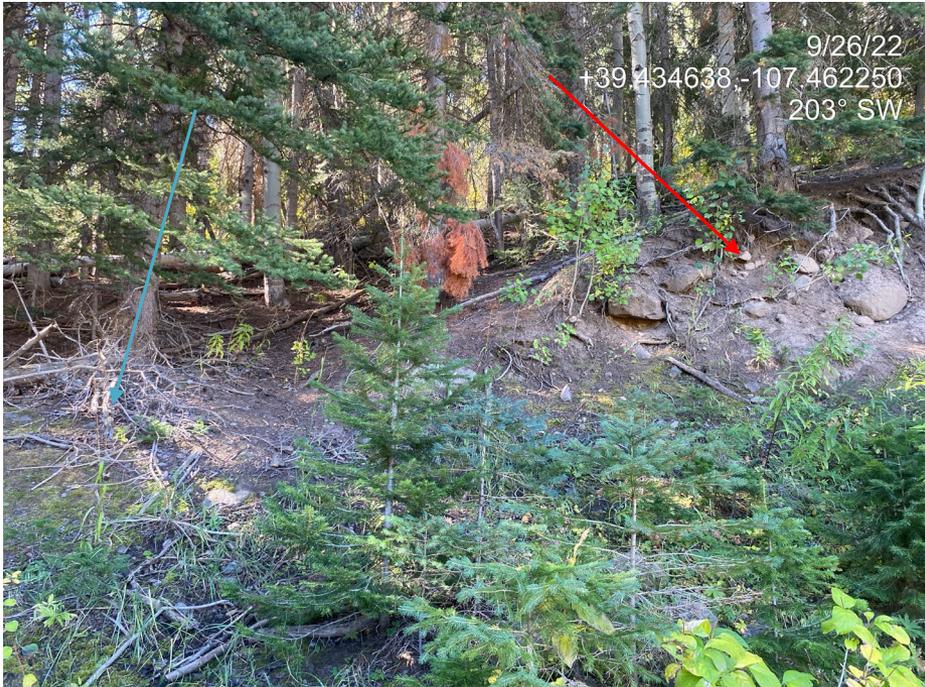
Photo 10. Photo taken from the south of the Location shows the slope/contour in the reference area (blue arrow) and the start of the Location cut slope (red arrow). The cut slope is eroding and undercutting into undisturbed areas above the cut exposing roots.

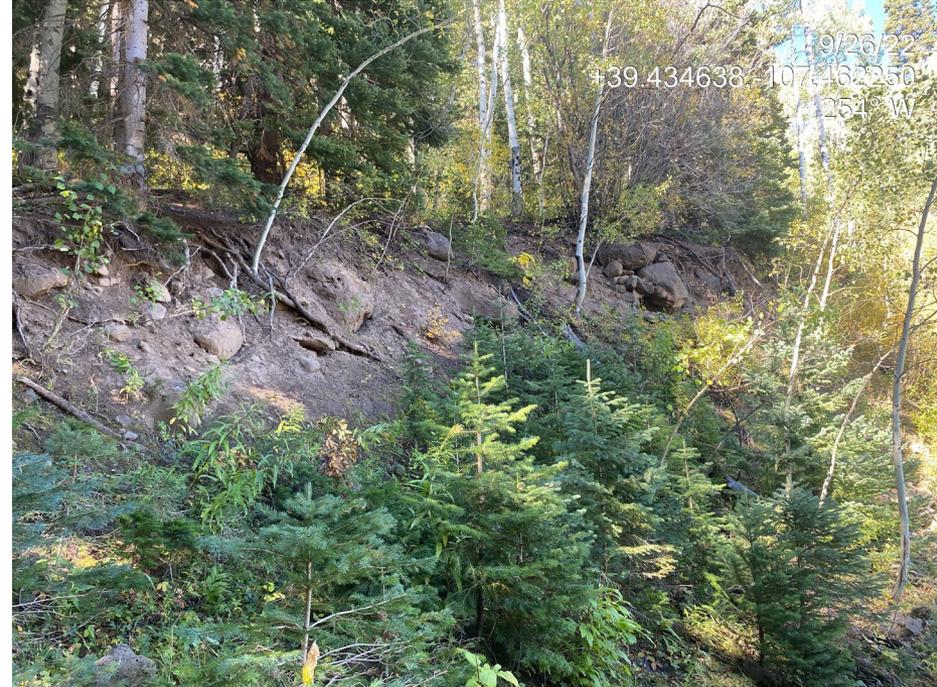
Photo 11. Photo taken from the south of the Location shows the cut slope is eroding and undercutting into undisturbed areas above the cut exposing roots.

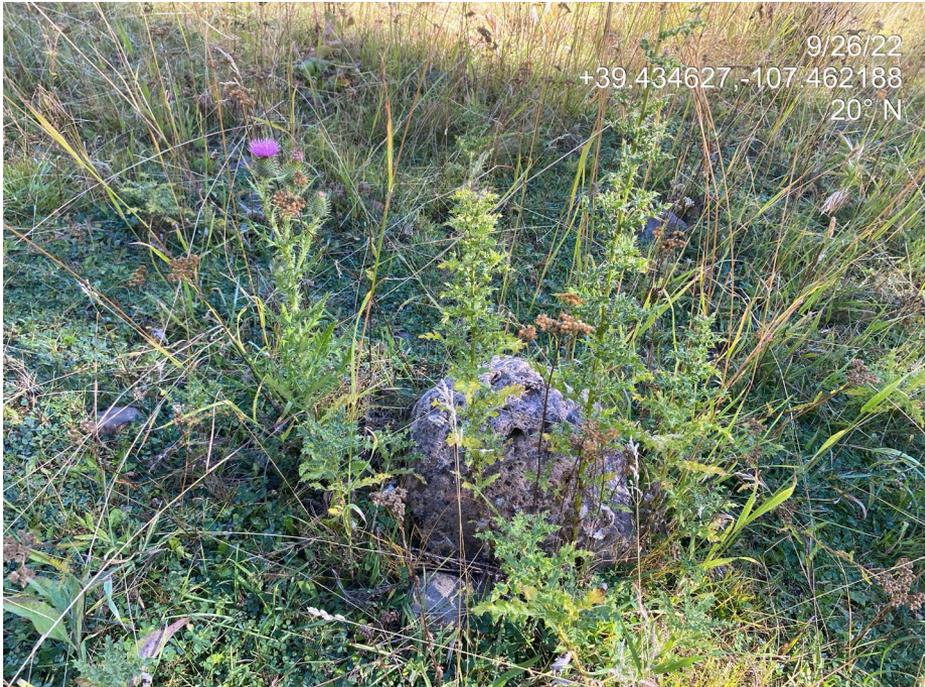
Photo 12. Photo shows an example of Canada and bull thistle, CO List B Noxious Weeds common throughout the Location.

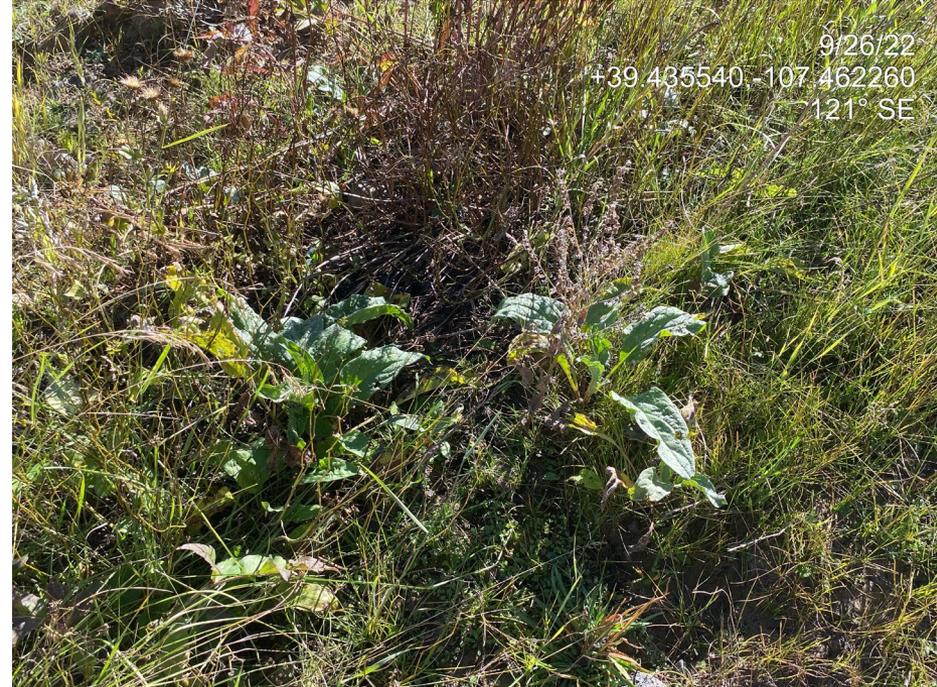
Photo 13. Photo shows an example of houndstongue, a CO List B Noxious Weed common throughout the Location.
