Inspection Photos

Location Name: CAERUS PICEANCE LLC ASPEN RM-67S92W /10SENW

Location ID: 324224

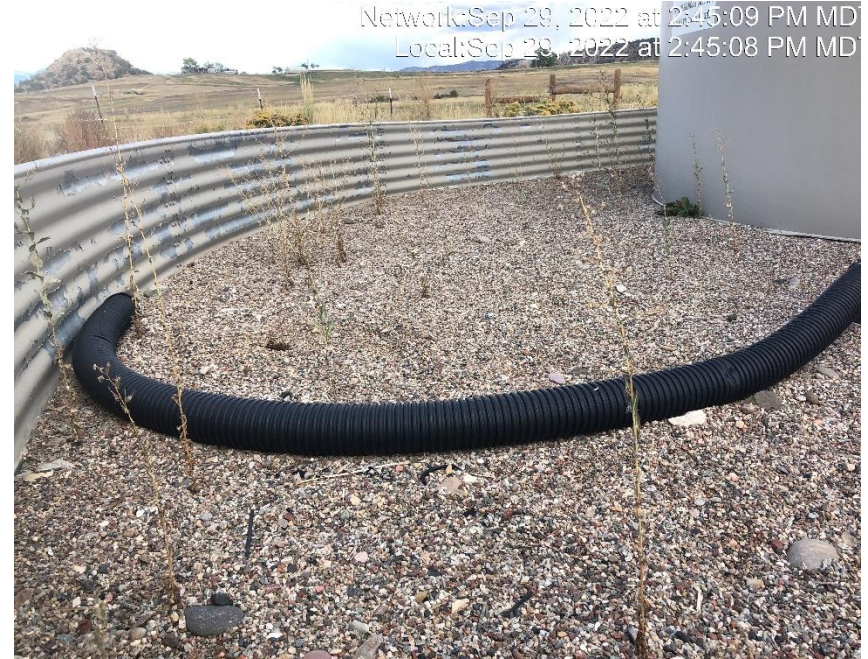
Photo #7877 Undesirable plant species in tank containment.

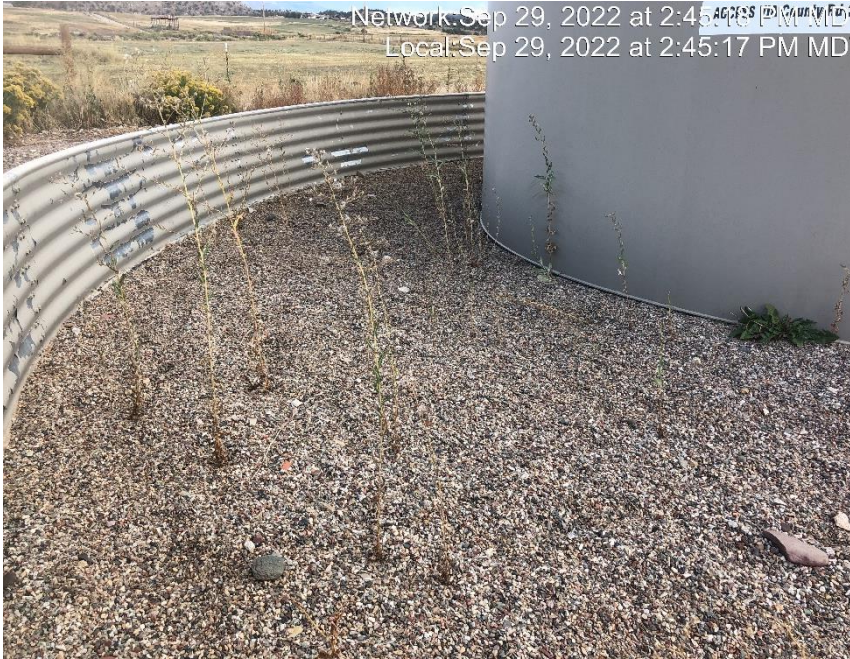
Photo #7878 Undesirable plant species in tank containment.

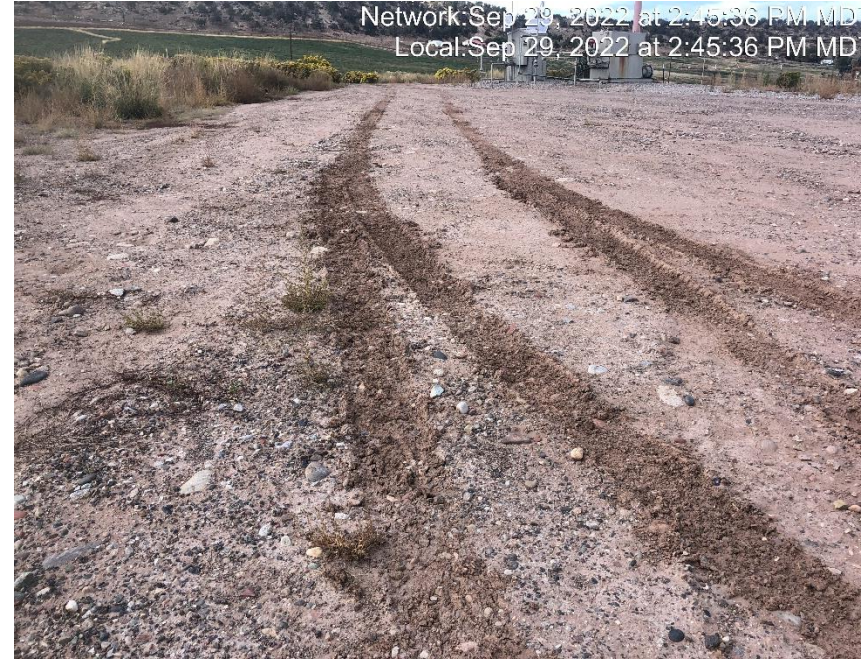
Photo #7879 Location lacks stabilization.

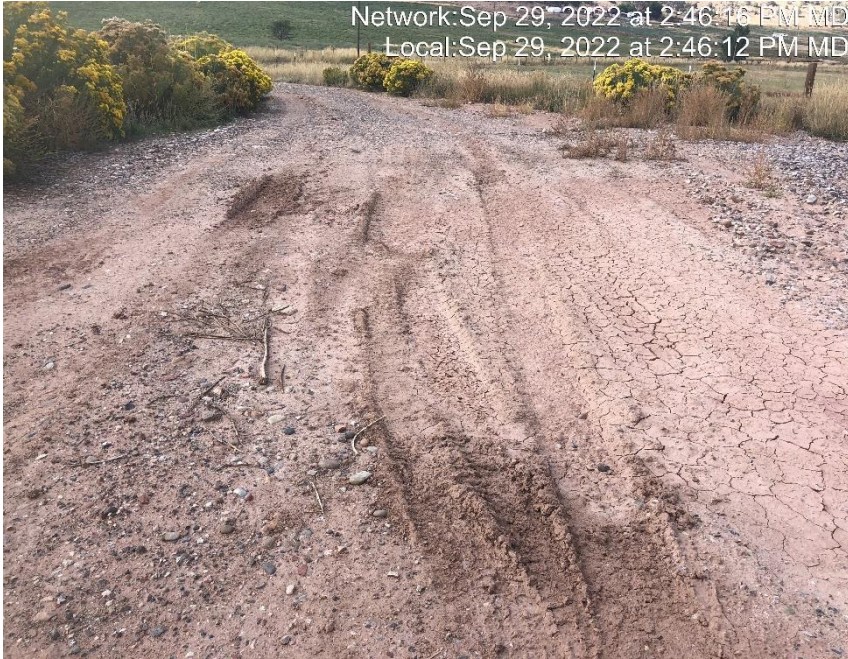
Photo #7880 Insufficient tracking BMP at entrance to location.
