Tiffany Pad 5

COGCC Inspection Doc # 690203356

CAs Completed between 09/13/2022 and 10/01/2022

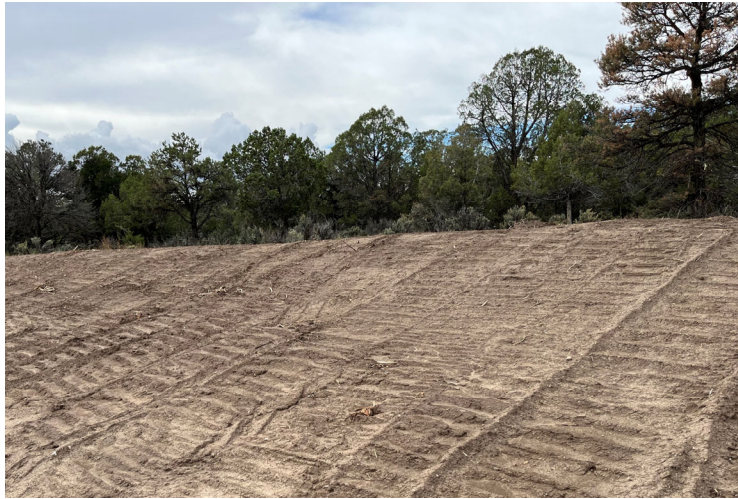
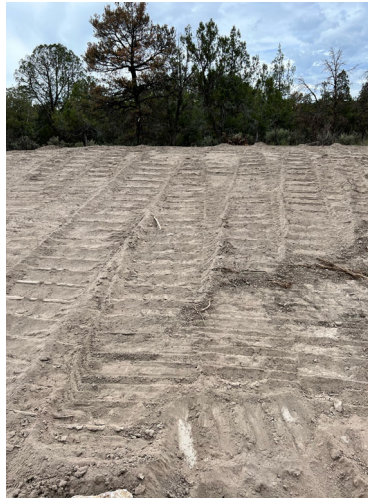
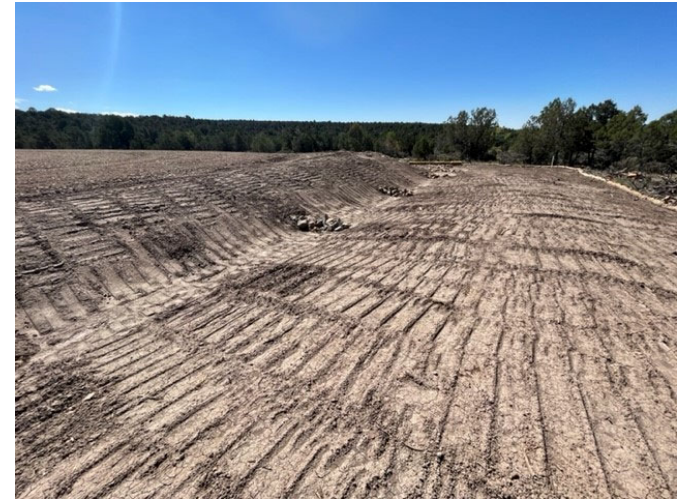
Western location side. Tracking is perpendicular to slope.

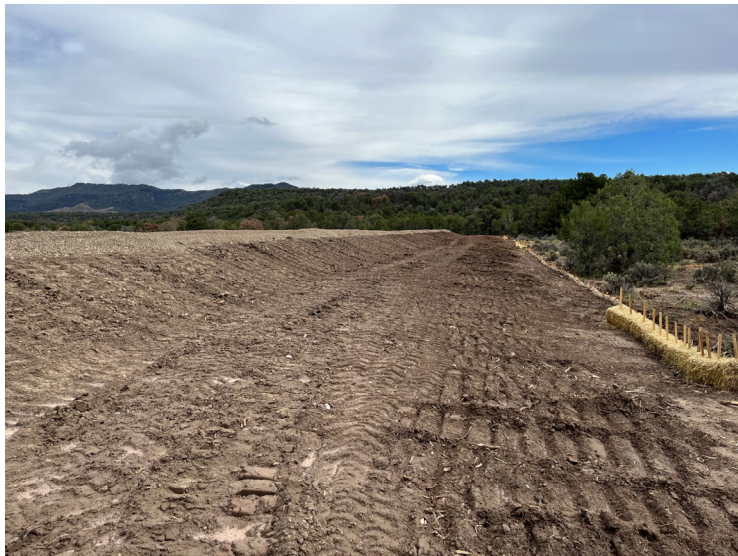
Facing southeast along fill slope. Tracking is perpendicular to the slope.

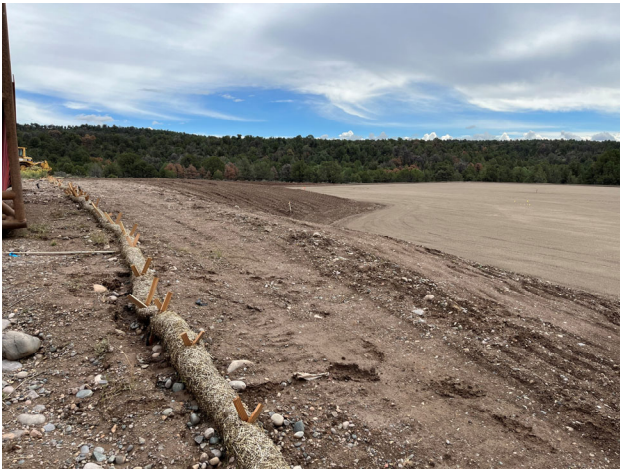
Perimeter wattles trenched in.

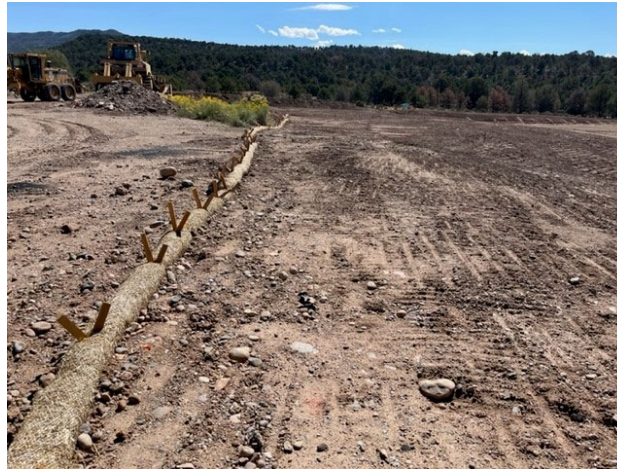
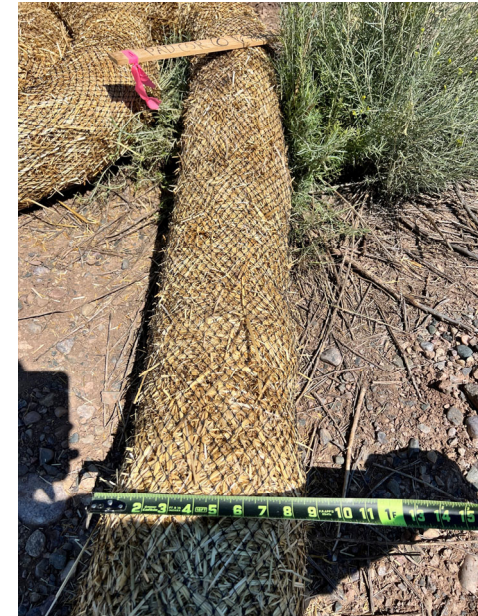
Wattles are 9-inch.

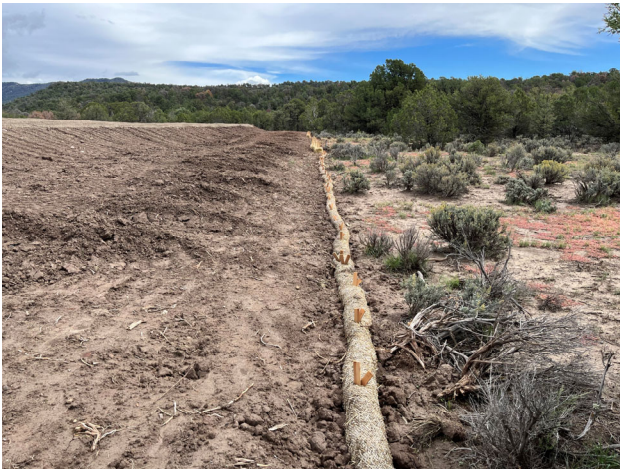
South side of location facing southeast, soil is no longer piled too high against wattles.

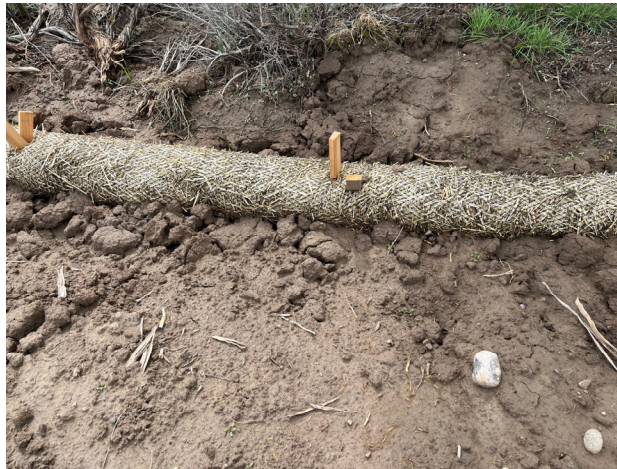
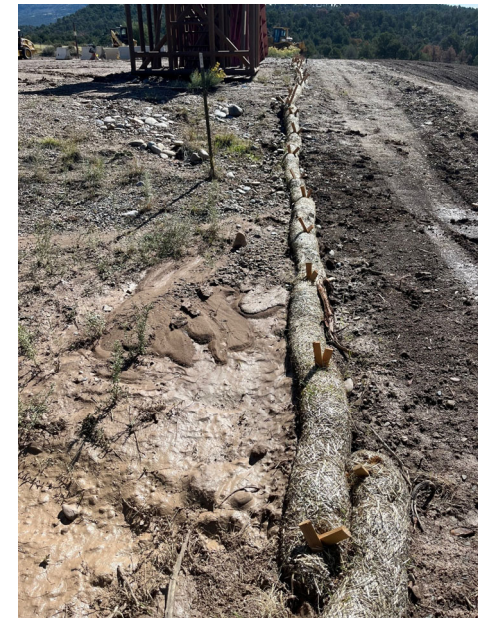
North side of pad, soil is no longer piled too high against wattles.

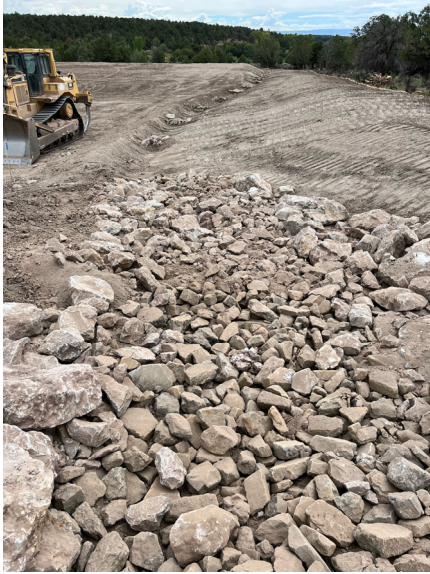
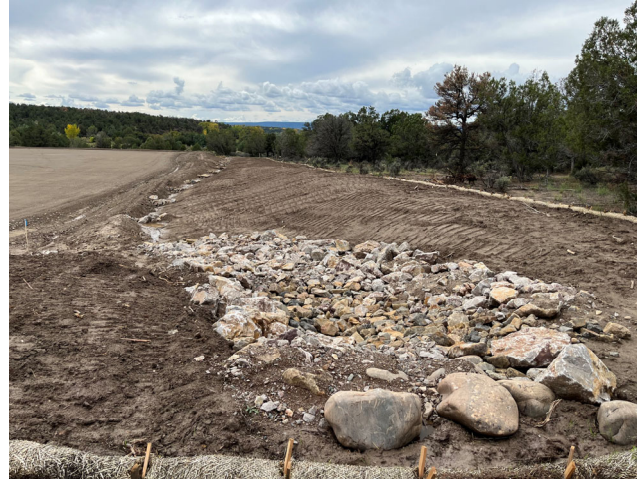
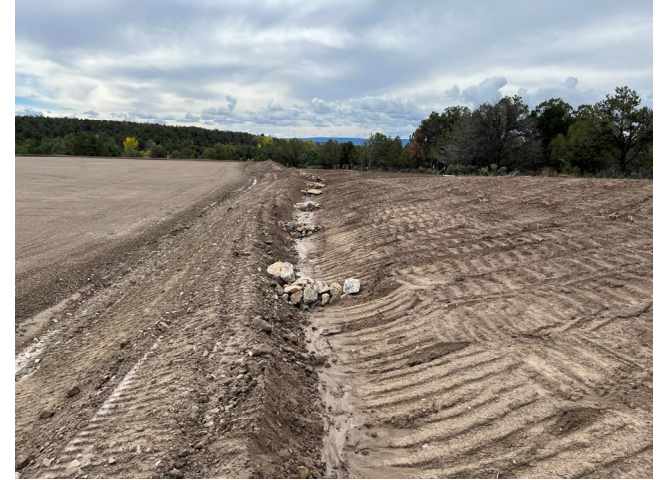
Angular rock and geotextile installed in northwest corner (facing southwest). BMPs also include rock check dams and diversion ditch.

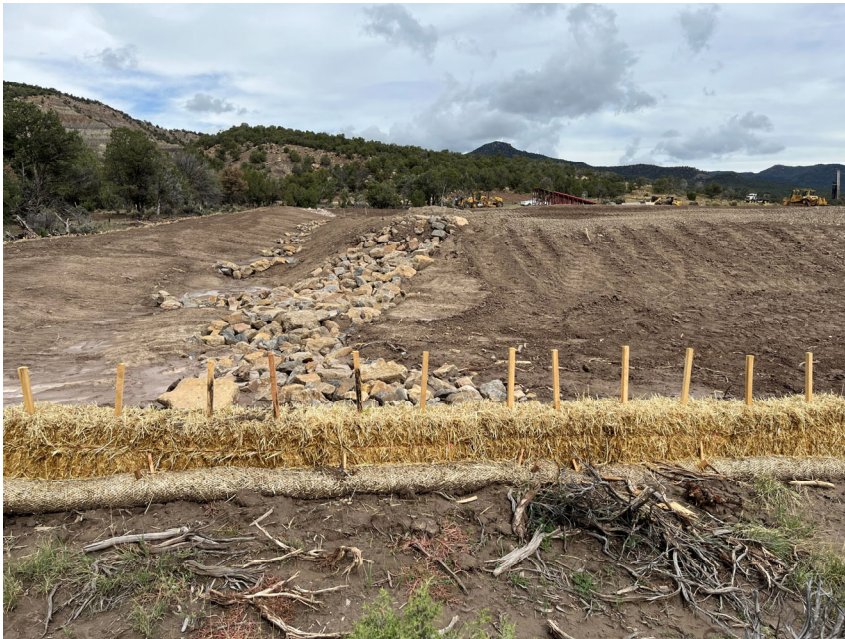
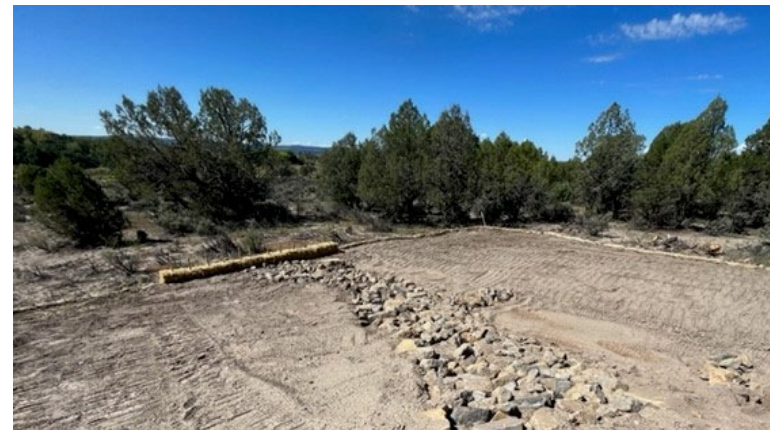
Southwest corner BMPs include diversion ditch with rock check dams, rock run down with geotextile material and angular rock, and straw bales.

Straw bales installed along south side of location/fill slope to mitigate sediment from entering drainage
Tracking is perpendicular to slope.

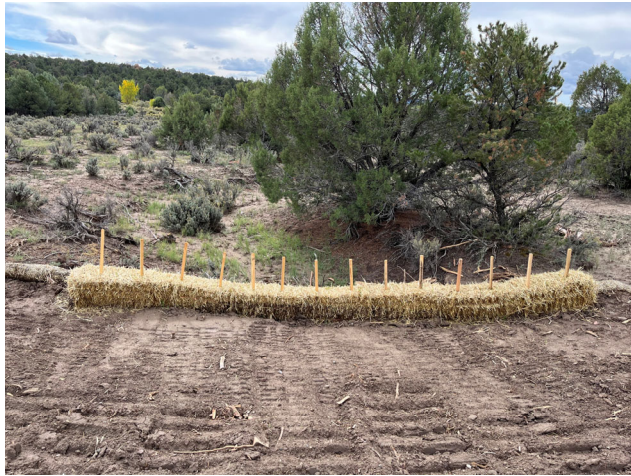
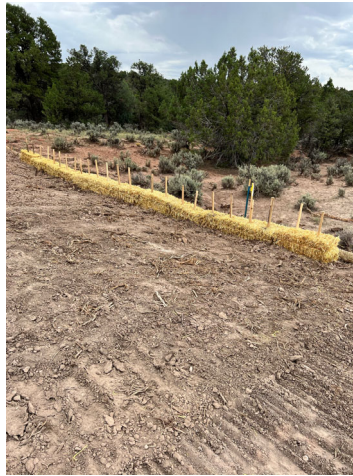
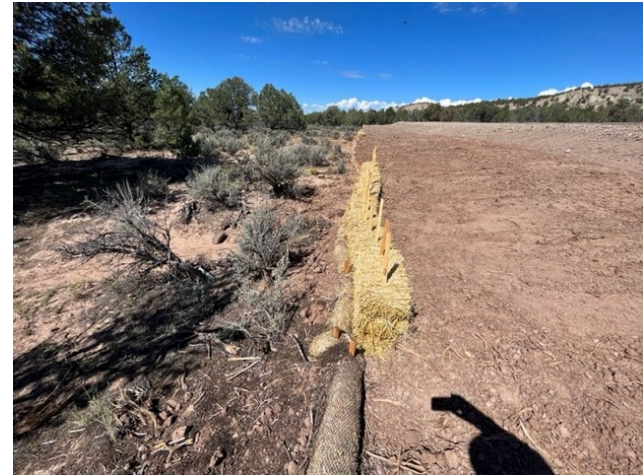
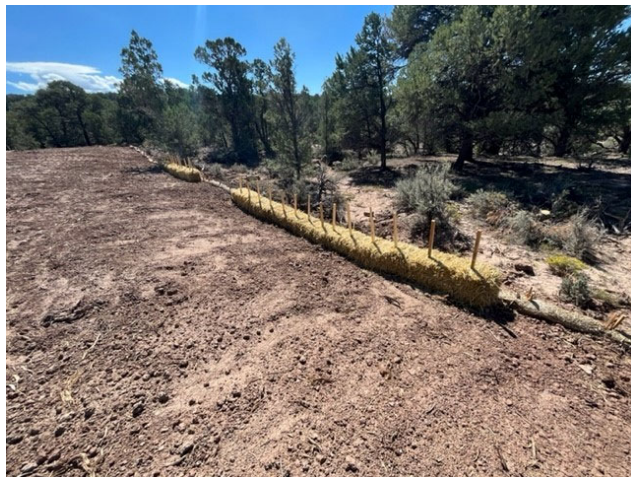
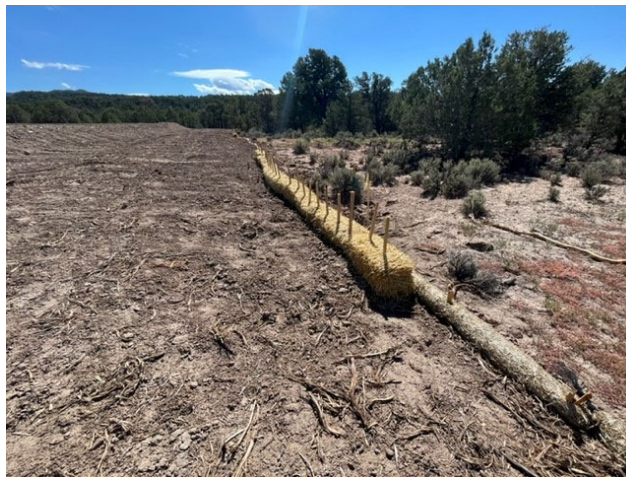
Southeast corner: BMPs in place including wide rock rundown installed with geotextile material and angular rock. Straw bales added to minimize sediment migration offsite. Tracking perpendicular to slope.

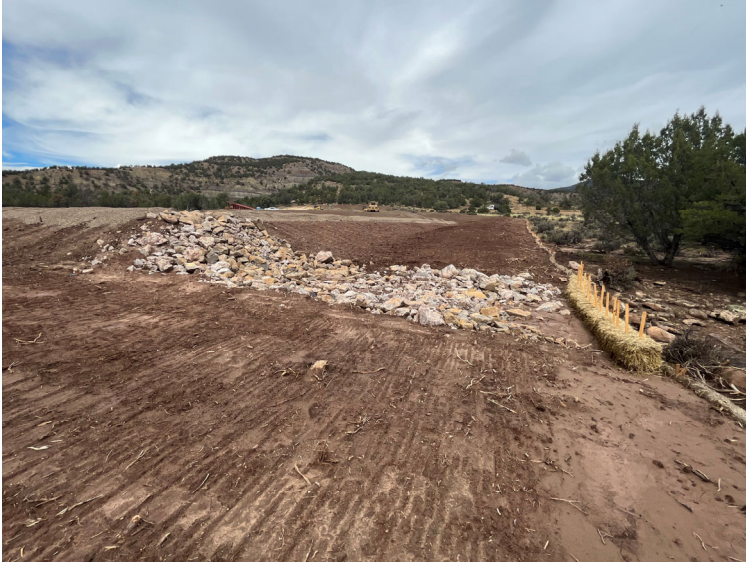
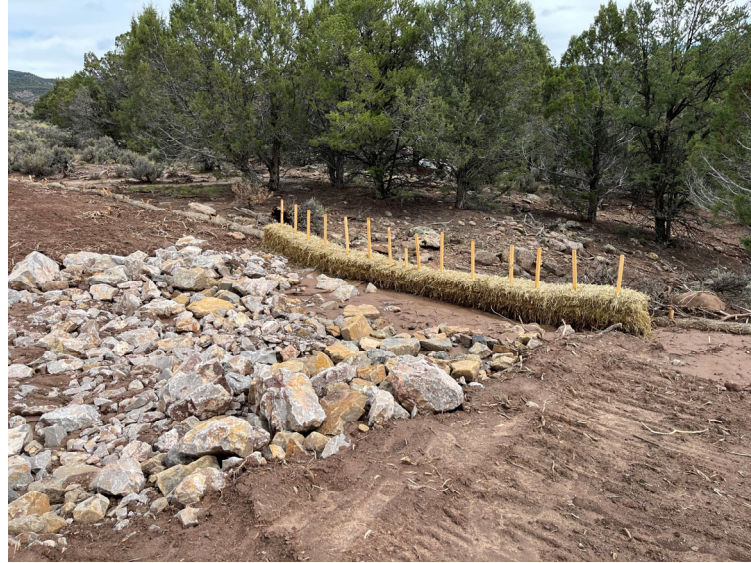
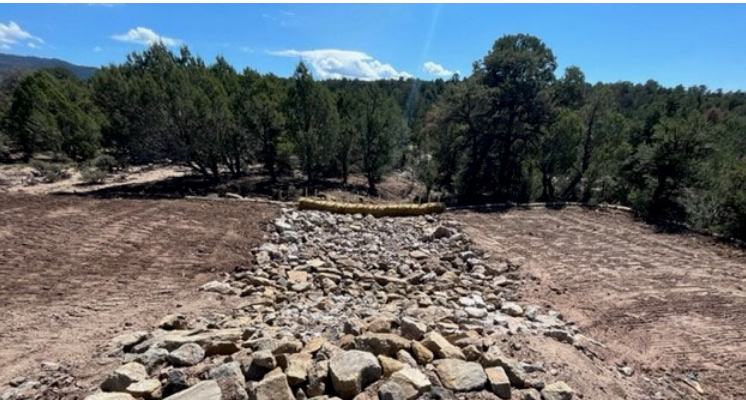
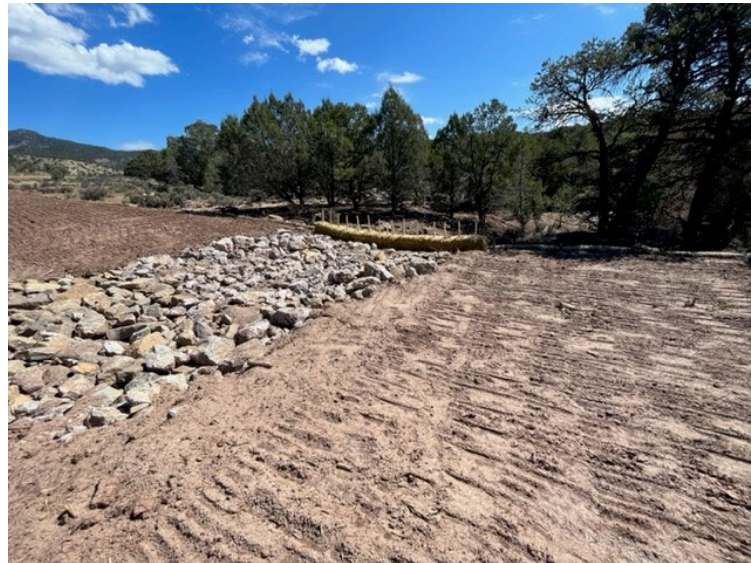
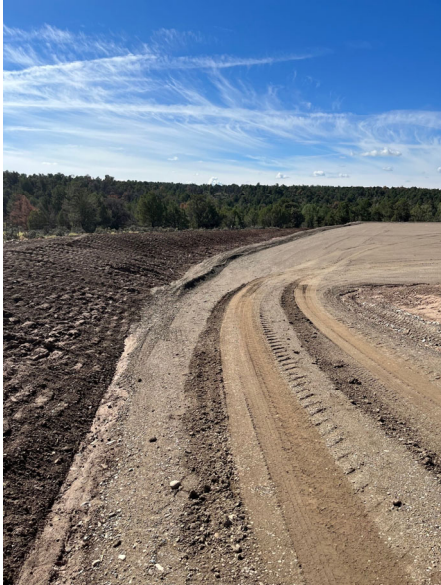
East side berm installed along pad edge to direct water to the rock rundown.
Tracking perpendicular to slope.

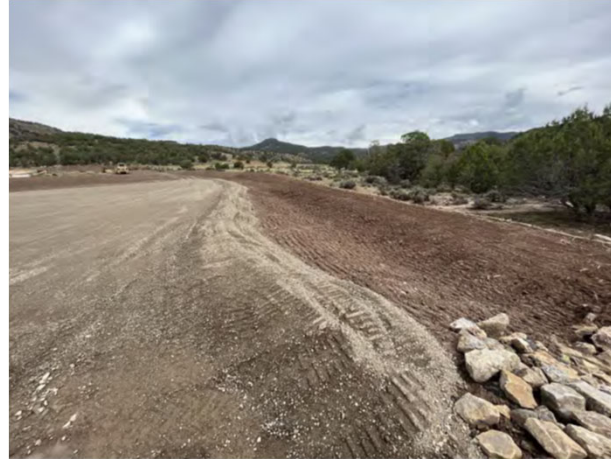
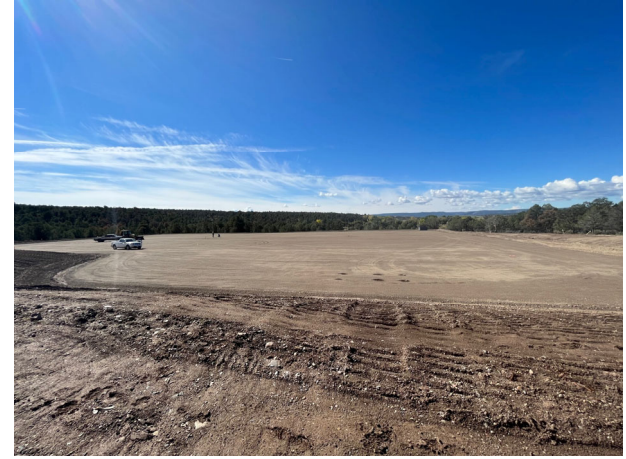
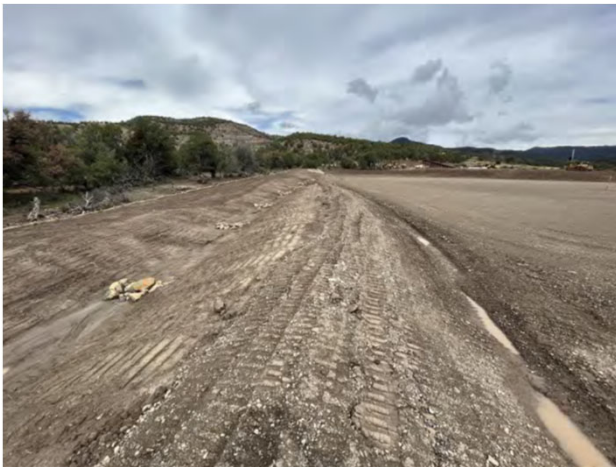
West side berm installed along pad edge to direct water to rock rundowns.

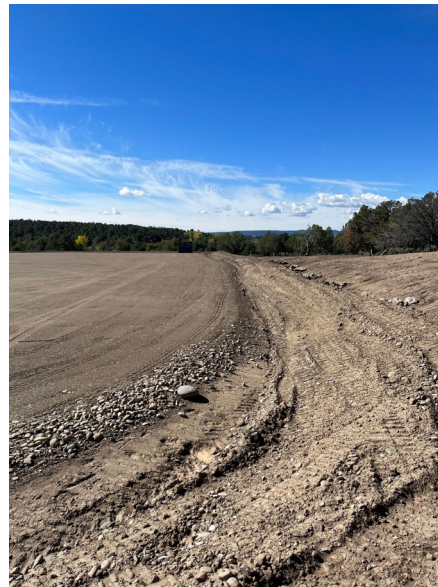
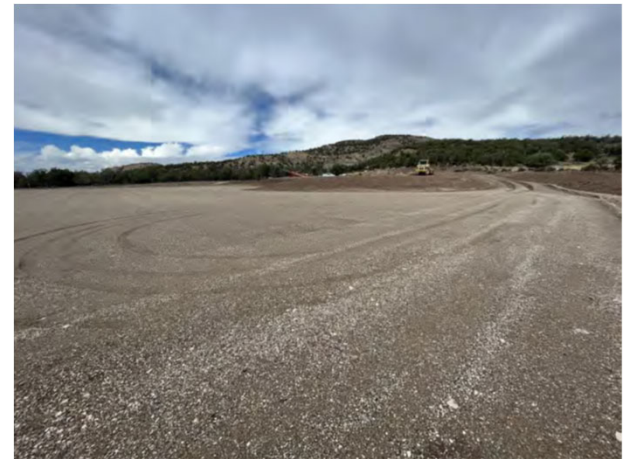
Pad surface grade finalized and aggregate applied.
