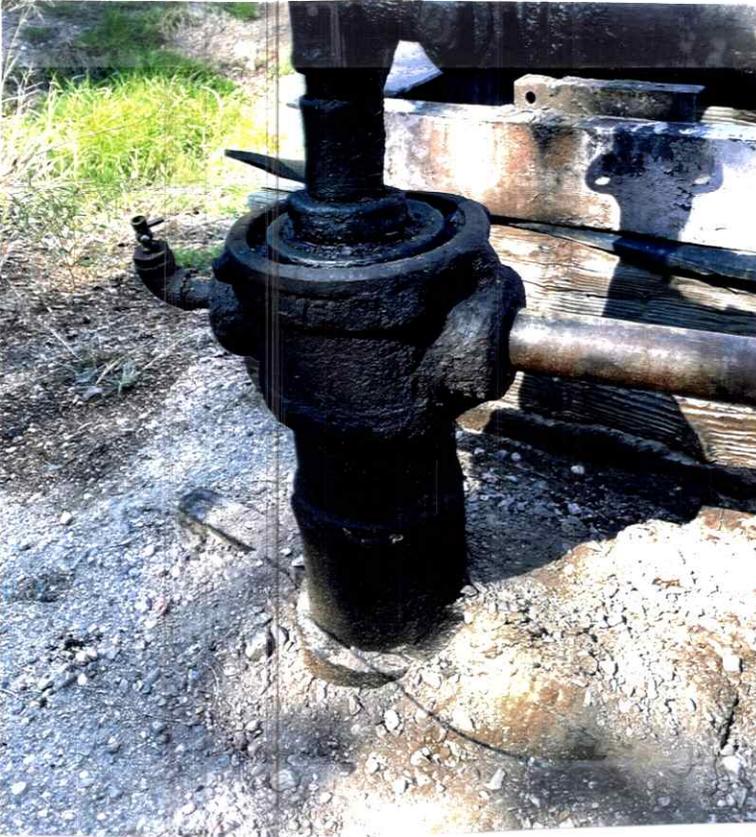
AREA OF IMPACTED SOIL AROUND WELLHEAD. CA: Conduct maintenance on equipment, cleanup stained material and review self inspection processes. COMPLY WITH RULE 1002,(2).D. CA DATE 5-4-2022.

Impacted soil noted during inspection was dug up on May 02, 2022 and replaced with clean soil.

CA completed 5/02/22

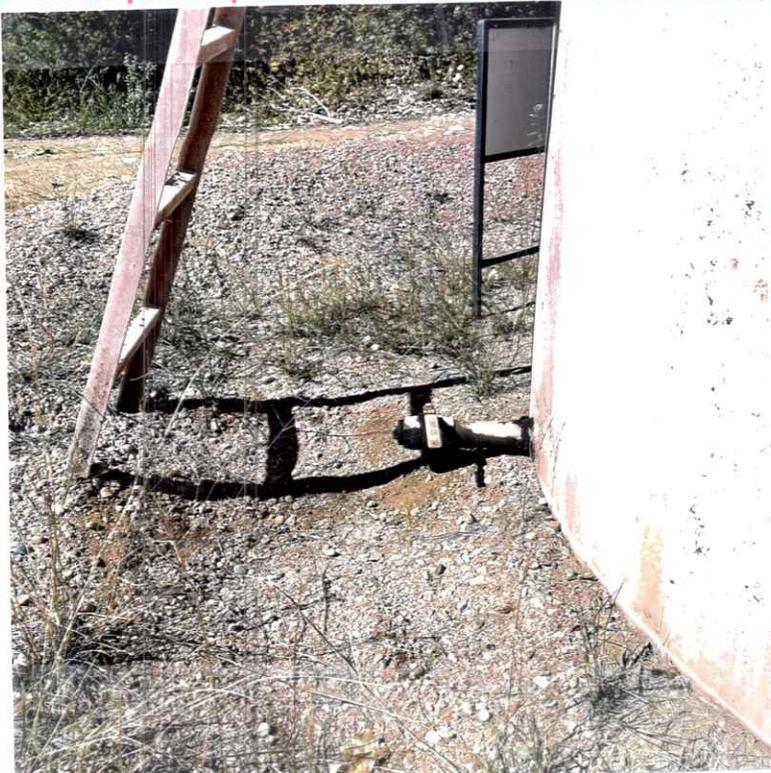
AREA OF IMPACTED SOIL NEAR TANK CA: Conduct maintenance on equipment, cleanup stained material and review self inspection processes. COMPLY WITH RULE 1002,(2).D. CA DATE 5-4-2022.

Impacted soil around equipment and tank was removed on May 02, 2022 and replaced with clean soil.

CA completed 5/02/22

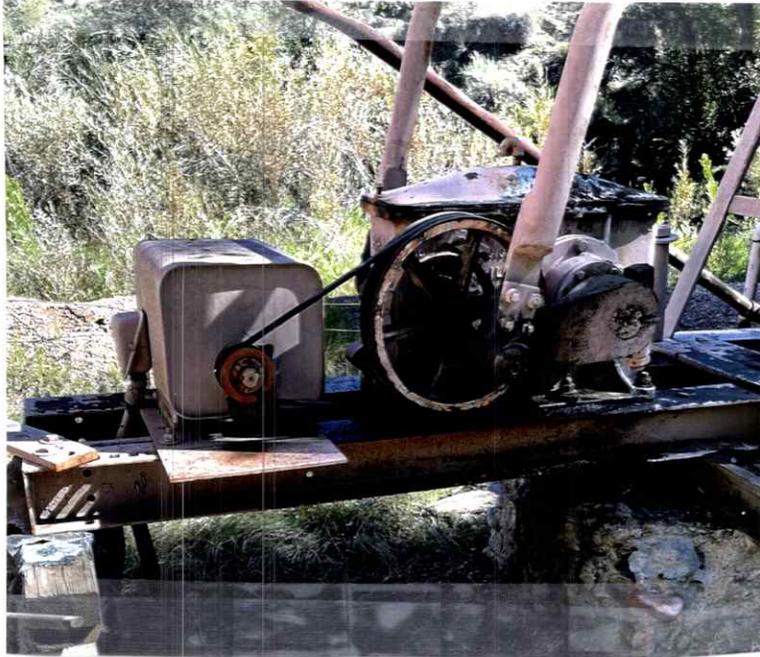
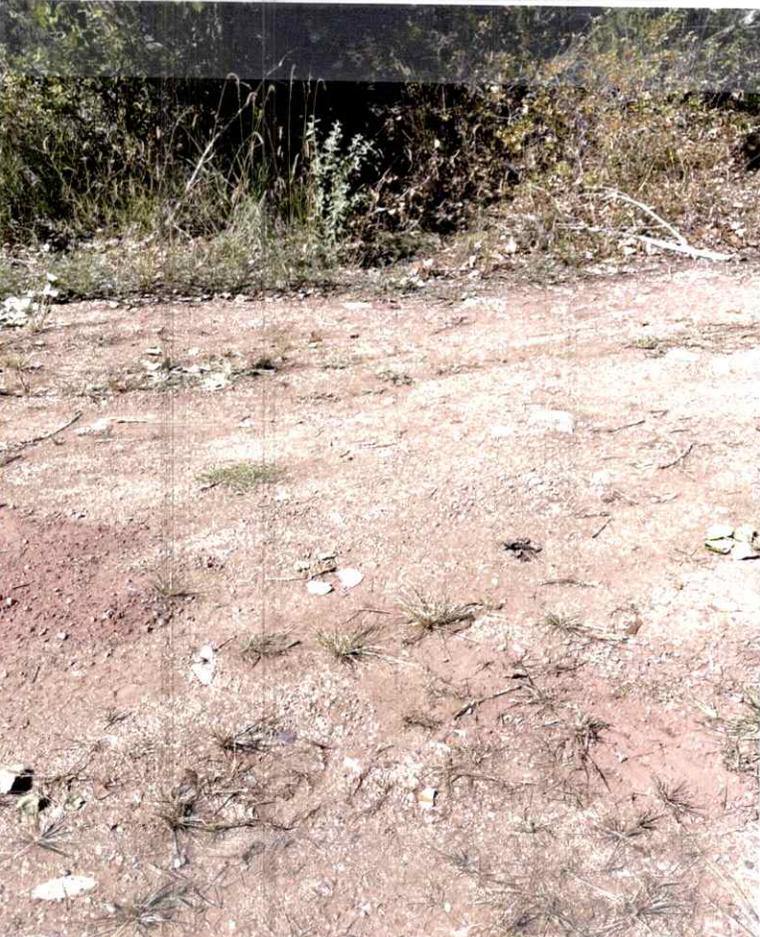
AREA OF IMPACTED SOIL OUTSIDE OF BURM NEXT TO TANK BATTERY. CA: Conduct maintenance on equipment, cleanup stained material and review self inspection processes. COMPLY WITH RULE 1002,(2).D. CA DATE 5-4-2022

Stained soil outside of berm next to tank battery (noted during inspection) was removed and replaced with clean soil.

Equipment maintenance was performed.

CA completed 5/02/22
