# Inspection Photos

Operator: Vision Energy LLC - #10770

Location Name: Baldy Creek Unit-67S90W /17SENW

Inspection Document #: 702800746

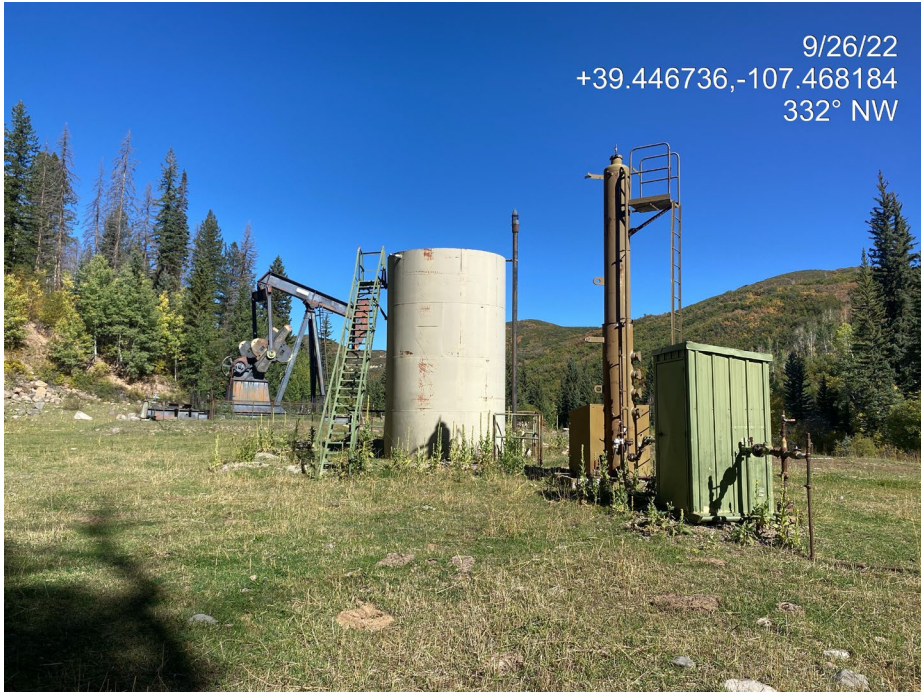
**Photo 1.** Photo taken from the south shows an overview of the Location. Note vegetation, including noxious weeds growing around equipment.

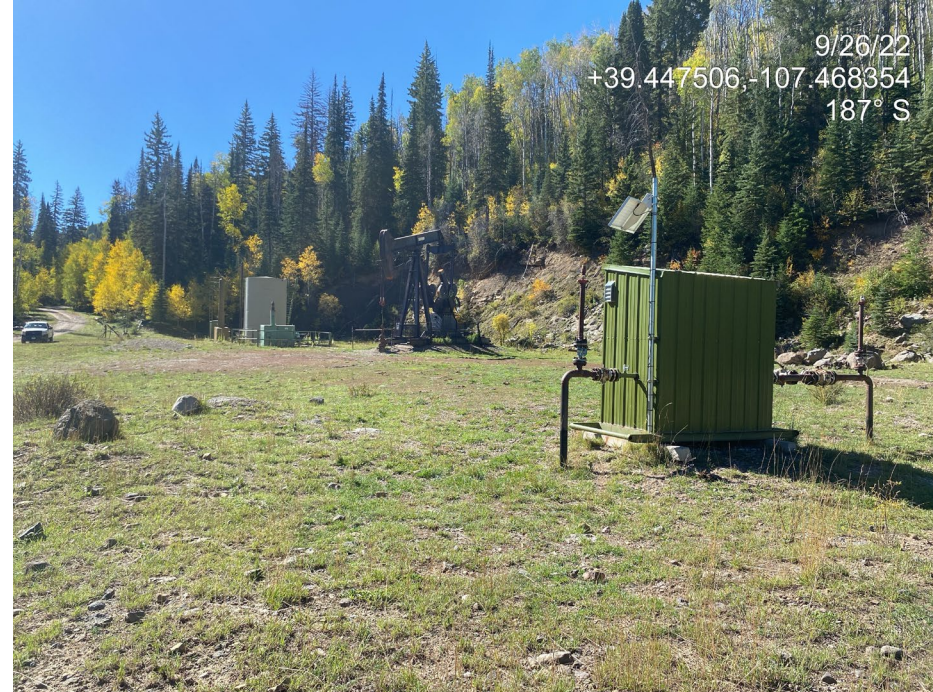
**Photo 2.** Photo taken from the north shows an overview of the Location.

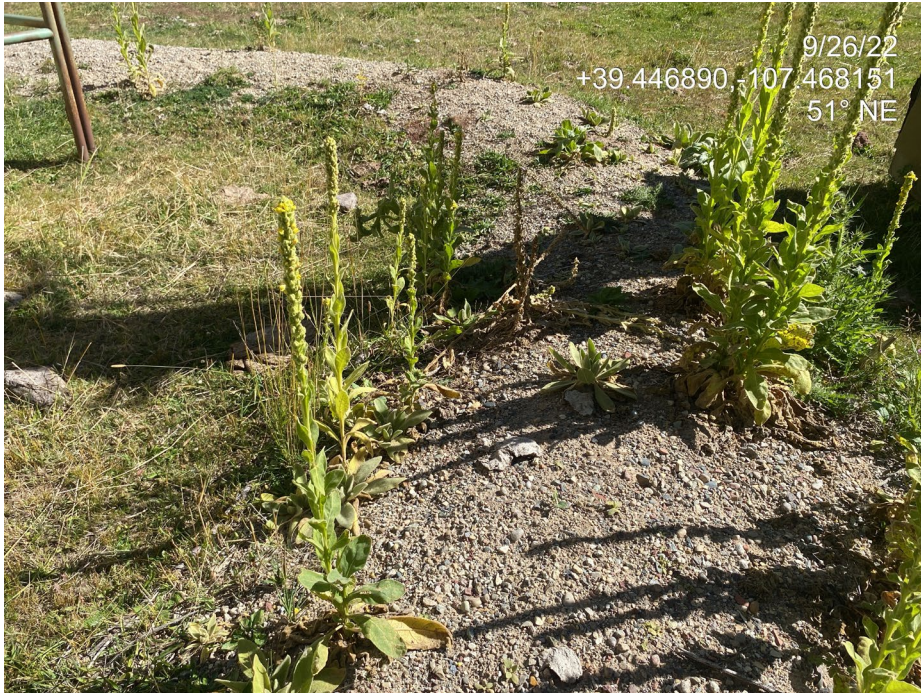
**Photo 3.** Photo taken from the south of the Location shows the tank secondary containment is not in proper functioning condition. The base of the secondary containment area is completely grown in with vegetation. The berm is eroded and compromised by vegetation growing on it. Species pictured include bull thistle (List B Noxious) and mullein (List C Noxious).

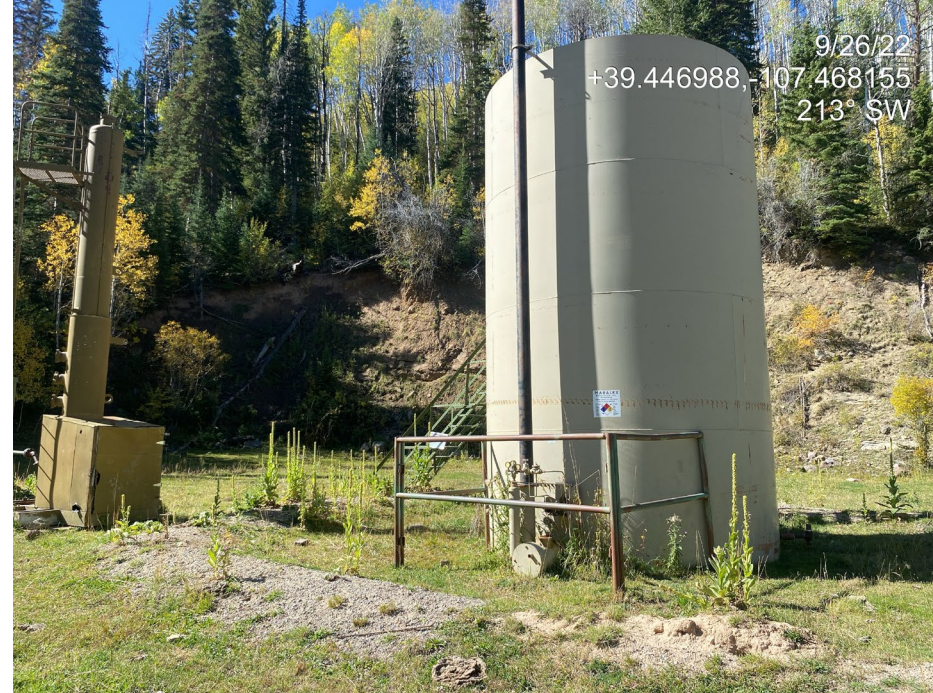
**Photo 4.** Refer to Photo 3 comment.

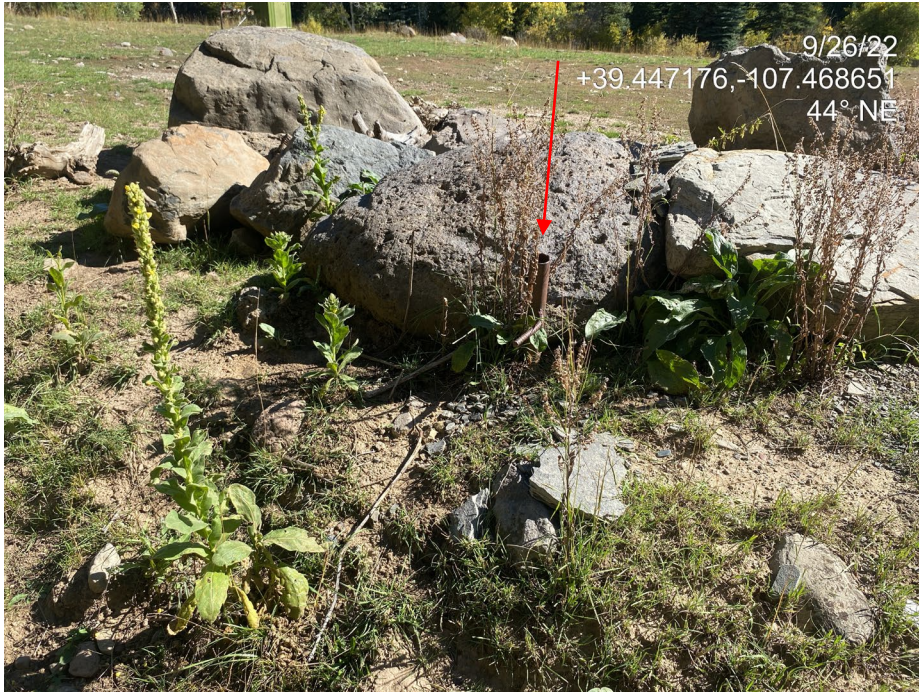
**Photo 5.** Photo taken from the north of the Location shows an example of unmarked anchor (red arrow). All anchors on Location are unmarked. Photo also shows noxious weeds houndstongue (List B) and mullein (List C).

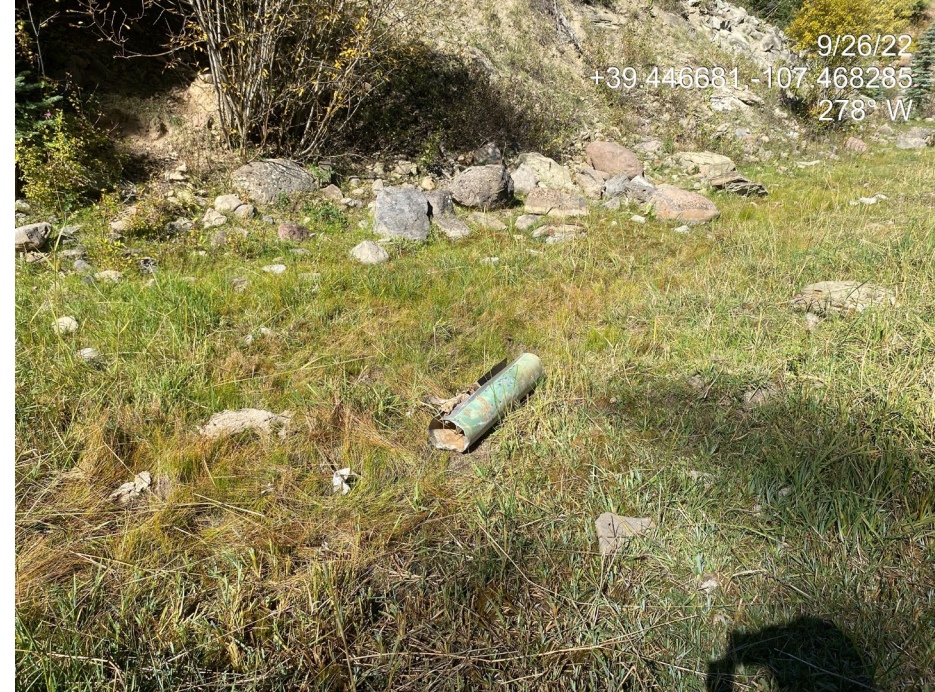
**Photo 6.** Photo shows an example of trash/debris.

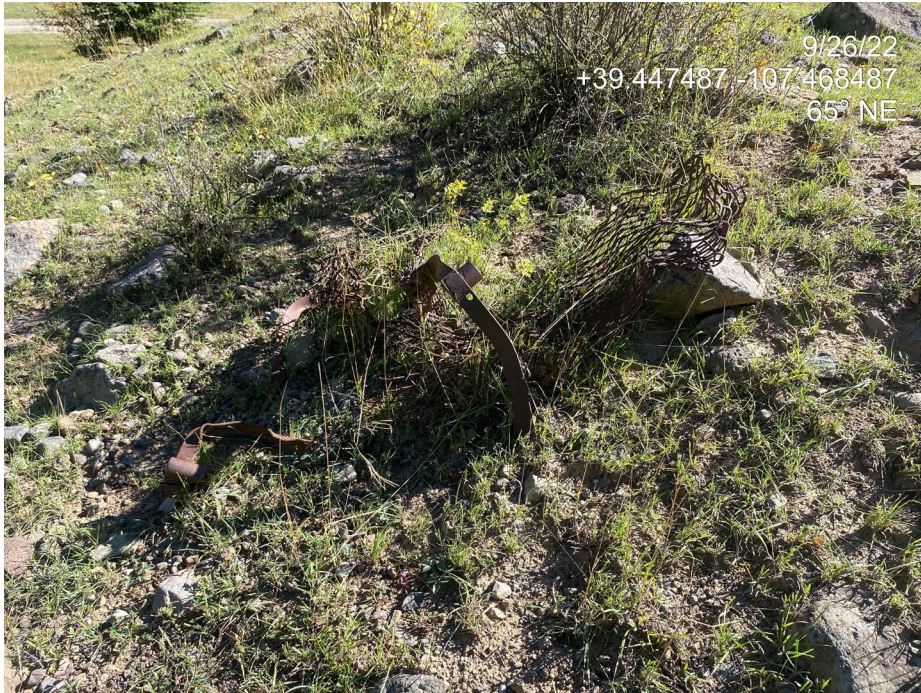
**Photo 7.** Photo shows an example of trash/debris.

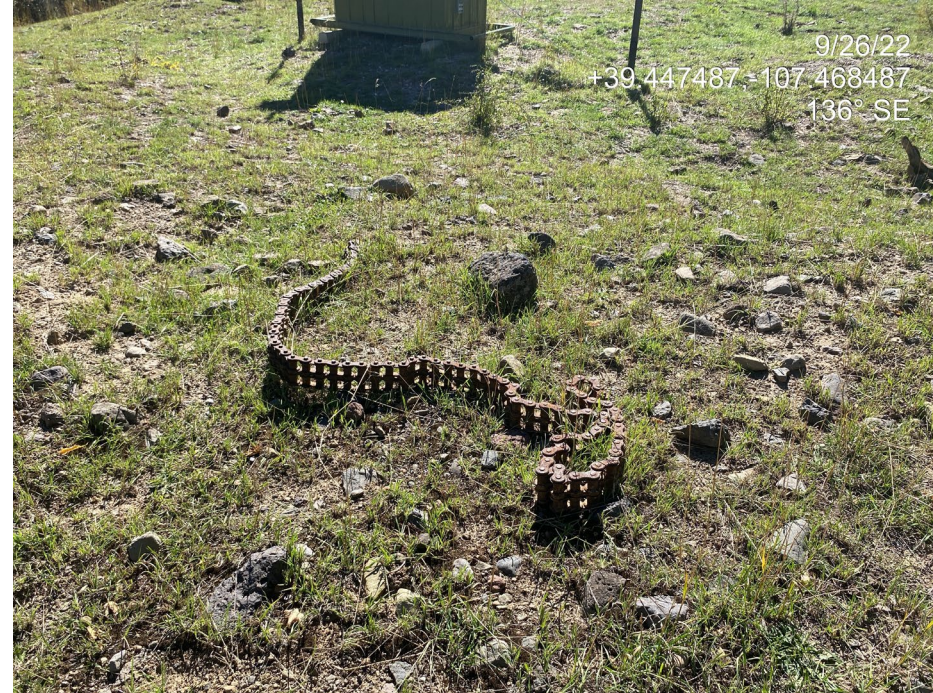
**Photo 8.** Photo shows an example of trash/debris.

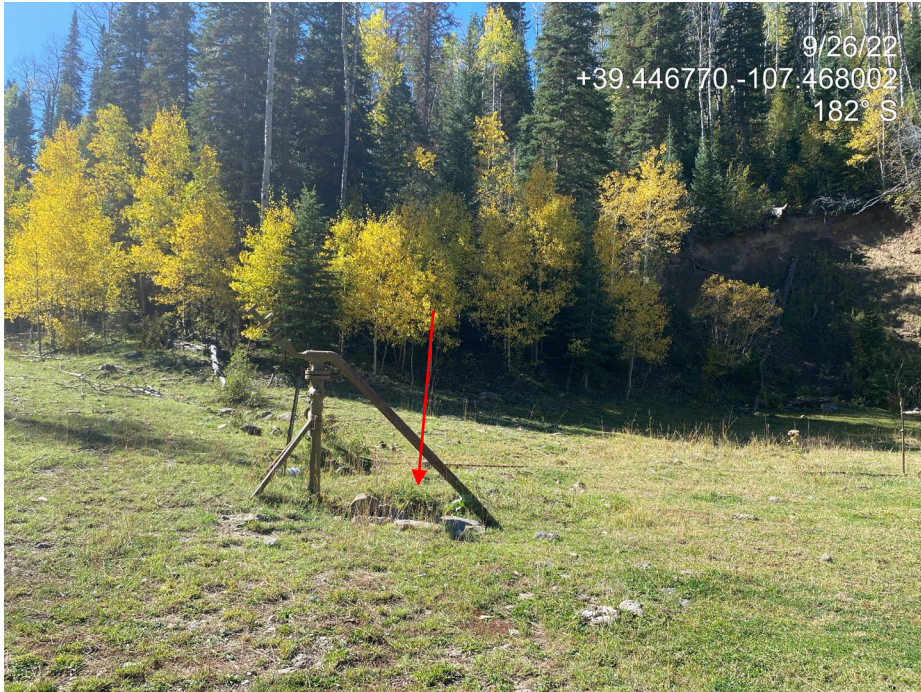
**Photo 9.** Photo shows where a hole/subsidence is occurring at a rock drain.

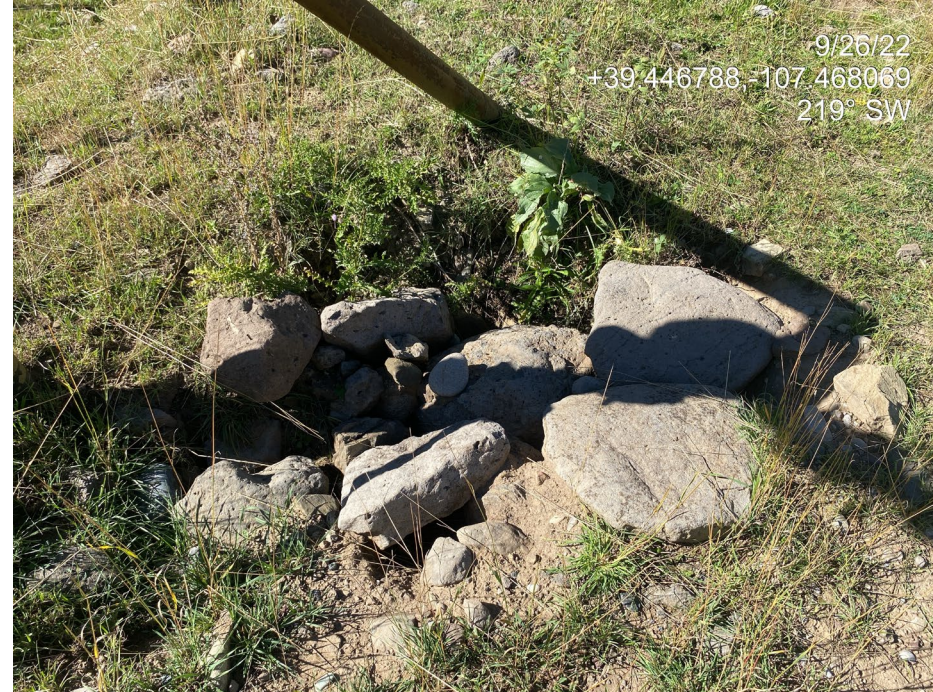
**Photo 10.** Photo shows a close-up of a hole/subsidence occurring at a rock drain.

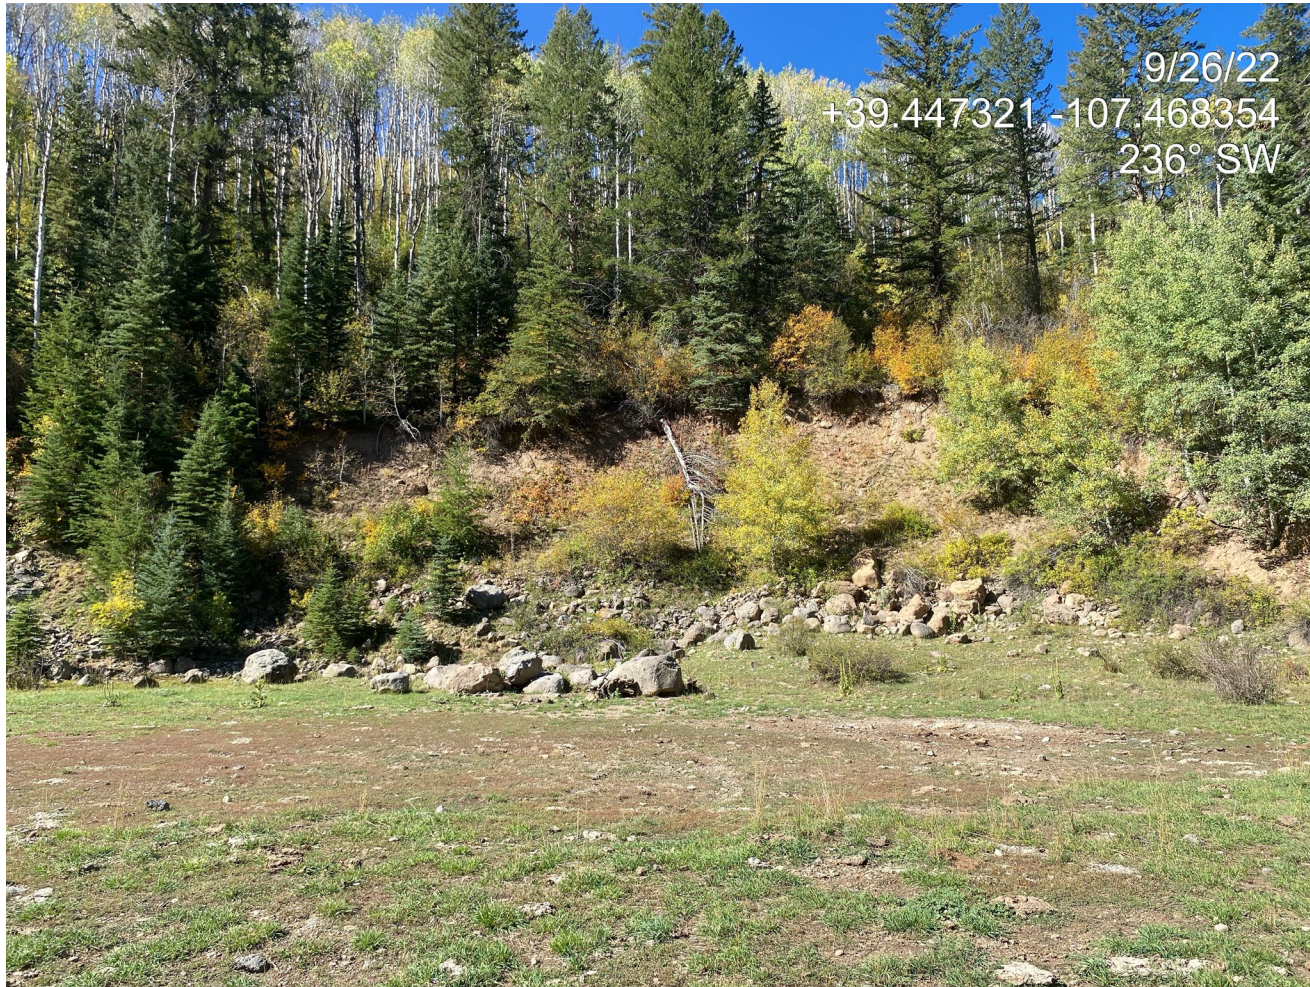
**Photo 11.** Photo taken from the north shows an overview of the eroding cut slope.

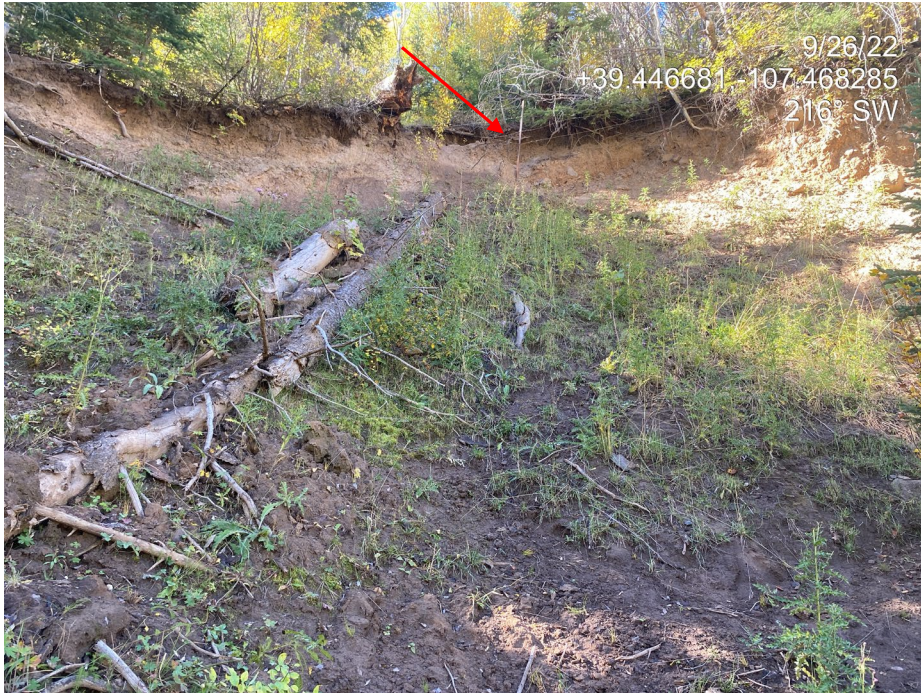
**Photo 12.** Photo taken from the southwest of the Location shows the cut slope is eroding and undercutting into undisturbed areas above the cut exposing roots. Arrow indicates an undermined fence. Vegetation at the center of the cut is Canada thistle (List B Noxious). Note also pedestals around vegetation throughout slope.

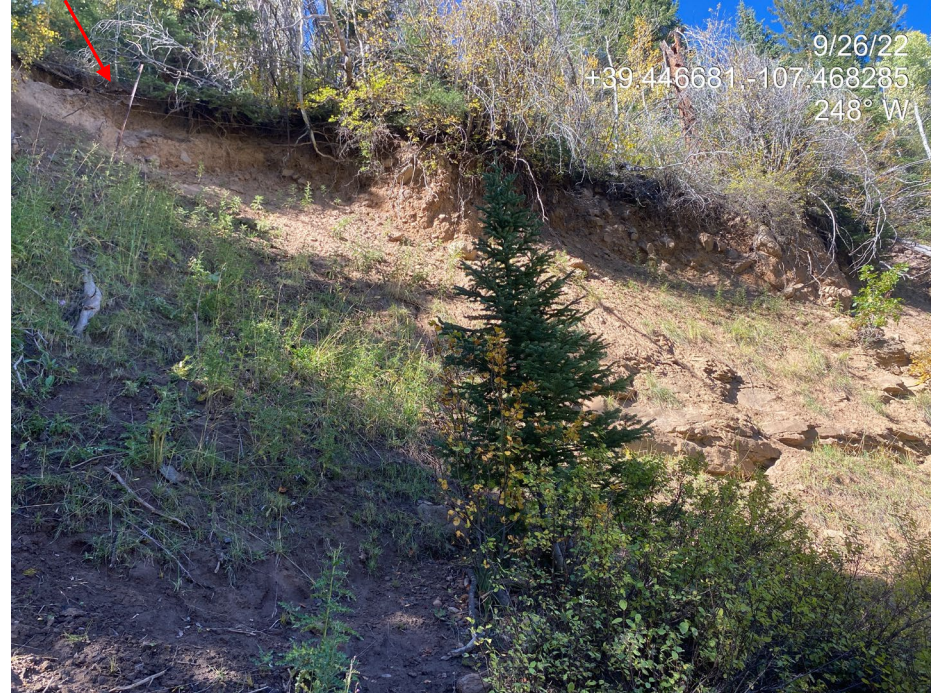
**Photo 13.** Refer to Photo 12 comment.
