Inspection Photos

API: 071-06094

Operator: AMOCO PRODUCTION COMPANY

Inspection Date: 10/4/2022

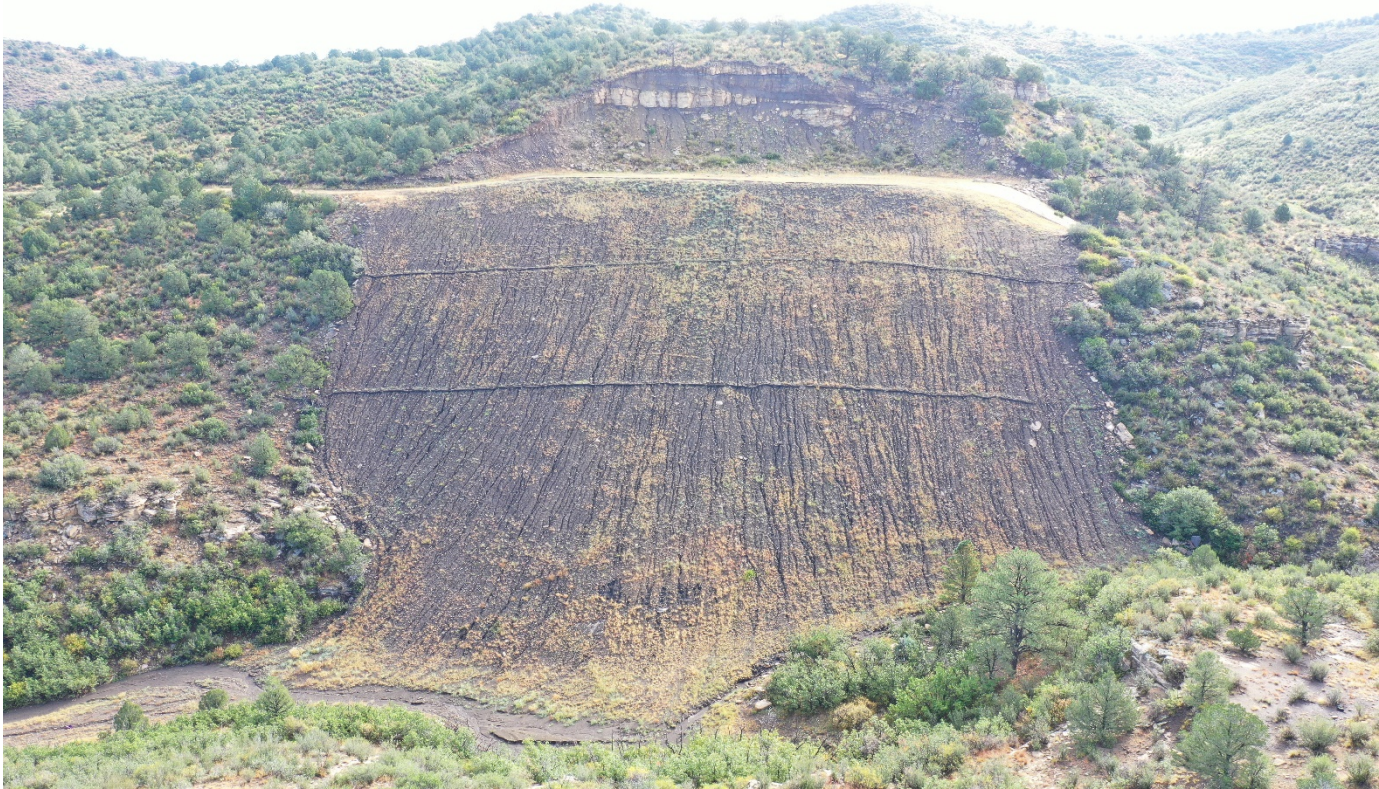
Photo 1. Drone aerial photo facing east toward the well site location. The access road and pad remain and were not recontoured back to the original condition per the rules. There has been significant erosion that has occurred.

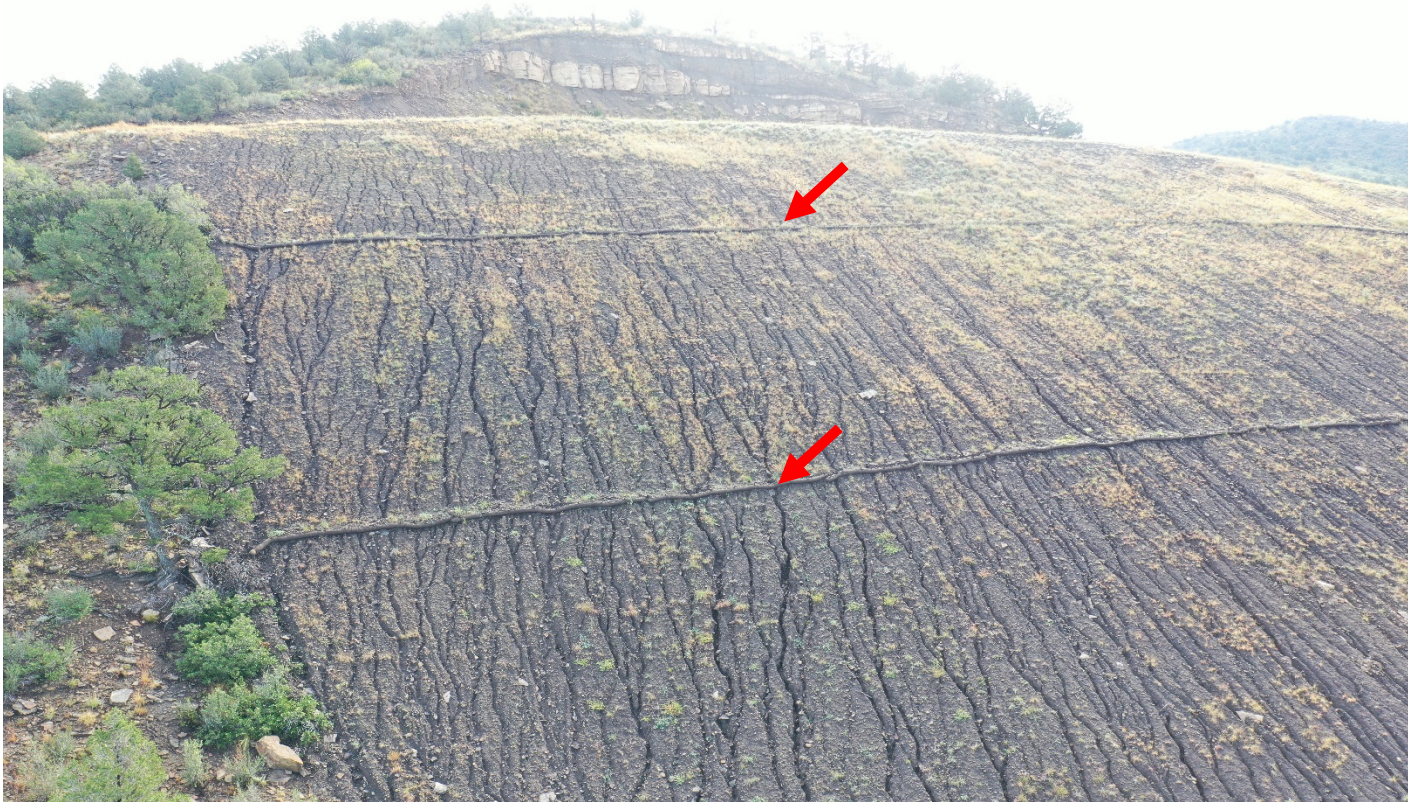
Photo 2. Facing east toward the fill slope. Stormwater controls were not sufficient and there is significant erosion along fill slope. The red arrows point to the two rows of wattles that are filled in with sediment and have not been maintained.

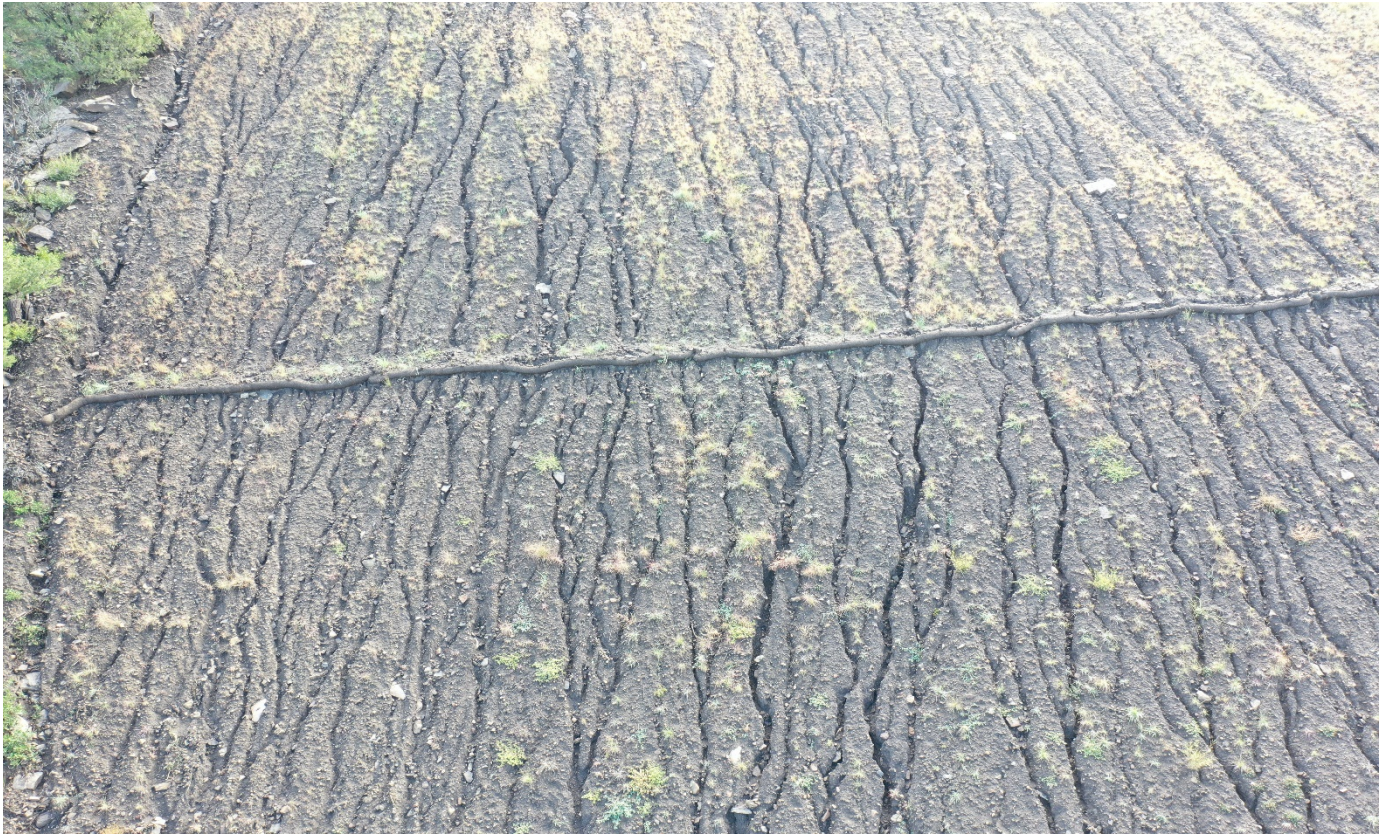
Photo 3. Facing closer to the fill slope shows the rilling erosion that has occurred. The wattles are not maintained and have filled in with sediment. Rilling erosion continues to occur underneath the wattles and down the slope.

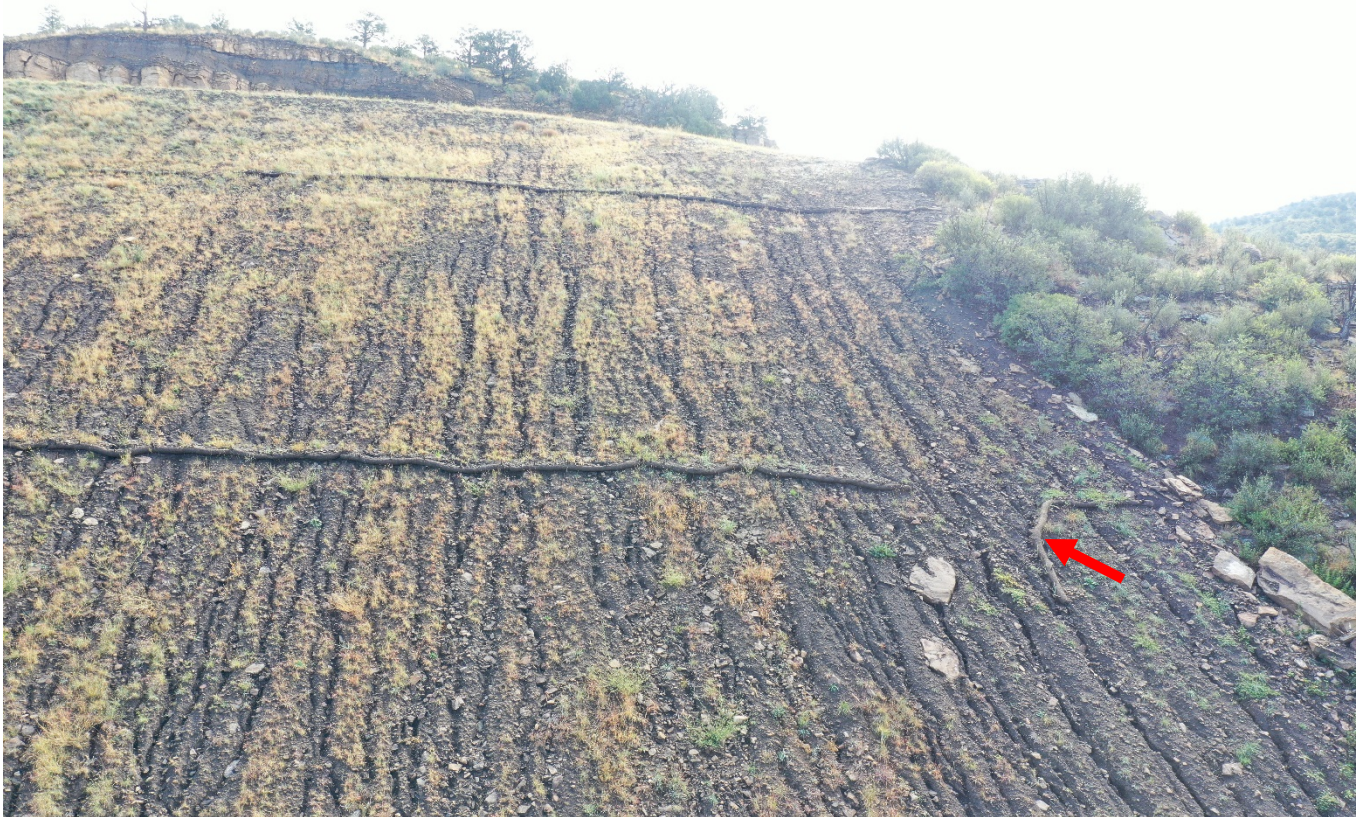
Photo 4. The straw wattles along the cut slope are displaced and not maintained. Red arrow points to the same displaced wattle observed during the previous inspection last year. Previous corrective action was not performed.

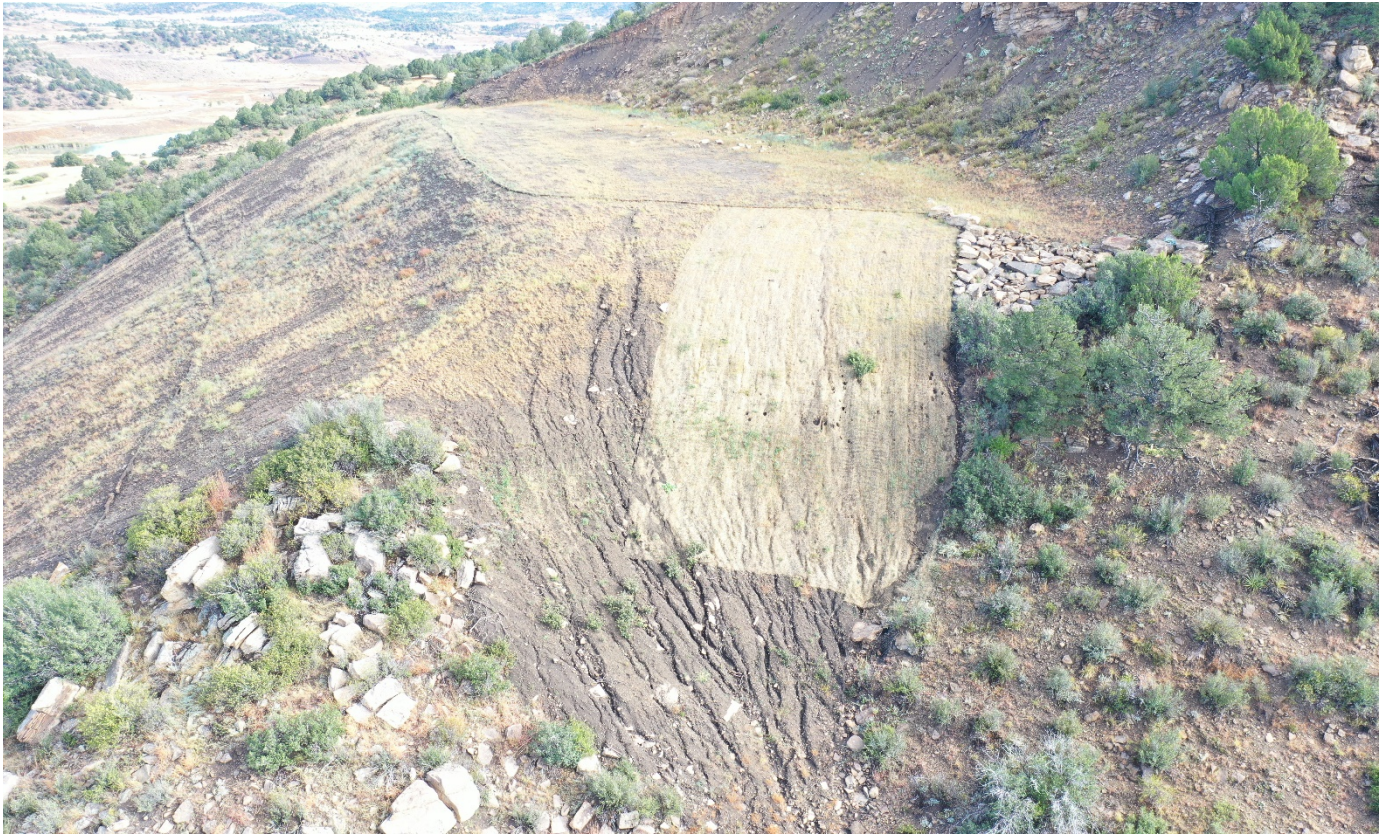
Photo 5. Facing north toward the location. There is rilling erosion that has not been repaired or controlled. There was erosion blanket installed on a portion of the slope however the rilling underneath the blanket is still evident and may continue to worsen.

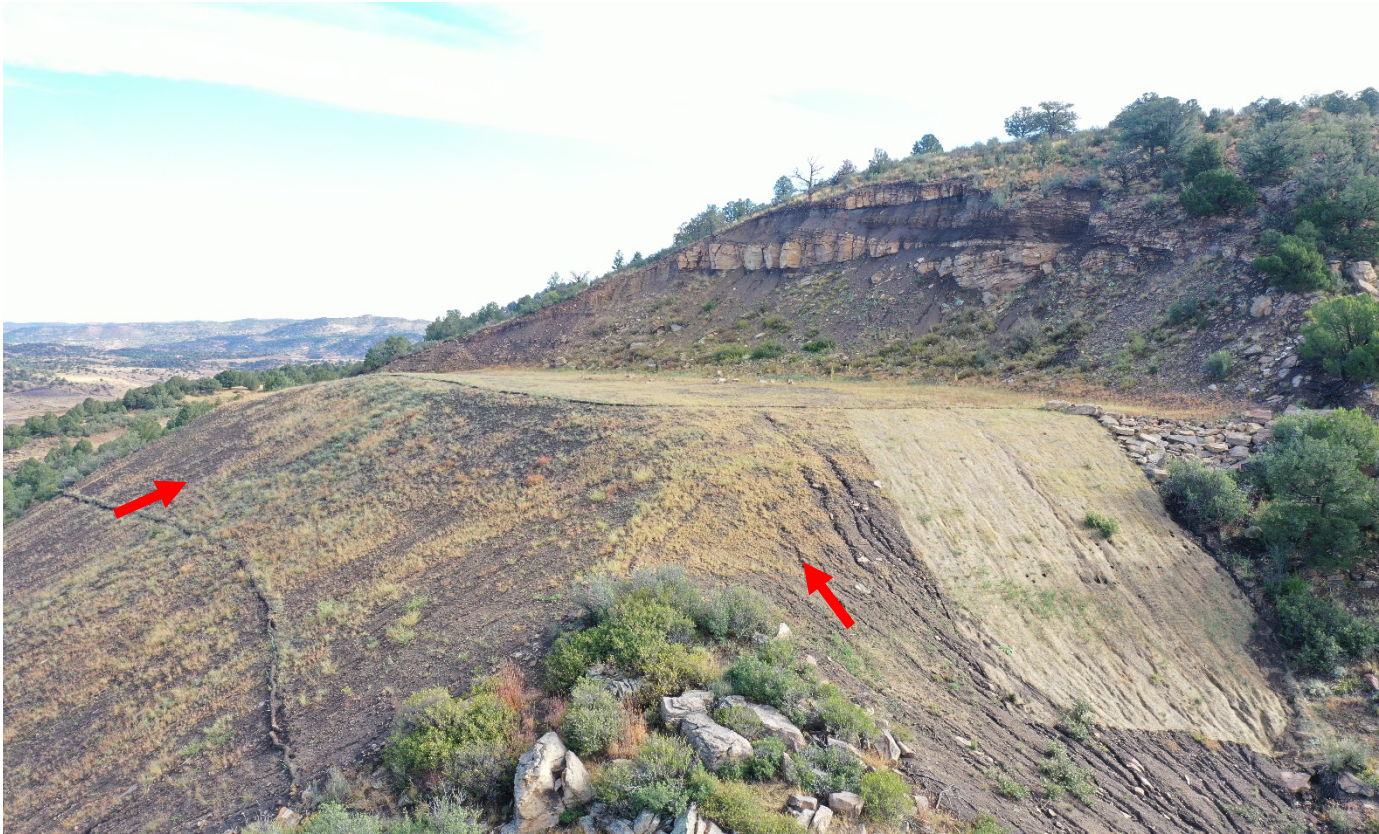
Photo 6. Facing north toward the location which was not recontoured per the rules. The red arrows point to fill material which could have been safely placed back to original contour which would have reduced the grade of the slope. Typically excavators are used to pull material back into the cut slope.

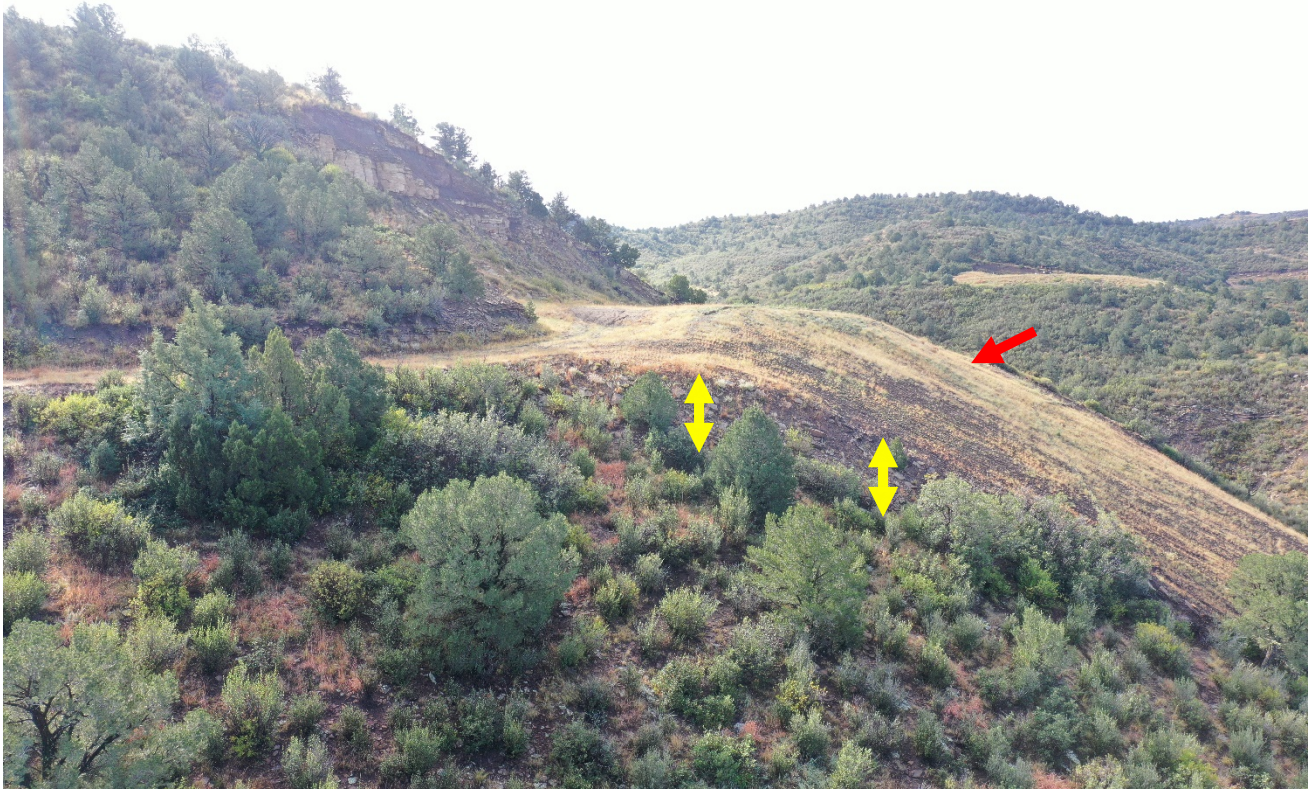
Photo 7. Facing southeast toward the location which was not recontoured per the rules. The red arrow point to fill material which could have been pushed back to original contour. The yellow arrows show fill material which is about 20ft. from the original grade.

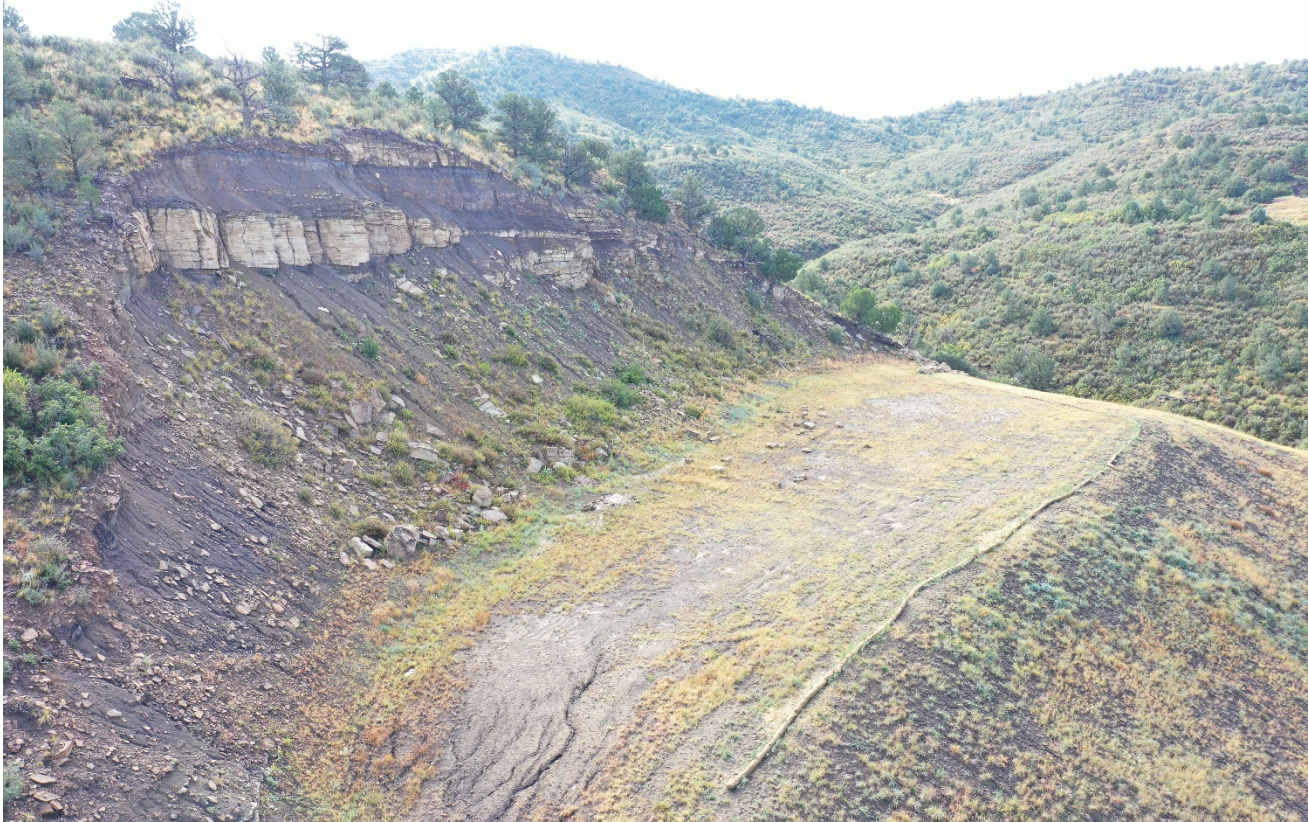
Photo 8. Facing southeast toward the location. A vertical unstable cut slope still remains and is not stabilized. The fill slope material was not resloped back to the original contour.

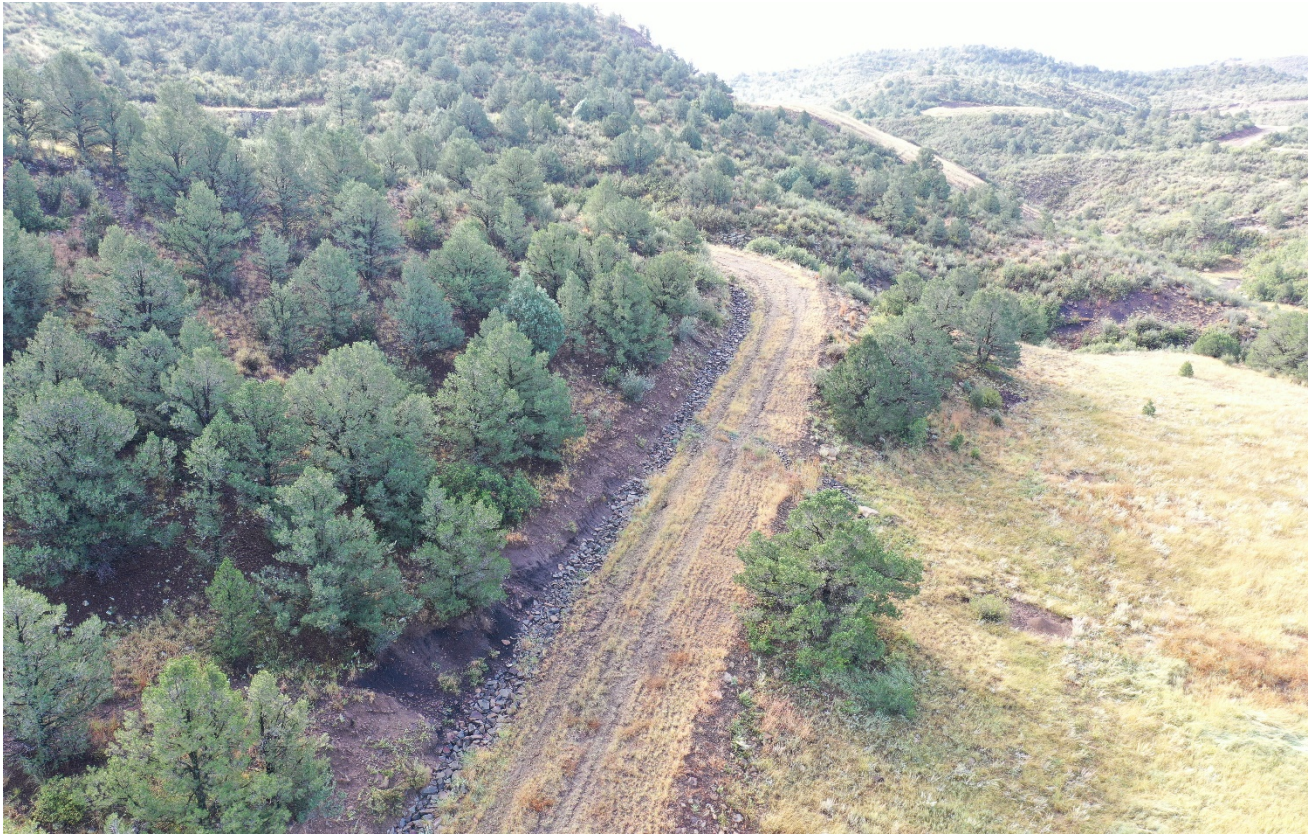
Photo 9. Facing south toward the access road which was not recontoured and reclaimed. The access road switches back and dead ends at the location.

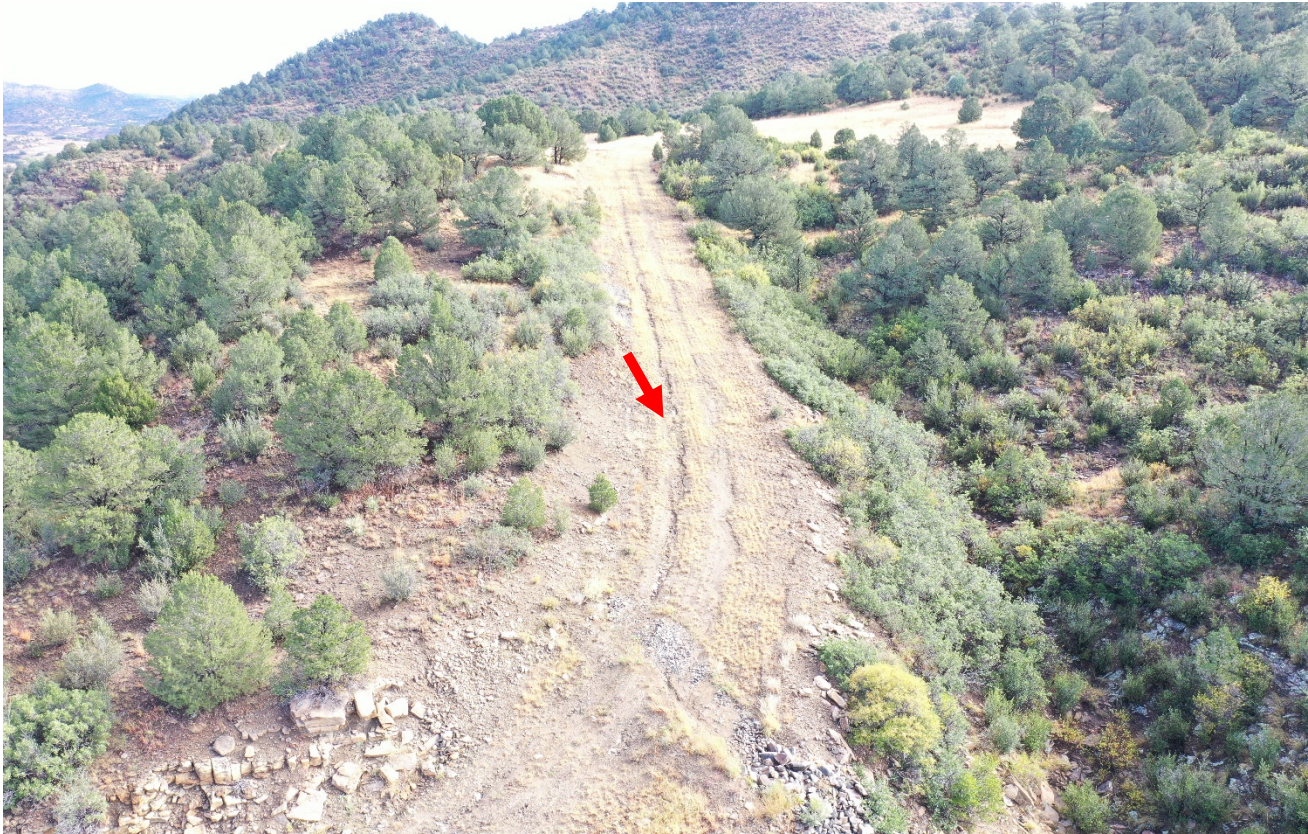
Photo 10. Facing northeast toward the access road which was not recontoured and reclaimed. The access road switches back and dead ends at the location. There is erosion occurring down the road shown at red arrow.

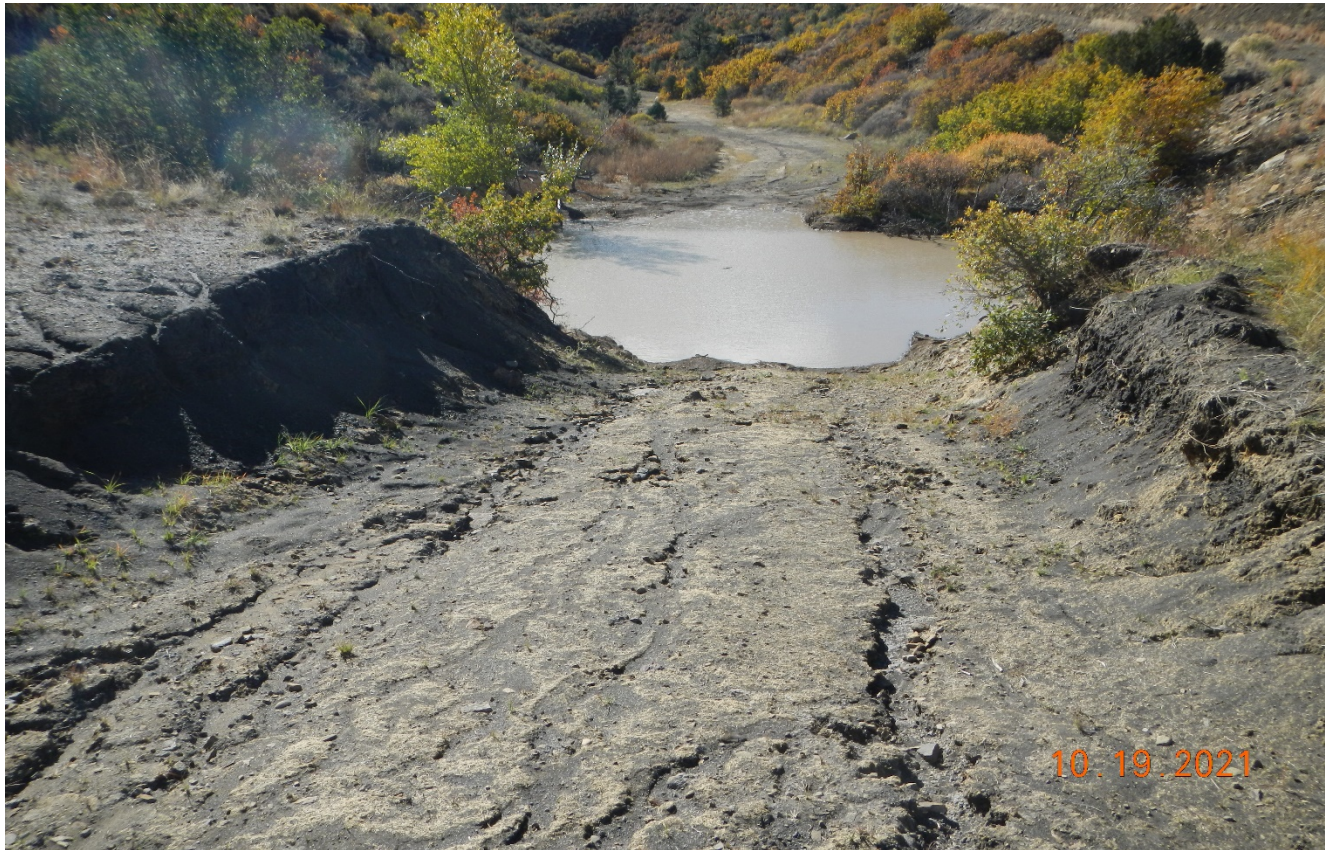
Photo 11. Facing south toward the road that was built to access the canyon bottom. There is erosion beginning to occur along this area which was not recontoured and reclaimed. Photo from previous inspection. See previous inspection details.

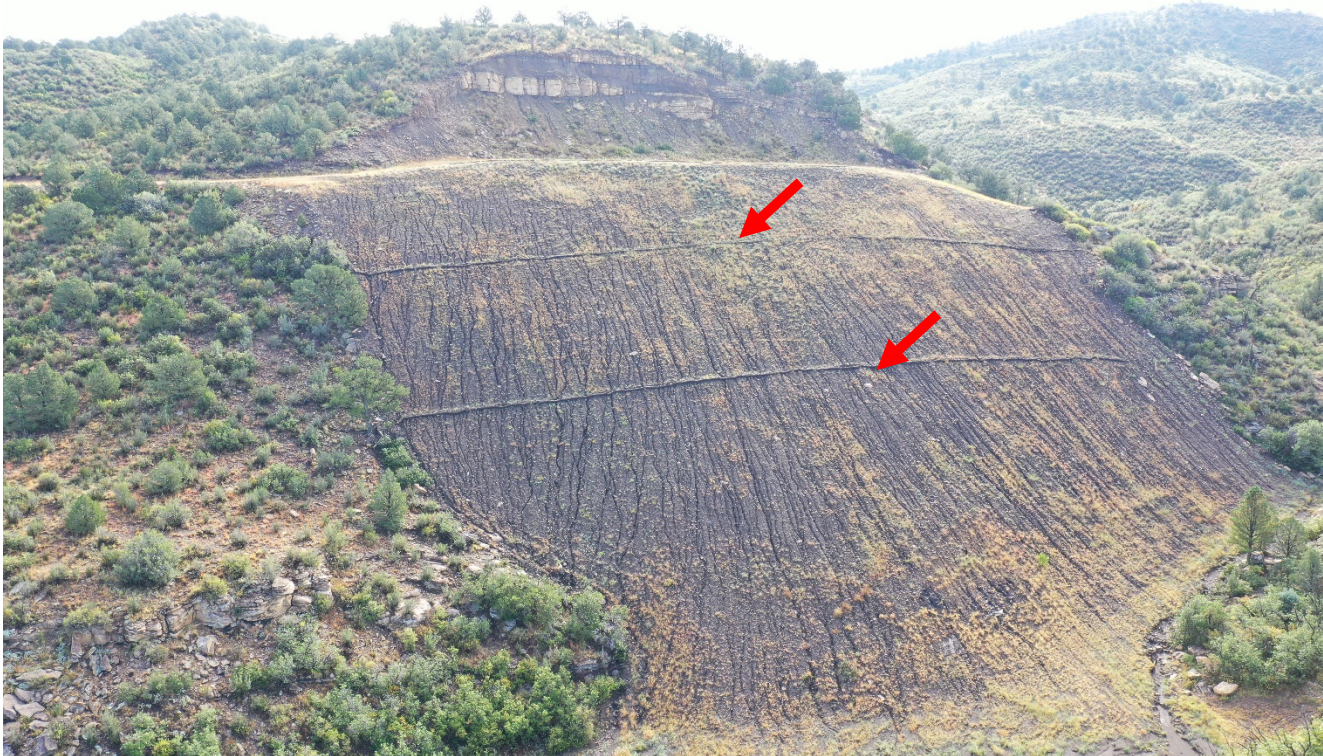
Photo 12. Facing east toward the location from across the canyon. There is not sufficient stormwater controls along the fill slope. The red arrows point to two rows of wattles along the approximate 250 ft. slope. Substantial erosion has occurred along the fill slope since the previous inspection. Previous corrective action was not completed.
