Inspection Photos  
Location Name: UPRR 43 PAN AM I #5  
Location ID: 318212

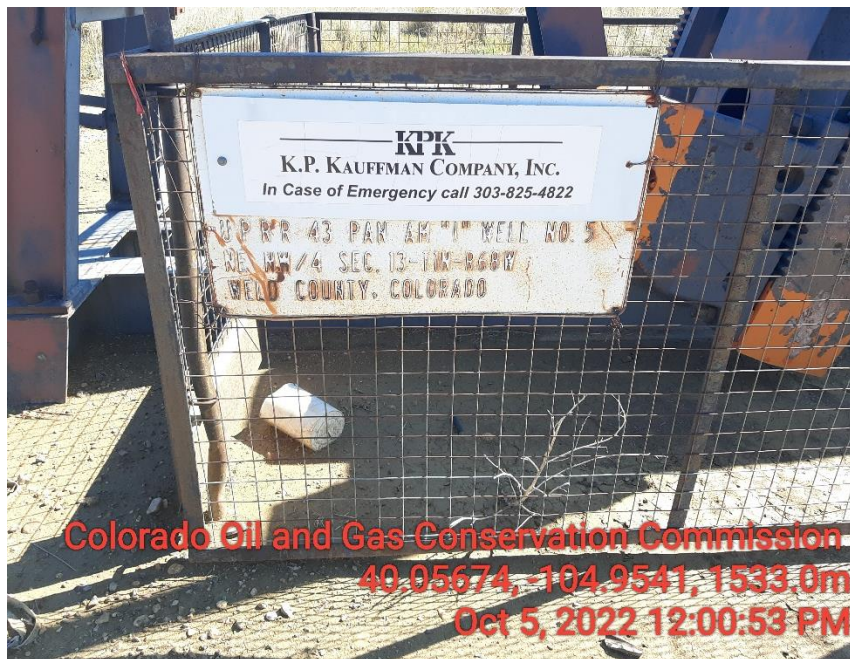
Photo 1 Well sign

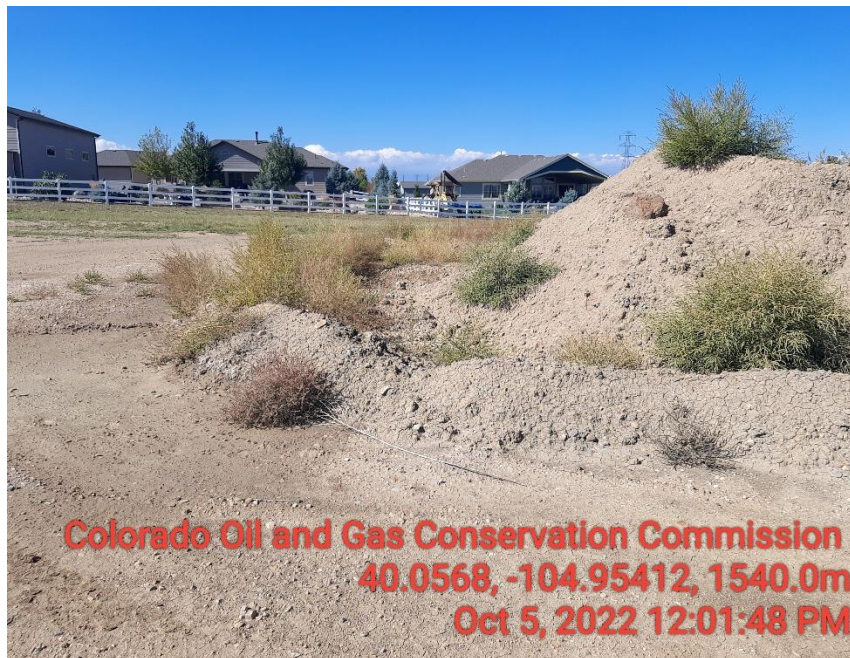
**Photo 3 non maintained BMP**

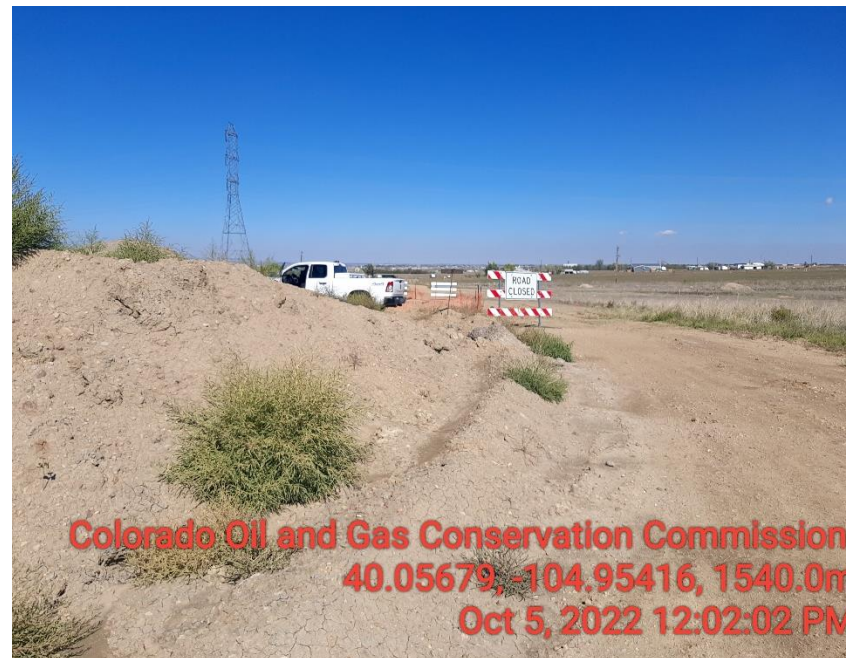
**Photo 4 improper BMP**

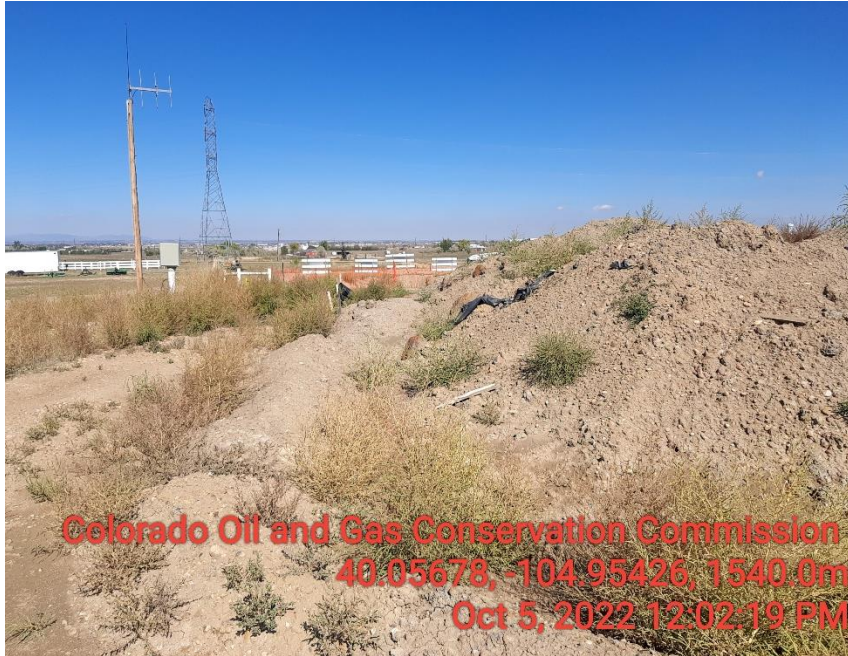
**Photo 5 inadequate BMP**

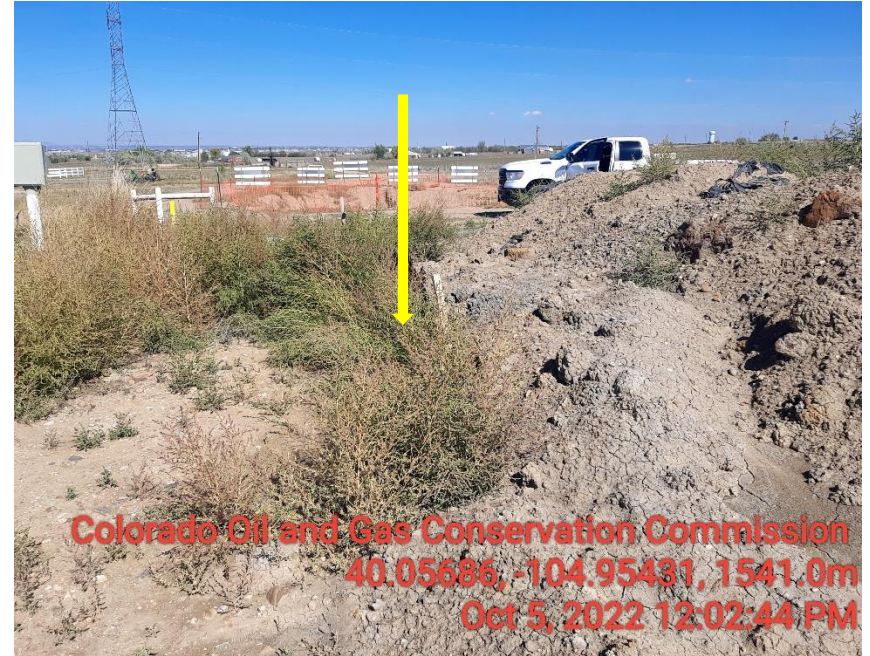
**Photo 6 contaminated stock pile BMP overloaded and sediment leaving BMP**

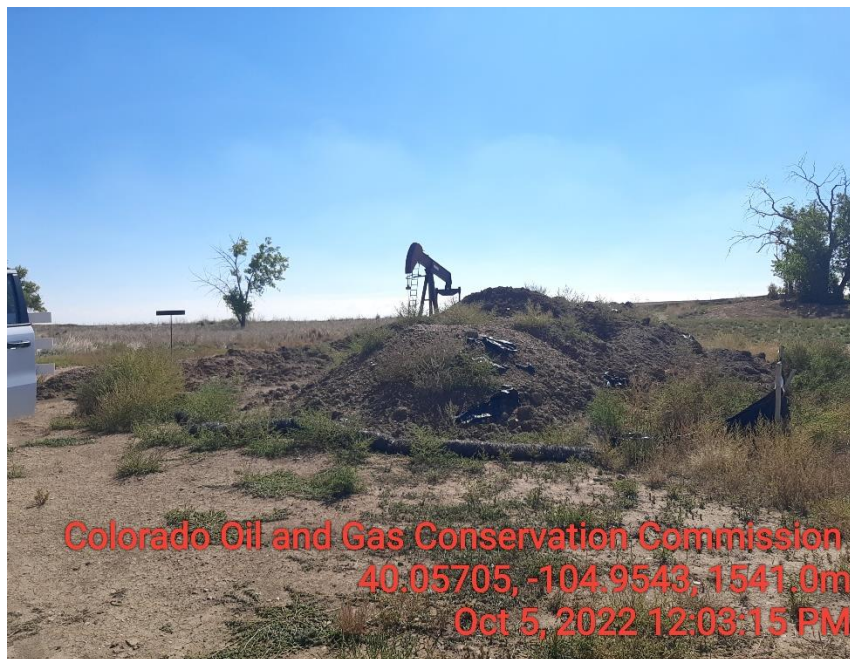
**Photo 7 Inadequate stockpile bmp**

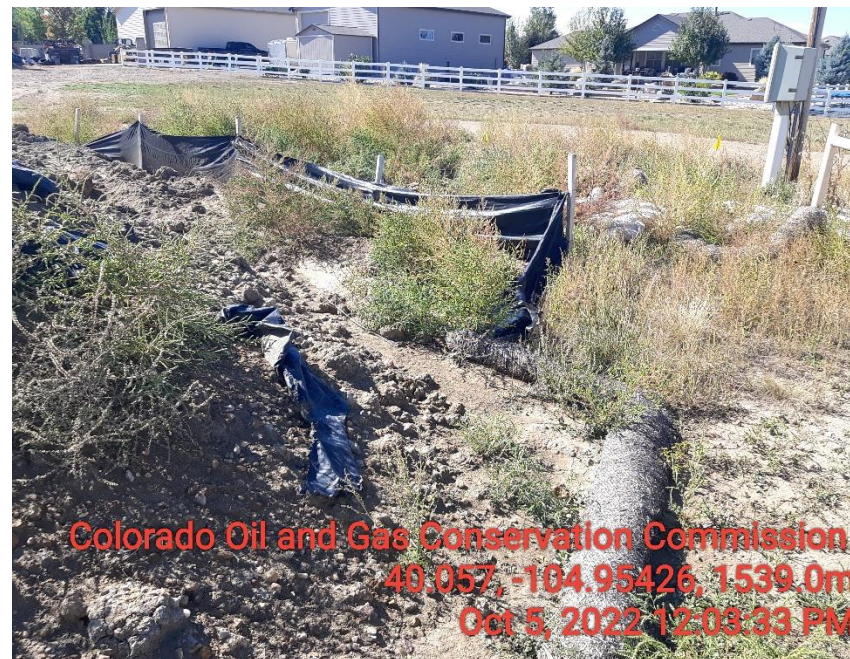
**Photo 8 Inadequate stockpile BMP. BMP sediment loaded.**

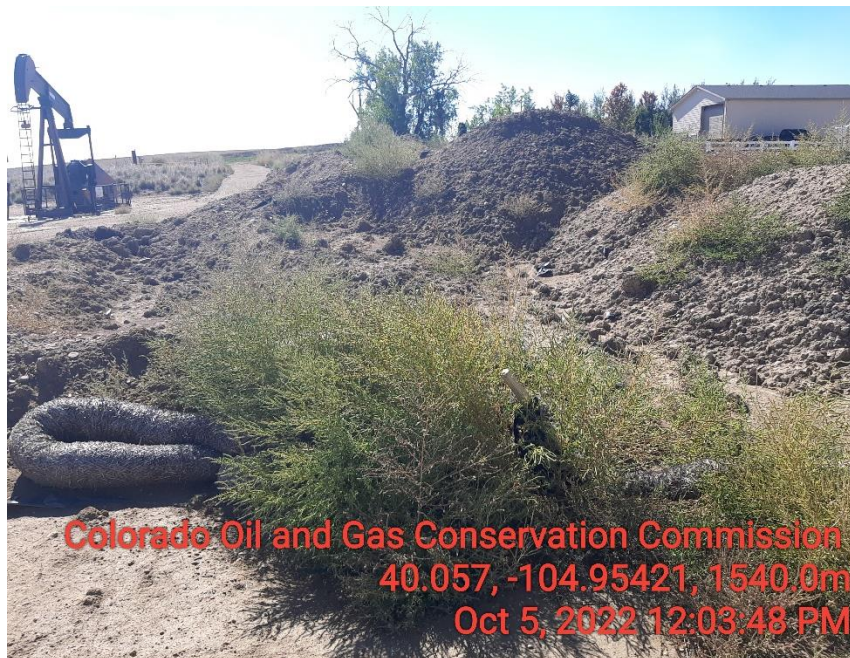
**Photo 9 Inadequate stockpile BMP No liner underneath contaminated soil stock pile**

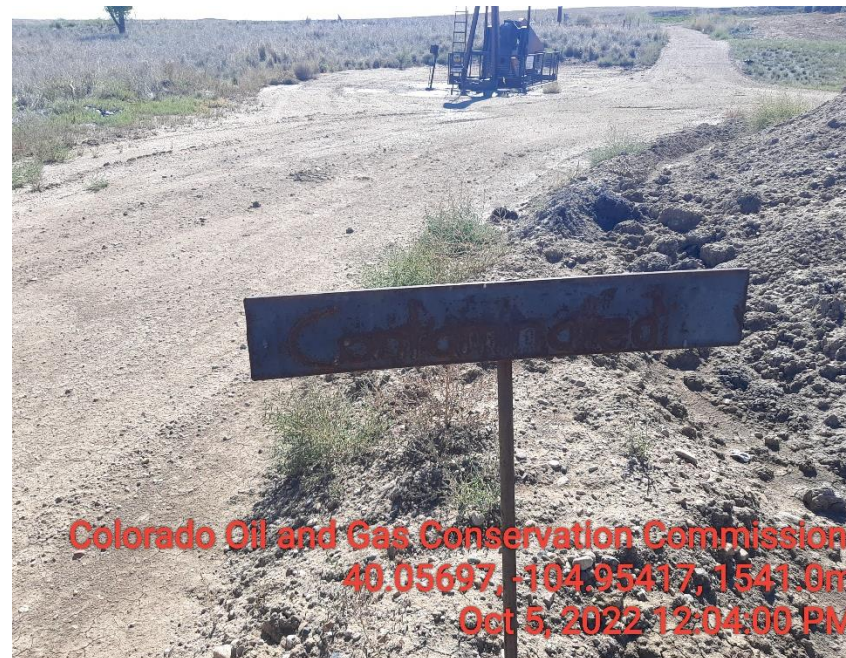
**Photo 10 Contaminated stock pile sign**

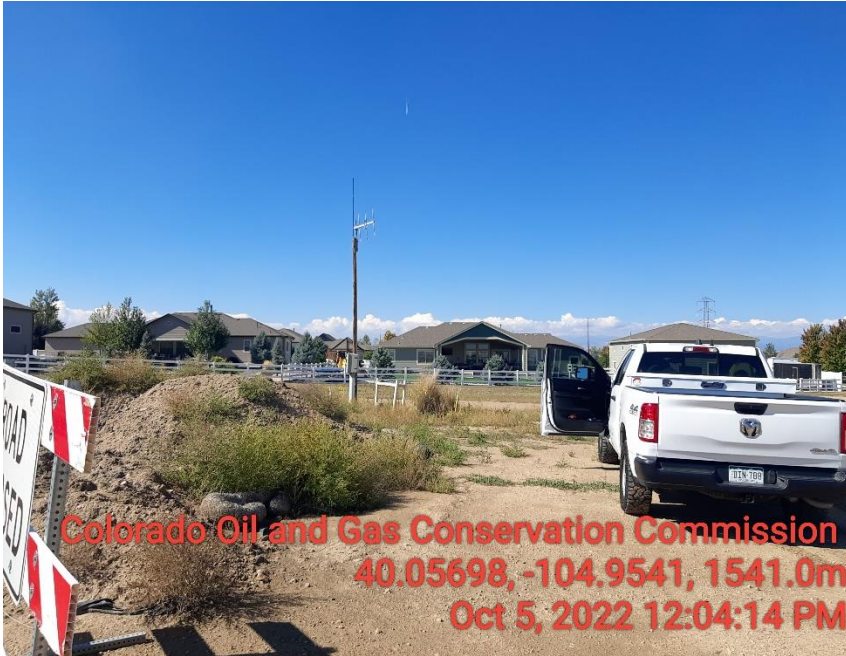
**Photo 11 location pic home are approx.. 150 to the west of stock pile and open excavatio,.**

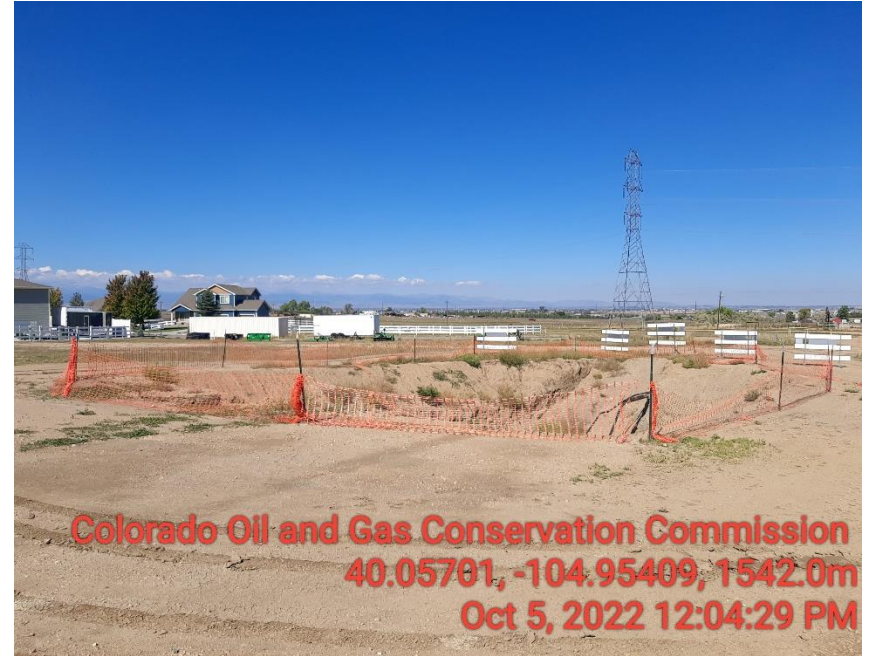
**Photo 12 inadequate fencing around open excavation. Homes are approx..150 feet to the west. No BMP in place to control run on of water into excavation.**

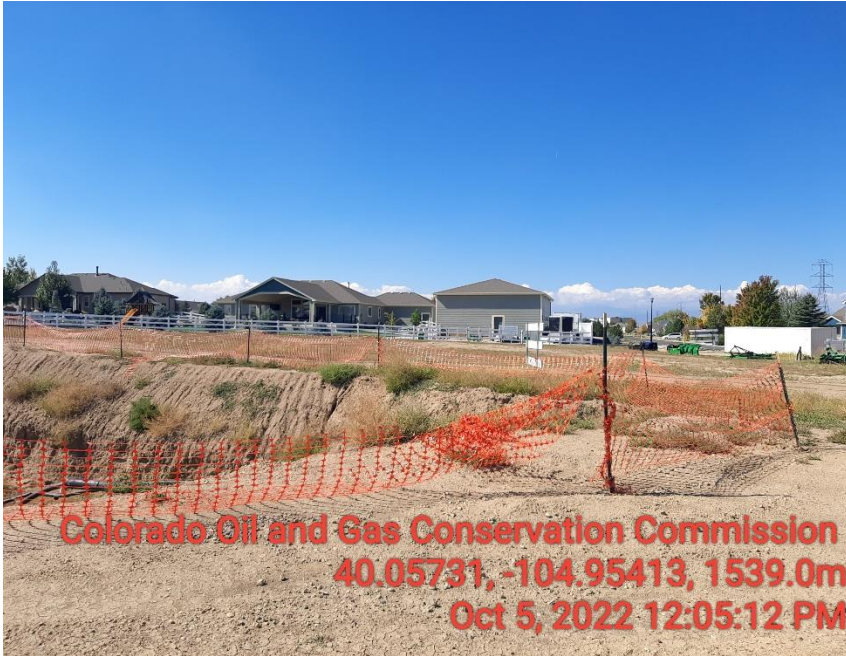
**Photo 13 loc pic. Inadequate fence and birm.**

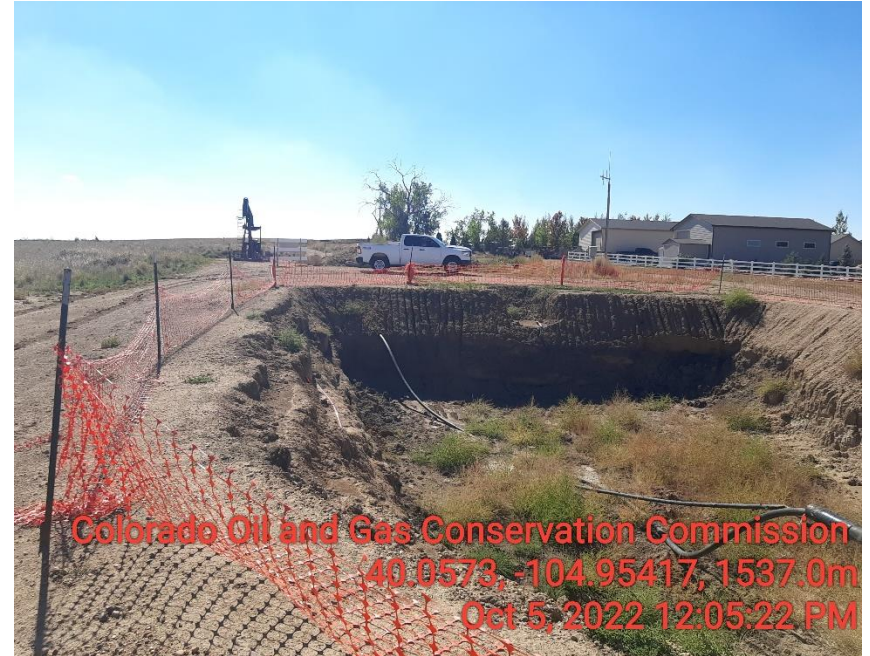
**Photo 14 loc pic. Inadequate fence and birm.**
