Inspection Photos

API: 071-06630

Operator: EVERGREEN NATURAL RESOURCES

Inspection Date: 10/4/2022

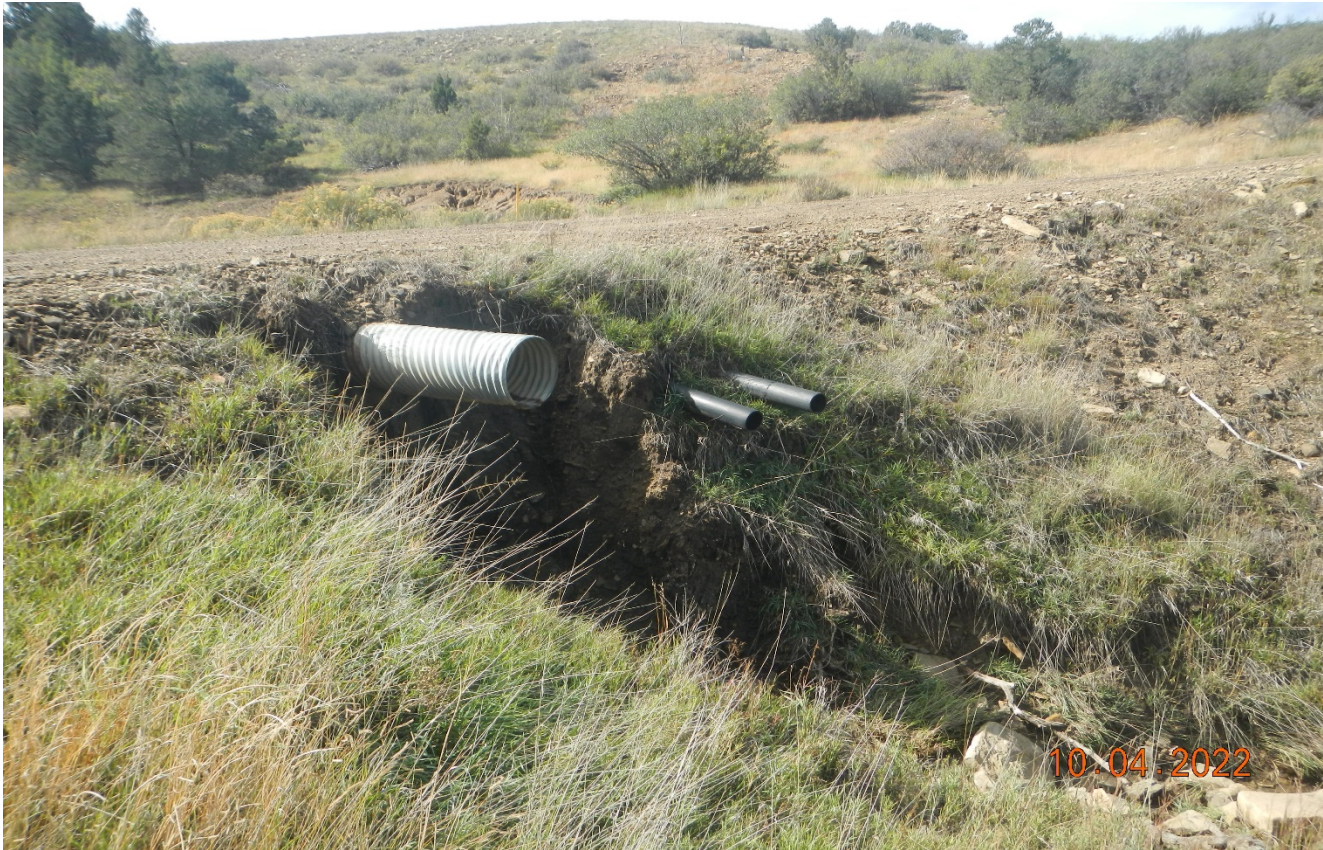
Photo 1. The culvert outlet at the drainage crossing has eroded and has no outlet protection.

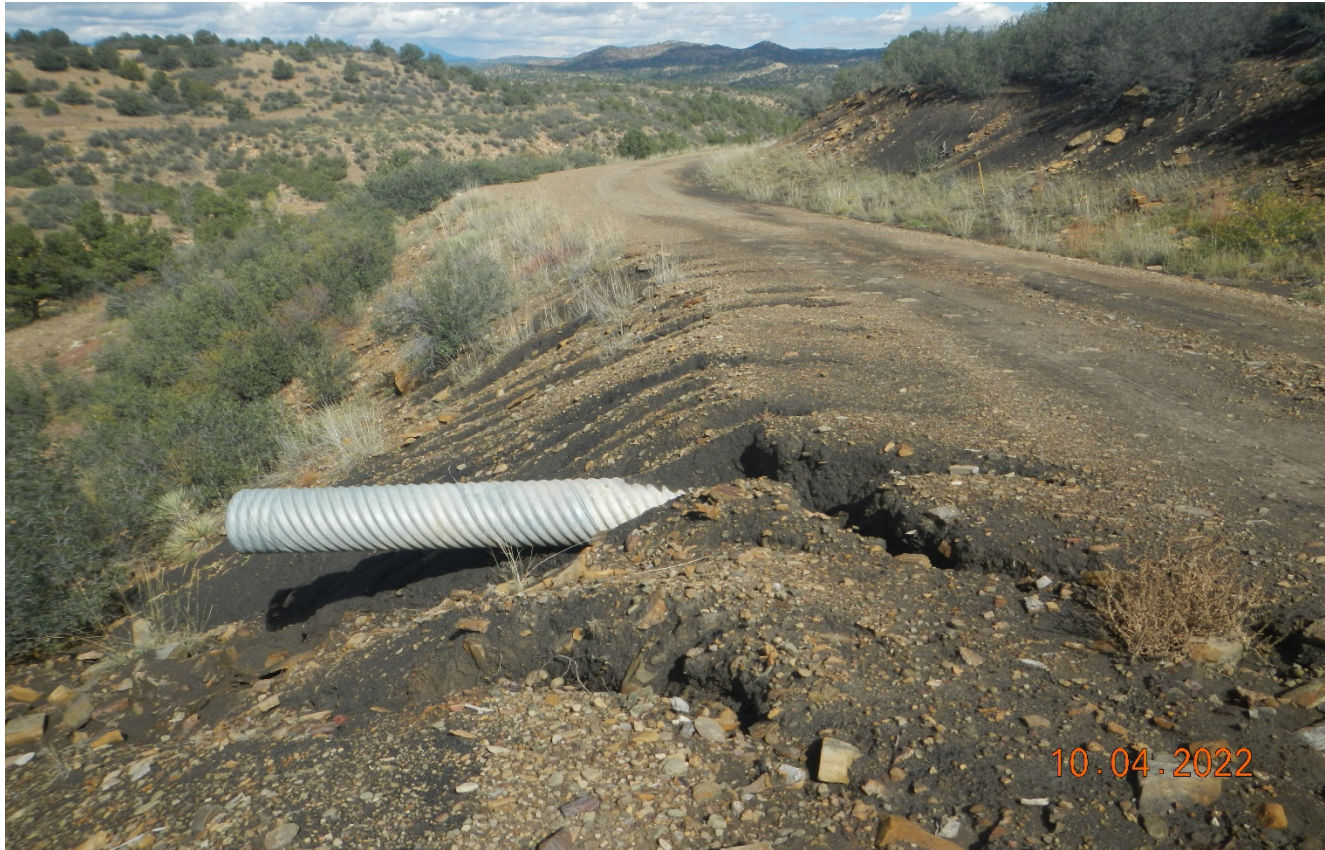
Photo 2. There is erosion occurring across the road and at the culvert outlet.

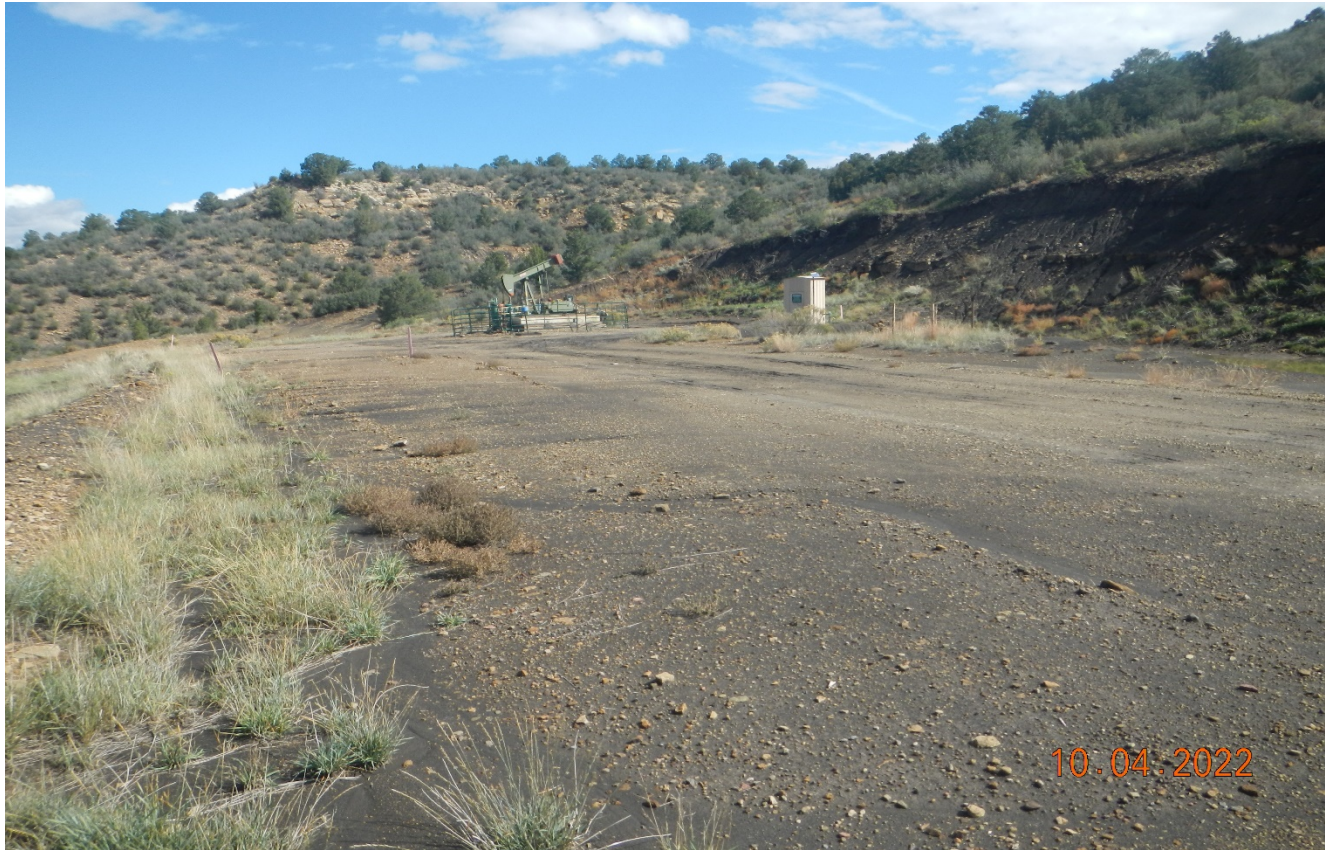
Photo 3. Facing northeast toward the wellsite.

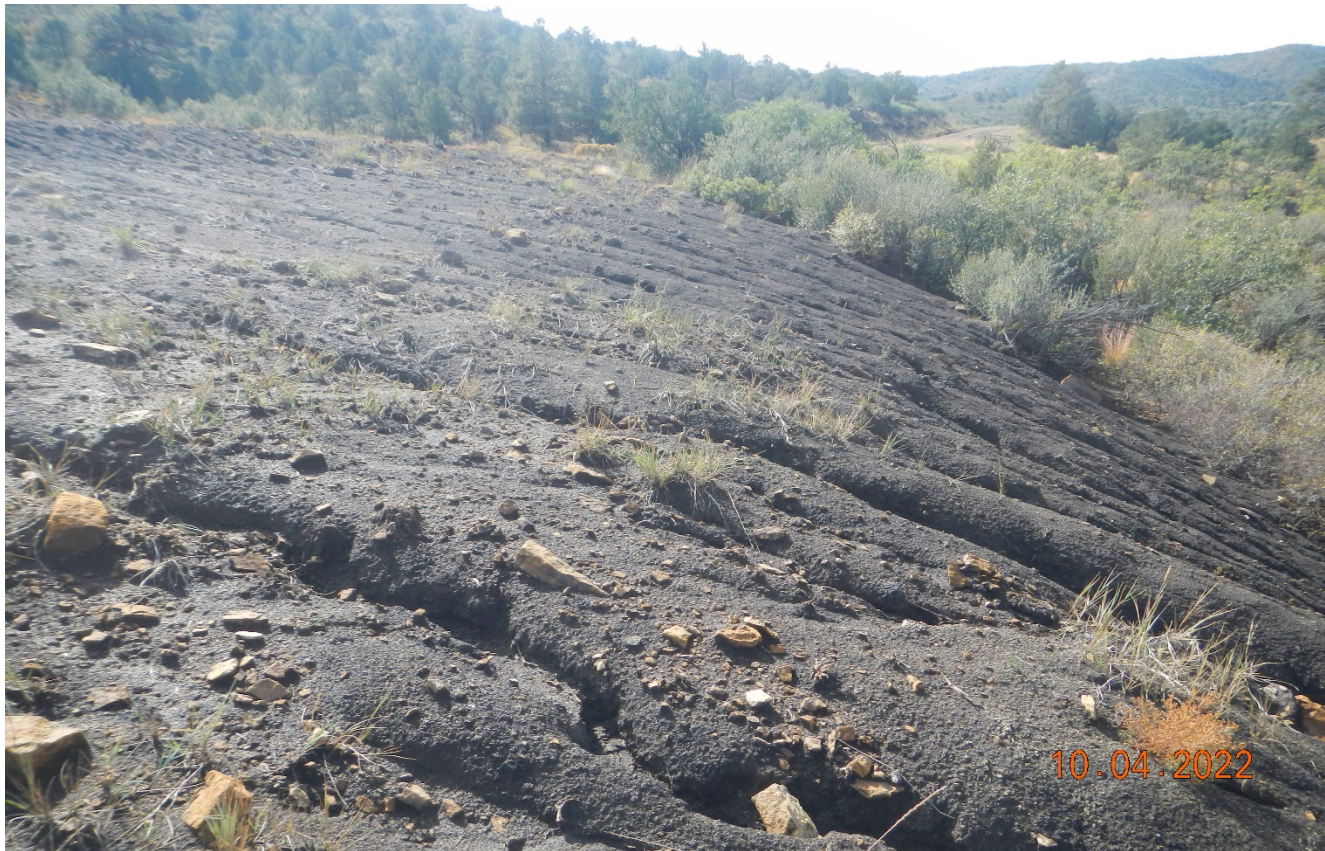
Photo 4. There is erosion along the fill slope which needs additional BMP's
