Site Inspection Report

Site: GREELEY NATIONAL BANK B-#1
10/05/2022

SITE/LOCATION	DATE	TIME	INSPECTOR
GREELEY NATIONAL BANK B-#1	10/05/2022	04:17 PM	Alexander Ahmadian
Comments			
Work Activity Notes	Crews were working on the excavation at the spill location		
Changes since previous inspection?	Yes	Drive by inspection	No
Actively being worked?	Yes		
Fieldwork Oversight Performed?	No	Oversite Type	
Were Oversight Samples Collected?	No	Sample Details

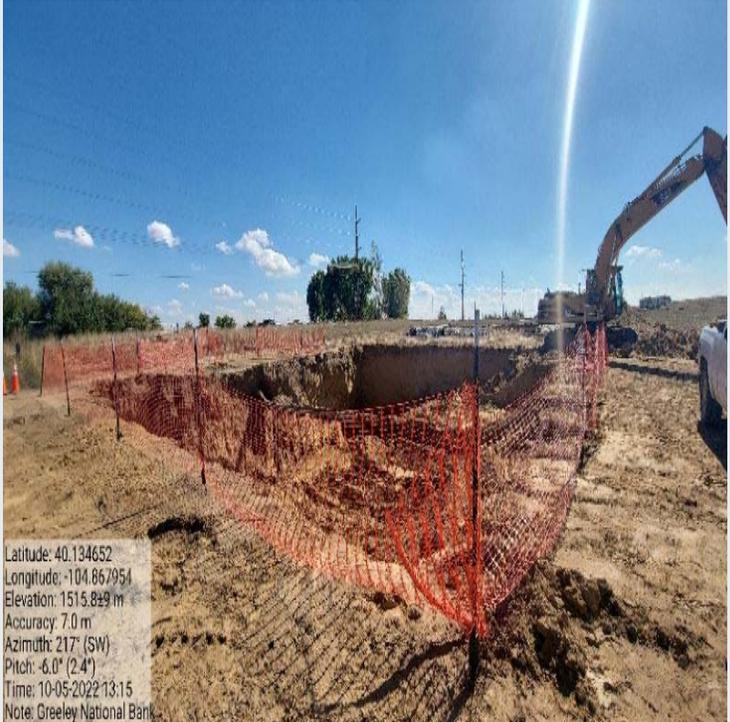
Photo
<p>Question: Open excavation(s)? Note: Approximate size(s) (Length x Width x Depth, ft)</p> <p>Response: Yes</p> <p>Notes: 78x64x16</p>

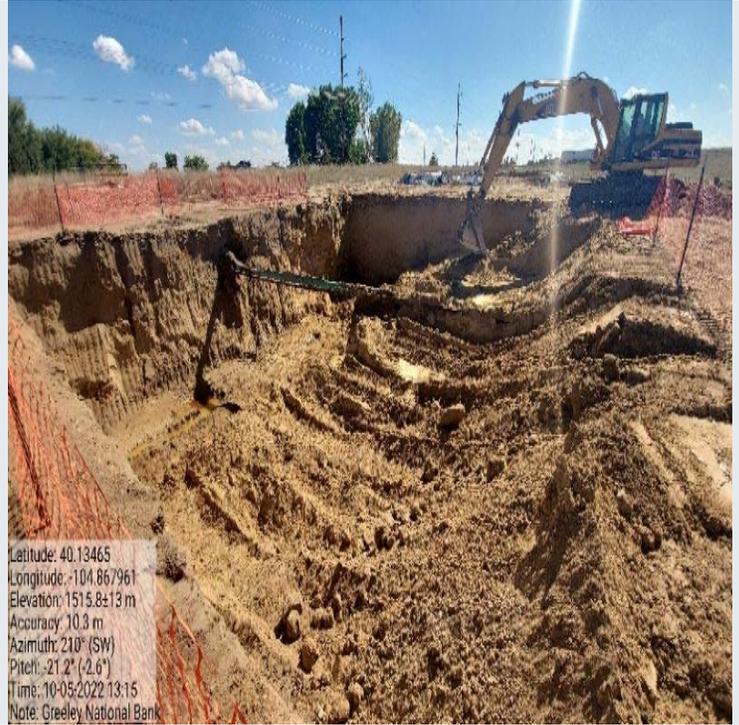
Question: Open excavation(s)? Note: Approximate size(s)
(Length x Width x Depth, ft)

Notes: 78x64x16

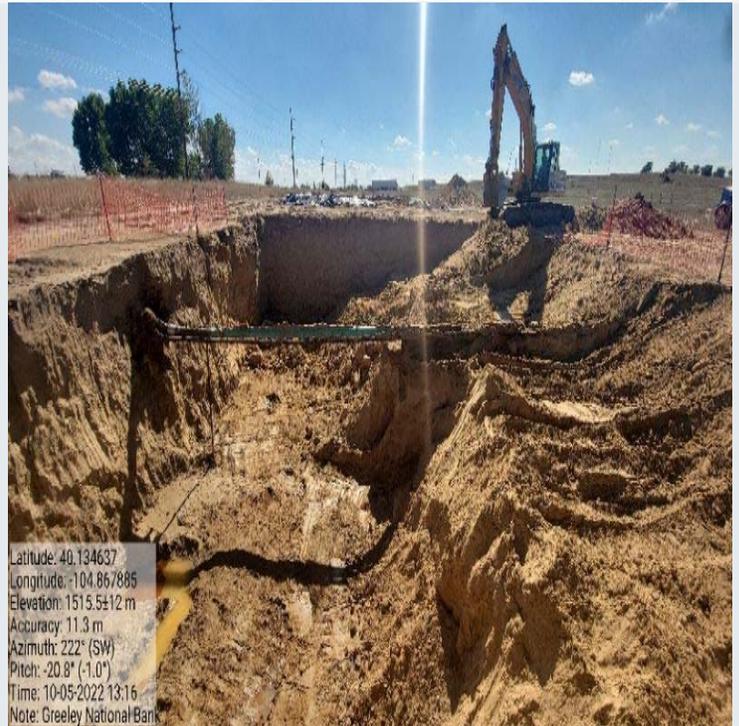
Question: Open excavation(s)? Note: Approximate size(s)
(Length x Width x Depth, ft)

Notes: 78x64x16

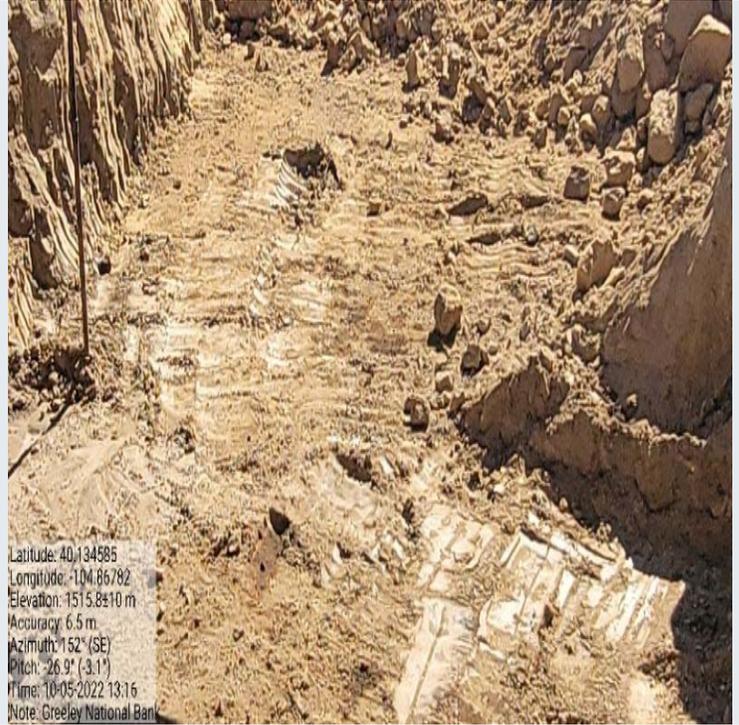
Question: Open excavation(s)? Note: Approximate size(s) (Length x Width x Depth, ft)

Notes: 78x64x16

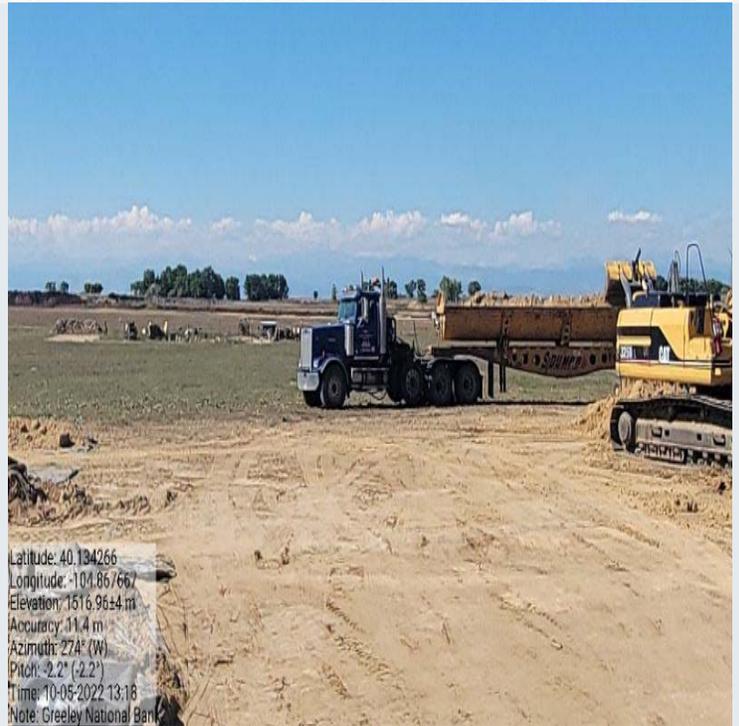
Question: Stockpiled E&P waste and approximate volume (cubic feet)?

Notes: Most of dirty stockpile has been hauled offsite

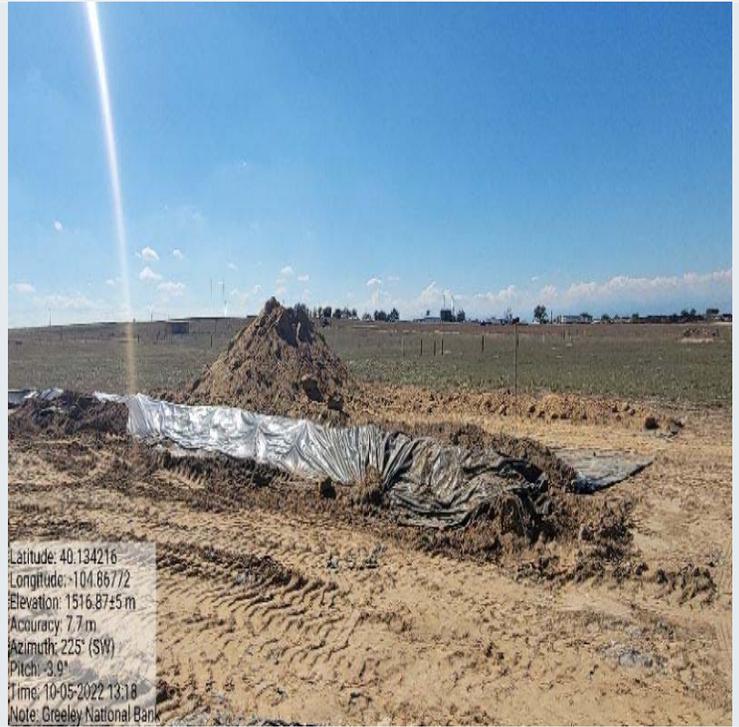
Question: Stockpiled E&P waste and approximate volume (cubic feet)?

Notes: Most of dirty stockpile has been hauled offsite

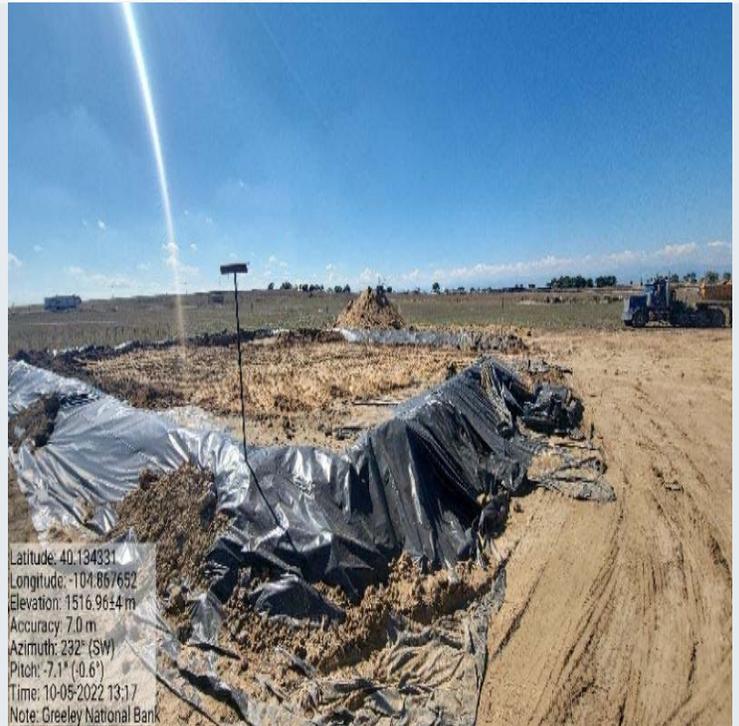
Question: Stockpiled E&P waste and approximate volume (cubic feet)?

Notes: Most of dirty stockpile has been hauled offsite

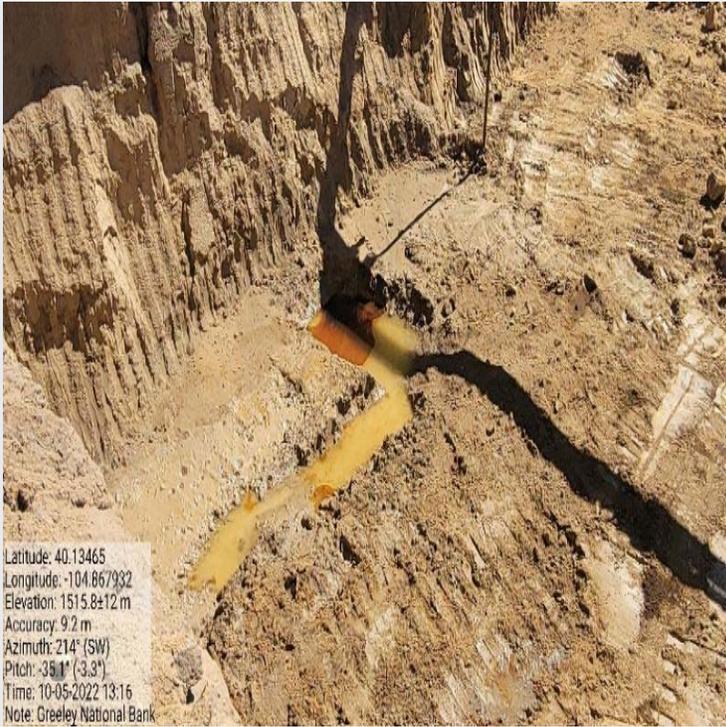
Photo
<p>Question: Groundwater present within excavation? Note: Depth to water below grade surface (ft), free product/sheen</p> <p>Response: Yes</p> <p>Notes: 16 feet</p>

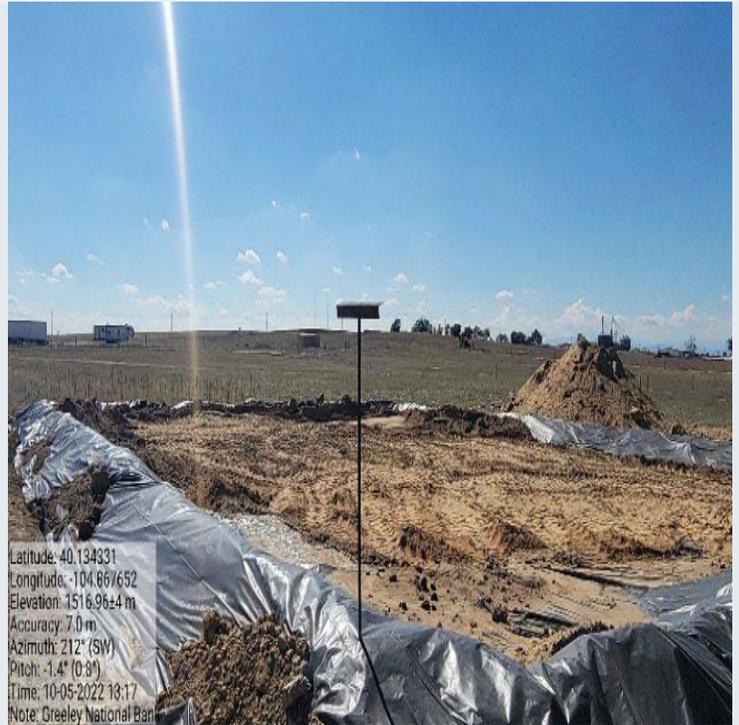
Question: E&P waste signage present, legible, accurate and up to date (labelled per KPK CWMP)?

Response: Yes

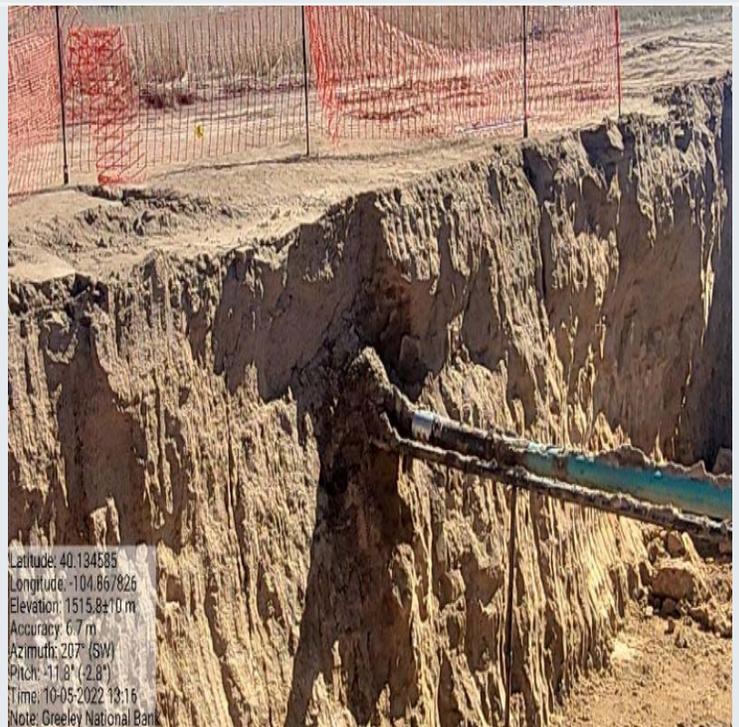
Question: Ground surface appears clean (no evidence of new equipment leaks, oil leaks, spills, or releases)?

Response: No

Notes: Staining visible within excavation

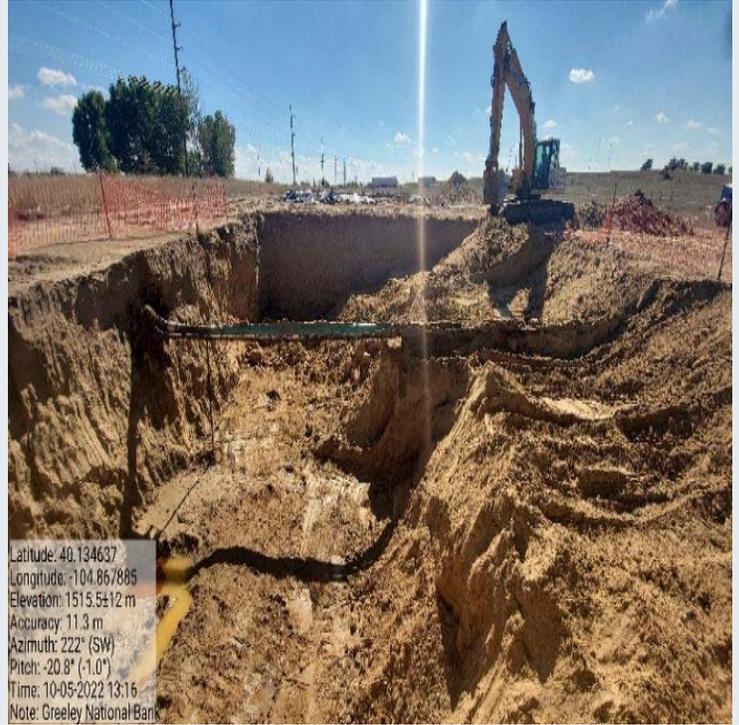
Question: Ground surface appears clean (no evidence of new equipment leaks, oil leaks, spills, or releases)?

Response: No

Notes: Staining visible within excavation

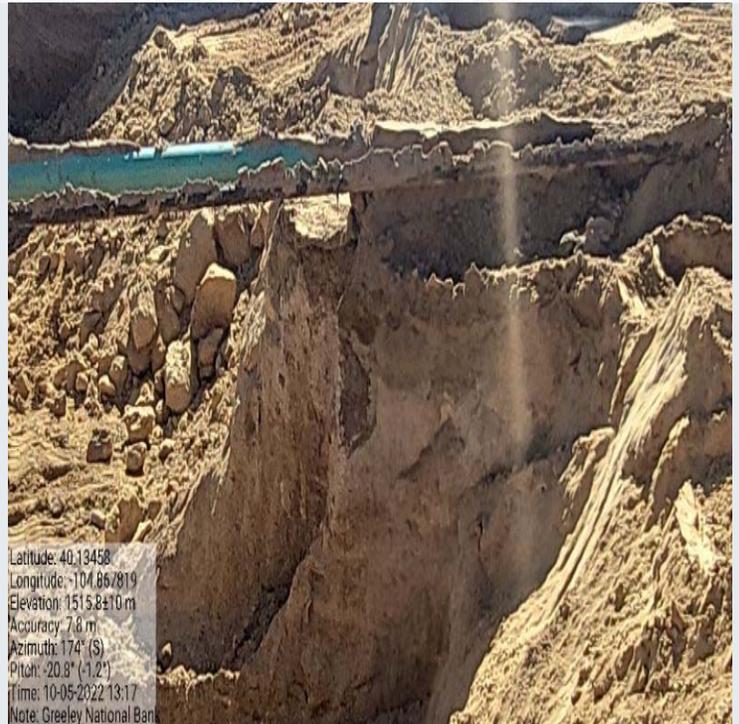
Question: Ground surface appears clean (no evidence of new equipment leaks, oil leaks, spills, or releases)?

Response: No

Notes: Staining visible within excavation

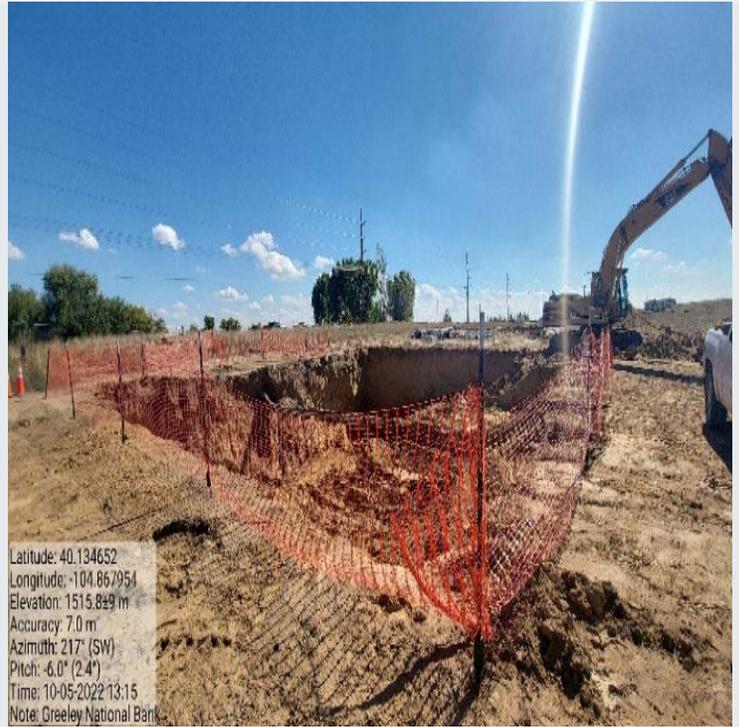
Question: Open excavation properly fenced/covered (in accordance with Rule 913.b.(5)B.i.)?

Response: Yes

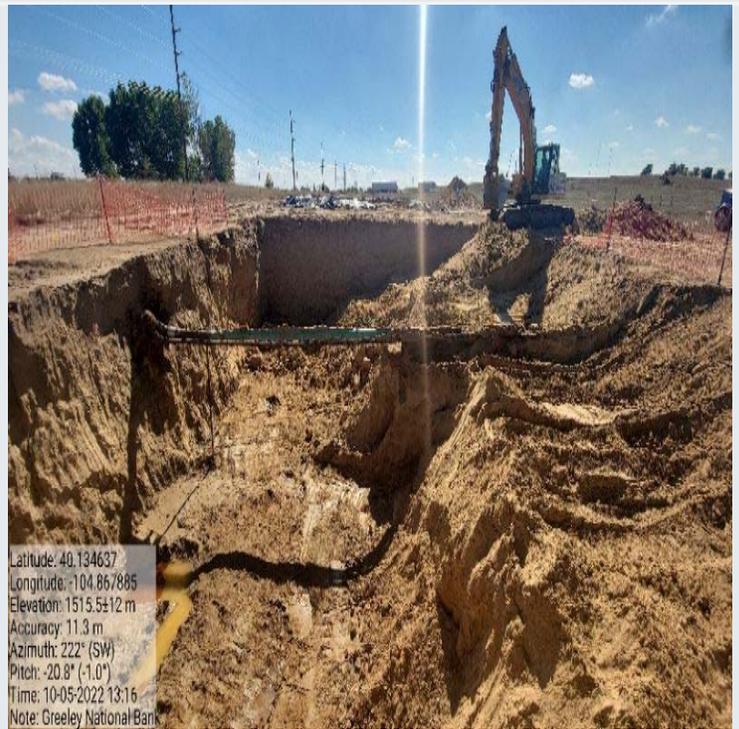
Question: Exposed buried/underground flowlines within excavation?

Response: Yes

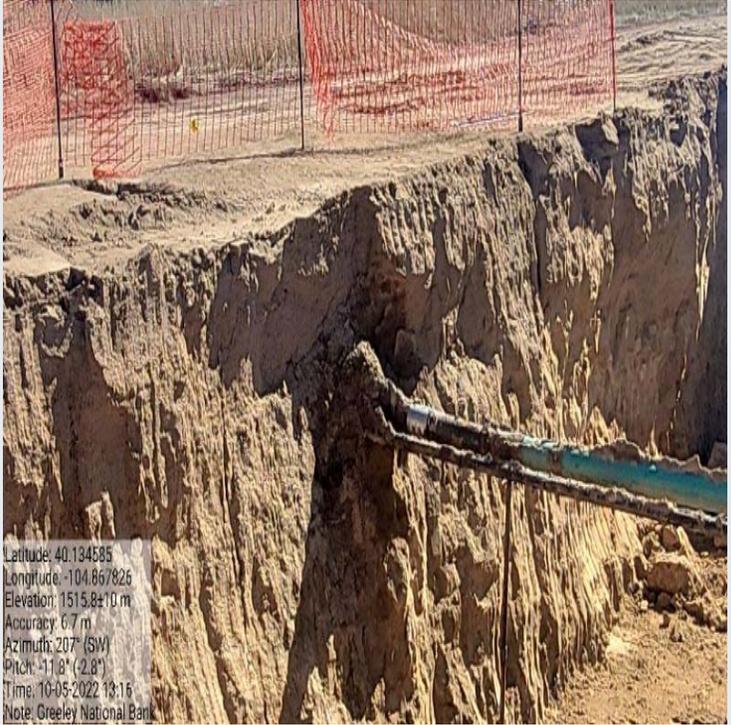
Photo
<p>Question: Exposed buried/underground flowlines within excavation? Response: Yes Notes:</p>

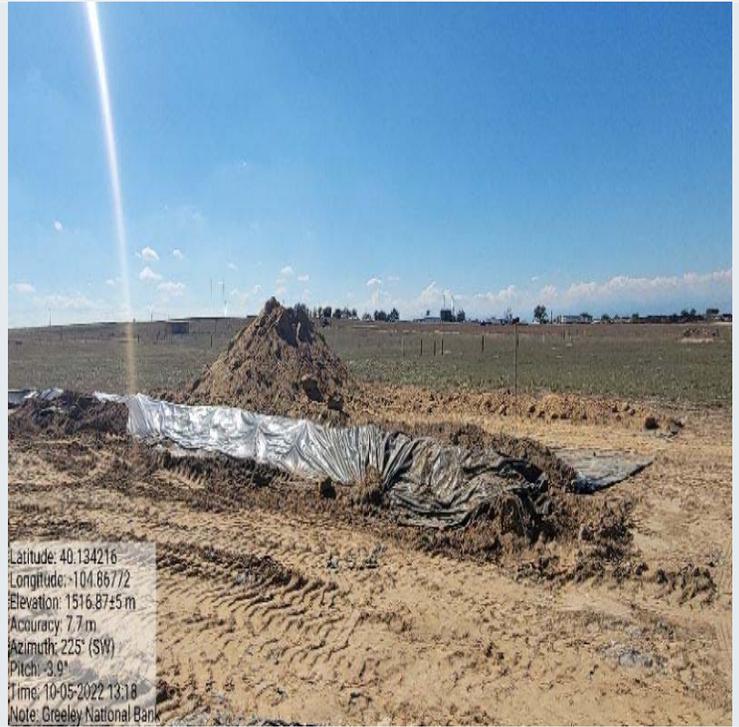
Question: Is earthen berm secondary containment present and in good condition (compacted, complete, no evidence of erosion, animal burrowing, etc.)?

Notes: Around stockpile

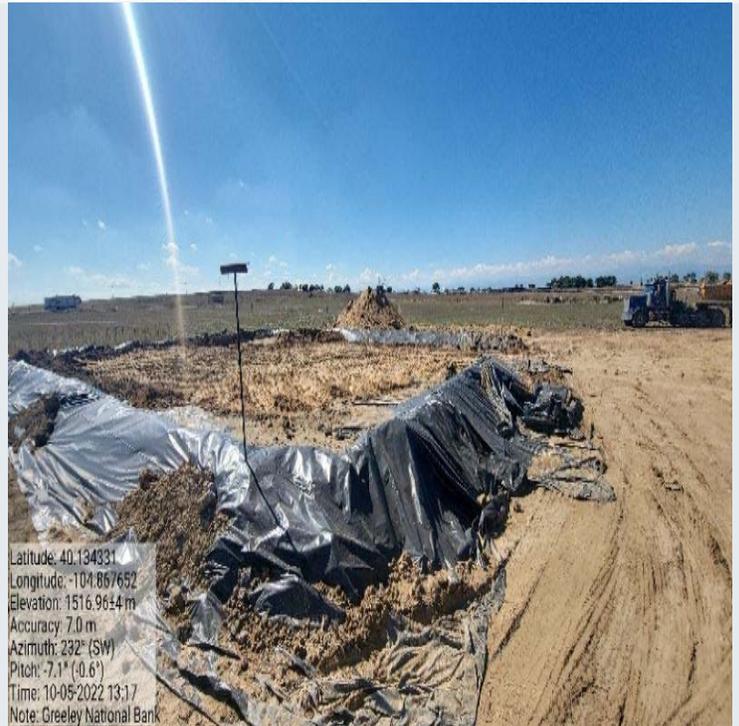
Question: Is earthen berm secondary containment present and in good condition (compacted, complete, no evidence of erosion, animal burrowing, etc.)?

Notes: Around stockpile

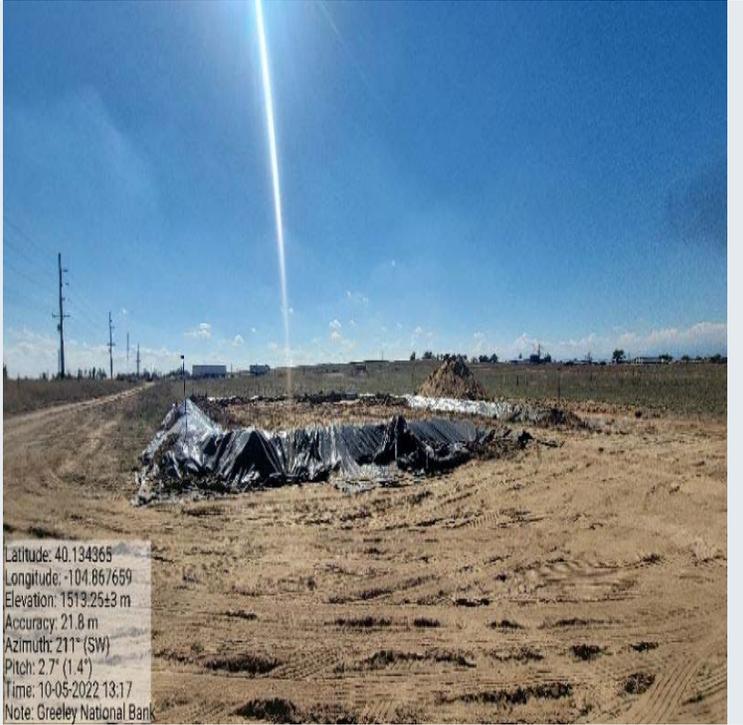
Photo
<p>Question: Is earthen berm secondary containment present and in good condition (compacted, complete, no evidence of erosion, animal burrowing, etc.)? Response: Yes Notes: Around stockpile</p>

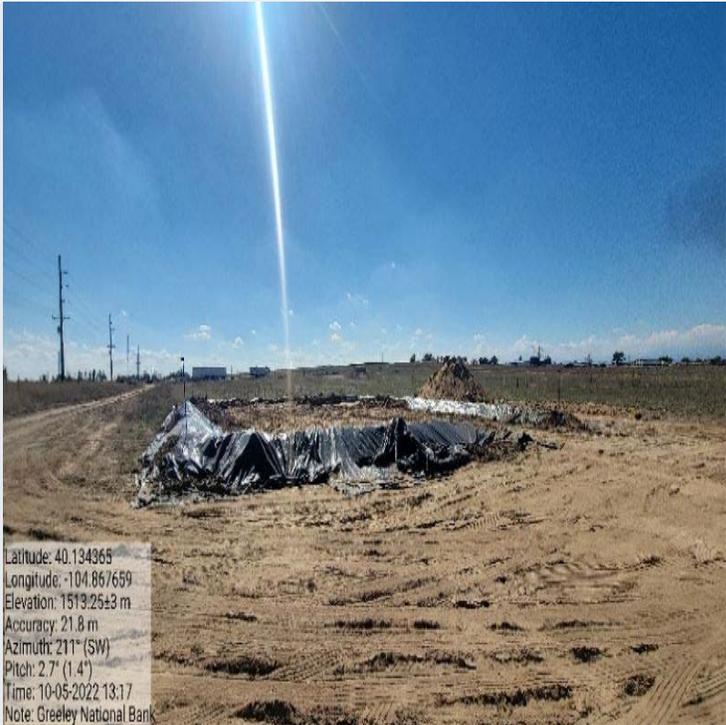
Photo
<p>Question: Stockpiled waste stored and handled in compliance with Rule 913.b.(5).B.iv.? Response: Yes Notes:</p>
