Annual Reclamation Assessment Report (2022)

COGCC Location Name (ID)	MATT-64N67W /24NWSW (331001)
Operator Location Name	Matt 1 Well Pad & Facility
COGCC Operator Name (ID)	PDC ENERGY, INC (69175)
Legal Description	NWSW Sec. 24 T4N-R67W
Well Pad Geographic Coordinates (WGS84)	40.295627/ -104.846841
Facility Pad Geographic Coordinates (WGS84)	40.294865/-104.848239

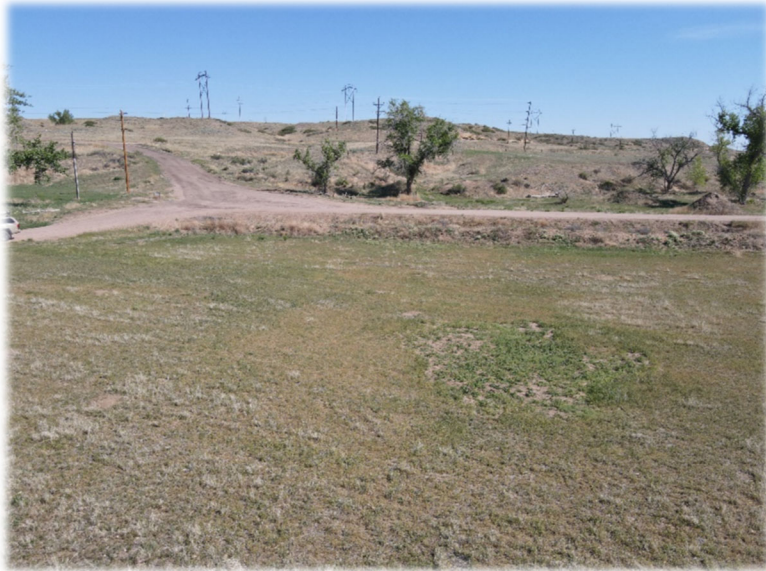
Photo Point E: South of well head facing recent maintenance area

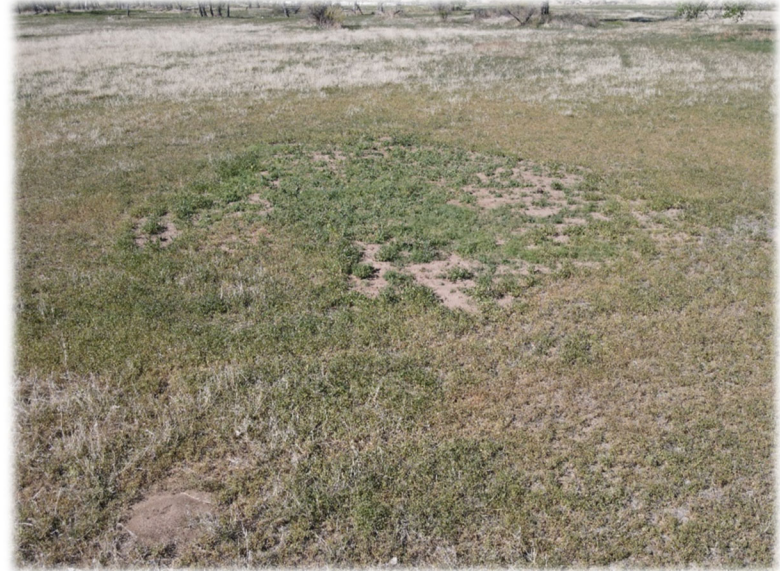
Photo Point F: North of well head facing recent maintenance area

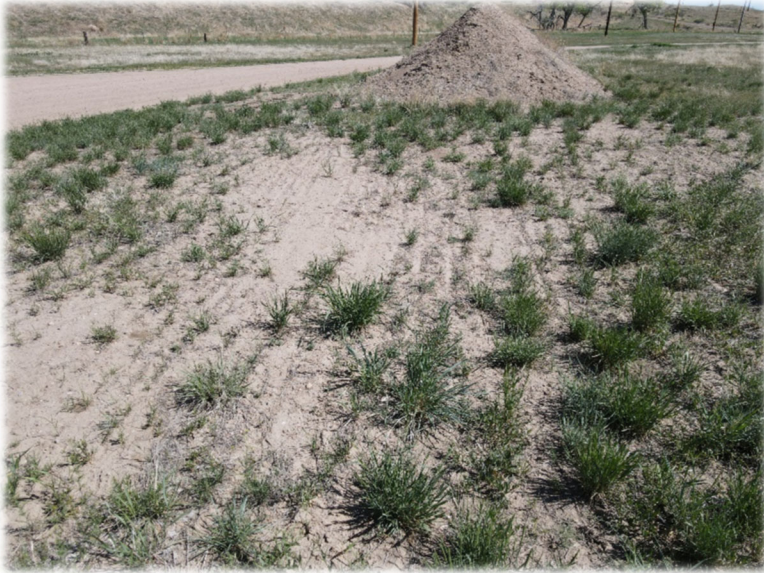
The former facility site exhibited moderate germination with stressed establishment of seeded grasses. Bare areas were observed, and inter-seeding and amendment application were recommended at the former facility site to increase desirable vegetation cover and proactive weed management was recommended to suppress further noxious and undesirable species encroachment from the adjacent Reference. Additionally, the landowner stockpile of road base remains within the facility reclaim. This stockpile is depositing sediment onto the reclaim area and impacting germination and overall reclamation success.

Photo Point M: Sediment deposition from stockpile impacting germination

to minimize or prevent vegetation composition degradation due to potential encroachment and establishment of noxious and undesirable weeds from the surrounding Reference. Inter-seeding and amendment application is also recommended for both reclaim areas to increase total desirable vegetation cover. Additionally, perimeter controls are recommended to be installed surrounding the road base stockpile remaining within the facility reclaim.

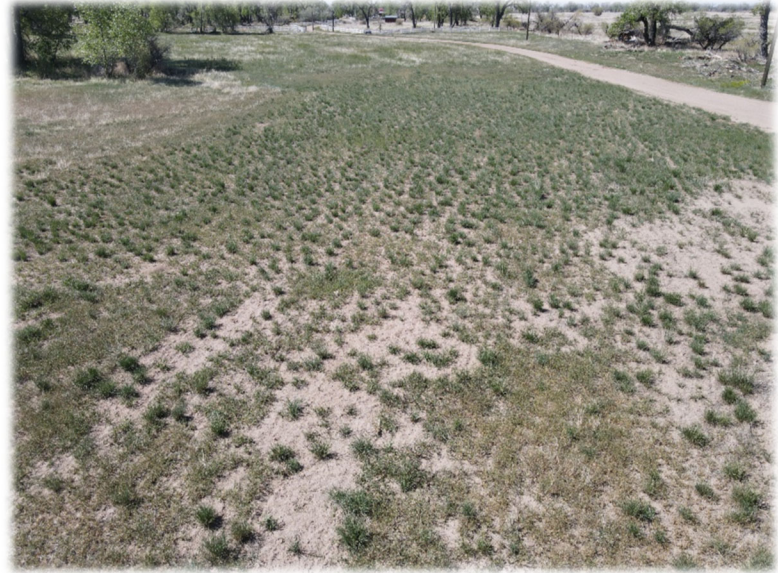
Photo Point N: Bare areas and greater inter-plant distances

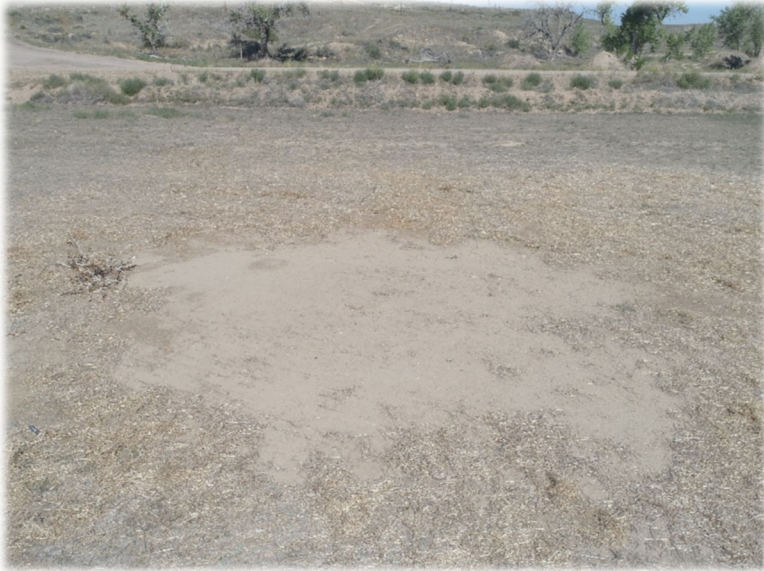
On September 16, 2022, additional VPEs were completed. The former well location showed signs of recent maintenance activities and the subsidence issues observed in the spring had been repaired. Both the Reclaim and the Reference areas had been mowed. The low vegetative height and overall condition made making an accurate evaluation of vigor and overall cover challenging. A spring 2023 assessment will be required to fully understand the reclamation trajectory at this location. Continued weed management was recommended at the former well location to prevent and suppress further noxious and undesirable species encroachment and establishment.

Photo Point E: South of well head facing recent maintenance area

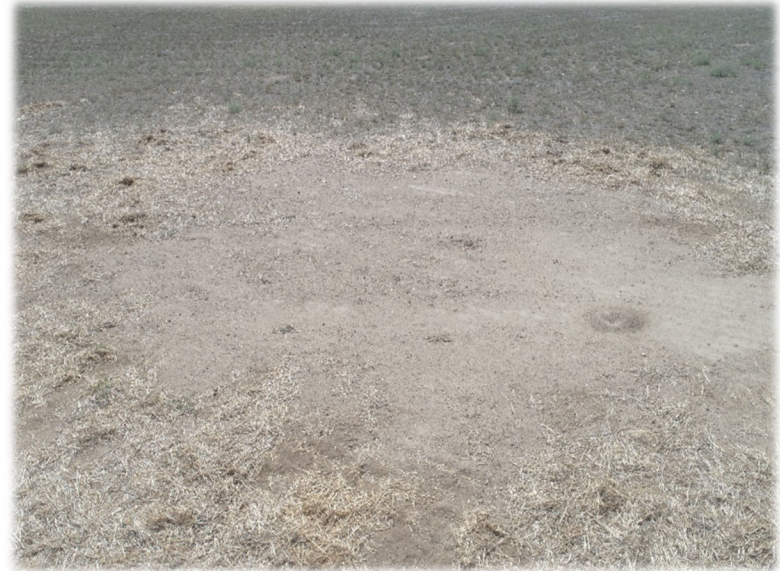
Photo Point F: North of well head facing recent maintenance area

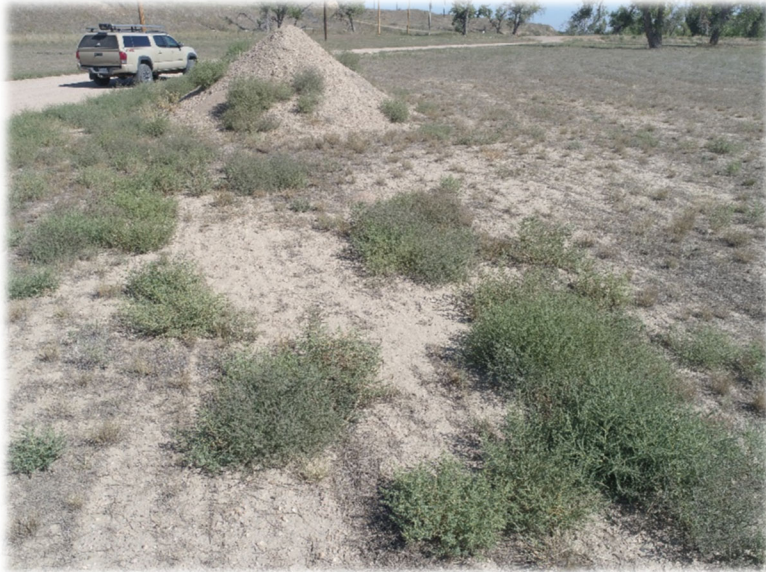
Photo Point M: Weed infestation – Northwest disturbance

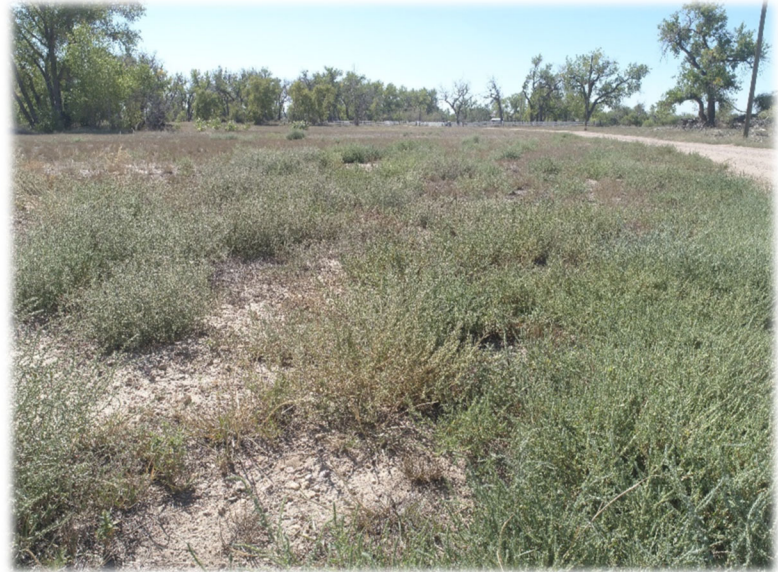
Photo Point N: Weed infestation – Northwest disturbance edge
