# Inspection Photos

API: 055-06105

Operator: OXY USA INC

Inspection Date: 10/6/2022

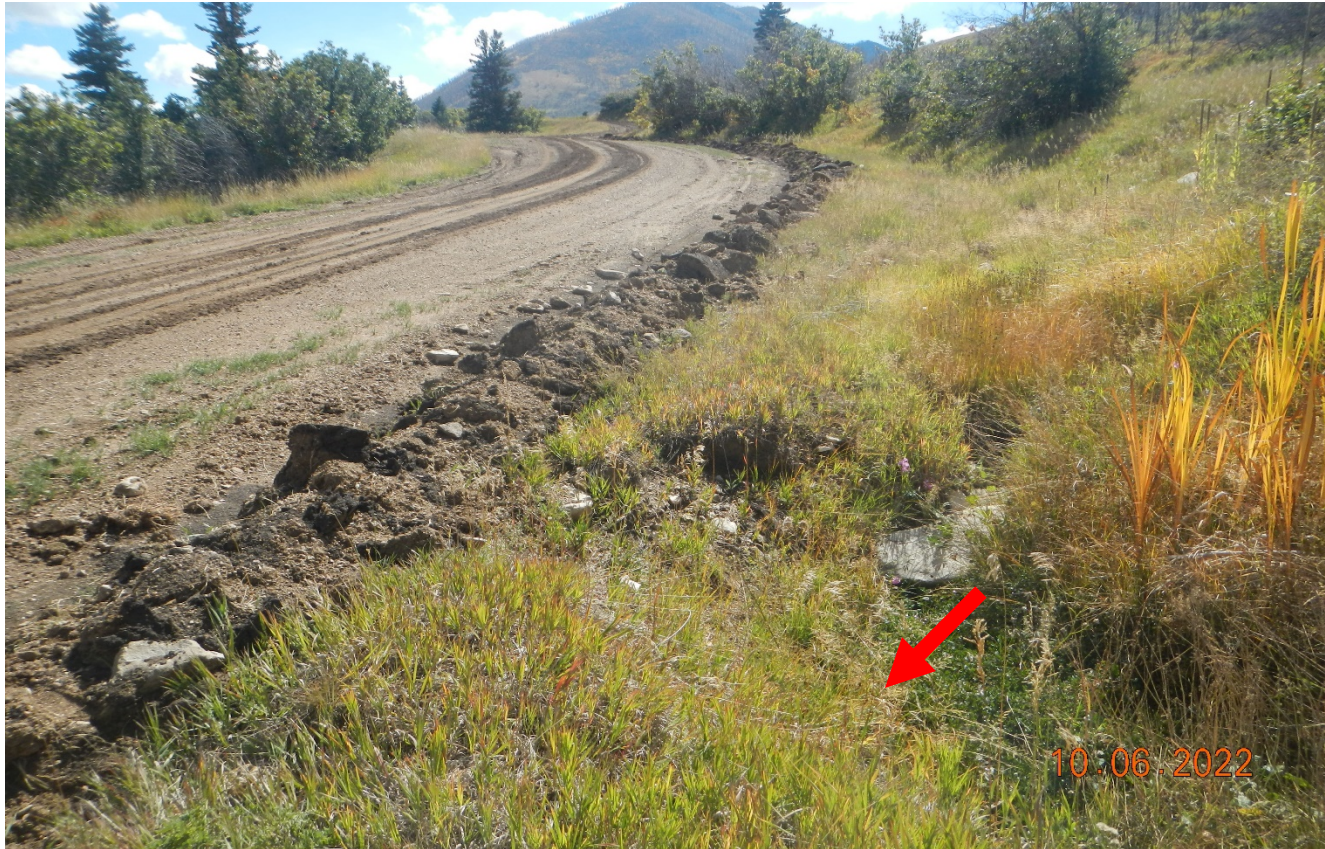
**Photo 1.** Facing southeast ascending the hill toward the location. There has been grading performed which has pushed gravel material to the side which is now interfering with stormwater flow to the culvert which is at the red arrow.

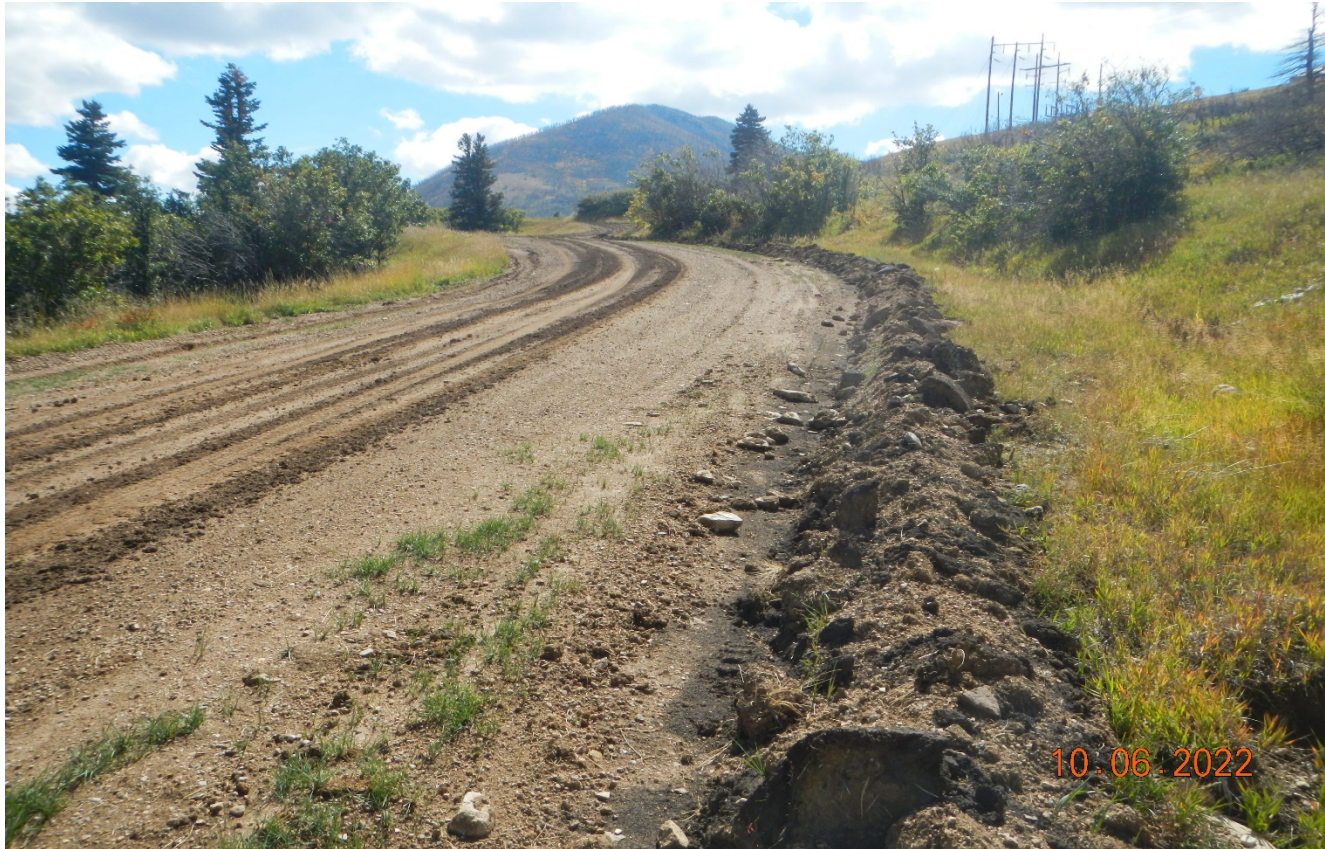
**Photo 2.** Facing southeast ascending the hill toward the location. The graded material is loose and susceptible to erosion. There are no BMP's to prevent erosion along this long stretch of road.

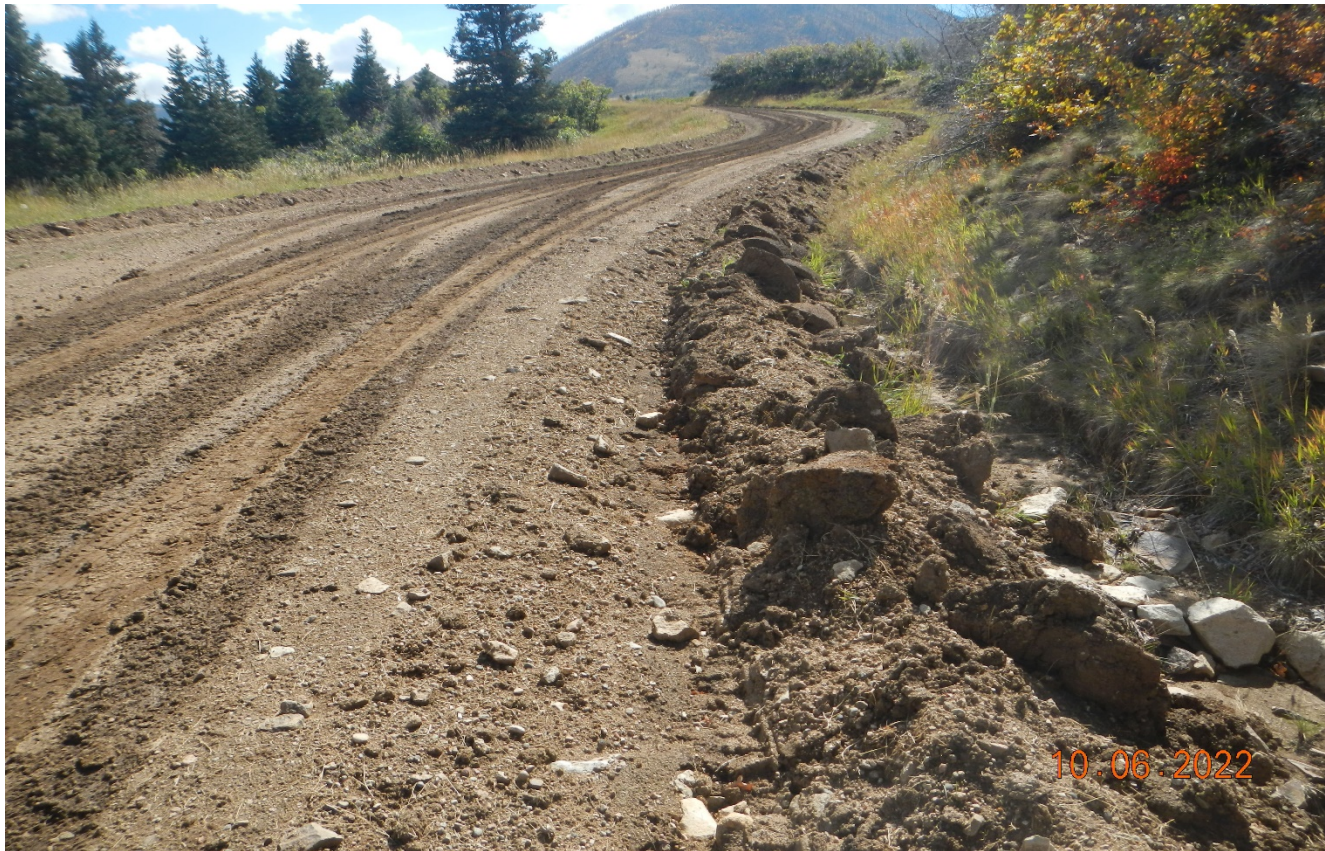
**Photo 3.** Facing southeast ascending the hill toward the location. There was no BMP's installed along the roadside where erosion had occurred and loose soils were pushed off the side which are susceptible to erosion.

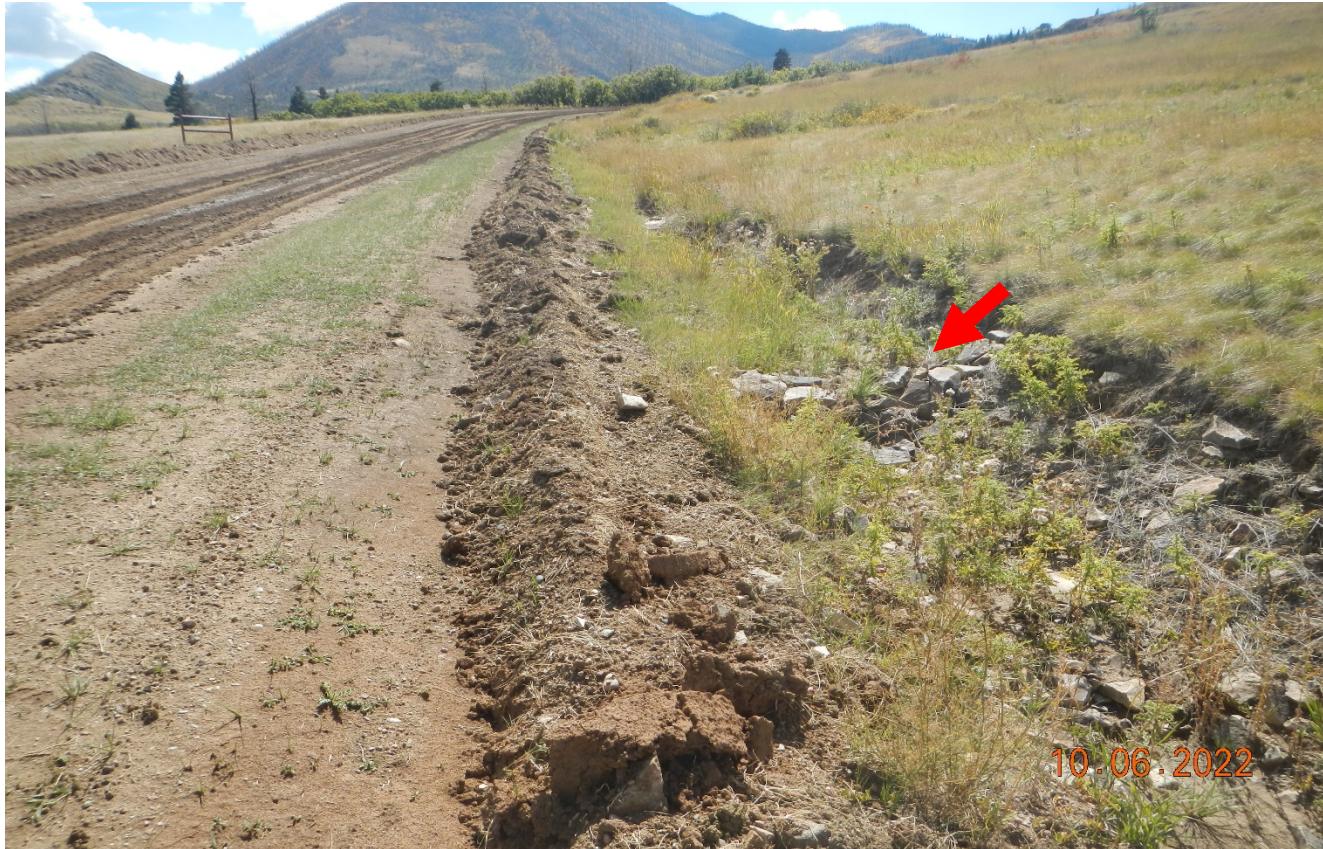
**Photo 4.** Facing southeast ascending the hill toward the location. There has been grading performed which has pushed gravel material to the side which is now interfering with previous BMP's. Red arrow points to rock check dam. There are also numerous noxious weeds in this area that have not been controlled.

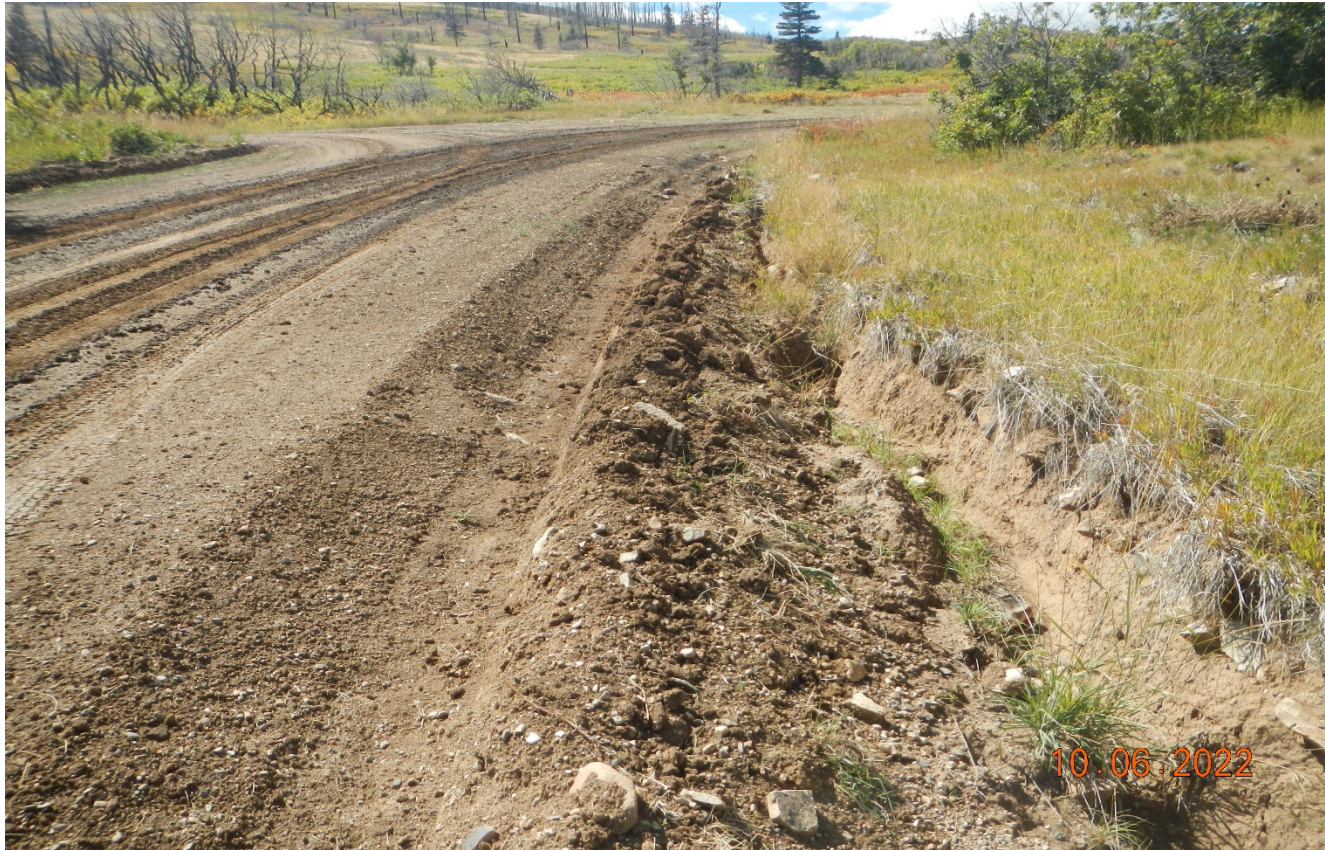
**Photo 5.** Further along the road is another area where erosion of the road side had occurred and loose soils have been pushed into this area. This area needs to be repaired and stabilized.

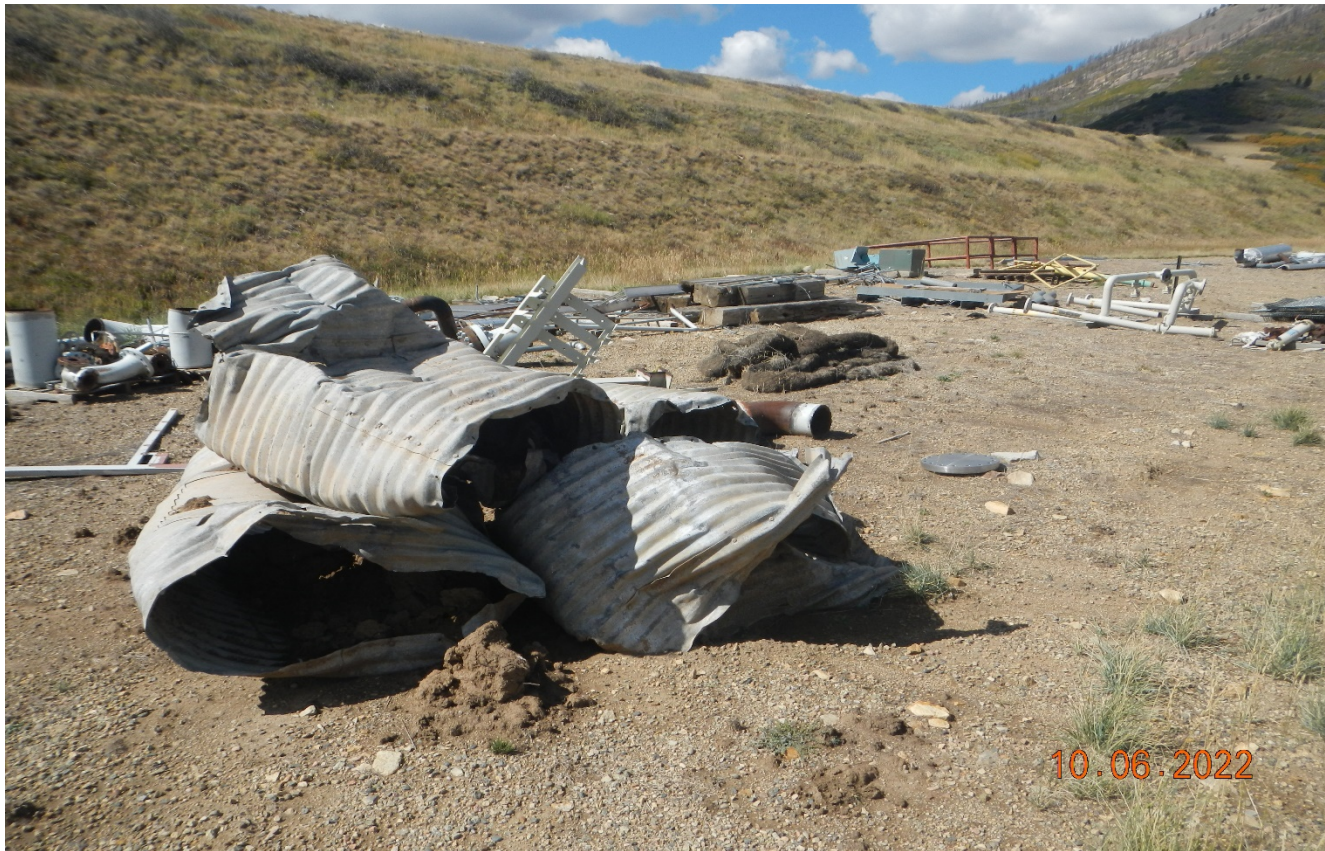
**Photo 6.** Facing northwest at the location. There is various unused equipment and trash debris stored in this area. The damaged culverts and degraded wattle are now stored in this area and need to be removed.
