Inspection Photos

API: 055-06037

Operator: OXY USA INC

Inspection Date: 10/6/2022

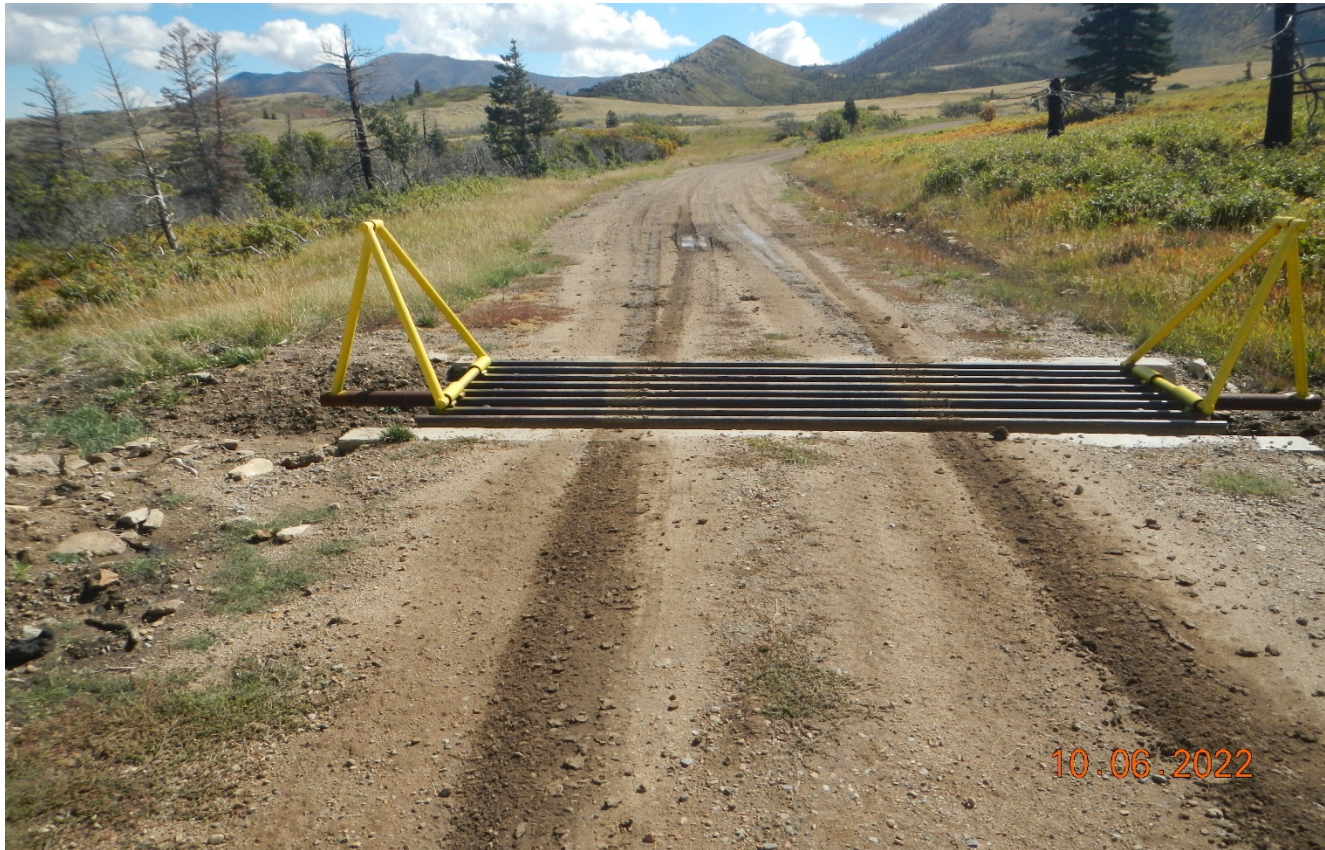
Photo 1. The cattle guard is damaged and needs to be repaired or removed.

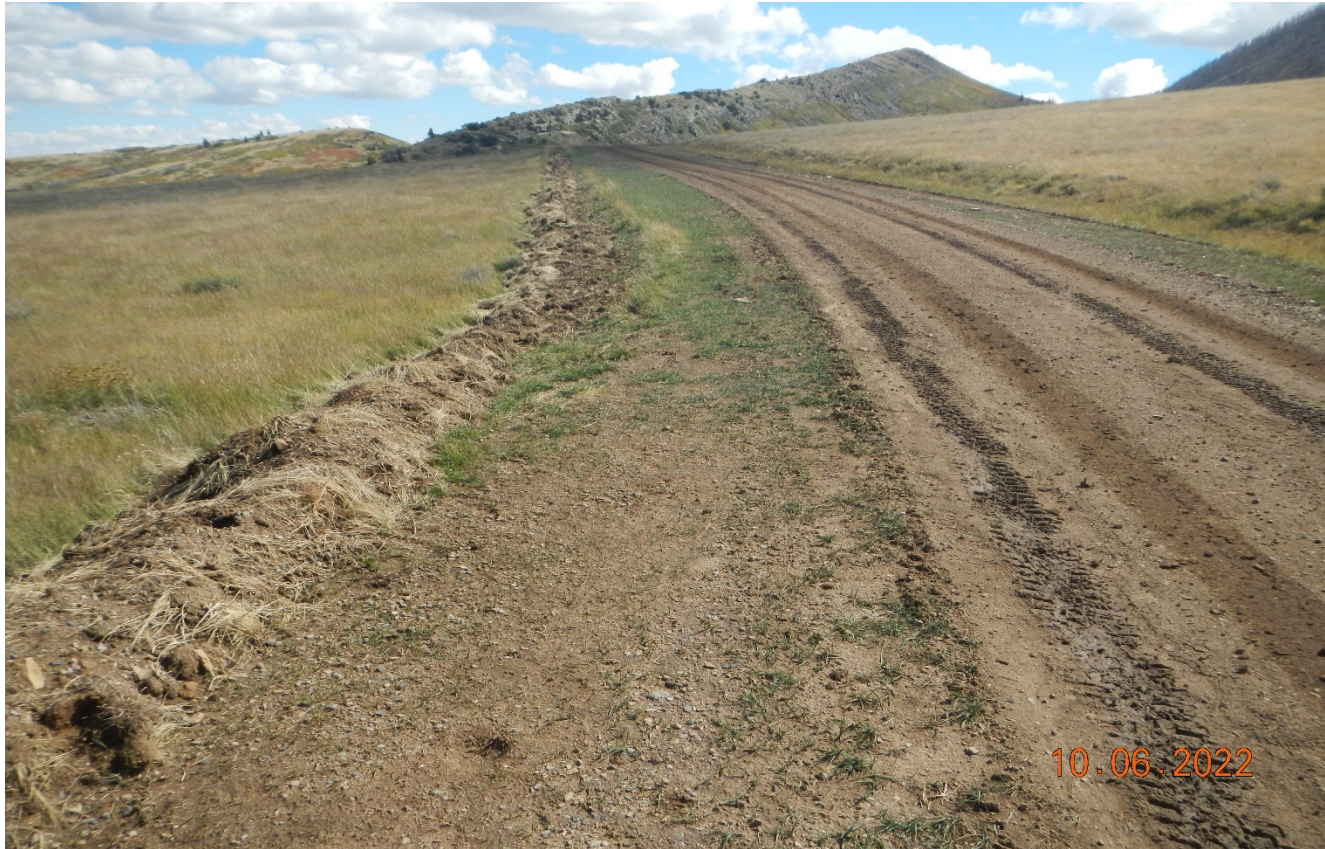
Photo 2. There has been grading performed along the road however, gravel material has been pushed off the road causing additional disturbance

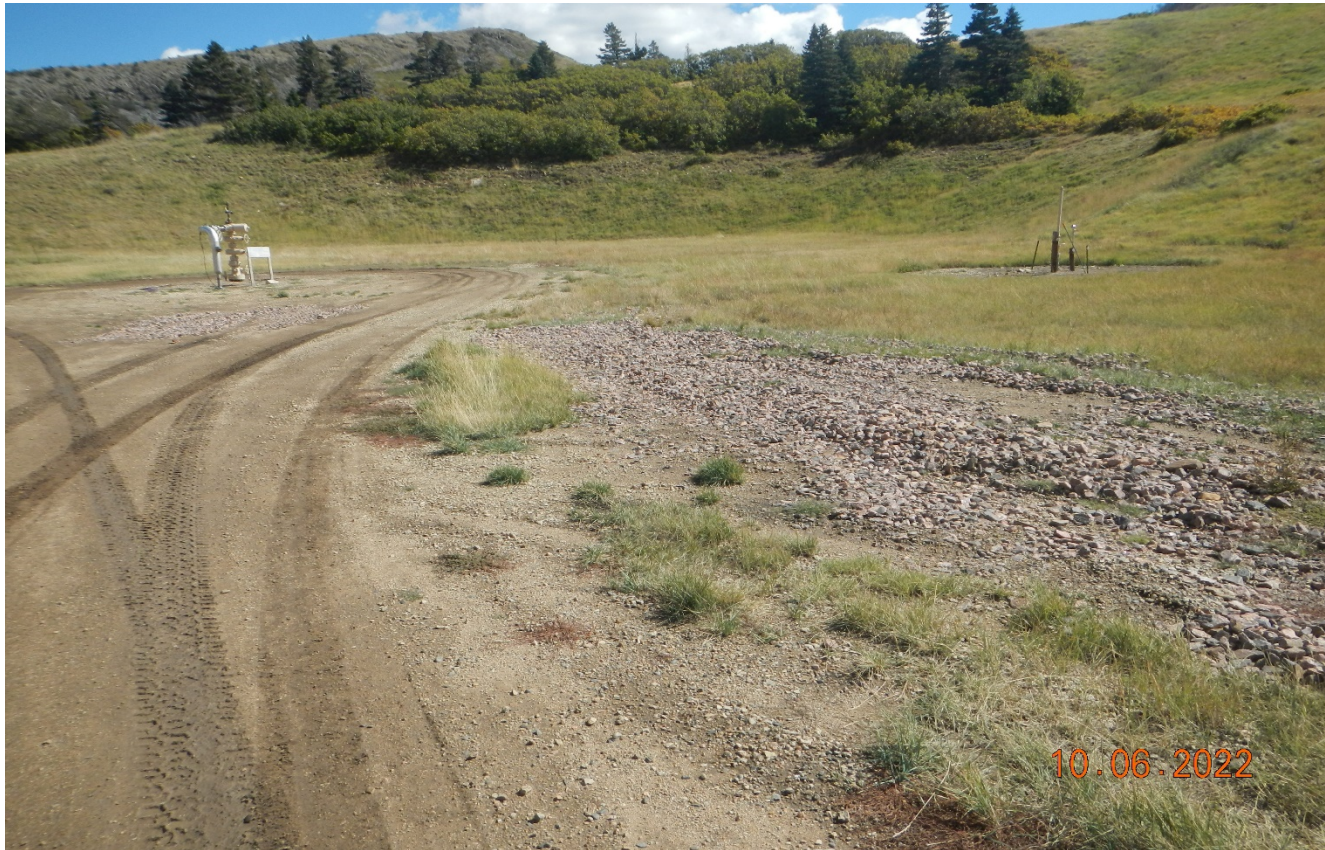
Photo 3. Facing southeast toward the well site. The gravel debris still remains and was just pushed out disturbing interim reclamation.

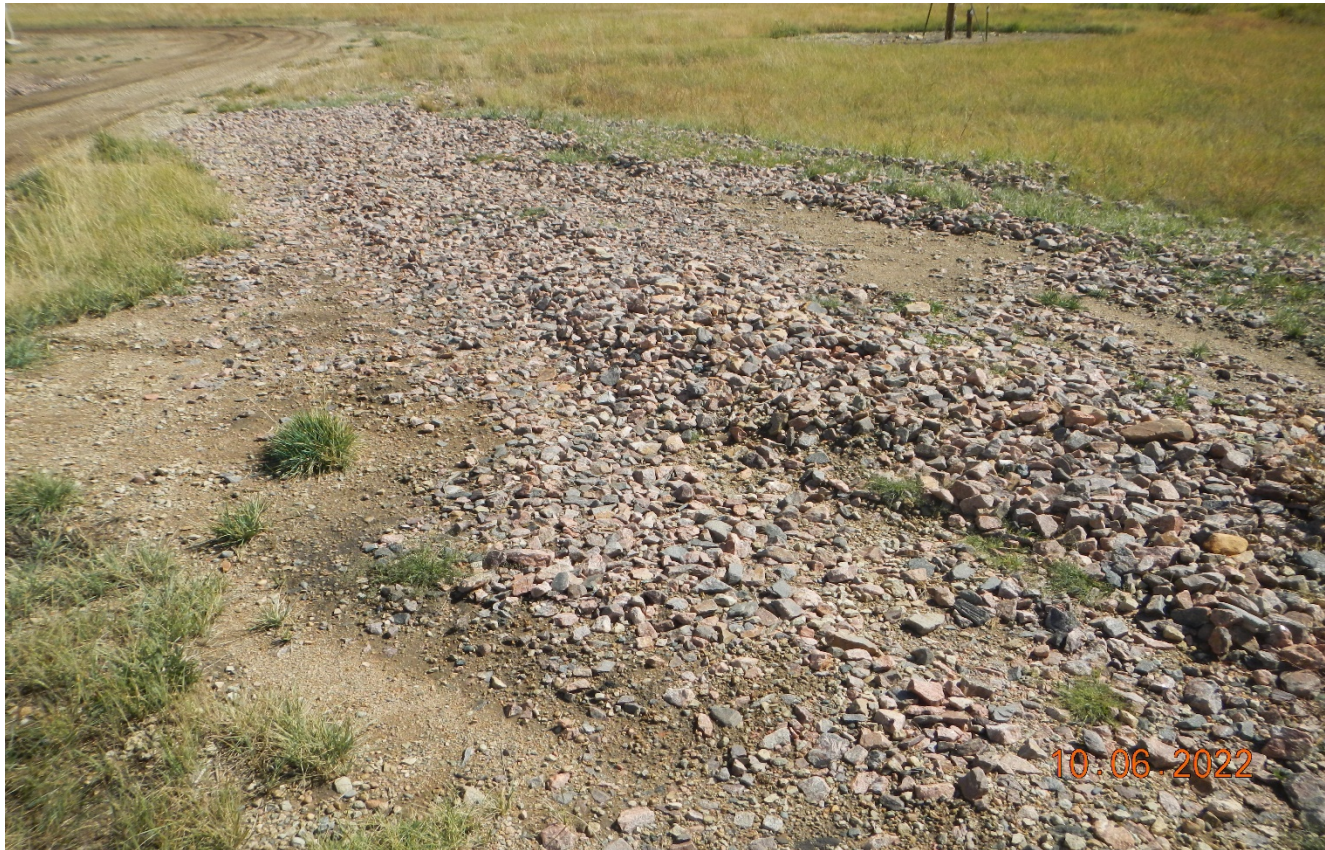
Photo 4. There is gravel debris from a pile stored on location. The leftover gravel needs to be removed. This disturbance area needs to be reclaimed.

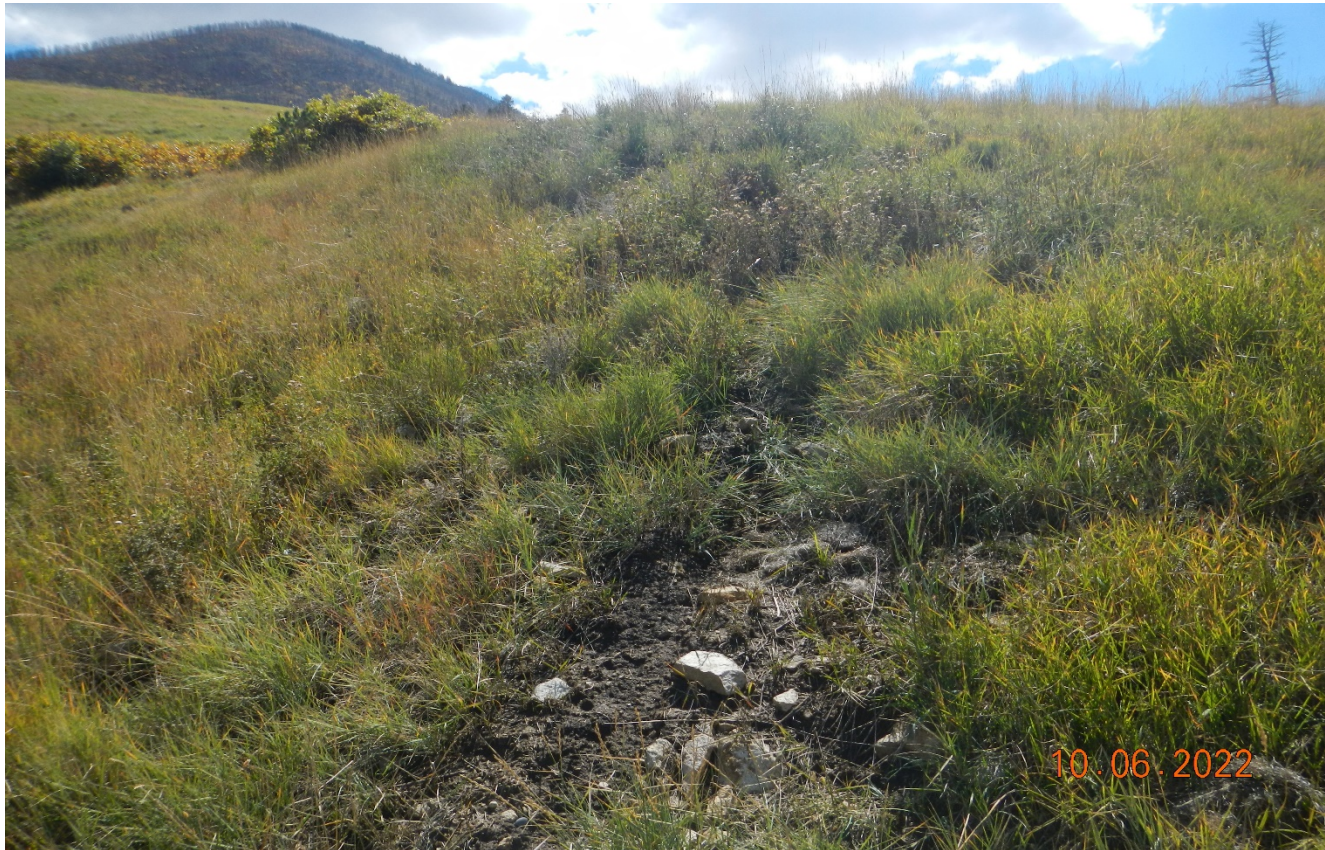
Photo 5. The degraded wattles were removed. There are still noxious weeds in this area that need to be controlled.
